# STRENGTHENING OF KEYED LONGITUDINAL CONSTRUCTION JOINTS IN RIGID PAVEMENTS

R. W. Grau

Army Engineer Waterways Experiment Station

TECHNICAL REPORT NO. AFWL-TR-72-174

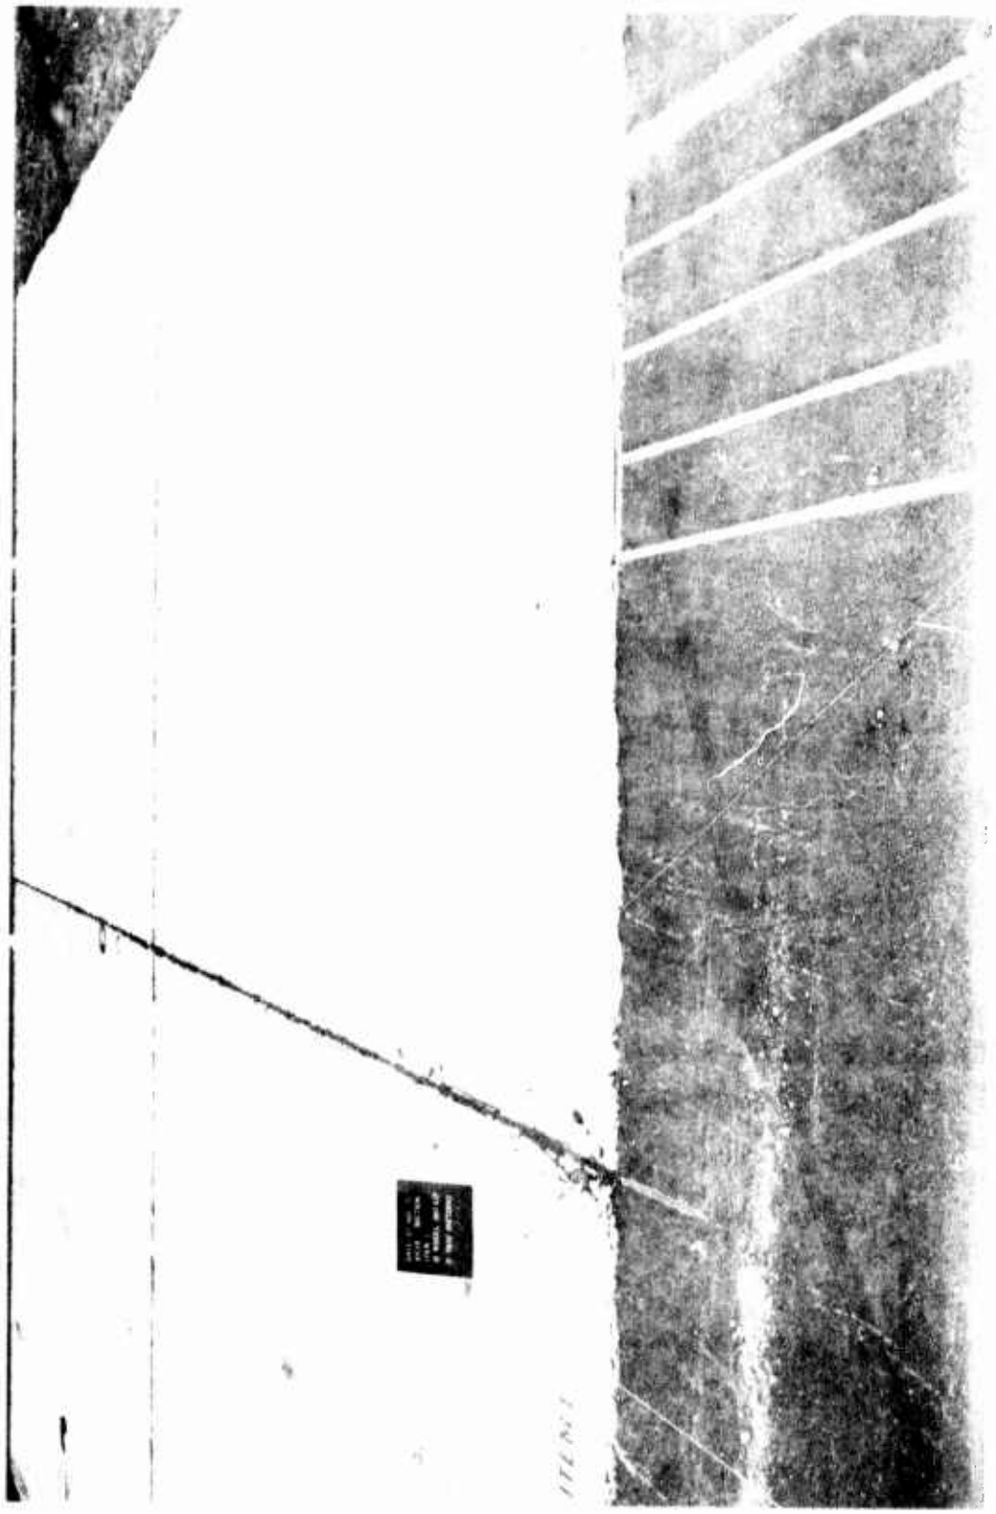
A general view of test item 1 prior to traffic is shown in figure 27. As can be seen in this photograph, both the southwest and northwest slabs contained longitudinal cracks prior to traffic. The crack in the southwest slab began at the west end of the item about 9 ft from the south free edge and ran approximately 13 ft longitudinally into the slab. The crack in the northwest slab began at the west edge of the item and ran 21 ft longitudinally through the center of the slab. Neither of these cracks was located inside the 200-in.-wide traffic lane.

Figure 27. General view of item 1 prior to test traffic.

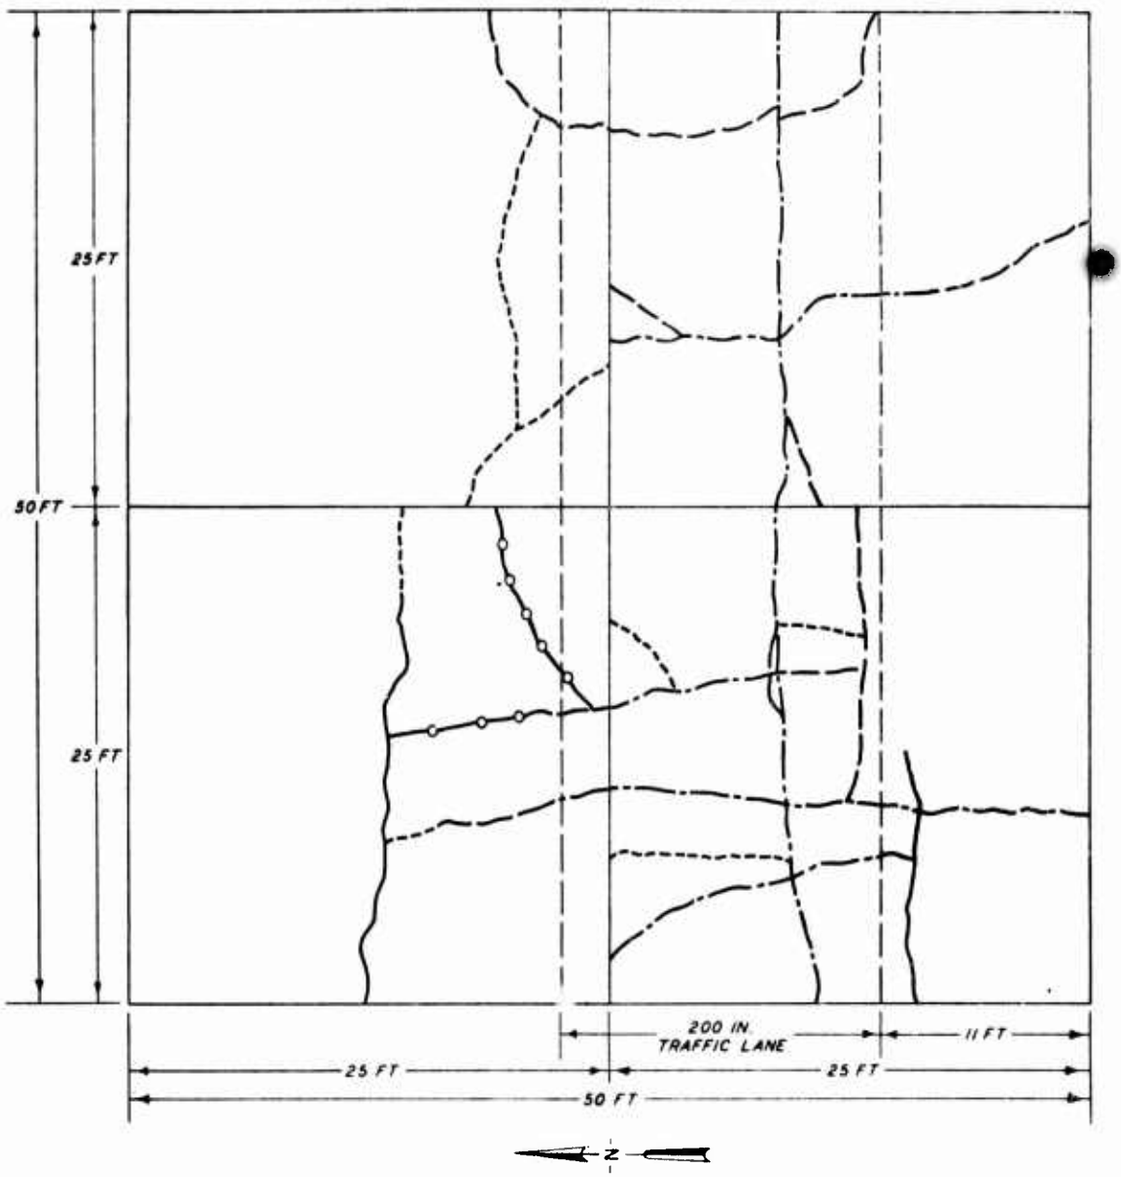
After one pattern of test traffic (16 coverages), flaking and spalling were evident along the edges of the existing cracks. Initial cracking due to test traffic occurred in the southwest slab at about 54 coverages. This cracking consisted of a 25-ft-long longitudinal crack about 10 ft south of the longitudinal construction joint and a transverse crack in about the center of the slab extending from the construction joint to the longitudinal crack. Between 54 and 144 coverages, cracks developed very rapidly in the two south slabs of the item. After 144 coverages, the surfaces of the southwest and southeast slabs were subdivided into 7 and 4 pieces, respectively, as shown in figure 28. Although the southwest slab met the shattered-slab failure criterion after 144 coverages, traffic was continued because the longitudinal construction joint was performing satisfactory.

Figure 32. Crack development in item 1 under 360-kip, 12-wheel-assembly traffic.

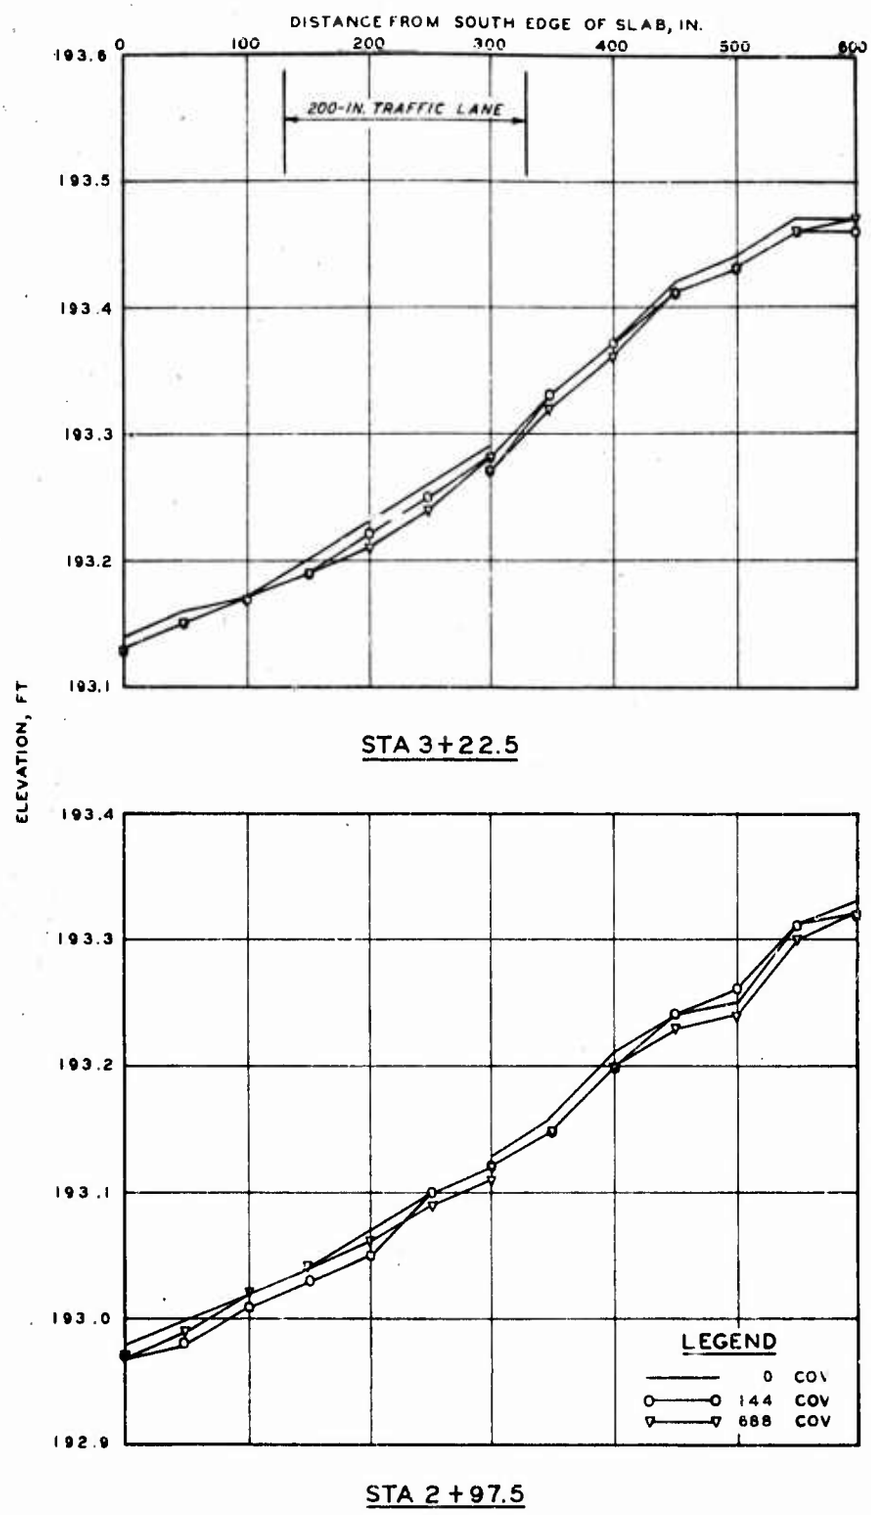
Figure 34. Typical cross sections of item 1, 360-kip, 12-wheel-assembly lane.

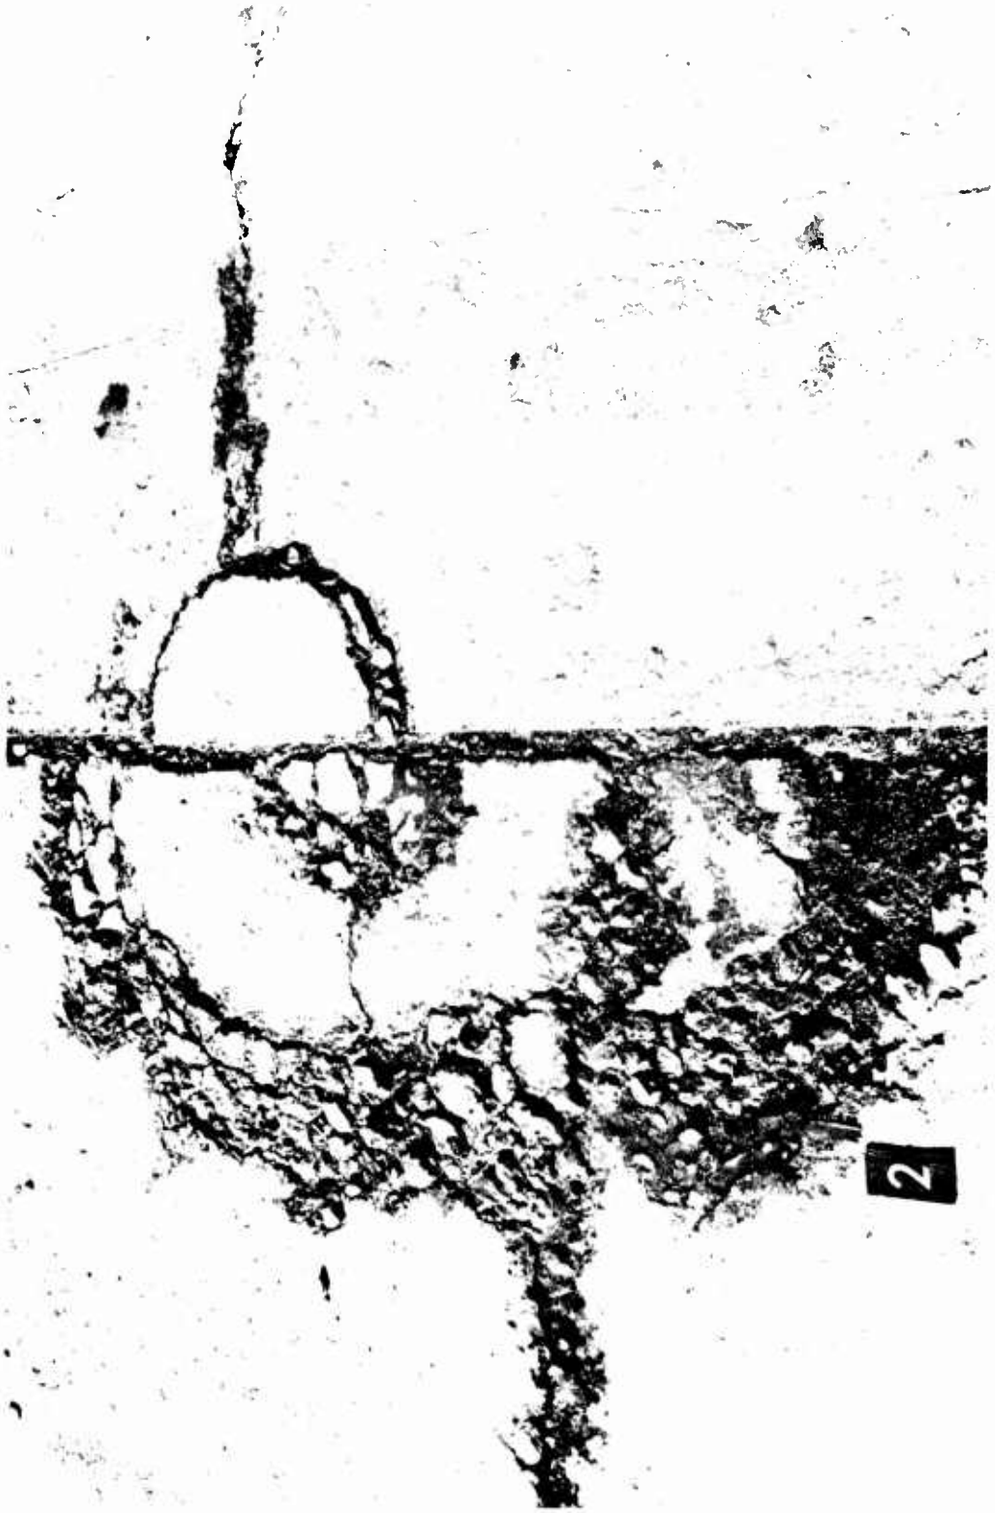
Figure 40. View of under-grouted joint in item 2, 360-kip, 12-wheel-assembly lane after 816 coverages.

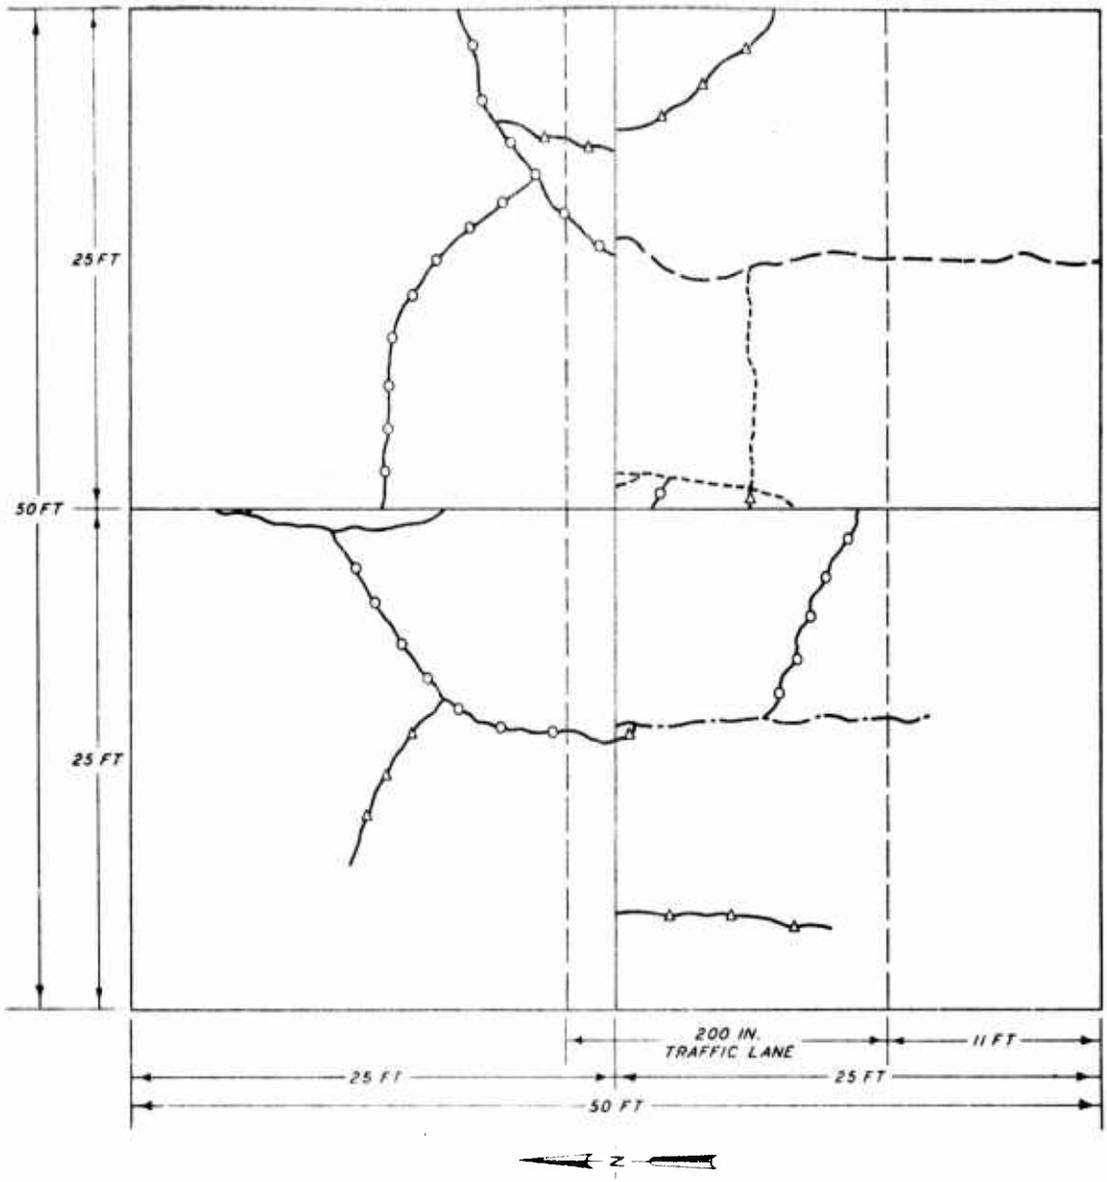
Figure 42. Crack development in item 2 under 360-kip, 12-wheel-assembly traffic.

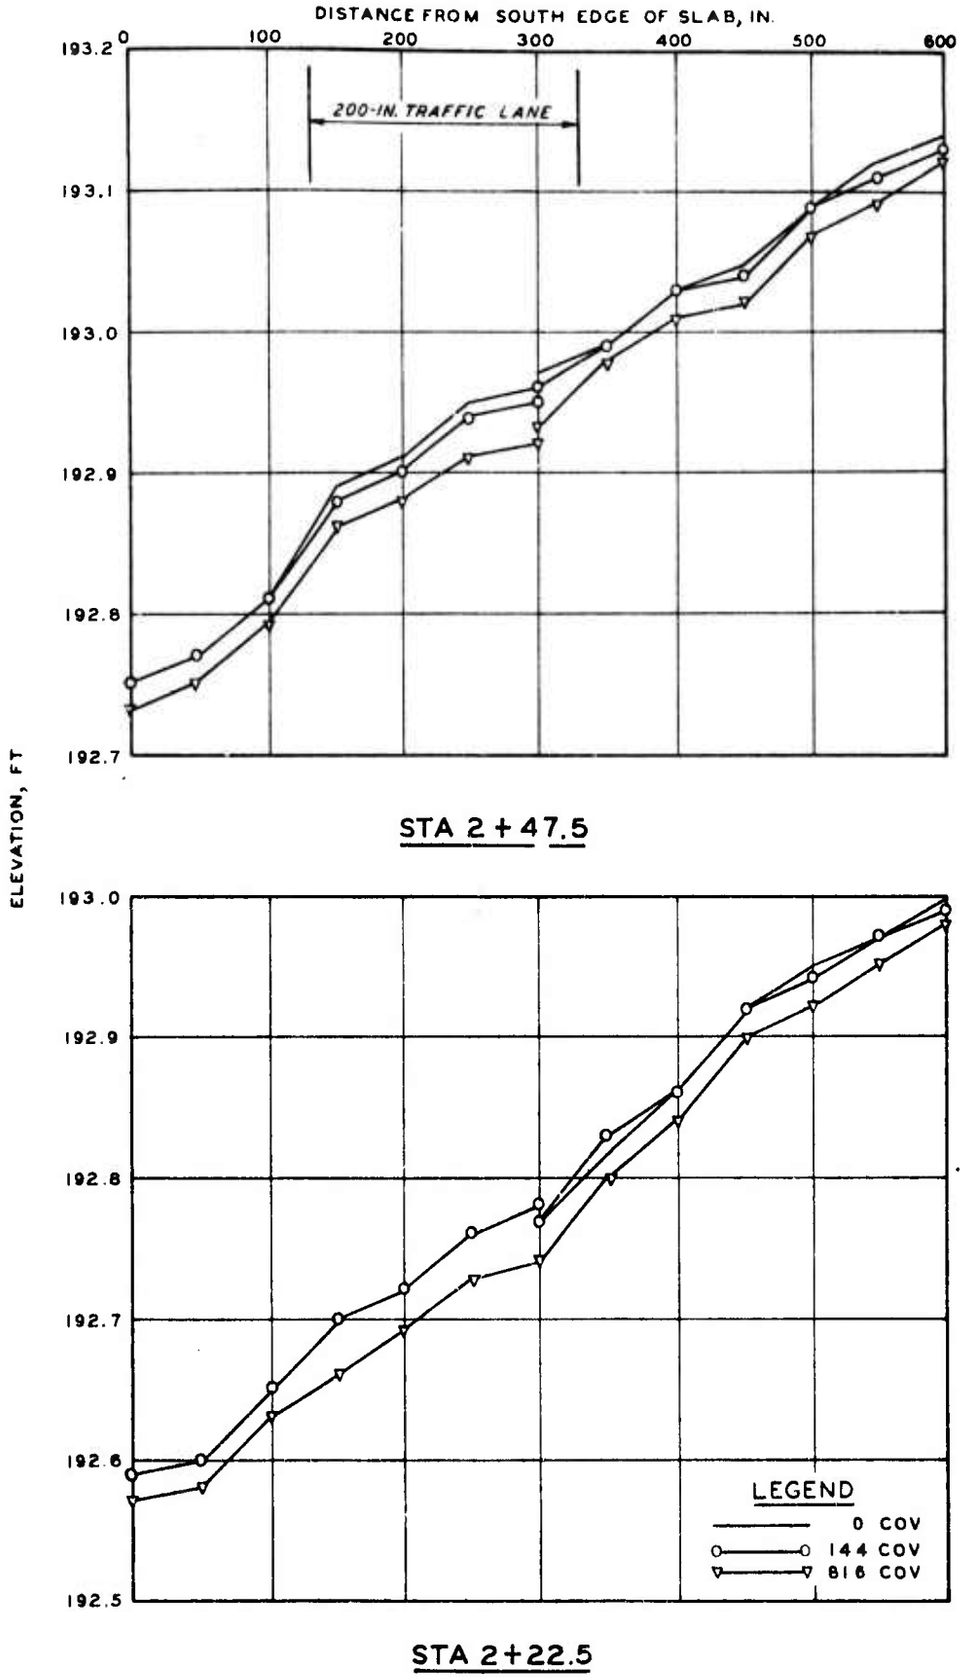
Figure 43. Typical cross sections of item 2, 360-kip, 12-wheel-assembly lane.

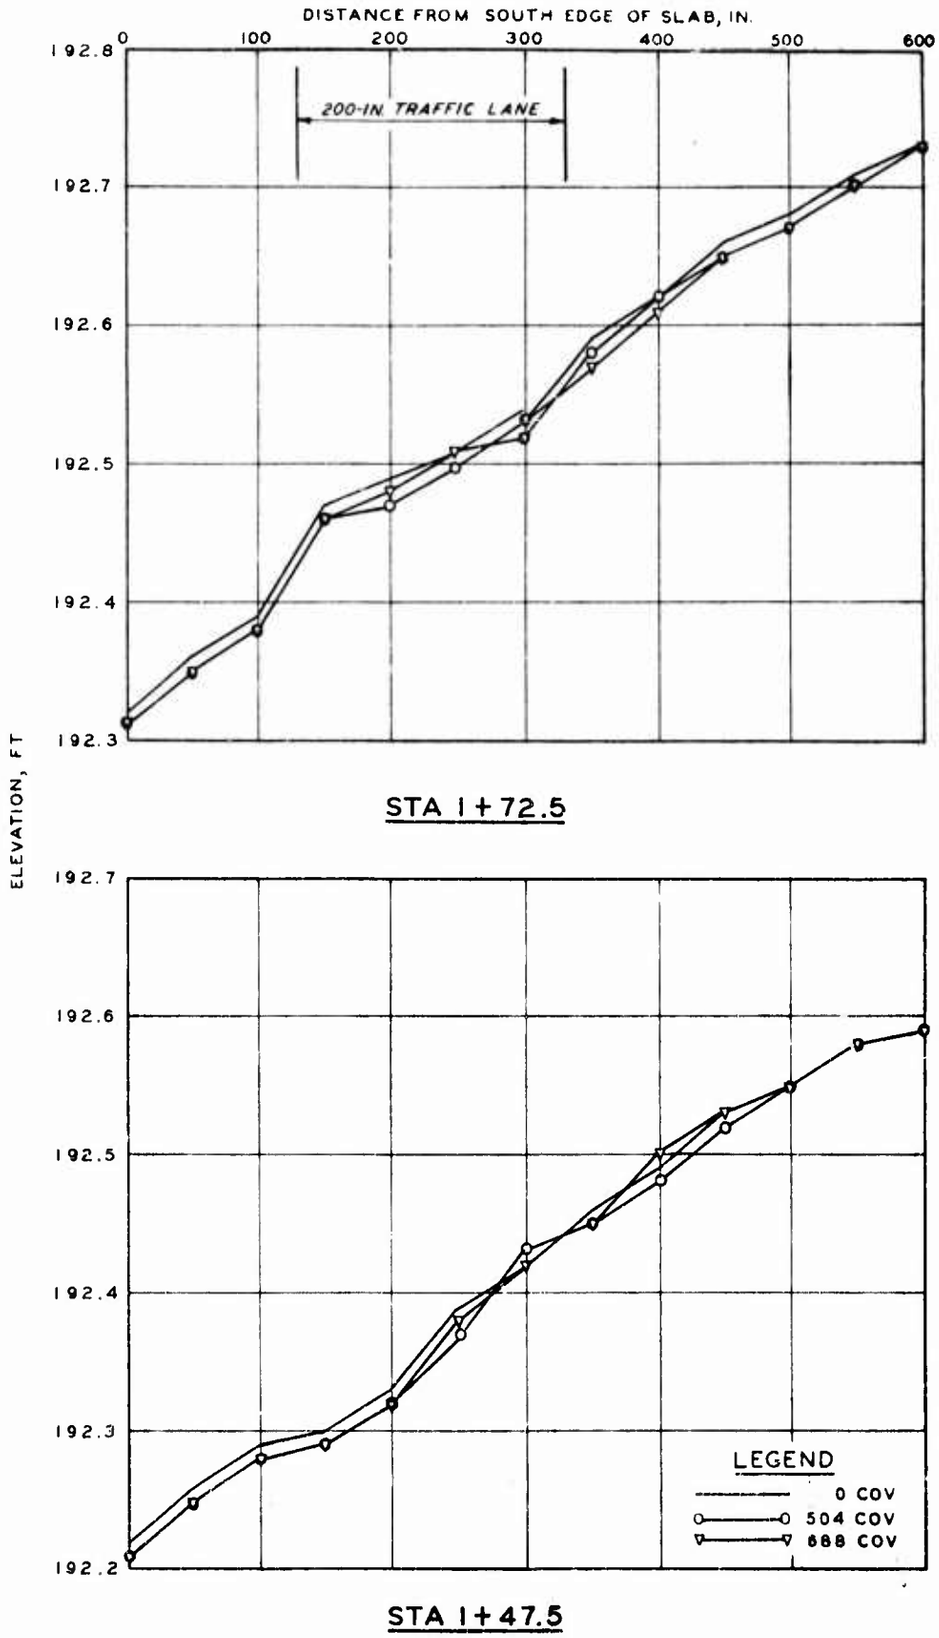
Figure 52. Typical cross sections of item 3, 360-kip, 12-wheel-assembly lane.

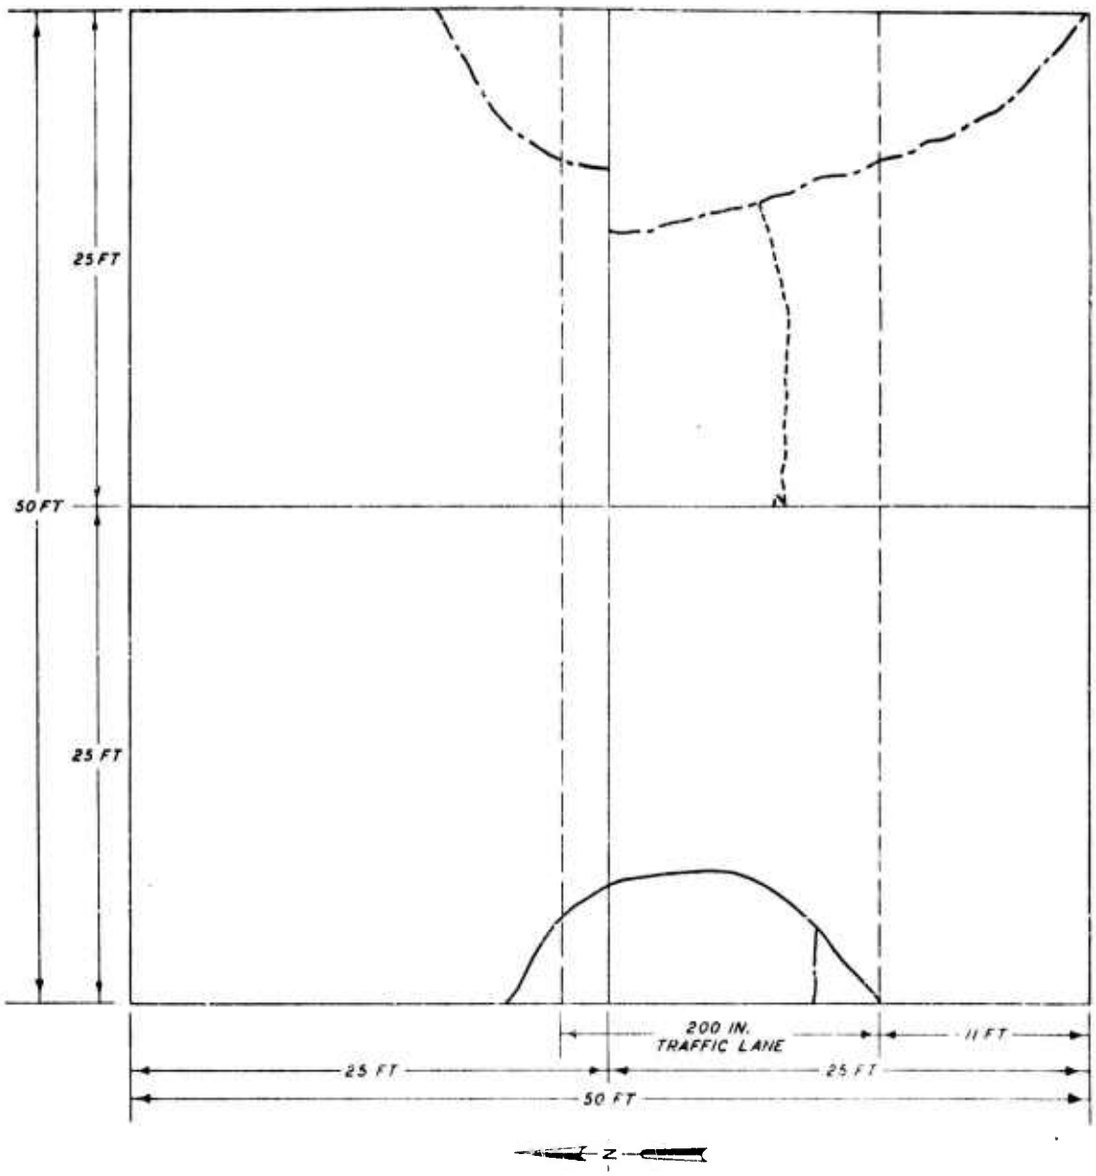
At the end of traffic (6336 coverages), the entire item was rated as in satisfactory condition, and the longitudinal construction joint was in excellent condition. Very little spalling was observed during the trafficking of this item. Traffic was discontinued because indications were that a large number of coverages would be required to produce a shattered-slab failure condition in the interior portion of the test item. It should be pointed out that the transition slabs were constructed directly on the clay subgrade during the initial construction of the MWHGL test section and were left in place for this test. This resulted in the pumping problem as discussed above. There was no evidence of subgrade pumping through the stabilized base course at any location in the test item.

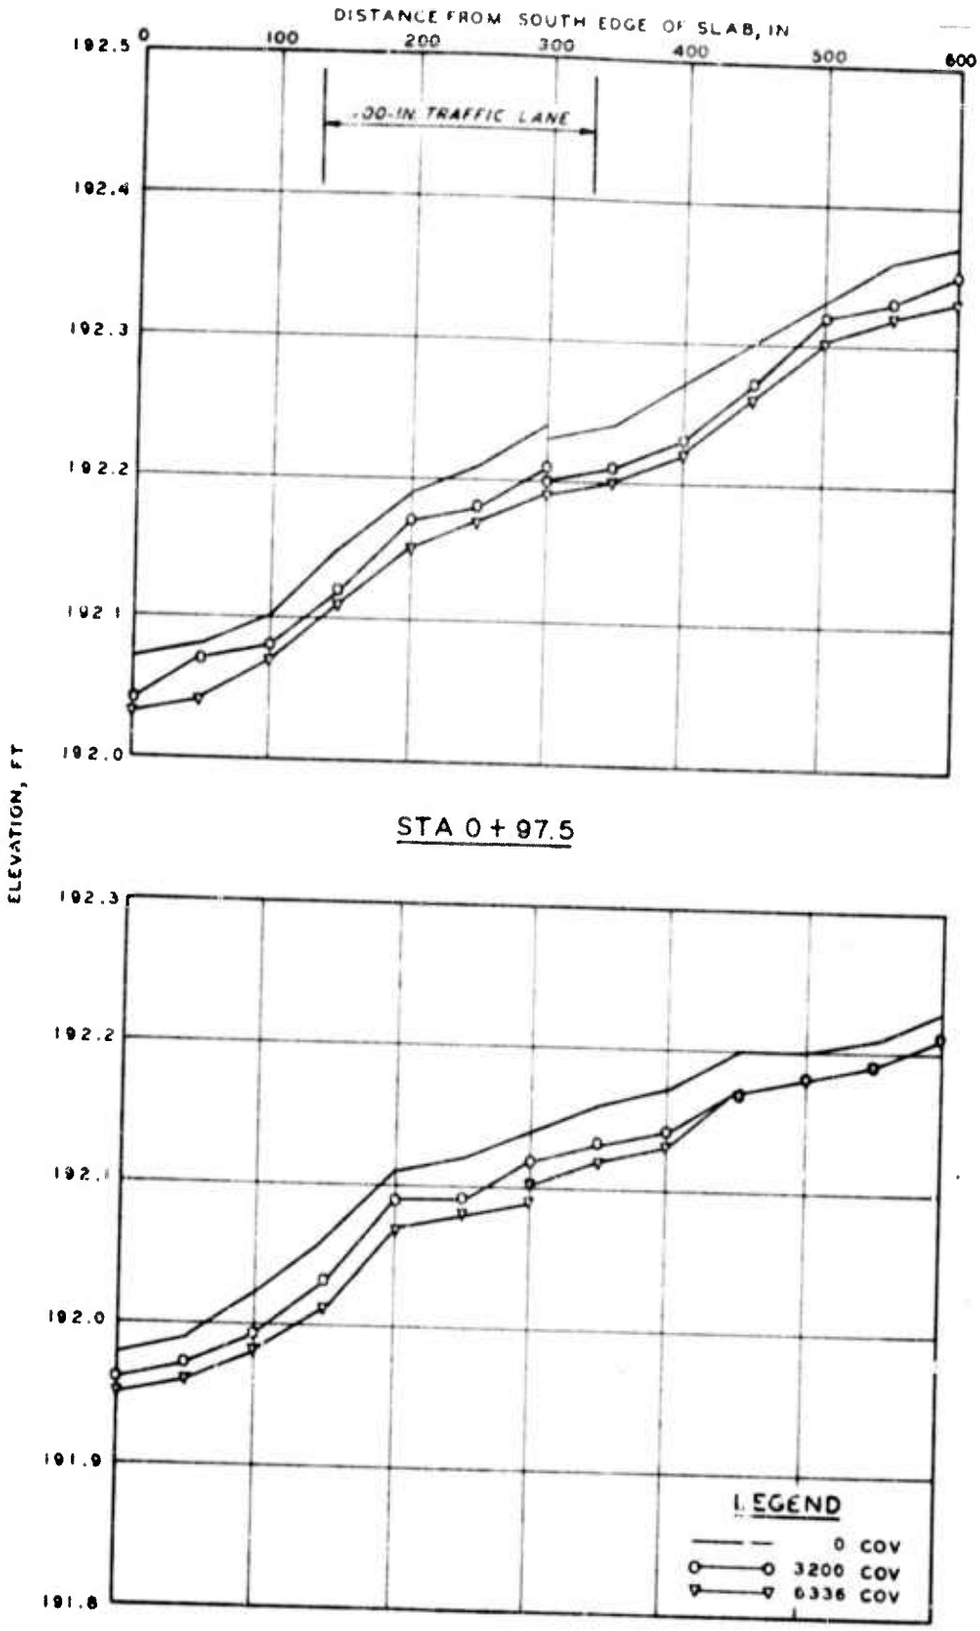
Figure 58. Typical cross sections of item 4, 360-kip, 12-wheel-assembly lane.

A typical cross section for this item indicating the permanent deformation due to traffic is shown in figure 58. The average permanent deformation was about 0.48 in. and the maximum deformation was 0.60 in. This plot indicates that about 75 percent of the average

permanent deformation occurred between 0 and 3200 coverages with the remaining 25 percent occurring between 3200 and 6336 coverages.

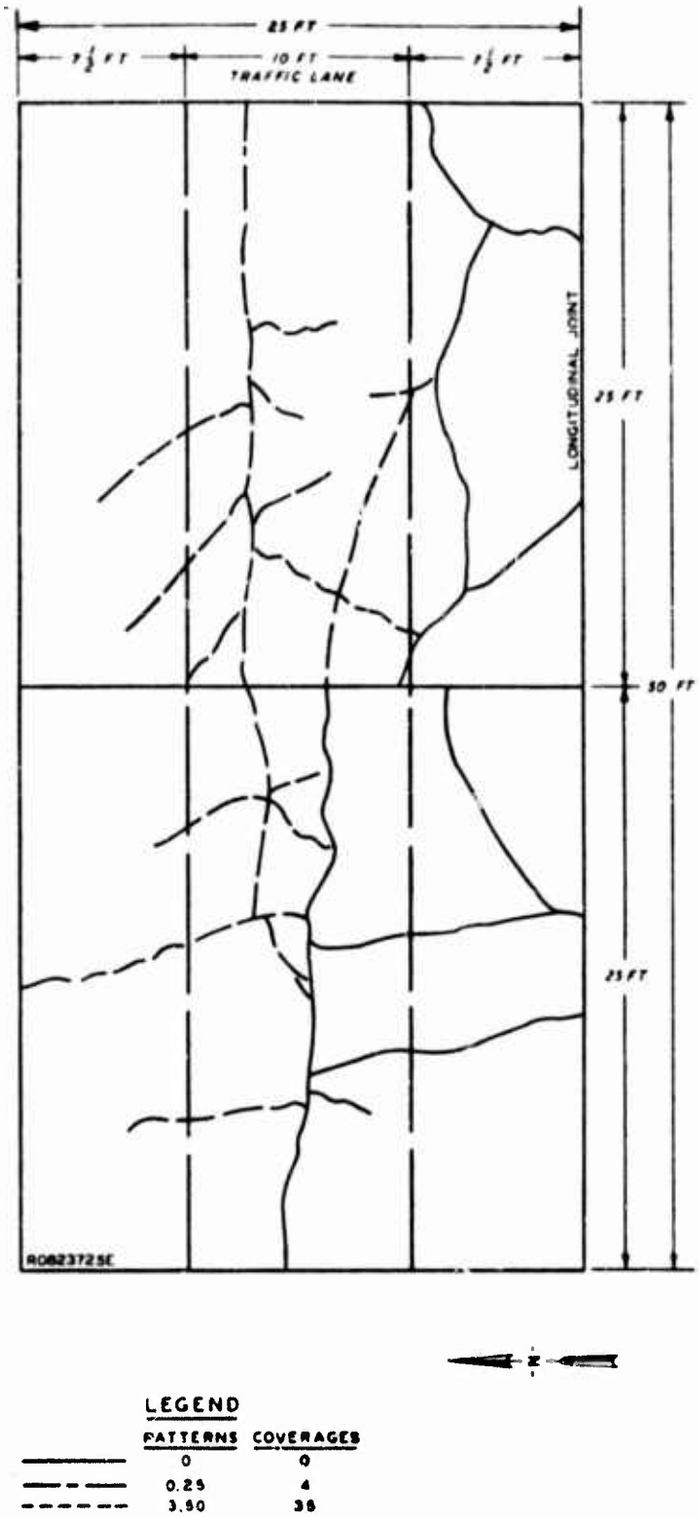
Figure 62. Crack development in item 1 under 166-kip, twin-tandem-assembly traffic.

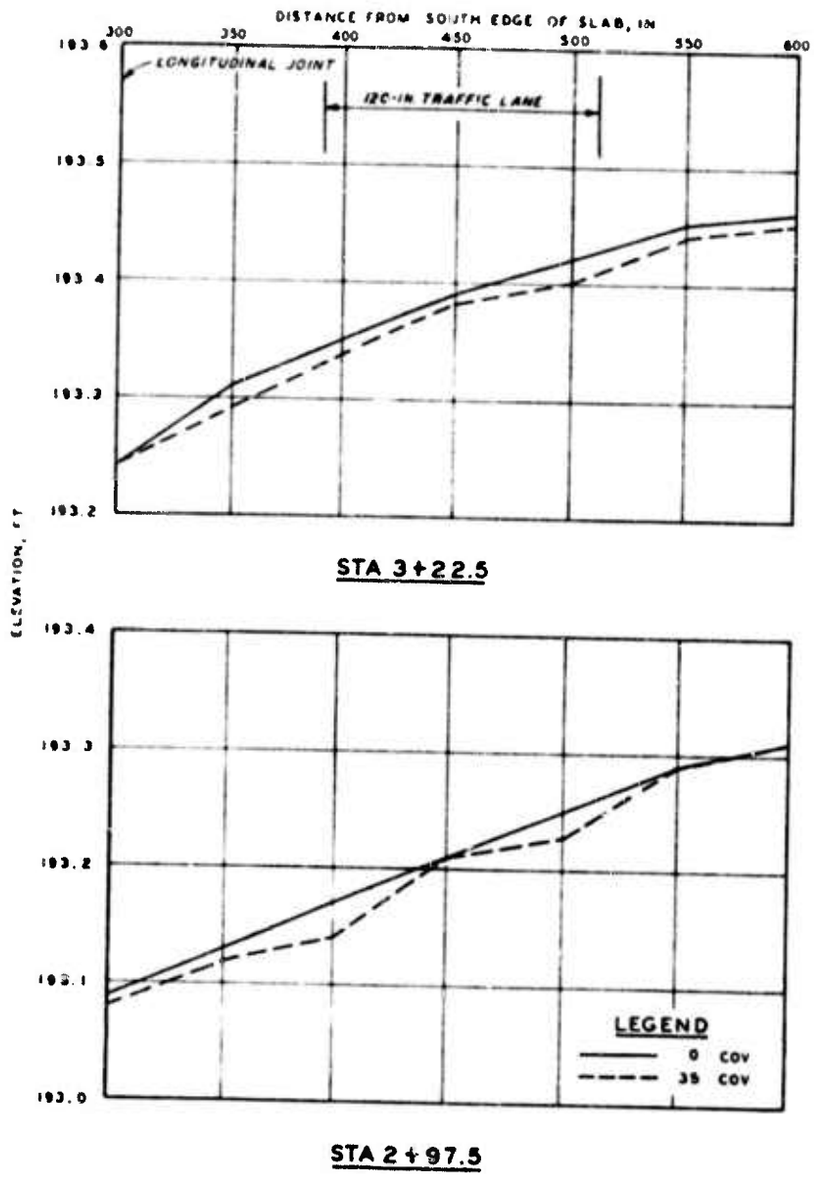
Figure 63. Typical cross sections of item 1, twin-tandem-assembly lane.

Typical permanent deformations, which occurred as a result of traffic, are shown by the typical cross-sections taken at the center of each slab (figure 63). Anaverage deformation of about 0.15 in. and a maximum of 0.36 in. were recorded. The maximum total deflection measured prior to traffic was about 0.12 in. Plots of deflection measurements taken prior to traffic are shown in figure 64.

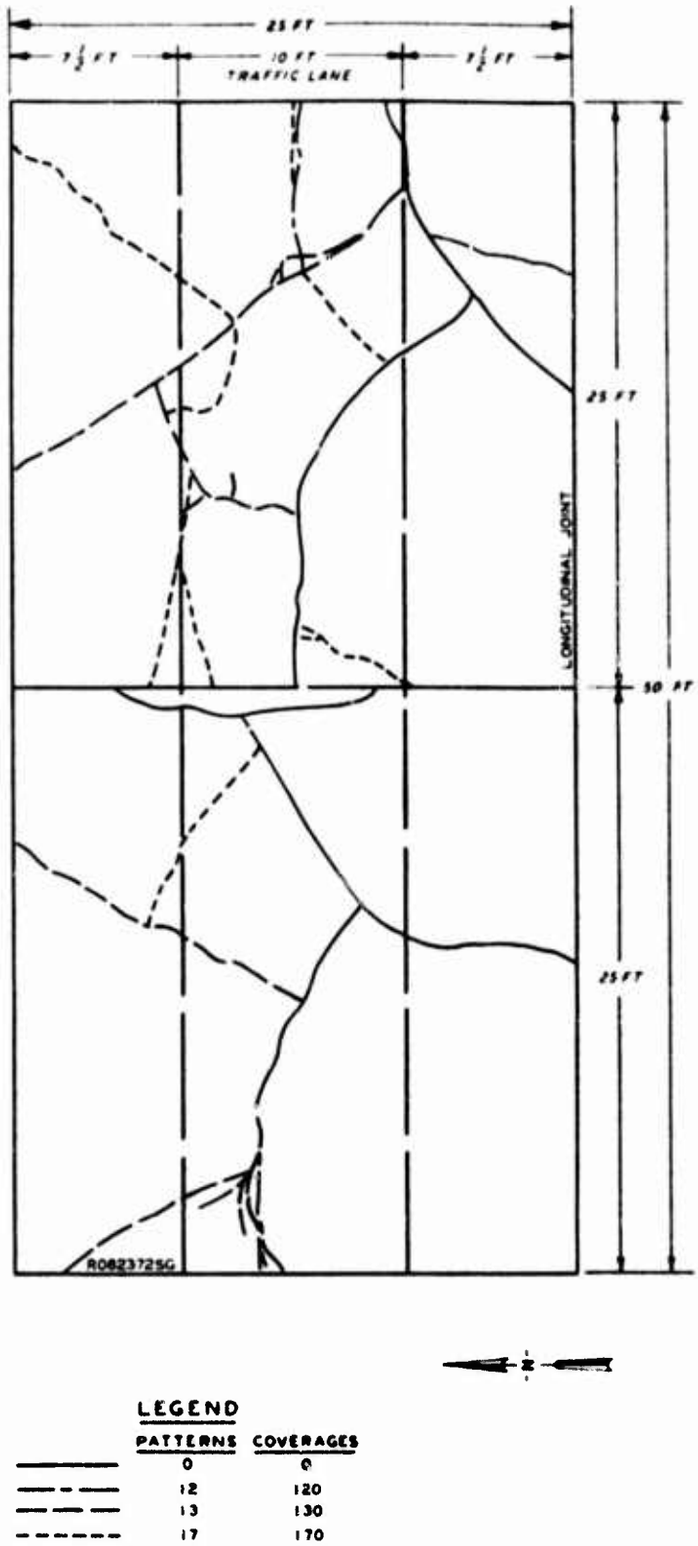
Figure 67. Crack development in item 2 under 166-kip, twin-tandem-assembly traffic.

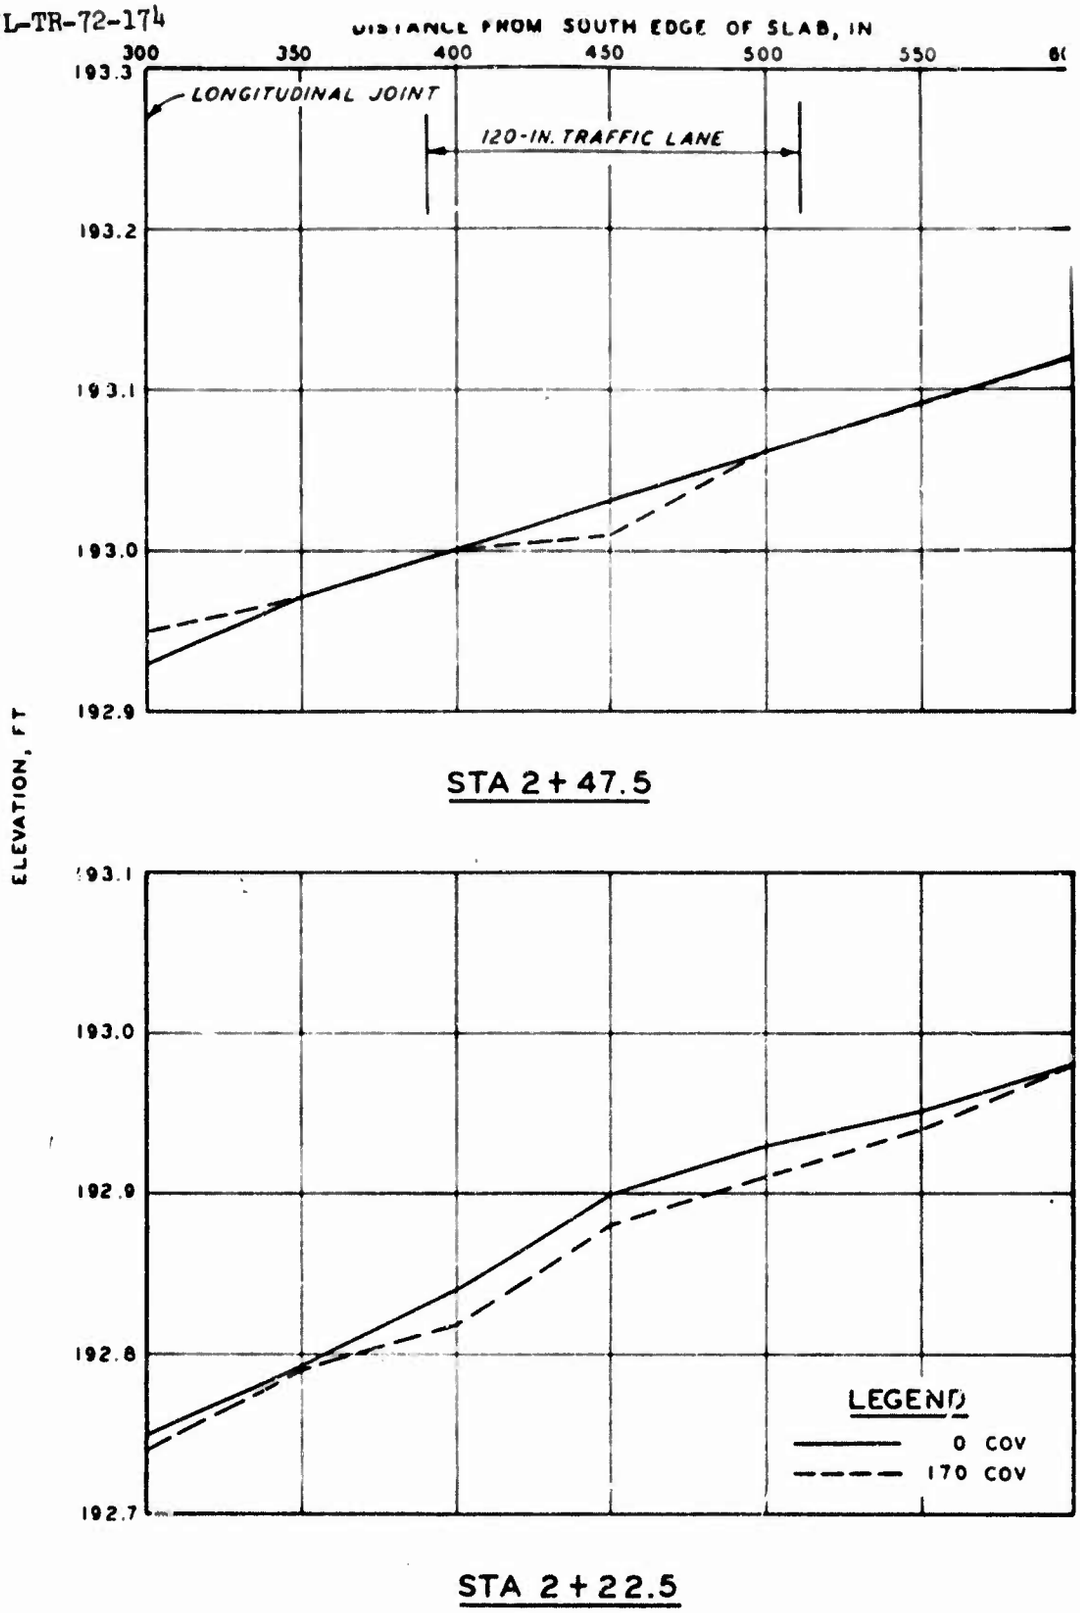
Figure 68. Typical cross sections of item 2, 166-kip, twin-tandem-assembly lane.

Typical cross-section plot showing the permanent deformation that occurred during traffic is shown in figure 68. The maximum deformation measured at the conclusion of traffic was 0.24 in. As shown in figure 69, a maximum total deflection of about 0.13 in. was measured prior to traffic.

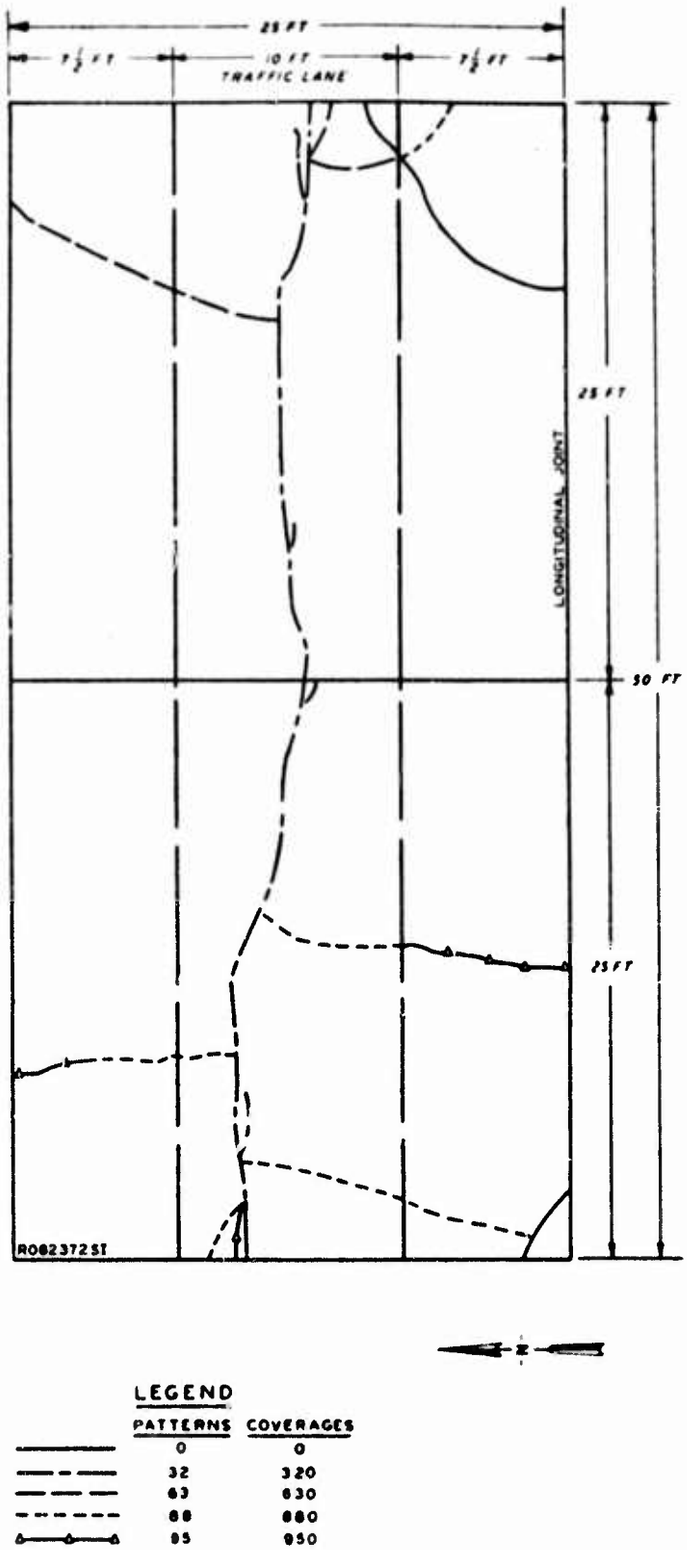
Figure 72. Crack development in item 4 under 166-kip, twin-tandem-assembly traffic.

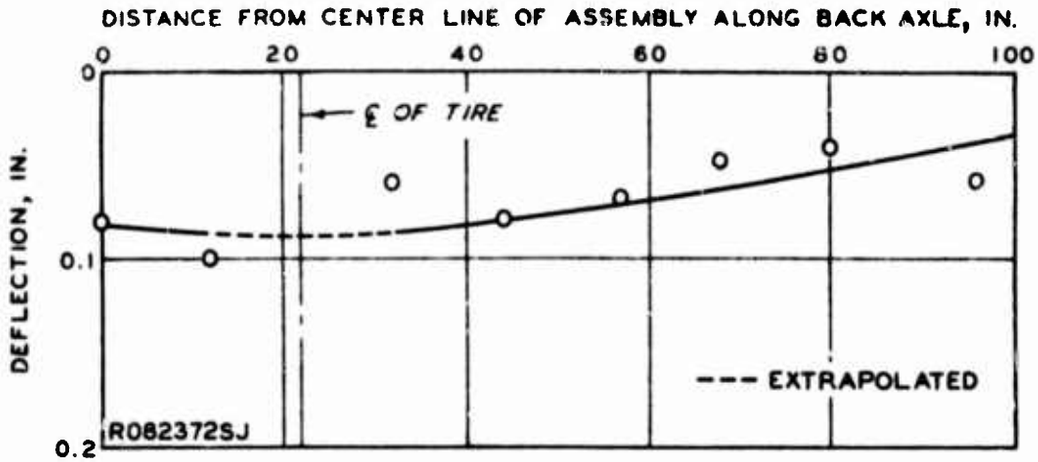
Figure 74. Total deflection in item 4, 166-kip, twin-tandem-assembly lane measured prior to traffic.

The maximum total deflection measured prior to traffic was about 0.09 in. A plot of the deflection basin measured before applying test traffic is shown in figure 74. As can be seen from the typical cross-section plots shown in figure 75, the average permanent deformation after failure was about 0.18 in., and the maximum permanent deformation was 0.24 in.
