HELICOPTER ICING SPRAY SYSTEM QUALIFICATION

Army Aviation Systems Test Activity
Edwards Air Force Base, California

October 1973

1. REPORT NUMBER: USAASTA PROJECT NO. 72-35

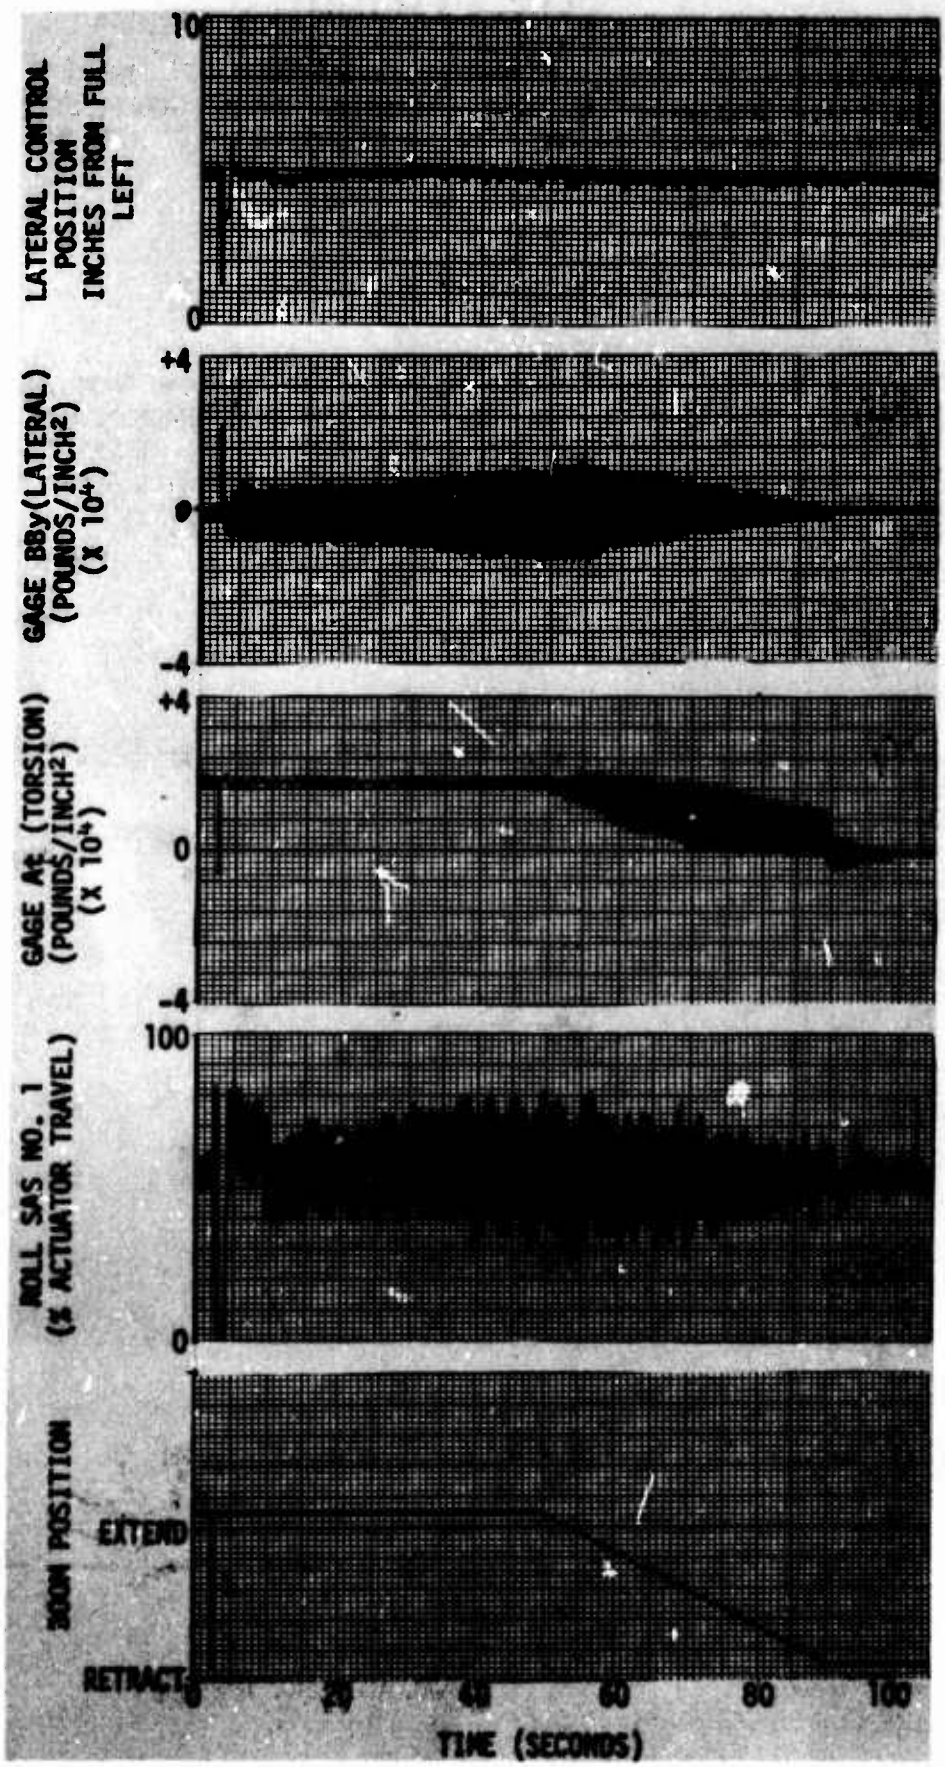
FIGURE C
SHORT BOOM DIVERGENCE
CH-47C S/N 15814

16. The dynamic stability characteristics of the CH-47C helicopter equipped with the short and long boom icing spray systems were investigated in hover, sideward, rearward, and level flight. The short boom system was tested first and found unsatisfactory in the extended position due to divergent lateral boom oscillation

at all conditions evaluated. Boom lateral divergence in the extended position was only present with the aircraft SAS operating and was discovered to be a lateral SAS-reinforced oscillation occurring at a frequency of approximately 2 Hz, which, as seen in figure 5, appendix F, diverged following a lateral pulse in a hover. Figure 6 shows the same condition with SAS OFF and a very low positive damping was present. With SAS OFF, moderate pilot effort is required to obtain the desired flight condition (HQRS 4). Level flight with the SAS operating was not possible with the short boom in the extended position without lateral boom oscillations, which were excited by natural aircraft motion (fig. 7). Operating with the SAS disabled eliminated boom lateral divergence but low damping was still present (fig. 8).

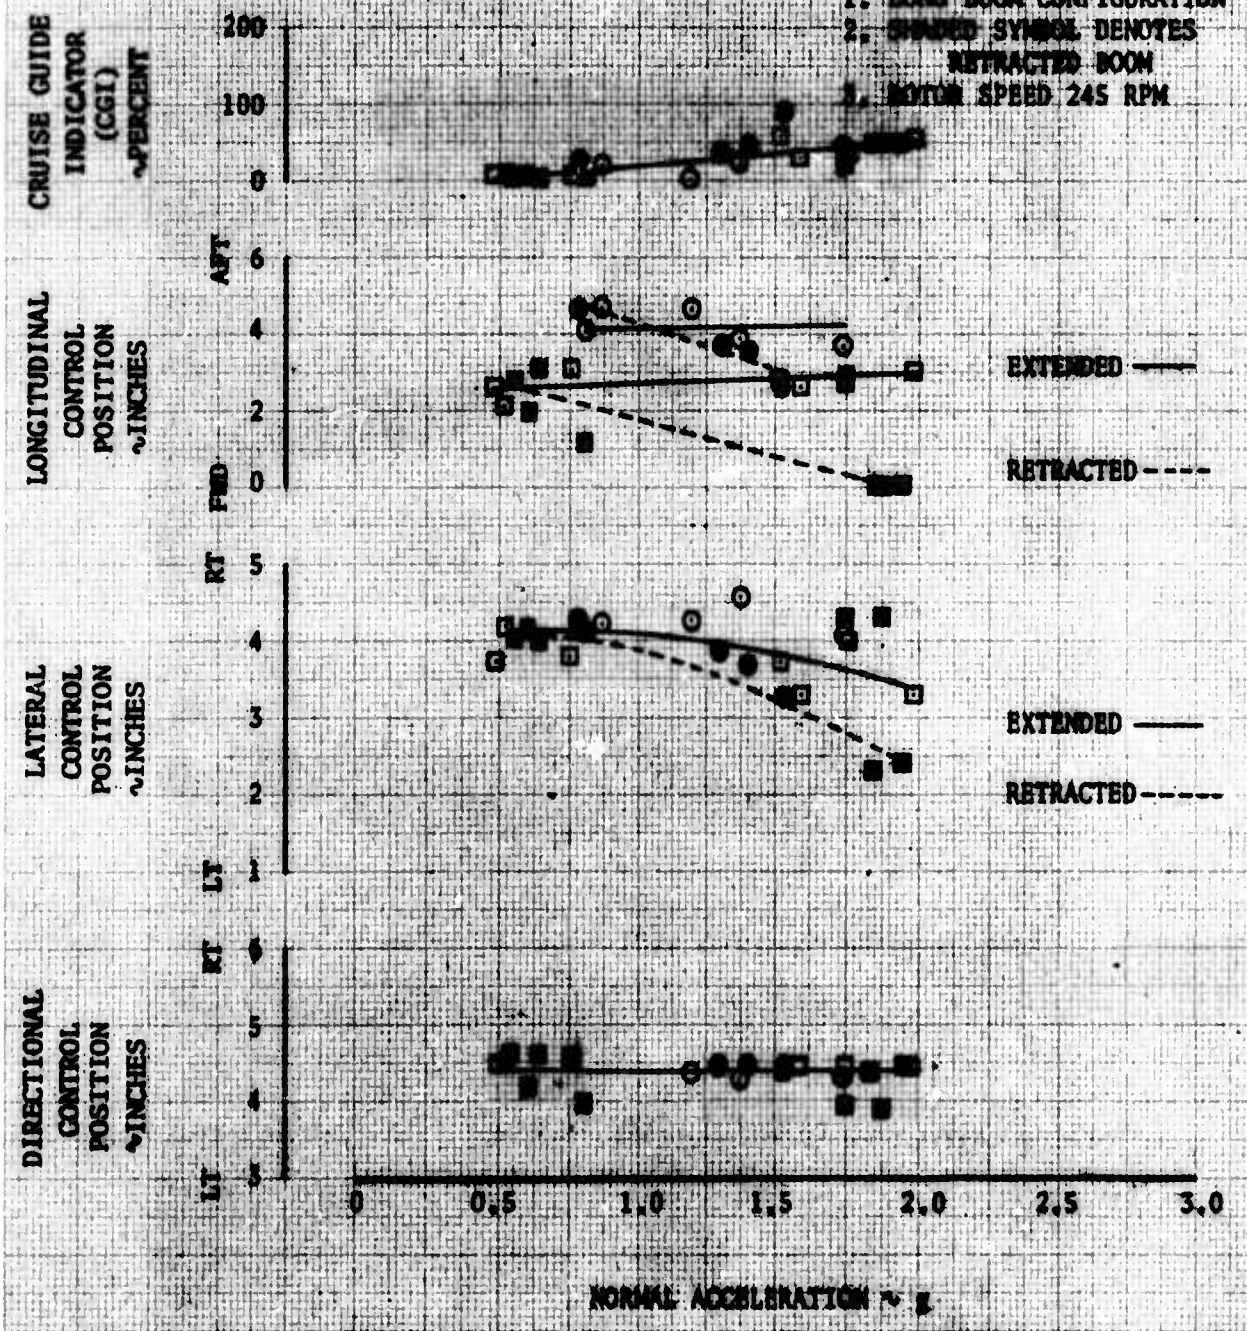
FIGURE 9

system possessed negative longitudinal maneuvering stability in the retracted boom configuration, as evidenced by an increased forward longitudinal control requirement with increasing load factor. No gradient change was experienced with variation in airspeed, although a pronounced gradient change was noted with variation in boom position. The longitudinal maneuvering stability of the CH-47C icing spray system was weakly positive for the extended boom configuration and appeared not to be a function of airspeed.

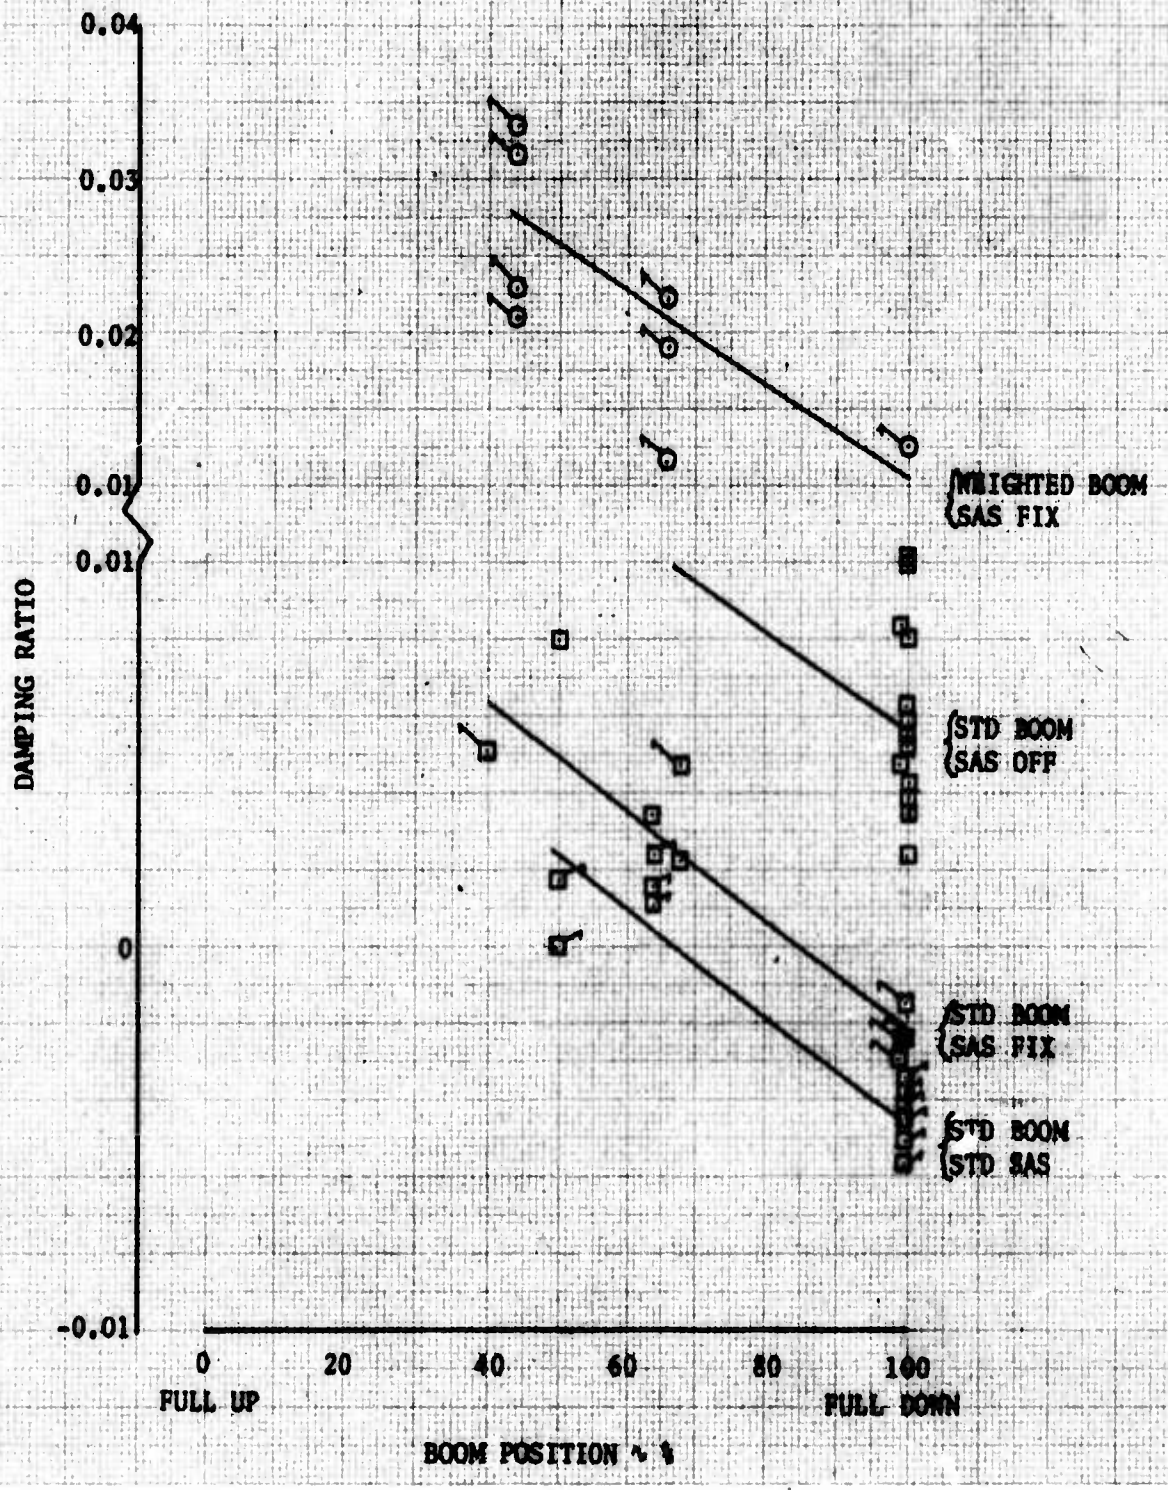
FIGURE E
DAMPING IN A HOVER
ICING SPRAY RIG SHORT BOOM CONFIGURATION

20. During envelope expansion, the short and long boom configurations were evaluated for dynamic response and divergent lateral oscillations were excited in the short boom configuration. Lateral spray boom divergence was first encountered in a hover when the natural frequency of the short spray boom in the extended position (- 1.85 Hz) coupled with the response frequency of the lateral SAS (- 2.0 Hz). The average damping ratio for this condition, as seen from figure E, was -0.005. No divergence was present with the SAS OFF, but the damping was insufficient. For normal operations pilot workload was moderate with the SAS inoperative (HQRS 4). Modification to the lateral SAS was limited to disconnecting the roll attitude feature, which, as seen in figure E, increased damping with the boom extended to -0.002. No further SAS modifications were made, due to possible degradation of aircraft handling qualities.

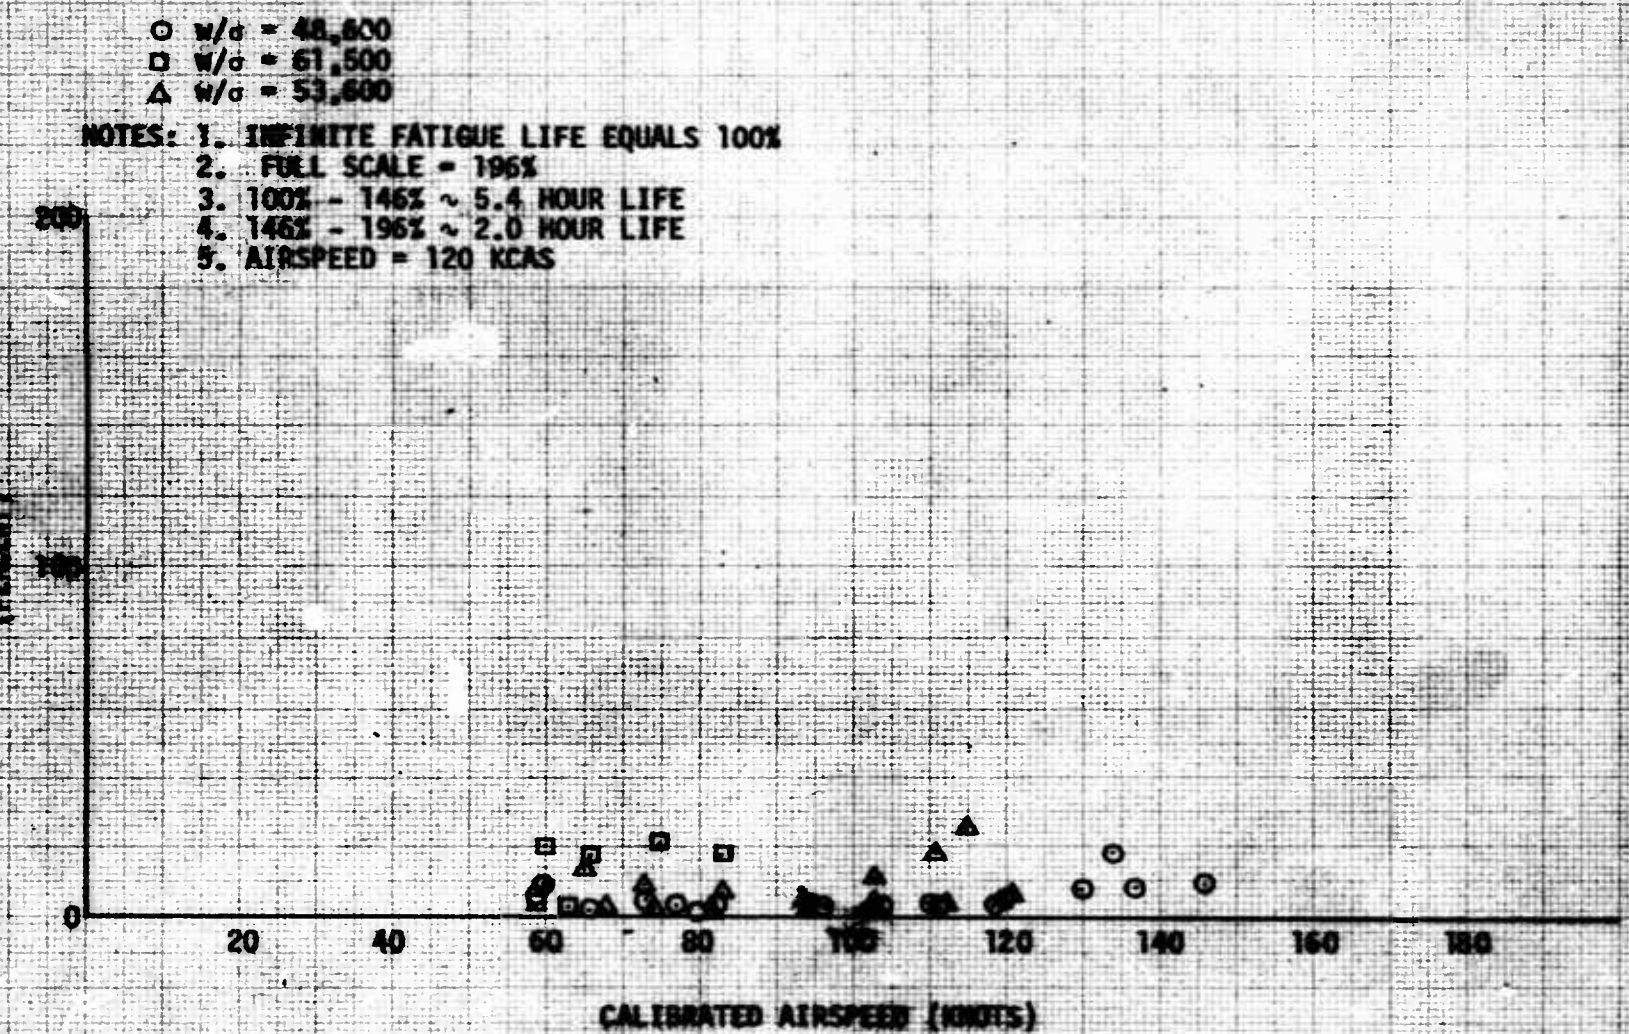
FIGURE I
CRUISE GUIDE INDICATOR VS
CALIBRATED AIRSPEED

as shown by figures I and J of the Loads Survey section (para 29), never limited the level flight or maneuvering flight envelope. The level flight envelope for the long boom extended configuration is 158 knots true airspeed (KTAS) and 149 KTAS with the long boom retracted. Maximum-allowable airspeed (V_{max}) in level flight was less with the boom retracted, due to excessive aircraft vibration terminating airspeed envelope expansion prior to reaching maximum power-available limits. Maximum-allowable level flight airspeed with the long boom extended was established by maximum power available. The maximum normal acceleration defining the maneuvering envelope was 2.0g in the long boom extended configuration and 1.98g in the retracted configuration. The minimum normal acceleration defining the maneuvering envelope was 0.68g and 0.42g in the long boom extended and retracted configurations, respectively.

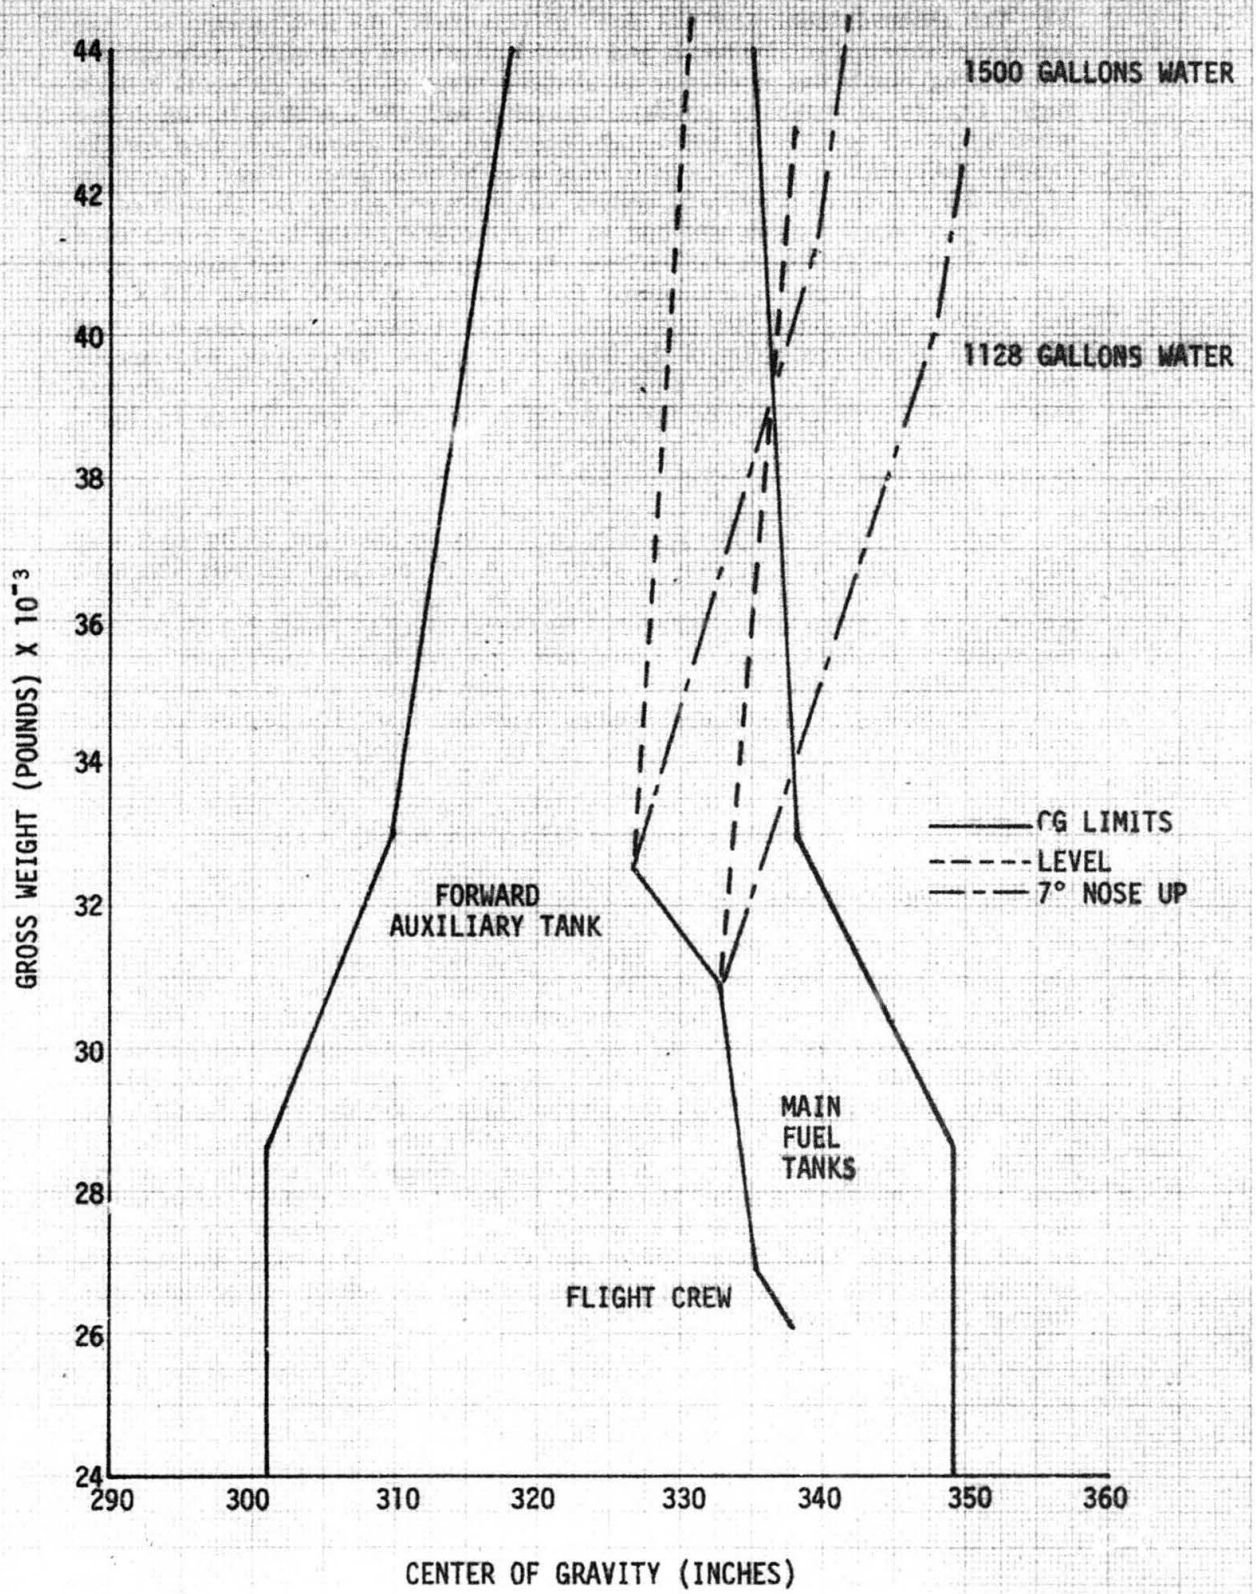
FIGURE K
CH-47C CENTER OF GRAVITY SUMMARY
BOOM STOWED

36. All the above weighings were completed at a level aircraft attitude except for configuration d, where a 7-degree nose-up attitude was attained to verify aircraft center-of-gravity (cg) shift with water transfer in a partially full water tank (1100/1800 gallons). As shown by figure K, the water transfer resulted in an aircraft aft cg transfer of approximately 9 inches, which moved the cg beyond the aft limit. As a result, the forward auxiliary fuel tanks were filled in addition to the main fuel tank, resulting in an additional 1650 pounds of fuel at fuselage station (FS) 214.0. The final configuration with the boom retracted resulted in an aircraft cg located at FS 339.5 for a 41,200-pound takeoff gross weight in a 7-degree nose-up attitude. Configuration c, plus 1650 pounds of fuel in the forward auxiliary tanks, was used for the duration of the test and, as seen in figure K, was 7 inches aft of the aft cg limit in a takeoff configuration (7 degrees nose-up). This condition was cleared for flight by an amendment to the safety-of-flight release.
