INVESTIGATION OF THE HOOD EFFECT OF THE 6" COMM. MK. 27-7 PROJECTILE AT VARIOUS OBLIQUITIES

Naval Proving Ground
Dahlgren, Virginia

21 April 1947

No. 1238-47

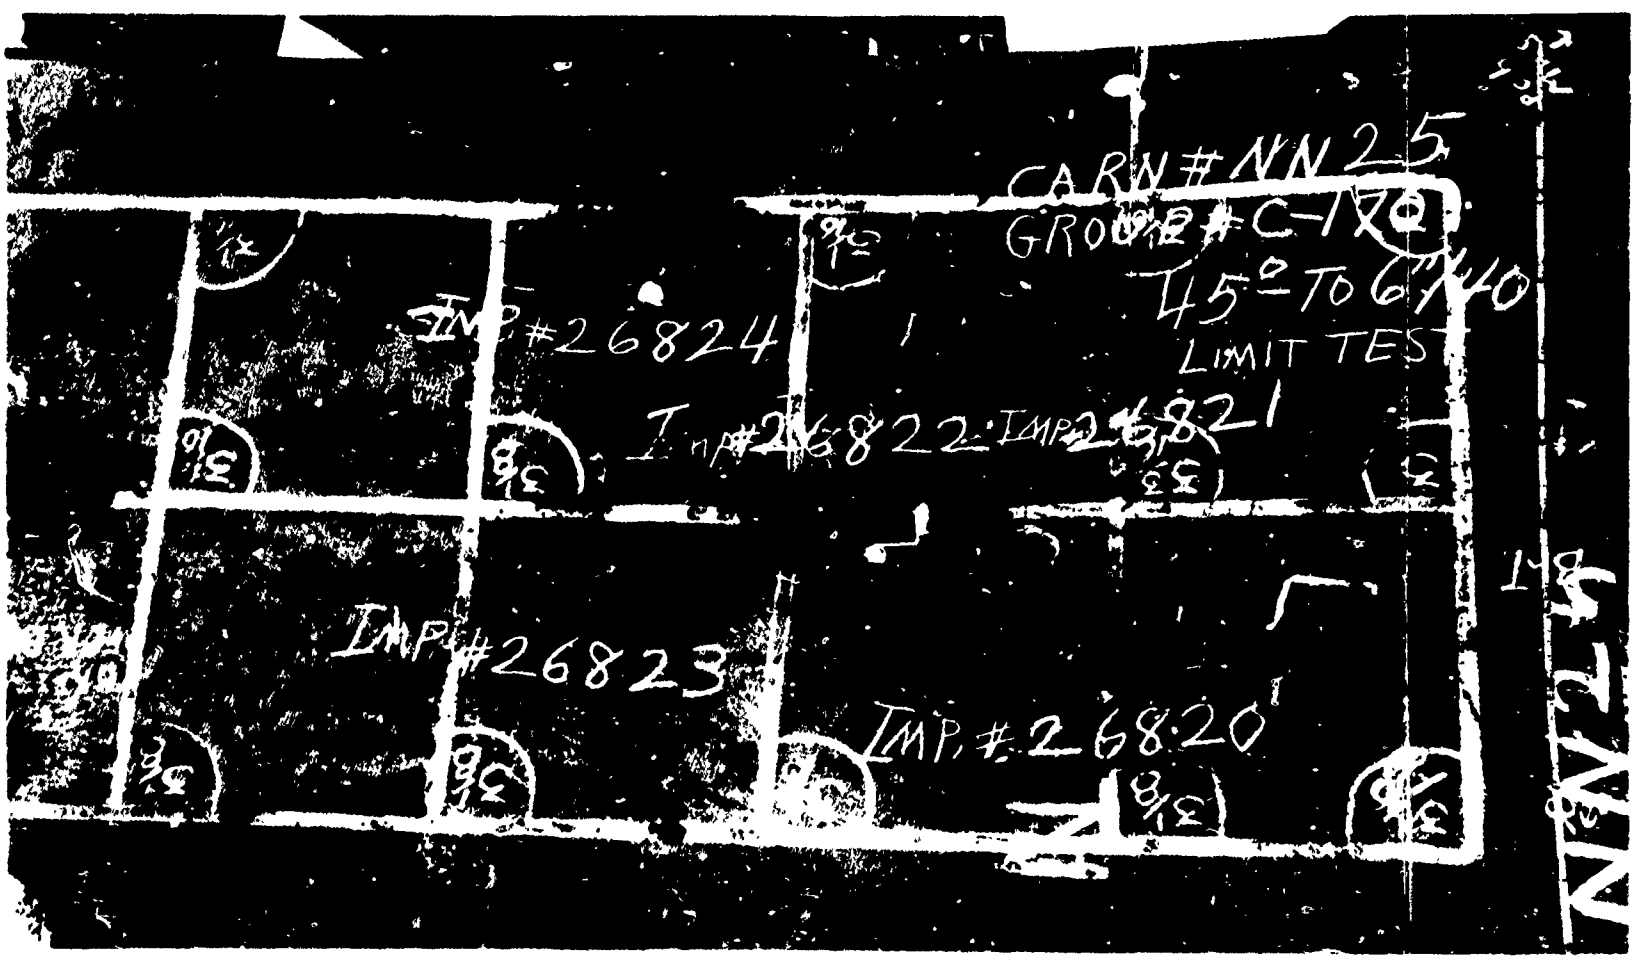
NTS 34055 - Bal. Limit Test of 3"13 STS Plate No. NN-25 Mfd. by Carnegie Illinois Steel Co. vs. 6" Common Pk. 27-7 Proj. IL&P with and without windshield and hood. View: Front of Plate. [redacted]

Impact	Obl.	S.V.	S.Sk. T8841	Pene.	Thru Open	Projectile
26820	45°00'	1438	97.6	2-3/4"	None	with windshield and hood
26821	45°40'	1507	100.9	2-1/4"	None	" " " "
26822	44°30'	1543	105.7	Comp.	6" x 7"	" " " "
26823	44°20'	1413	92.3	2-1/2"	None	without windshield and hood
26824	45°00'	1421	97.4	Comp.	6" x 7"	" " " "

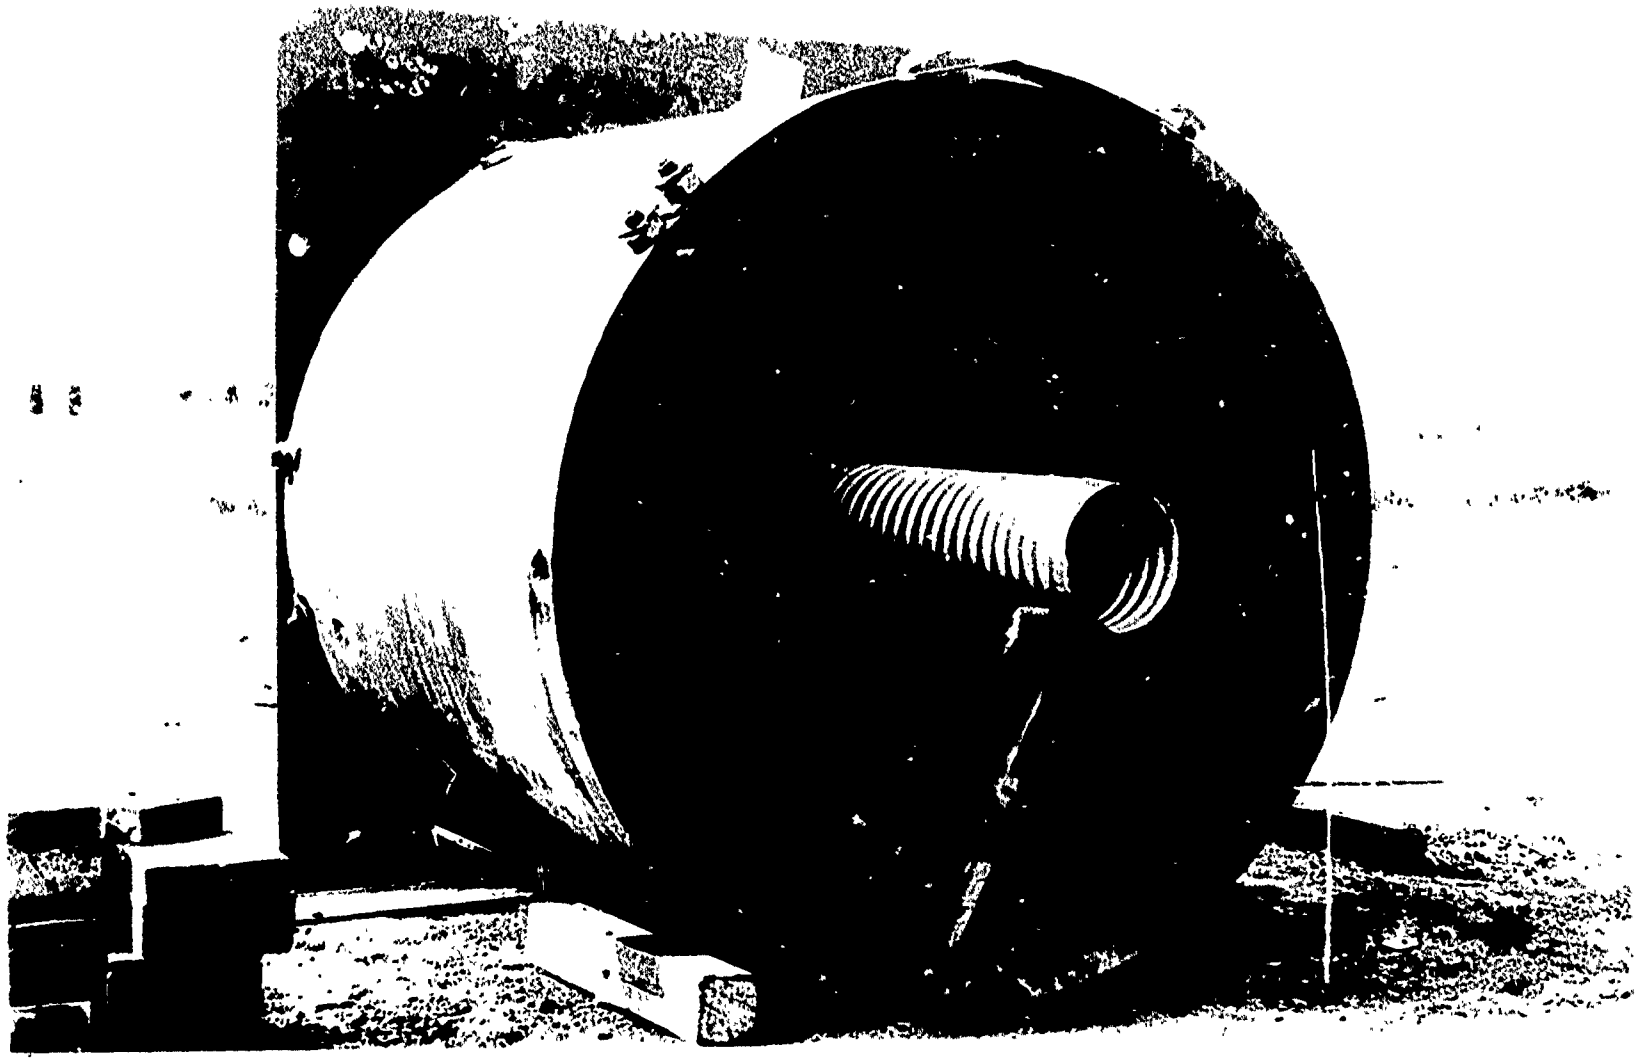
NPG 35058 - Bal. Exp. Test of 1"908 STS Plate No. 98503 Mfd. by Carnegie Illinois Steel Corp. vs. 6" Common Mk. 27-7 Proj. IL&P fired for recovery of fragments of the windshield and hood. View: Front of fragment recovery tube with cover plate removed to show concentric arrangement of culvert pipe and armor tube. [redacted]

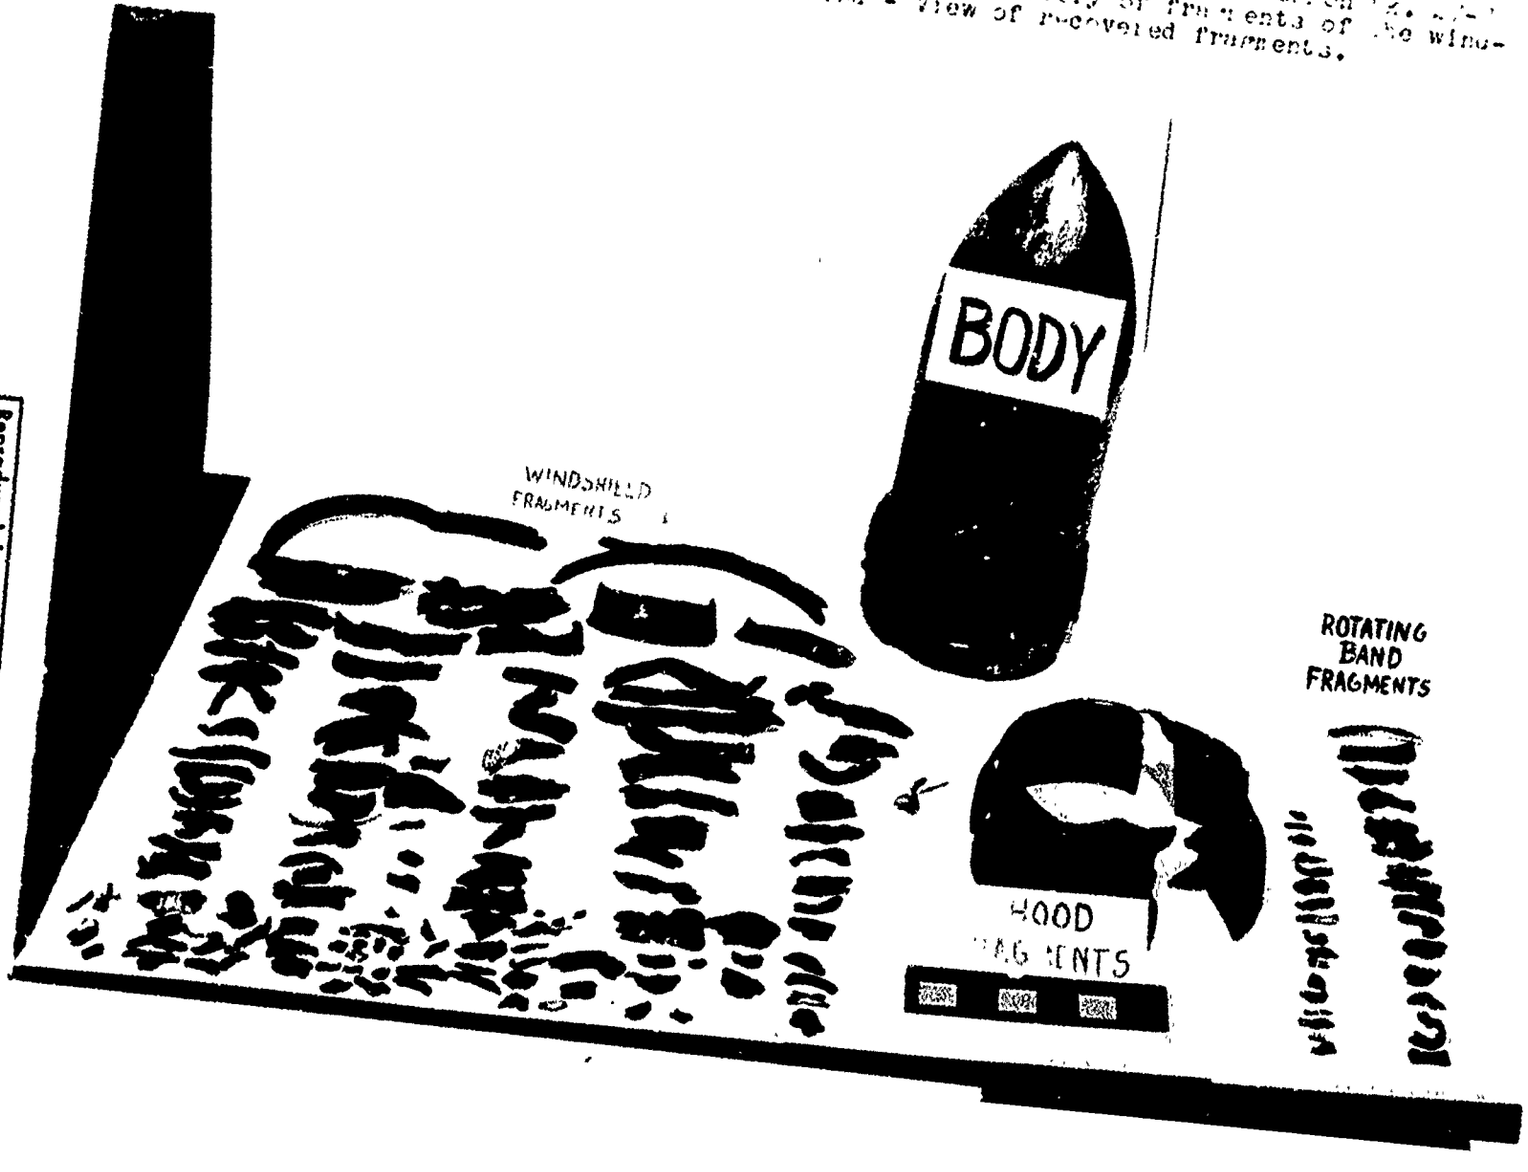
The fragments were recovered without evidence of any secondary damage. The windshield and the crown of the hood were splintered into many small pieces, but the skirt of the hood was recovered in three equal pieces. The crown of the hood appeared to have fractured by shear after severe plastic deformation, as illustrated by lamellar blocks of the metal which have slipped over each other without becoming separated. The skirt of the hood experienced several brittle fractures on planes normal to the prevailing axis of tension in the region free from severe cold work, but each normal fracture shifted to the shear type of fracture when it ran into the severely worked region. Three of these brittle fractures were initiated by three minute punched indentations on the shoulder of the

hood, but a fourth crack was also observed which did not originate from any obvious imperfection. The fourth crack did not pass into the plastically deformed region, as revealed by microsections of the recovered fragment. The fourth crack probably failed to reach completion because of a release of stress by the prior completion of the other three fractures. Measurements of the fragments show that the reduction of area at the brittle fractures was not more than 2%, whereas the material of the hood would undergo a reduction of area of more than 65% in a standard tensile test. The full elongation was, in fact, obtained in the region of severe plastic deformation.

129 34290 - Ballistic [illegible] of 1.9[illegible] [illegible] by Carnegie-Illinois Steel Corp. vs. [illegible] Corporation [illegible] Ill. [illegible] fired for recovery of fragments of the windshield and hood - View of recovered fragments.

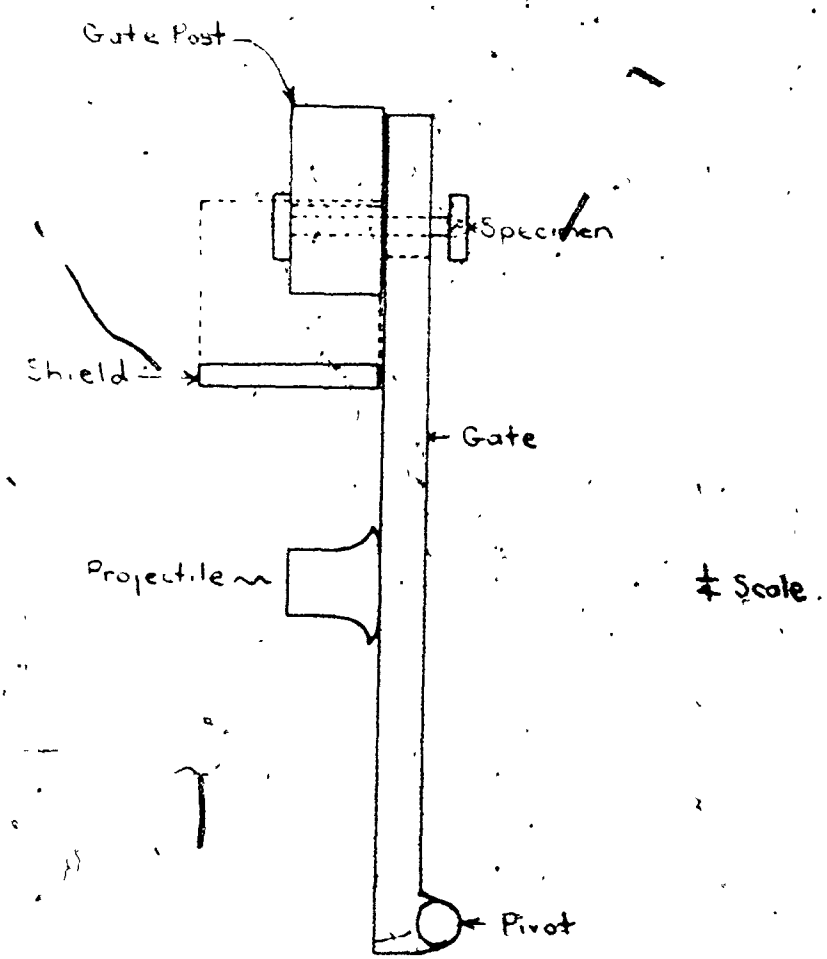
SCHEMATIC DIAGRAM OF APPARATUS FOR SHOCK LOADING OF TENSILE SPECIMENS

The first specimen was machined from a 37mm T21 mild steel projectile. Another 37mm T21 projectile was fired at the center of the gate with a striking velocity of the order of 700 (ft.)/(sec.). The specimen was necked down and not broken.

The second specimen was machined from a piece of annealed mild steel bar stock with a BHN of 120. A 37mm T21 projectile was fired at the gate with a striking velocity of the order of 1800 (ft.)/(sec.). The gate was broken in half at the point of impact, and the projectile was demolished from the nose to the rotating band. The gate was also broken at the point where it came into contact with the head of the specimen. The specimen itself was necked down to fracture with the full reduction of area in a
