ENDURANCE TESTING OF AN LM-726-4 ELASTOMERIC PITCH CHANGE BEARING

Lord Kinematics

Army Air Mobility Research and Development Laboratory

USAAMRDL-TR-74-35

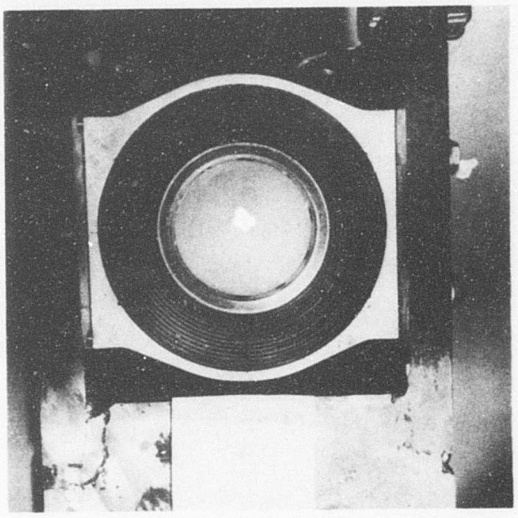
Figure 26. Test Sample 1 (S/N 004) After 400 Hours of Endurance Testing. (No deterioration visible. Appearance typical of all samples.)

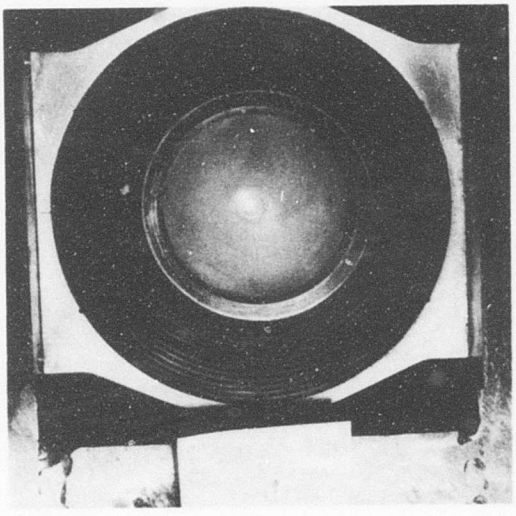
Figure 27. Test Sample 1 (S/N 004) After 600 Hours of Endurance Testing. (No deterioration visible. Appearance typical of all samples.)

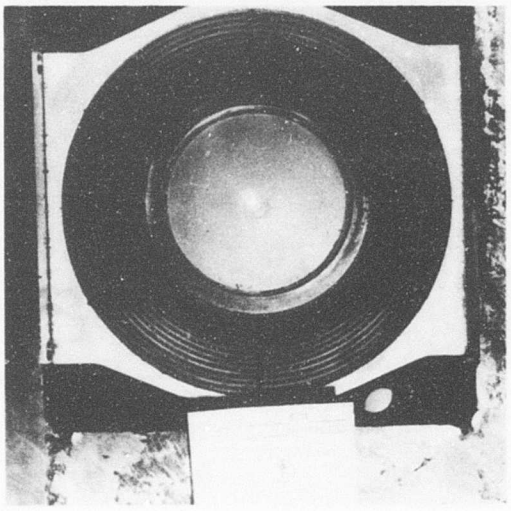
Figure 28. Test Sample 3 (S/N 006) After 600 Hours of Endurance Testing. (Slight elastomer abrasion visible in innermost elastomer layer.)

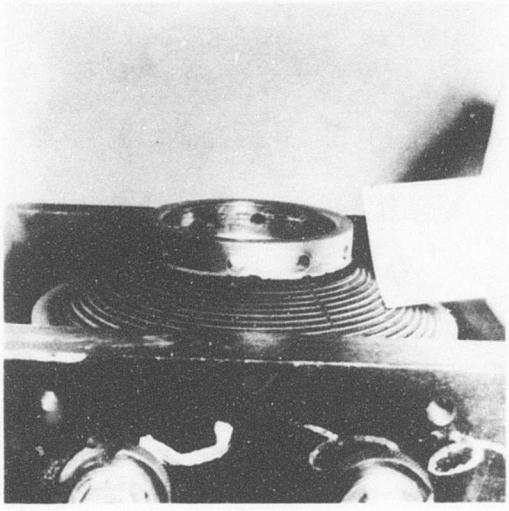
Figure 29. Test Sample 3 (S/N 006) After 600 Hours. (Elastomer abrasion visible in innermost layer, extending around entire circumference.)

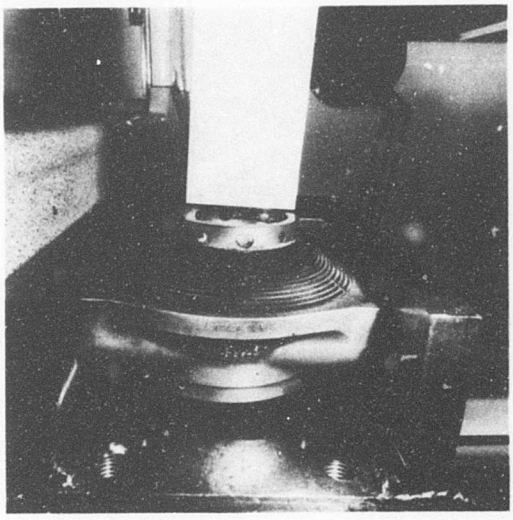
Figure 30. Test Sample 3 (S/N 006) After 800 Hours of Endurance Testing. (Most severe abrasion occurring in innermost layer, but abrasion can now be seen in layers 2 through 10.)

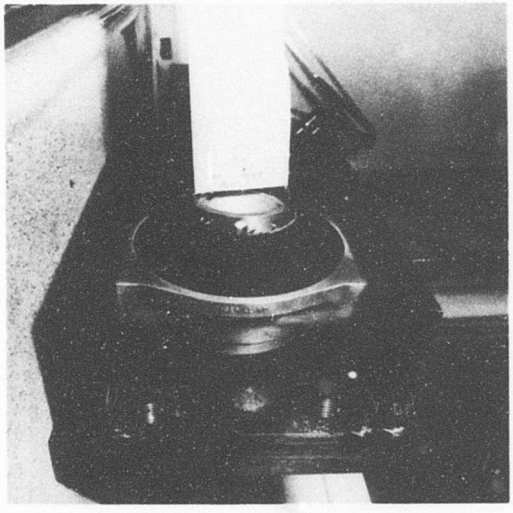
Figure 31. Test Sample 1 (S/N 004) After 1000 Hours of Endurance Testing. (Slight abrasion visible in sections 1 through 10.)

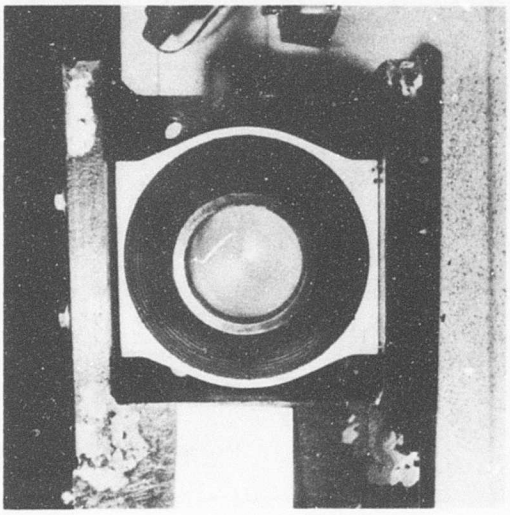
Figure 32. Test Sample 2 (S/N 005) After 1000 Hours of Endurance Testing.

Endurance Test Hours	Comments on Appearance: Test Sample 1 (S/N 004)	Comments on Appearance: Test Sample 2 (S/N 005)
148	No change from new	No change from new
172	No change	No change
503	No change	No change
790	No change	Slight abrasion noted in innermost elastomer layer.
952	No change	Abrasion continuing
1060	Slight abrasion noted in innermost elastomer layer.	Abrasion continuing
1800	Depth of elastomer loss in innermost layer is 1.4 inches. Layers 2 through 10 show abrasion but no appreciable depth.	Depth of elastomer loss in innermost layer is 1.4 inches. Layers 2 through 10 show abrasion but no appreciable depth.
2000	Depth of elastomer loss in innermost layer is 1.4 inches. All layers show abrasion. Sections 1, 7, and 8 most severe.	Inner member nearly separated. Radial load has cracked shim number 1 and bent shim number 2. All sections show abrasion. Sections 1, 5, 6, 7, and 8 most severe.

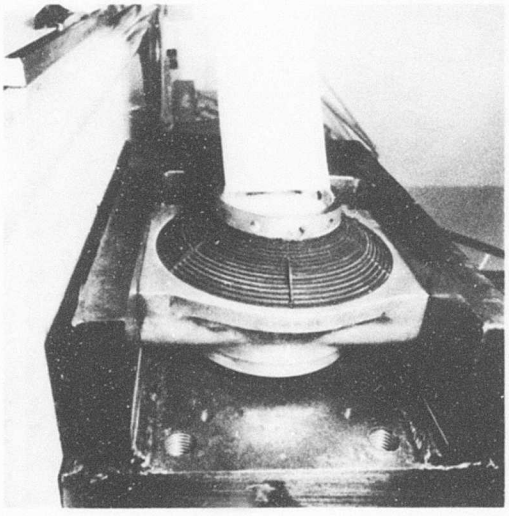
Test sample 3 may be considered to have failed even though it did not fulfill a strict interpretation of the failure criterion. The torsional spring rate at 2000 hours was approximately 37% below the initial value, and the depth of elastomer loss in the innermost section exceeded 2.0 inches. Good engineering judgment would not allow this bearing to continue on test beyond 2000 hours.

Figure 33. Test Sample 3 (S/N 006) After 1000 Hours of Endurance Testing. (This sample considered to be the most severly damaged at this point.)

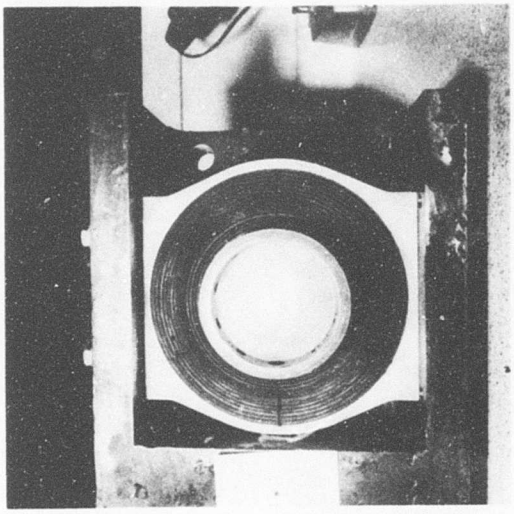
Figure 34. Test Sample 4 (S/N 009) After 1000 Hours of Endurance Testing.

Endurance Test Hours	Comments on Appearance: Test Sample 3 (S/N 006)	Comments on Appearance: Test Sample 4 (S/N 009)
148	No change from new	No change from new
172	No change	No change
503	Slight abrasion noted in innermost elastomer layer	No change
555	Slight increase in amount of abrasion.	No change
790	Abrasion continuing	Slight abrasion noted in innermost layer.
952	Abrasion noted in layers 1 through 10. Depth of elastomer loss is .2 to .4 inch in first layer.	Abrasion noted in layers 1 through 10. Depth of elastomer loss is .2 inch in first layer.
997	Abrasion has become hairlike and slightly more severe.	No change - abrasion continuing.
1400	Depth of elastomer loss is .8 inch in first layer.	Abrasion continuing - no depth measurement taken.
1600	Depth of elastomer loss is 2.0 inches in first layer.	Abrasion continuing
1800	Depth of elastomer loss is 2.0 inches in first layer.	Failure - inner member separation due to loss of elastomer.

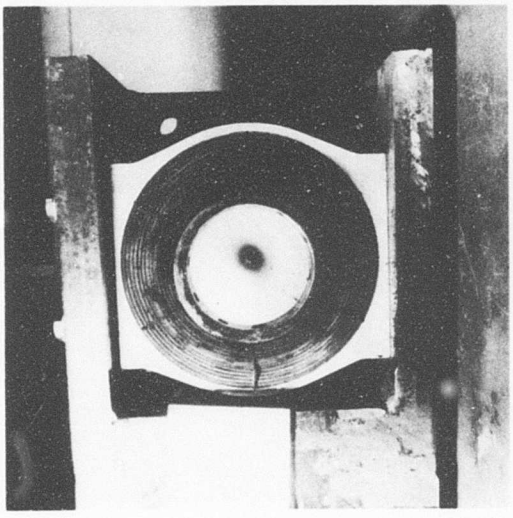
Figure 39. Test Sample 3 (S/N 006) After 1200 Hours of Endurance Testing. (Note the hairlike abrasion of elastomer.)

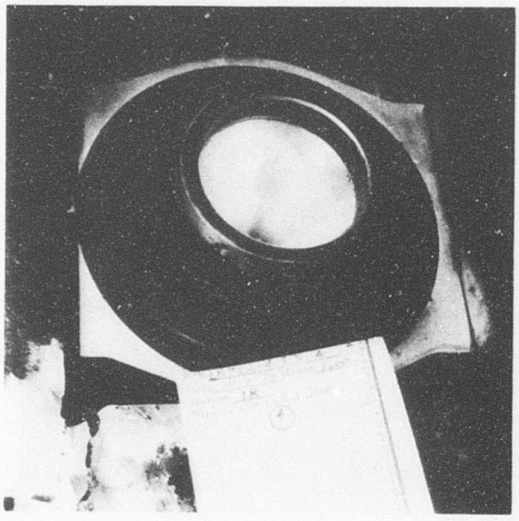
Figure 46. Test Sample 1 (S/N 004) After 1600 Hours of Endurance Testing. (Appearance is typical of test samples 2, 4, 5, and 6.)

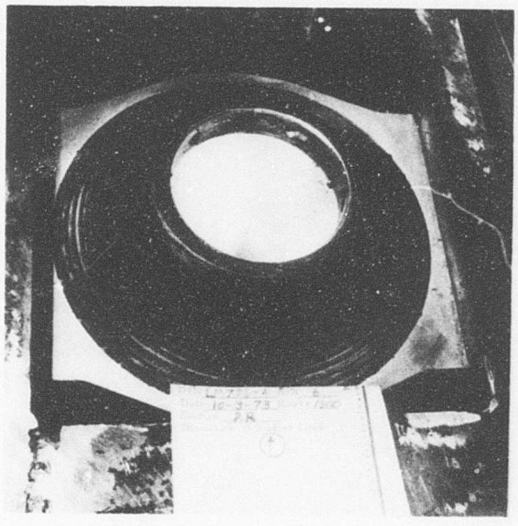
Figure 47. Test Sample 3 (S/N 006) After 1600 Hours of Endurance Testing. (Most severely damaged sample. Note depth of separation visible in left center of photograph.)

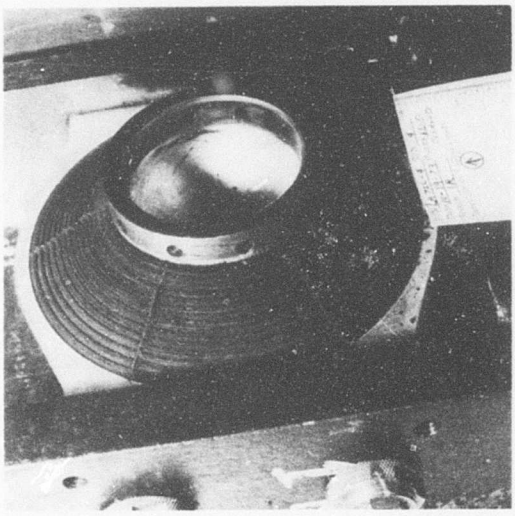
Figure 48. Test Sample 1 (S/N 004) After 1800 Hours of Endurance Testing. (Loose elastomer has been brushed away to allow close examination. Note depth of separation visible in first layer.)

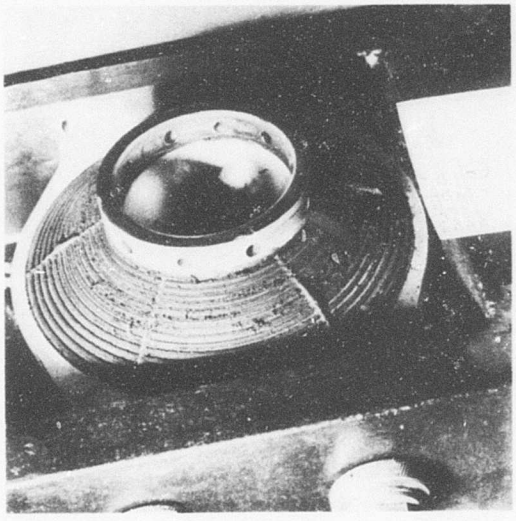
The second failure occurred during the manual conditions after 2000 hours of endurance testing. Test sample 2 experienced inner member separation after completion of 750 cycles of the first manual condition: the ±12-degree pitch input. The cause of failure was identical to that of test sample 4.

Figure 49. Test Sample 2 (S/N 005) After 1800 Hours of Endurance Testing. (Loose elastomer has been brushed away to allow close examination.)

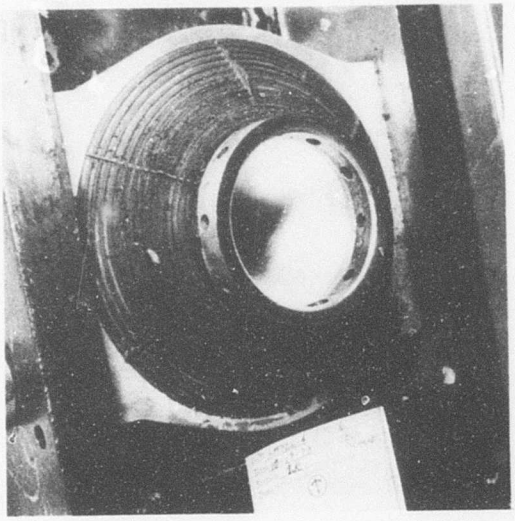
Figure 50. Test Sample 3 (S/N 006) After 1800 Hours of Endurance Testing. (Loose elastomer has been brushed away. Note depth of separation visible in first layer.)

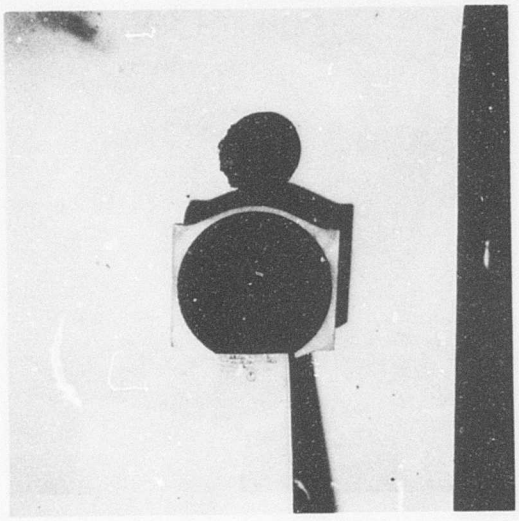
Test sample 4 was the first sample to fail, with failure occurring after 1800 hours of endurance testing and during the performance of 1800-hour manual conditions. Upon removal from the test machine after completion of the manual conditions, the inner member completely separated from the flexing element. The loss of elastomer due to abrasion resulted in a significant decrease in the shear load area of the innermost section. As a result, the bearing was unable to withstand the manual conditions and failed in shear. Inspection of the failed area revealed a good bond.

Figure 51. Test Sample 4 (S/N 009) After 1800 Hours of Endurance Testing. (Loose elastomer has been brushed away to allow close examination. Note depth of separation visible in first layer.)

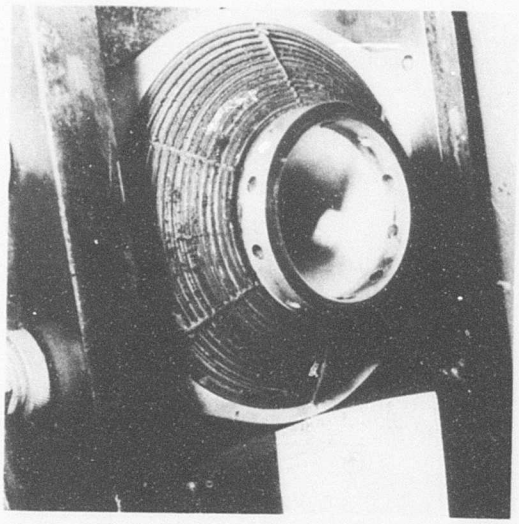
Figure 52. Test Sample 5 (S/N 014) After 1800 Hours of Endurance Testing. (Loose elastomer has been brushed away to allow close examination. Note depth of separation visible in first layer.)

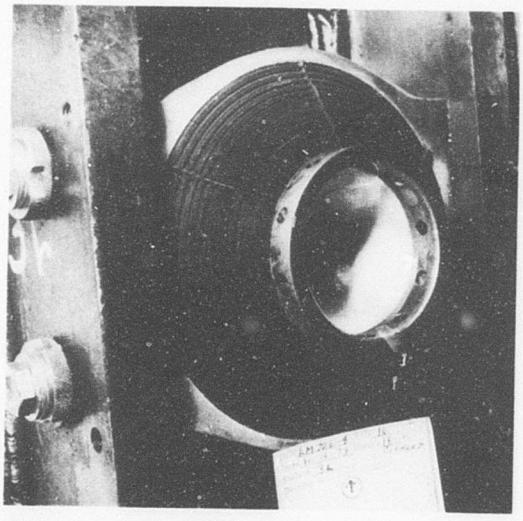
Figure 53. Test Sample 6 (S/N 016) After 1800 Hours of Endurance Testing. (Loose elastomer has been brushed away to allow close examination.)

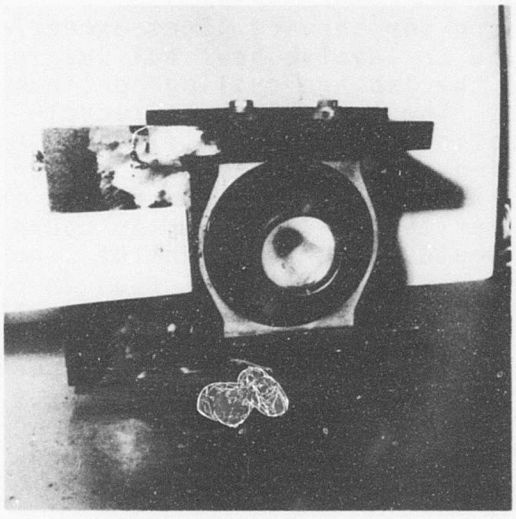
Figure 54. Test Sample 4 (S/N 009) After 2000 Hours of Endurance Testing. (Appearance typical of all samples.)
