TURBINE ENGINE FUEL CONTROL RELIABILITY TEST AND EVALUATION

R. D. Zagranski, et al

Colt Industries, Incorporated

July 1974

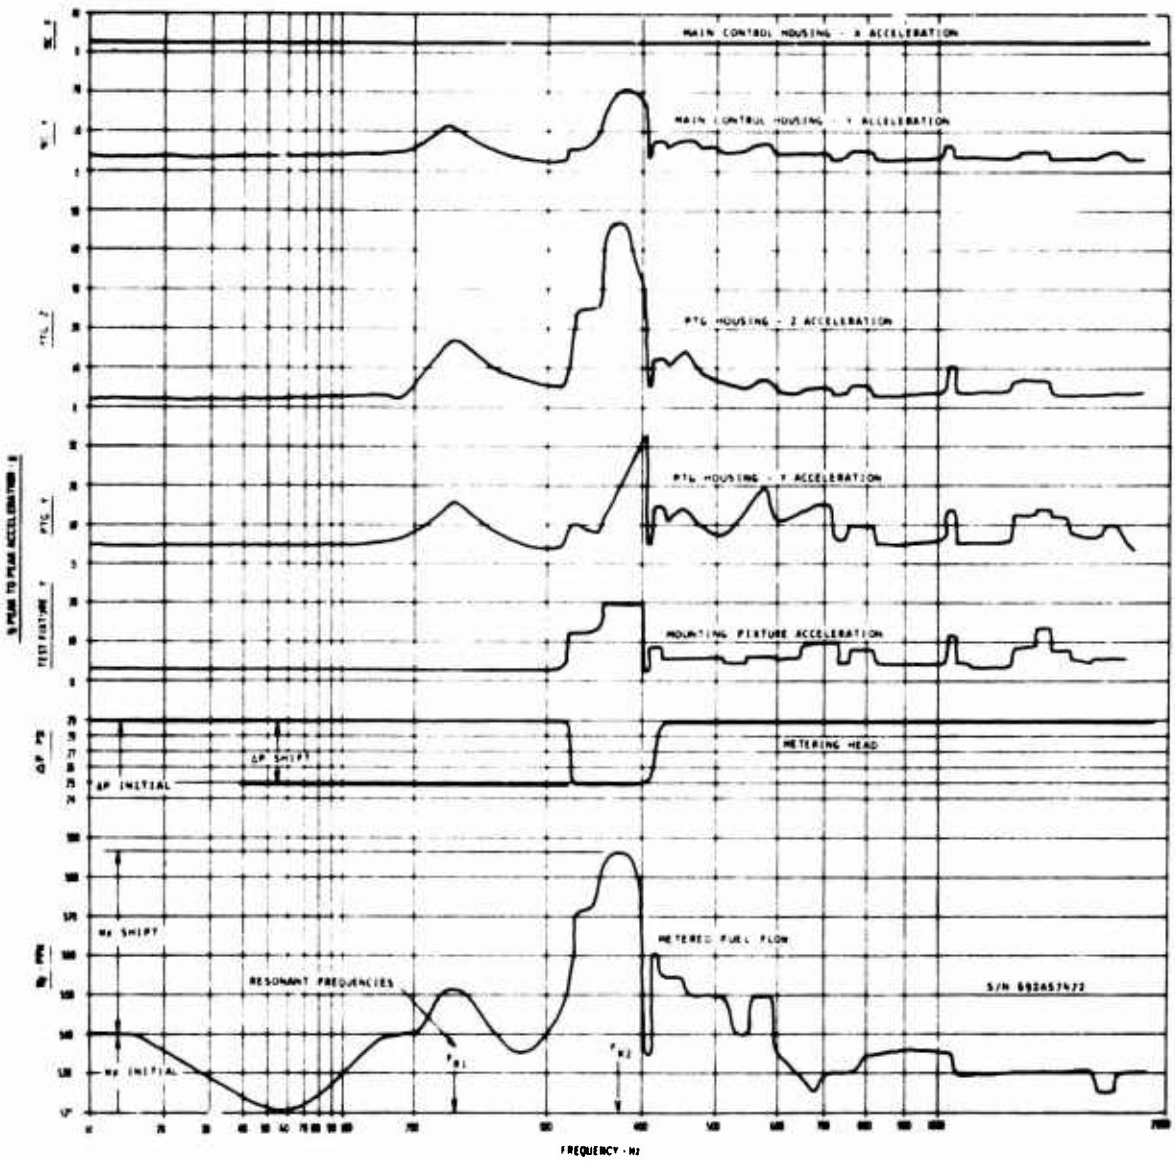
Figure 7. Power Turbine Governor Performance During Vibration in Y Plane.

Table 1 contains a tabulation of the power turbine governor performance of both control systems during vibration testing. The major fuel flow deviations occurred at an excitation frequency of 400 Hz. As is shown in Figure 4, the input vibration at this frequency level is at maximum amplitude, and fuel flow shifts of 55-70 pph out of 550 pph were experienced at this condition. A plot of a typical worst-case governor response is given in Figure 7. Fuel flow excursions generally followed the magnitude of the power turbine governor housing acceleration and the peak fuel flow variations occurred at the two structural resonant frequencies of 230 and 400 Hz. The lower frequency structural resonant point was dominant; however, low g levels of excitation exist at this frequency which result in a maximum governor acceleration of 24 g's.

At 400 Hz, although the structural transmissibility is significantly lower, the high level of input excitation resulted in accelerations of the PTG housing of approximately 50 g's. A plot of governor performance of both control systems at a constant, low level of excitation is given in Figure 8. This figure shows operation at the two major structural resonant points and reveals their relative magnitudes and effect on metered flow.

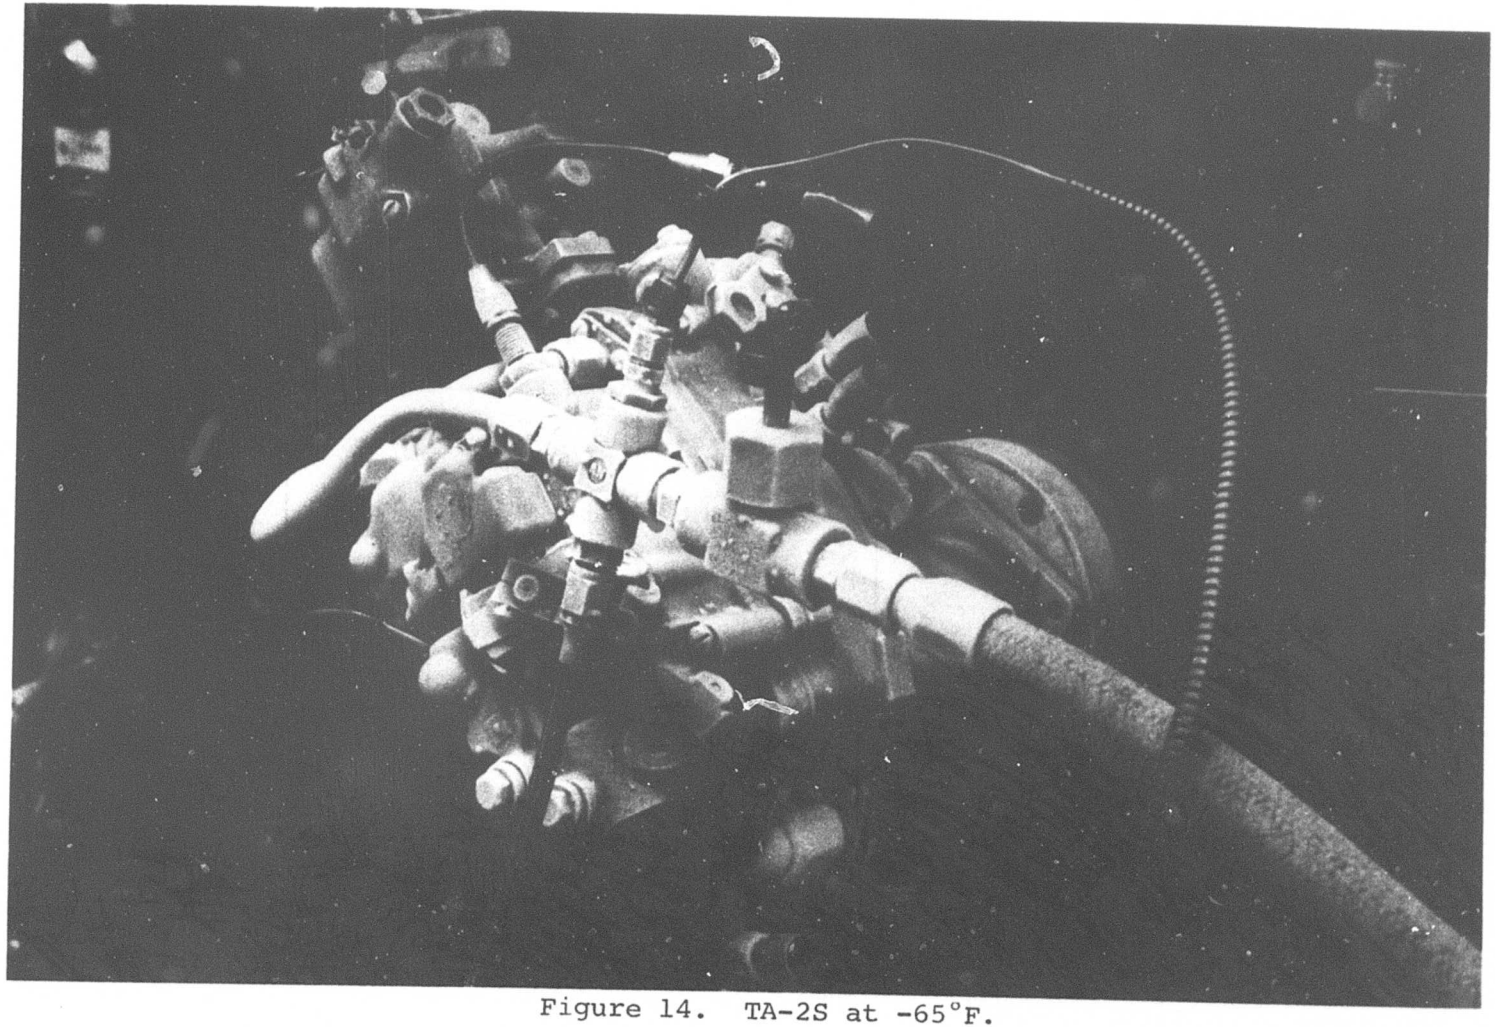
Figure 14. TA-2S at -65°F.

Fifty hours, which is equivalent to twenty-five cycles, were accumulated on each control with the fuel at the inlet maintained at room temperature. Twenty hours corresponding to ten cycles were run on each control with fuel at the inlet to the filter at -65°F ± 5°F. No attempt was made to control the ambient temperature; however, the steady-state temperature at the control was noted at -55°F when inlet was -65°F. Figure 14 shows the control during -65°F fuel testing.

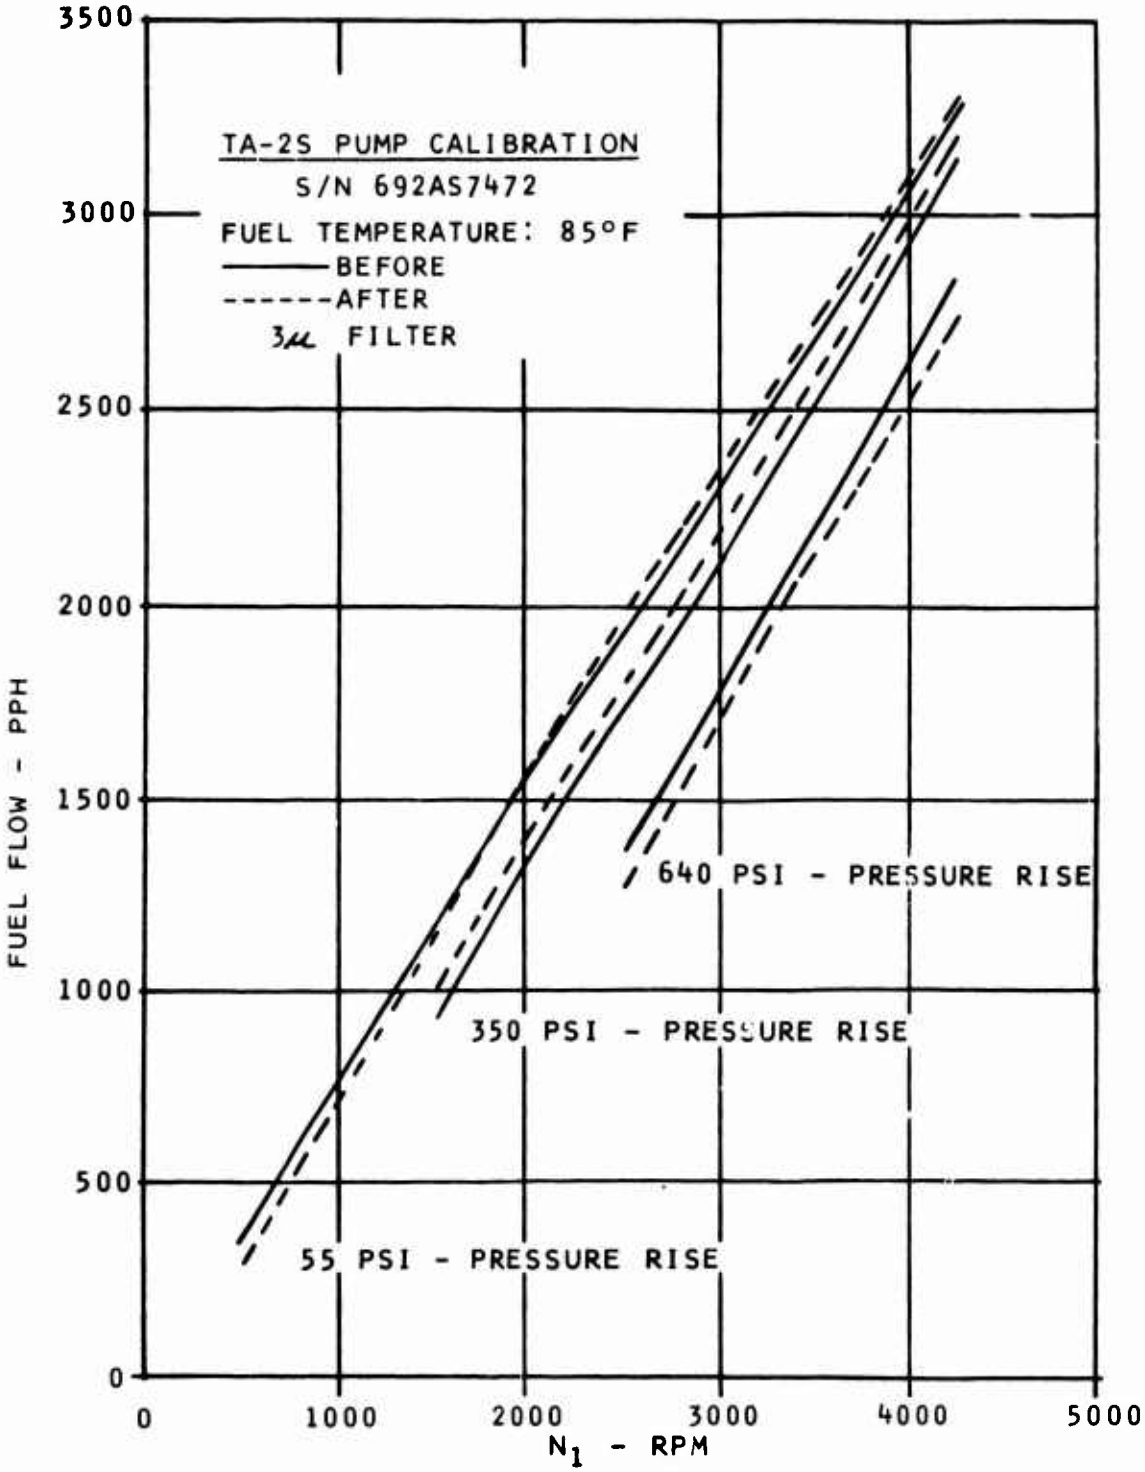
Figure 15. Pump Performance, S/N 692AS7472.

The pump in each control system was tested before and after contamination testing. The test results are shown plotted in Figures 15 and 16. The results show that after the contamination test, fuel flow increases slightly at low discharge pressures and decreases at the high discharge pressure. There is no clear explanation for the slight flow increase but it is probably due to test equipment inaccuracies, and operator-to-operator variations in setting and recording pressures, speeds and flows. The decrease in fuel flow at high discharge pressure is of the order of 100 pph. This loss in performance can be attributed to normal wear and settling of the bearings resulting in additional clearance between the gears and housing.

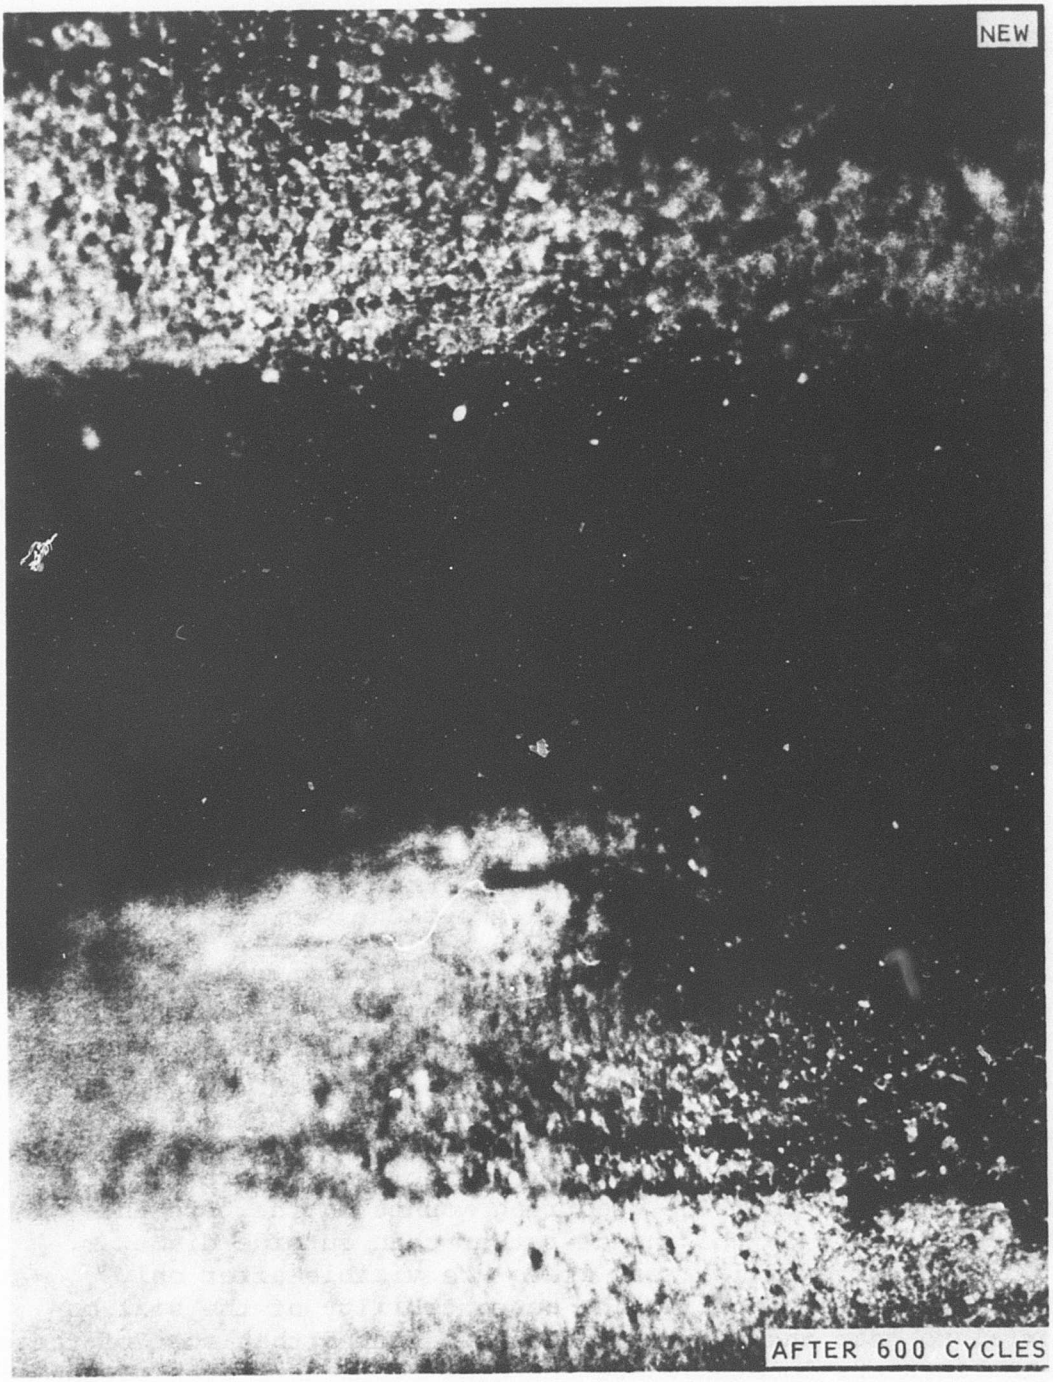
Figure 22. Rotary Seal Polyurethane A-1086.

The first seal listed in Table 10 is a polyurethane compound A-1086. All six seals of that type failed at hot test. Two of them lasted 30,000 cycles at -65°F but failed after only 600 cycles at 250°F. All seals except one showed a severe breakdown of the material at disassembly. Figure 22 shows a new and a used seal side-by-side, magnified 30 times. Although not revealed by the photo, the used seal was considerably flattened at the outer circumference after only 600 cycles, which is the reason it leaked.

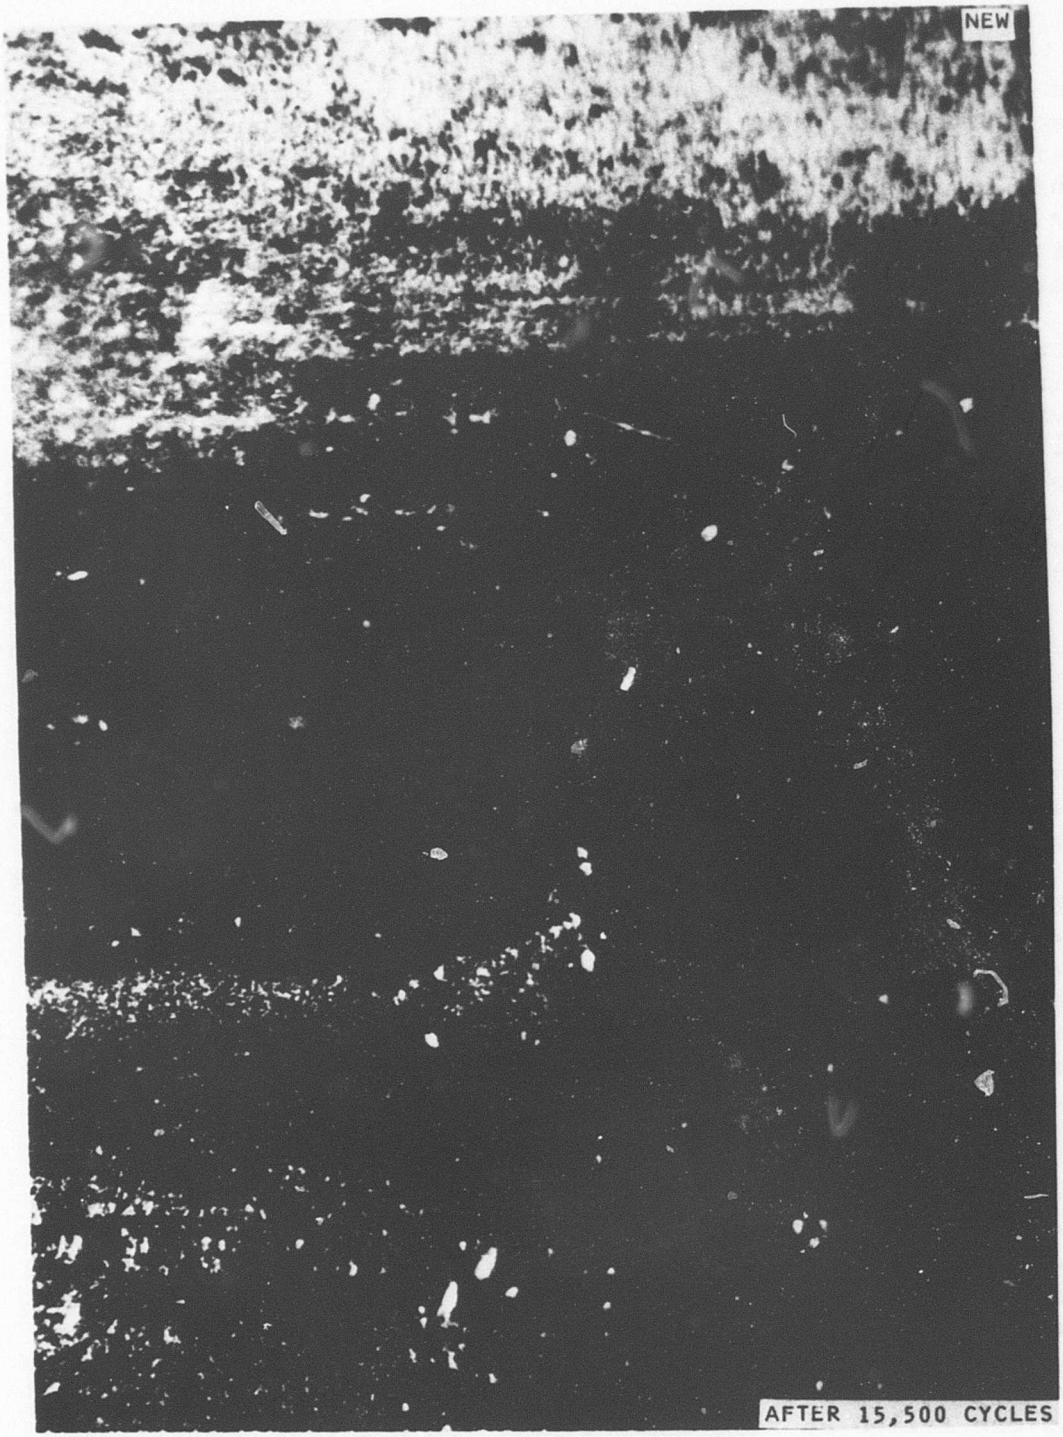
Figure 23. Rotary Seal Viton 523A Q4113.

The next type of seal is a Viton, compound 523A Q4113. All seals experienced excessive wear as shown by Figure 23. It should be noted that the quad ring mounts in the bore and therefore seals on the inside rather than outside diameter. Minute circumferential wear lines are visible after only 15,500 cycles, indicating the susceptibility of the seal material to tear and wear. It should be noted that most of these wear lines are located where the seal could have been caught in the clearance between the rotating shaft and the fixed sleeve. The decrease in weight of all six seals appears to

be proportional to the number of cycles run, confirming the excessive wear. The specific gravity did not change by a significant amount. All seals hardened during cycling; however, this increase in hardness is unrelated to the number of cycles or the type of test. Both inside and outside diameters of five seals showed a decrease due to shrinkage but the thickness did not vary appreciably.

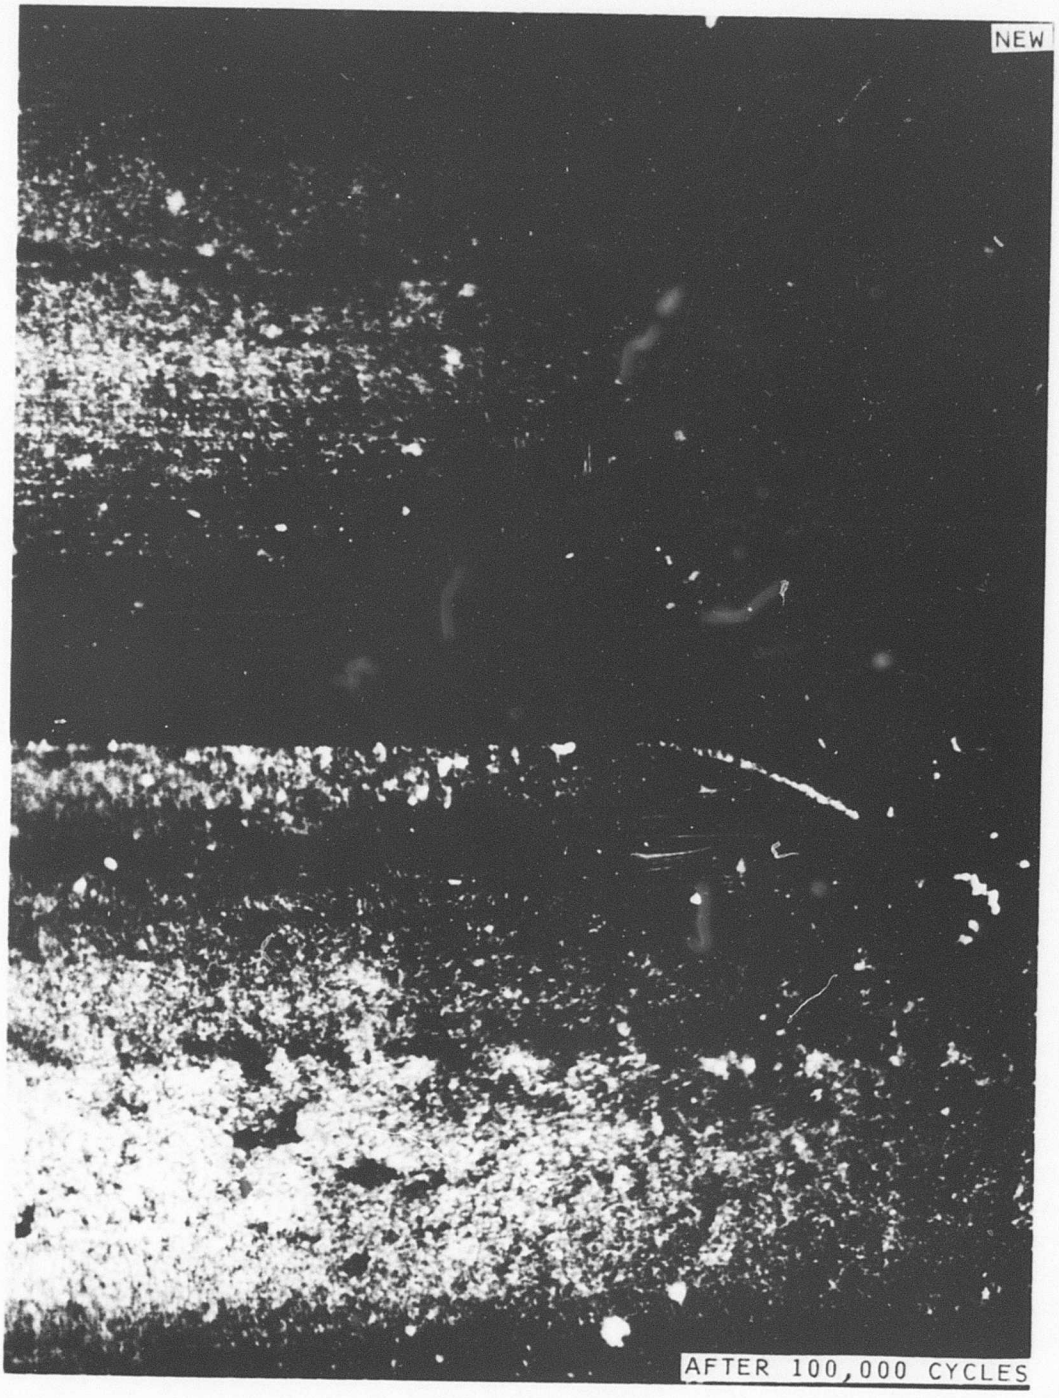
Figure 26. Rotary Seal Buna XN 1996-2.

Four out of seven Buna XN 1996-2 seals completed 100,000 cycles. The decrease in weight varied between 10 and 31 percent, indicating substantial wear not visible on the photograph, Figure 26. This wear was confirmed when measuring the change in thickness. Specific gravity varied ± 3 percent. This variation did not indicate a trend leading to a conclusion. Hardness increased up to 16.5 percent but the increase is not constant from one seal to another. Three of the seven seals were cut when removed from the test shaft groove, indicating a loss of tensile strength which, when coupled with the increase in hardness, could lead to cracks while in operation, and eventually to leakage. This Buna XN 1996-2 seal was treated with an ultralube process designed to reduce friction and ultimately reduce wear. There are no indications that this ultralube process accomplished the goal it was intended to do since weight loss was 10 to 31 percent. All seven seals of this type completed 89,000 cycles or better and yet the changes in mechanical characteristics of all seals are spread over a wide range, pointing to an unstable material requiring further refinement. Figure 26 shows a new seal next to one that completed 100,000 cycles without leakage. A slight cut is visible on the side of the test seal, on the right side of the photo. This sliver, 0.002-inch wide, was most likely cut when the test pressure forced the seal in the clearance between the test shaft and the sleeve. This clearance is, by design, 0.0005 to 0.0035 inch. In addition, the photo shows the used seal outside diameter to reflect the light better than the new one, due to a smoother surface resulting from wear.

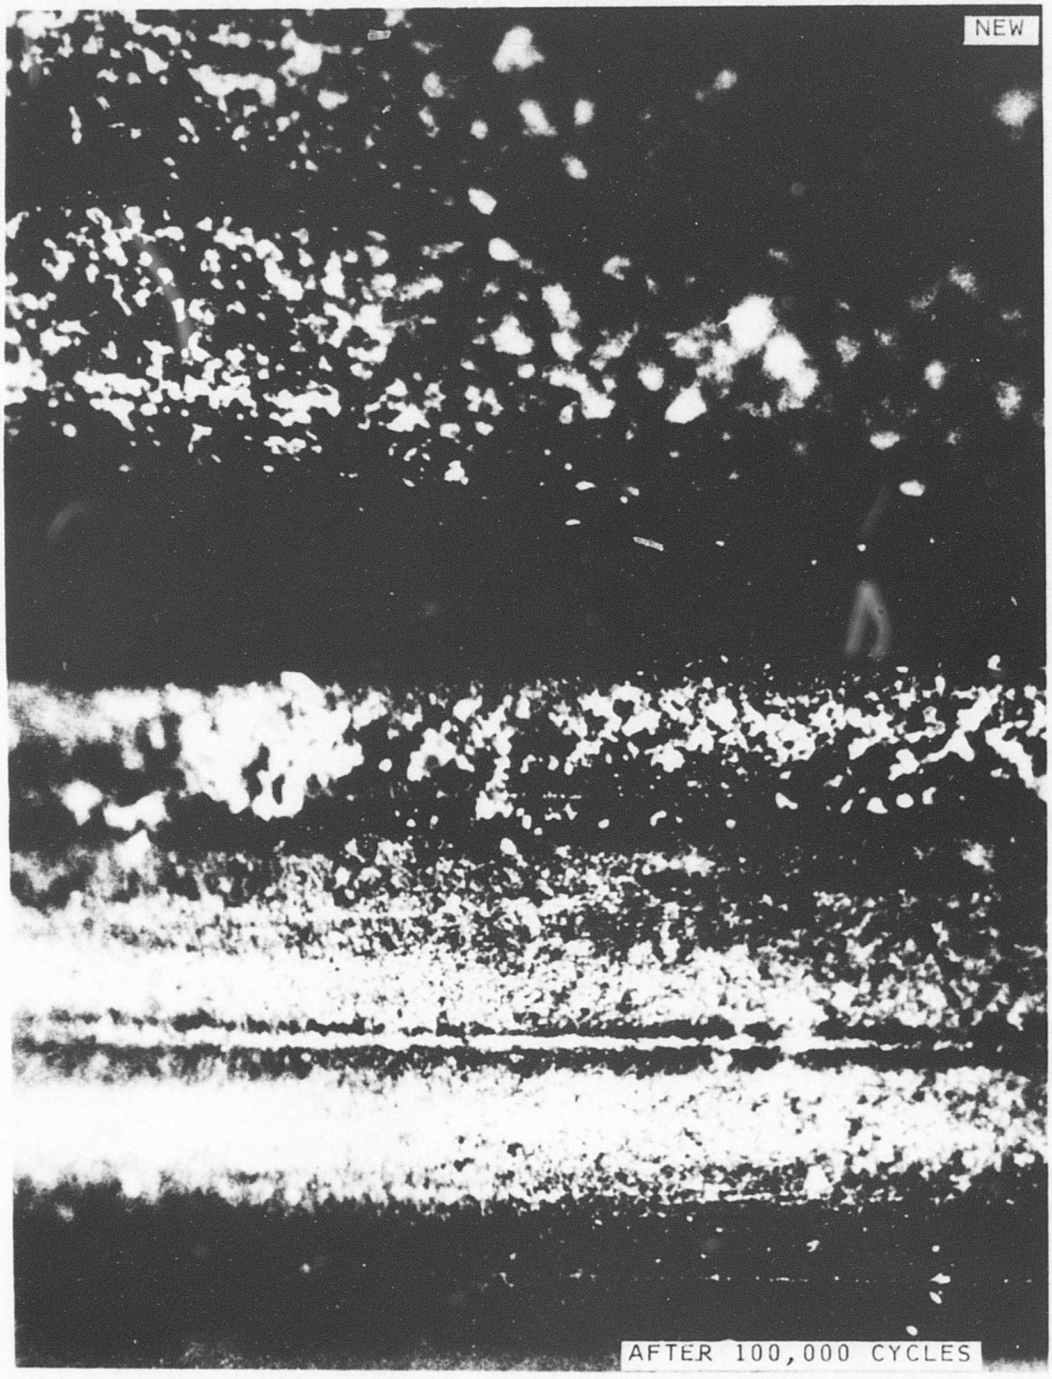
Figure 27. Rotary Seal Buna N 756-75.

The Buna N 756-75 seal (shown in Figure 27), contrary to the preceding Buna XN 1996-2 seal, did not exhibit circumference wear (as can be seen in the photograph), although its weight

loss ranged from 14 to 17 percent. Examination of the tested seal shows the mold flash still visible after 100,000 cycles; however, shiny surfaces on either side of that flash indicate a smoother surface than the new seal, revealing some wear. Specific gravity increased from 3.3 to 9.9 percent, pointing to some material instability also confirmed by the range of hardness increase from 4.1 to 19 percent. Six out of eight seals completed 100,000 cycles. It should be noted that one seal completed only 8700 cycles because of a possible erroneous assembly; it also experienced the highest weight loss of all the seals. This would indicate that weight loss occurs during the early stage of testing. Five seals were cut at disassembly, thereby preventing diameter measurements and also indicating loss of tensile strength as with the Buna XN 1996-2 seal.

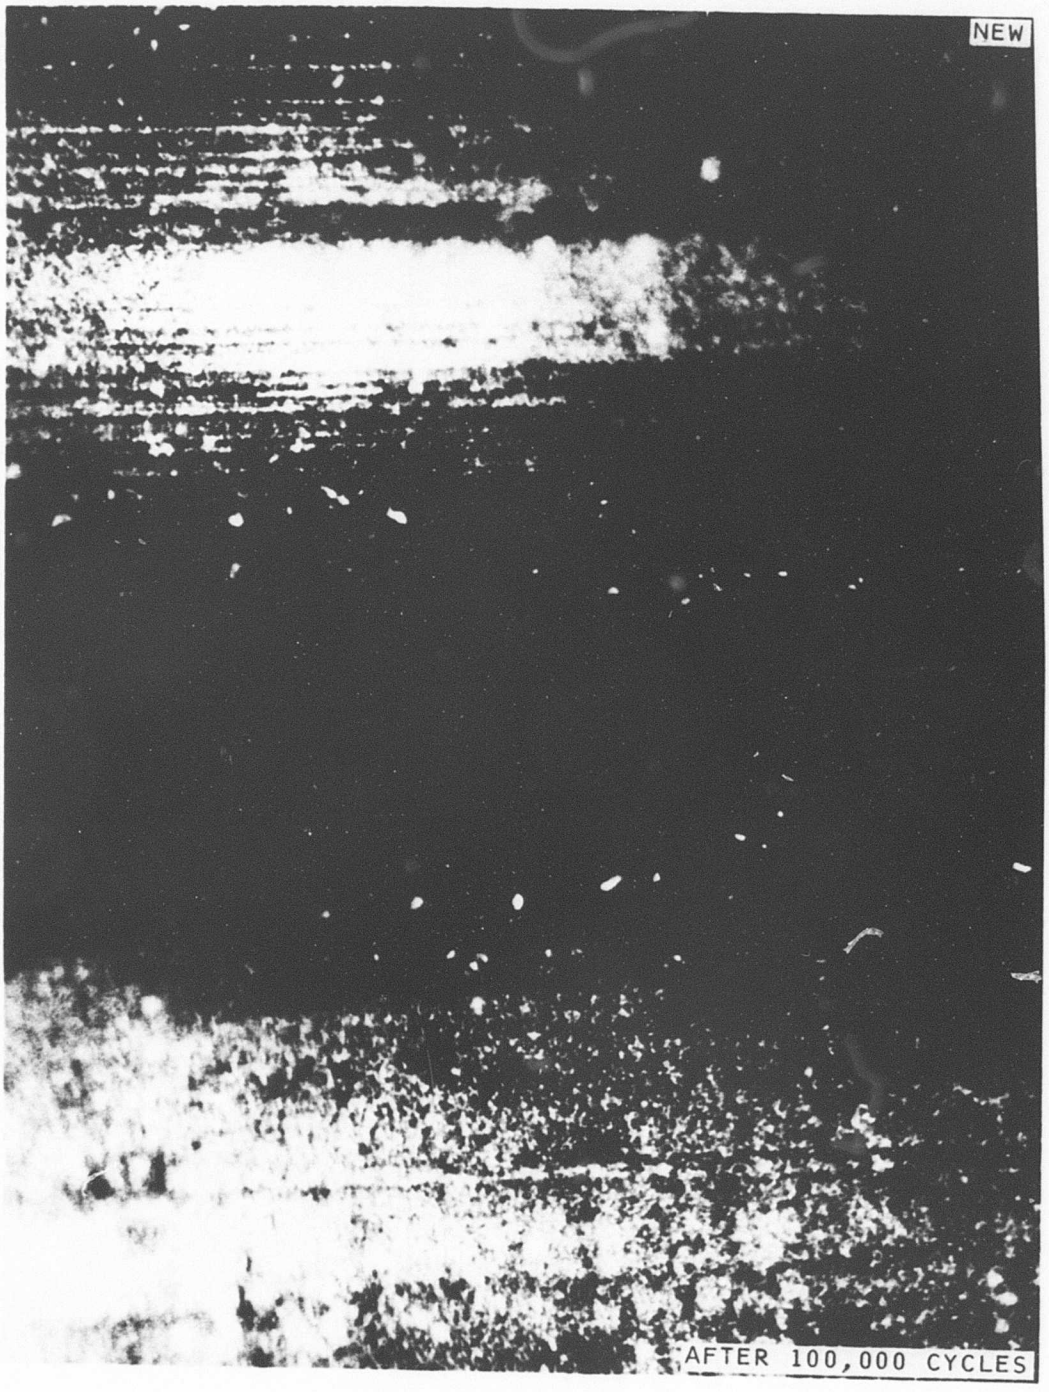
Figure 28. Rotary Seal Nitrile C-69.

The Nitrile C-69 seal is shown in Figure 28. The circumferential lines visible in the new seal are worn away in the 100,000 cycle seal; however, this wear is minimal because the mold flash of the tested seal is still visible. All six seals tested completed 100,000 cycles each without leaking. The changes in properties are not too different from the two Buna N seals; however, the changes are more consistent, indicating a more stable material, thus a better seal. This seal is qualified to MIL-P-5315. Table 14 lists the properties of the C-69 seal as well as the specified limits. Two properties stand out as being better in the C-69 seal: First, the tensile strength is highest of the group at 1740 psi. This explains why only one C-69 seal was cut at disassembly while being pulled out of its groove. Obviously, the higher the tensile strength of the seal, the better the protection of that seal will be against tearing and possibly pinching. Second, the compression set is the lowest of the group at 7 percent at 158°F for 70 hours. Note that 30,000 cycles at 250°F corresponds to 25 hours of testing.

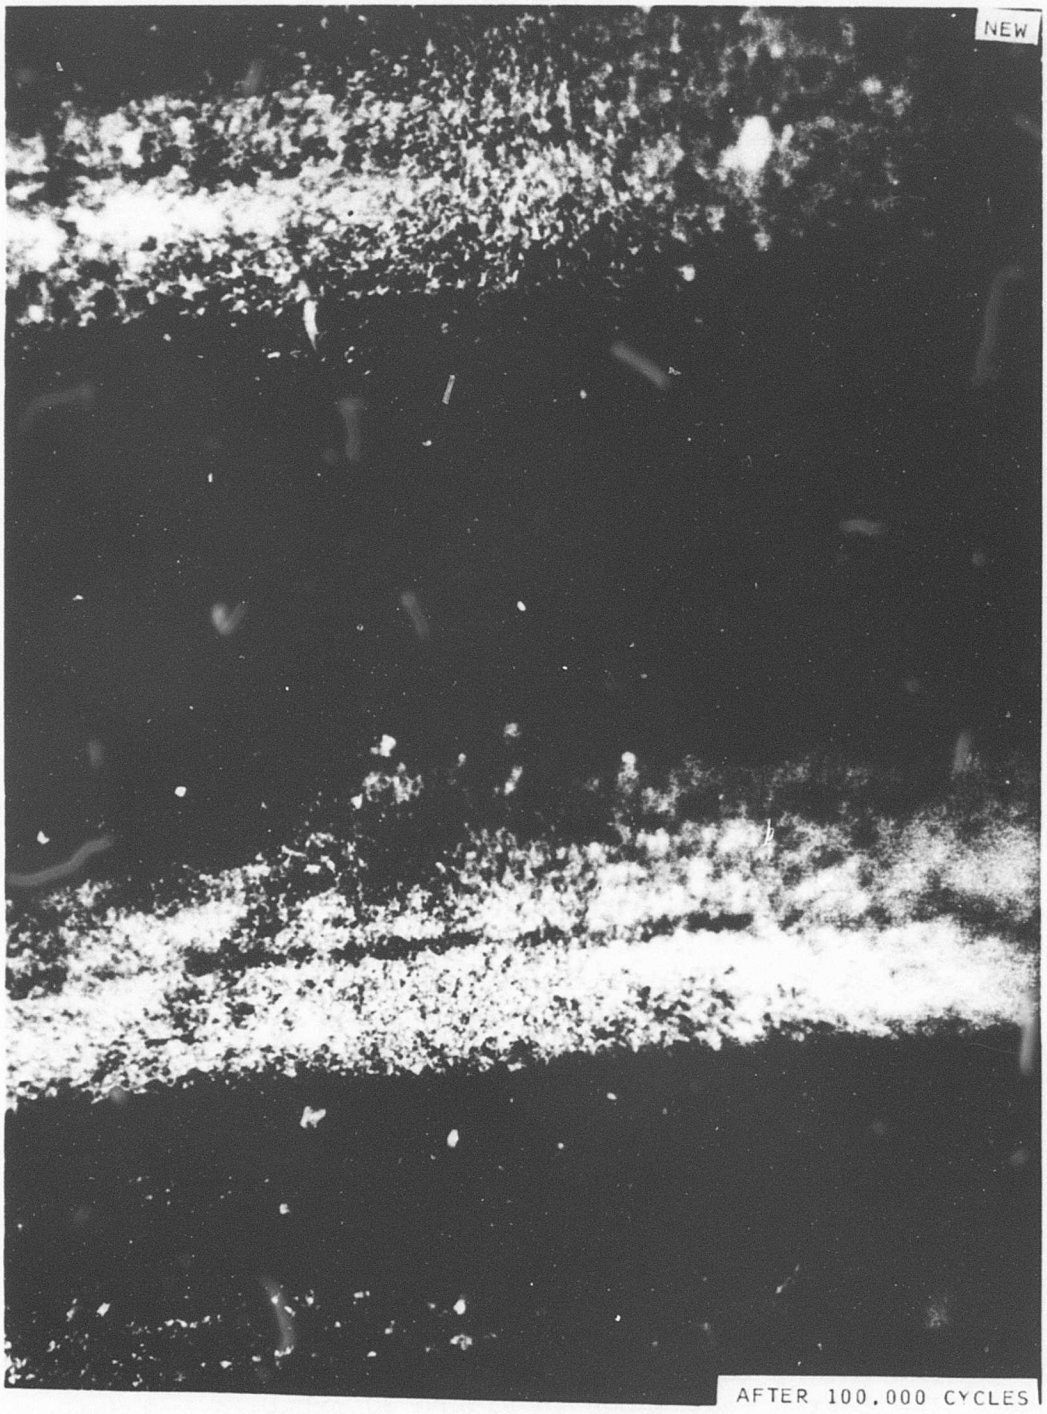
Figure 29. Rotary Seal Buna N 9021.

Three Buna N 9021 O-rings were tested in three different configurations. Buna N 9021 is presently used in Chandler Evans MC-40 fuel control. The first configuration is a standard O-ring. Five out of six samples completed 100,000 cycles, and one failed after 30,000 cycles of room temperature testing. When removed from the fixture, the failed O-ring was found disintegrated and separated into two complete rings, which explains the high weight loss listed in Table 10. The other samples also experienced weight loss ranging from 12 to 32.1 percent. One sample which lost 32.1 percent weight also had a reduction in thickness of 25 percent, indicating excessive side wear, even though it completed 100,000 cycles without failure. Specific gravity of all six samples increased between 7.7 and 11 percent, indicating the loss of lighter components of the material. Hardness also increased somewhat in relation to the specific gravity increase. Figure 29 shows a new seal next to a seal tested for 100,000 cycles. The latter exhibits a darker area representative of a compression set groove caused by the test pressure forcing the seal against the groove wall. Note that the mold flash is still visible in both seals.

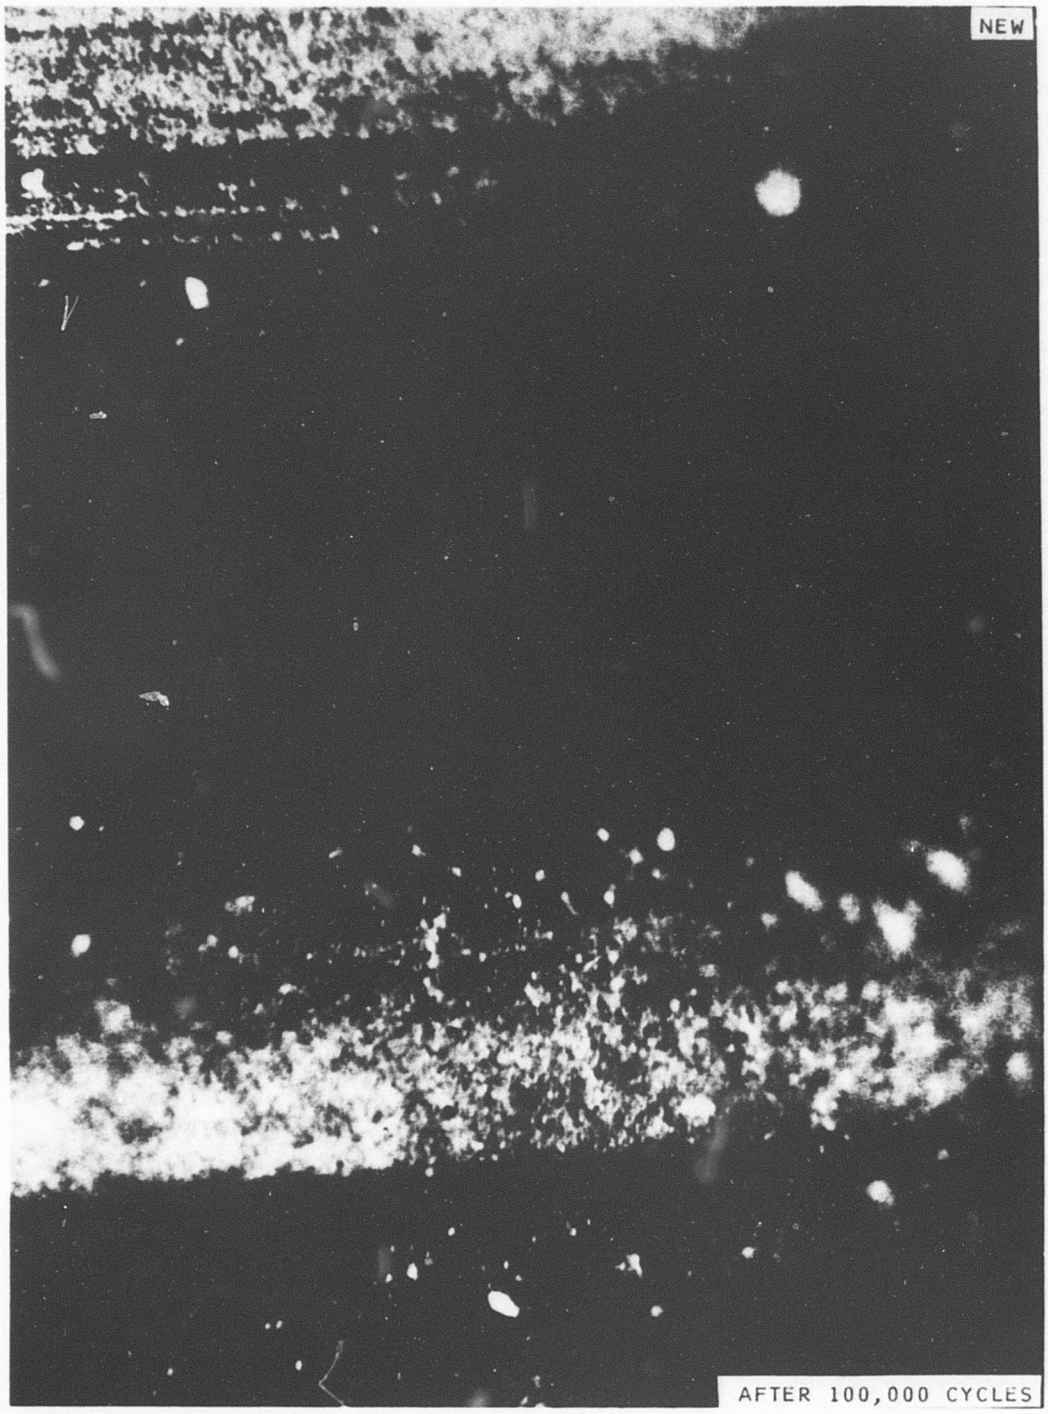
Figure 30. Rotary Seal Buna N 9021 in TFE-Coated Groove.

The second Buna N 9021 configuration is an O-ring assembled in a TFE-coated groove. Four out of six samples completed 100,000 cycles. One failed after 74,000 cycles and was so badly damaged before disassembly that no measurements were possible. Another failed after 36,000 cycles with a weight loss of 5.9 percent. The other four samples experienced weight losses of 14.4 to 20.6 percent, and one lost 7.3 percent of its thickness while the other three retained their thickness. The significant fact is that none of the samples examined increased its hardness and at the same time none increased its specific gravity by more than 5 percent. It can be theorized that the groove TFE coating transferred from the groove to the O-ring, thereby preventing the loss of lighter components as in other cases. The tested seal shown in Figure 30 exhibits the same darker area as the one shown in Figure 29. The object of a

TFE-coated groove was to eliminate rubbing between the O-ring and the sleeve bore and to have rubbing occur instead between the O-ring and the shaft groove. However, this resulted in additional wear, although it is not clearly shown in the photo.

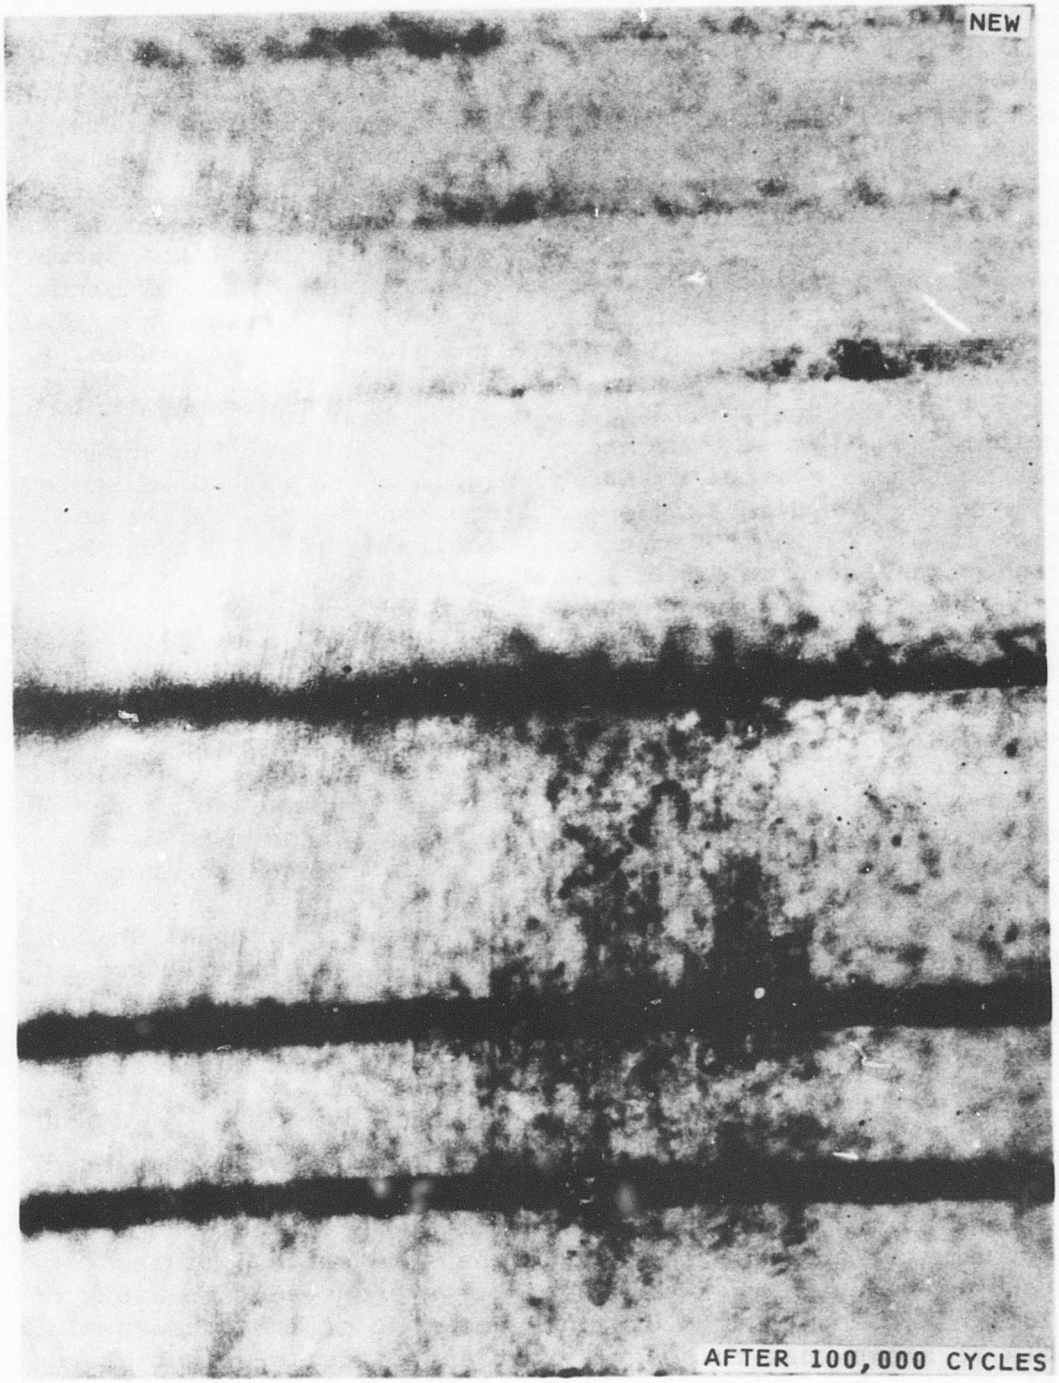
Figure 33. Translational Seal Tetralon 720.

The Tetralon 720 seals are of the same material as the rotary seal listed in Table 10 but of a different configuration. Only one of the six seals completed 100,000 cycles and then a slight leakage occurred toward the end of testing (one drop/minute). Hardness and diameters could not be measured. The only significant physical change is the increase in thickness due to the flowing characteristic of that material. Axial wear lines are shown in Figure 33. The dark circumferential lines shown on the tested seal are grooves which are filled with aluminum oxide. As in the case of the rotary seal of the same material, leakage is a function of the seal and sleeve bore finishes.

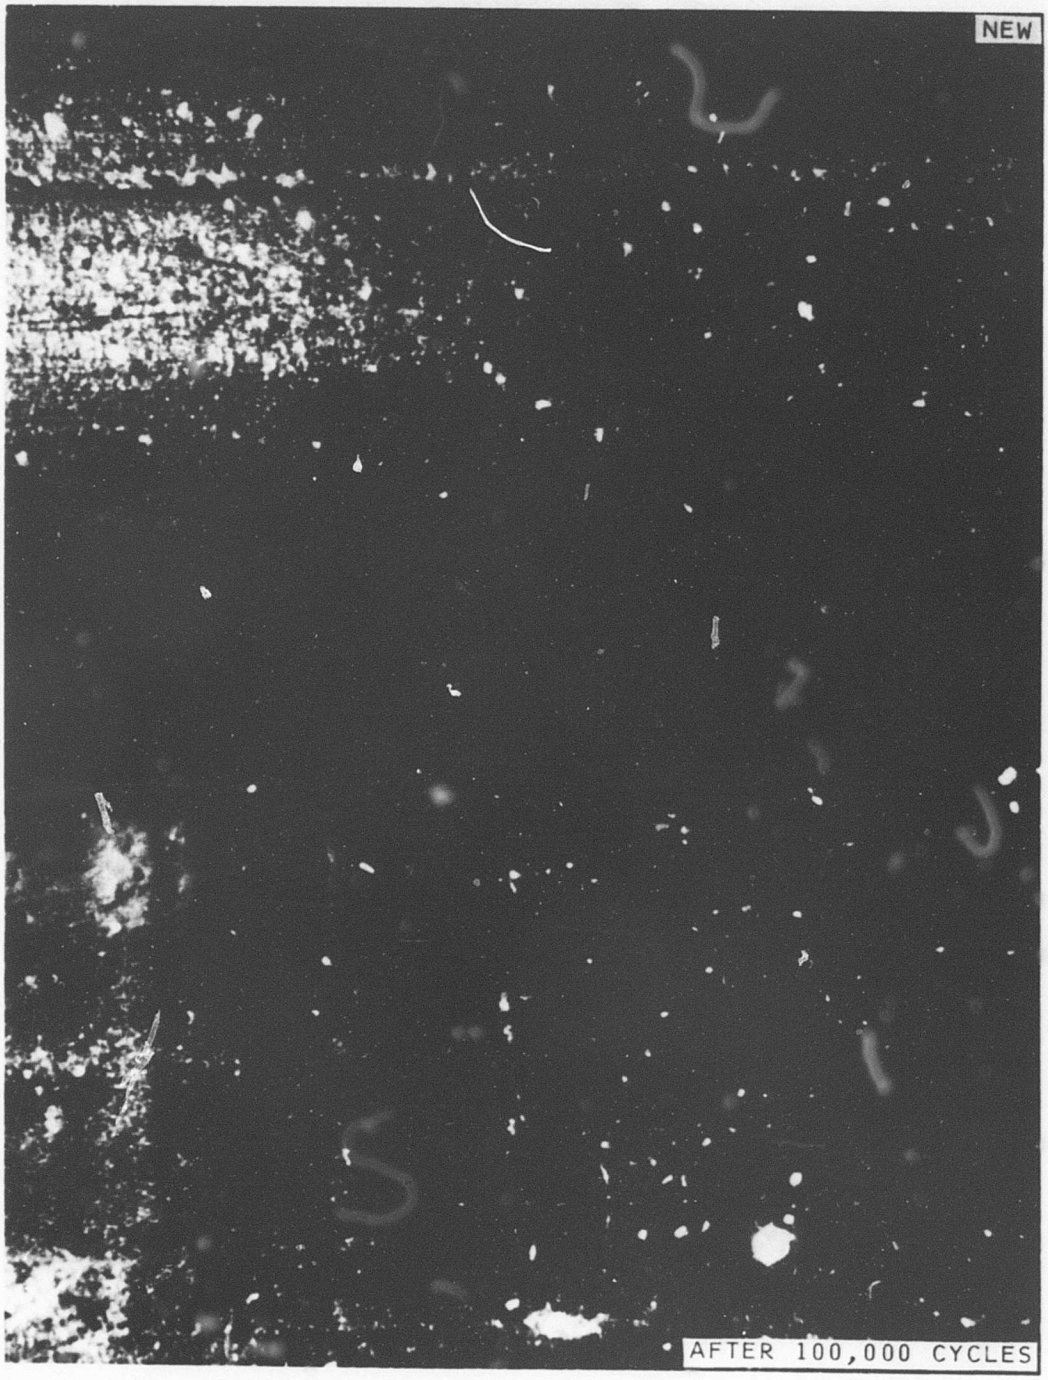
Figure 34. Translational Seal Buna N 756-75.

Four of six Buna N 756-75 seals tested completed 100,000 cycles; two of these four had a slight leakage at the end of testing (2 and 4 drops/minute). Figure 34 shows two of these seals side-by-side. Axial wear lines are visible on the seal which completed 100,000 cycles. Confirming this wear is the weight loss shown in Table 11. It should be noted that, although the tested seal shown in Figure 34 appears to have flattened out, none of the seals tested took a compression set. This seal was treated with an ultralube process designed to reduce friction and wear. As in the case of the rotary seal Buna XN 1996-2, this process failed to reduce the wear. Hardness increased as a function of the number of cycles completed to a maximum of 18.5 percent. Specific gravity also increased up to 5.8 percent and physical measurements tended to decrease, indicating shrinkage of the seals. Hardness increase is related to the increase in specific gravity which is due to compression set. This loss leads to a denser material which is harder to compress. It is interesting to note that rotary seals of the same material were fairly successful and did not show any wear, as can be seen in Figure 27. This leads to the conclusion that rolling motion of the seal tends to accelerate wear.
