TURBINE ENGINE FUEL CONTROL RELIABILITY TEST AND EVALUATION

R. D. Zagranski, et al

Colt Industries, Incorporated

July 1974

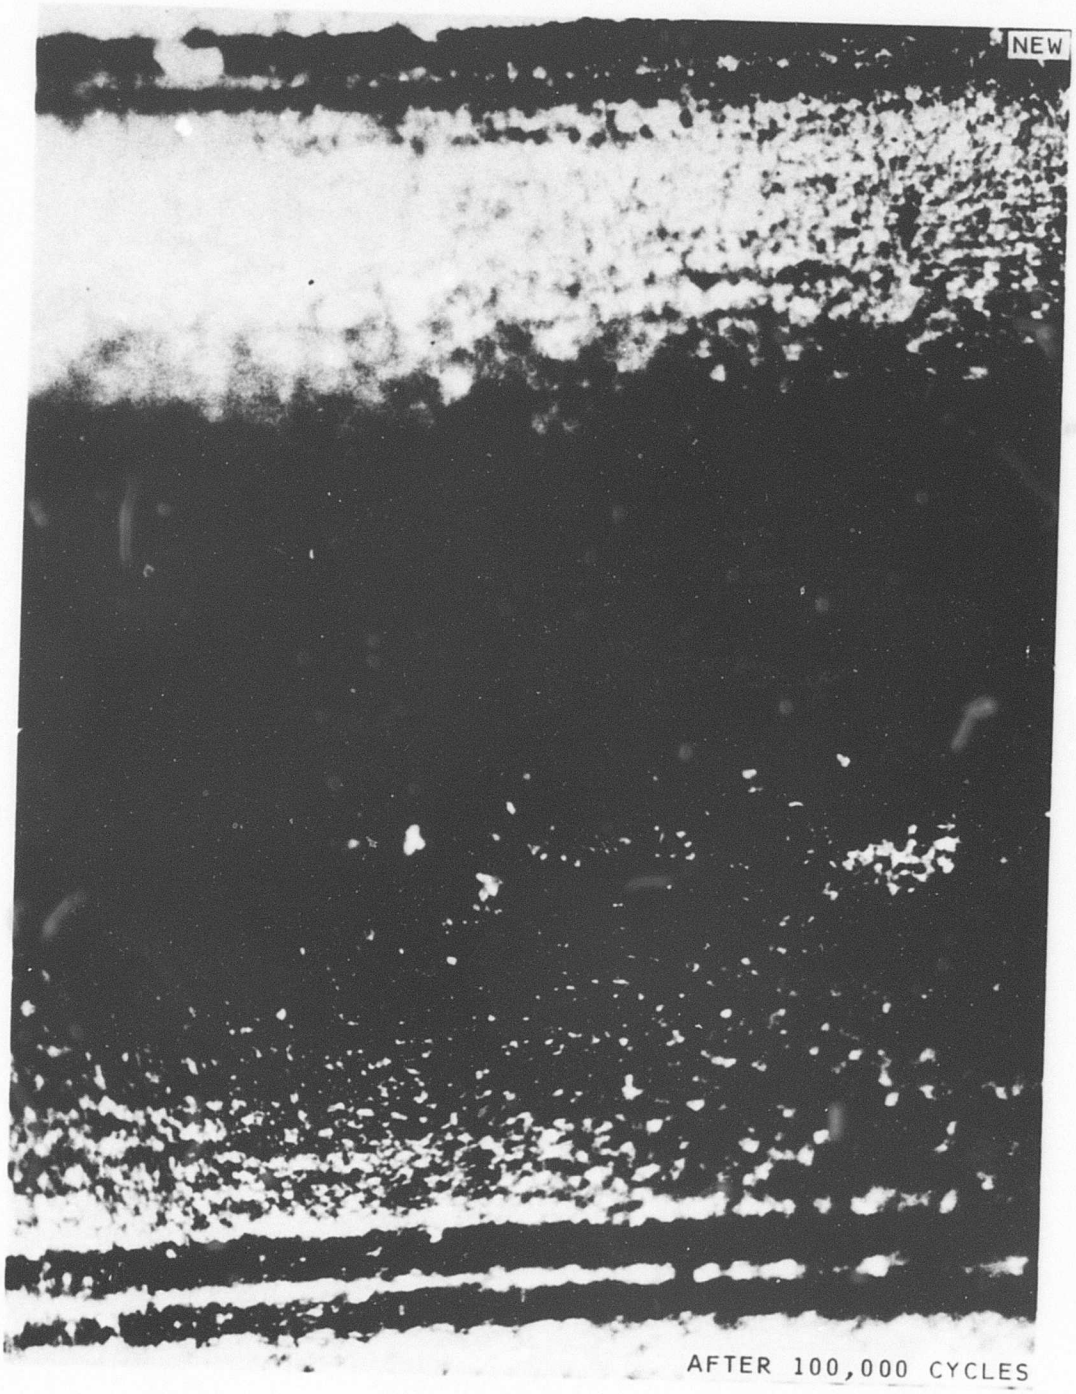
Figure 35. Translational Seal Viton V-135.

Three of six Viton V-135 translational seals tested completed 100,000 cycles without leakage. Figure 35 shows no wear at the seal which completed 100,000 cycles. Both seals, new and used, exhibit the mold flash, and the same surface finish. It should be noted that this seal has a cross-section width of 0.100 inch compared to 0.070 inch for most of the other seals. Table 11 shows that this seal experienced little weight change. Most of the physical changes were insignificant, indicating a

very stable material. The measurement which showed the greatest variation is the outside diameter. This varied from -4.6 to +3.3 percent. After making allowance for measuring errors, this small change in diameter confirms the lack of wear and indicates a low compression set of the material, which, as in the case of the C-69 rotary seal, results in a superior seal.

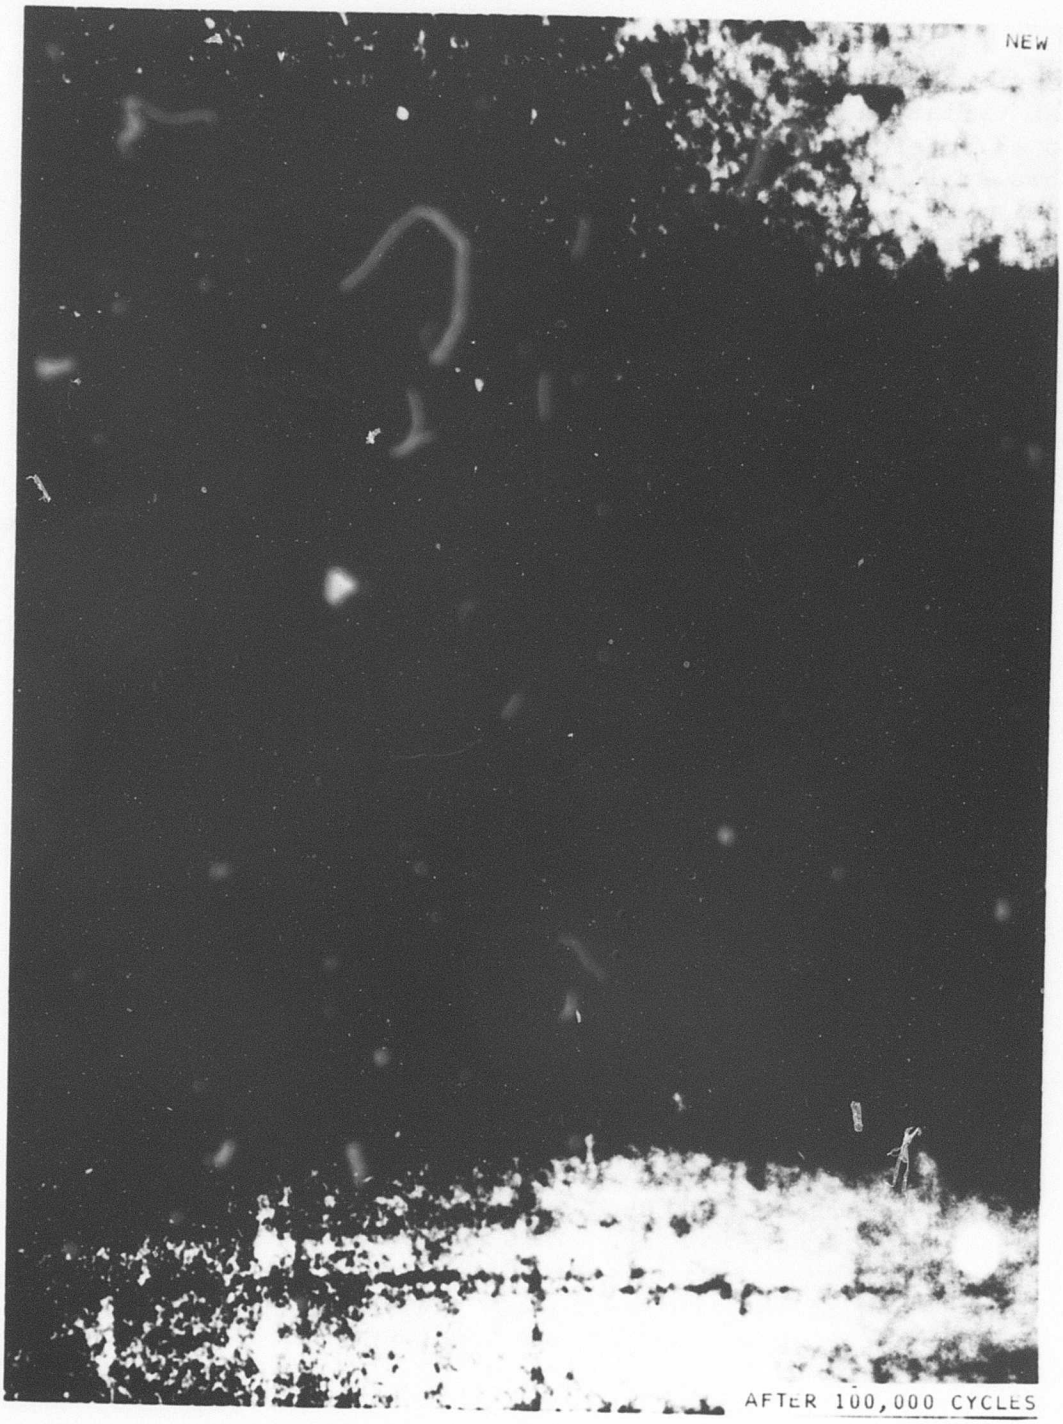
Figure 36. Translational Seal Nitrile C-69.

Tables 10 and 11 list the 15 seals tested. In both cases, rotary and translational, the best seals were standard O-rings. The only seal to complete 100,000 cycles as a rotary and translational seal was the nitrile C-69, which is a Buna N. Other Buna N seals had good results; however, their physical properties had wide variations. It appears that Buna N O-rings are the best seals available. Additional development is required, however, to arrive at a Buna N material which will give consistently good performance. This performance can be achieved only if the physical properties do not vary from one seal to the next and if the limits of such properties as tensile strength and compression set are tightened.
