STRUCTURAL EVALUATION OF UH-1D TUBULAR ROTOR BLADE

Fiber Science, Incorporated

Army Air Mobility Research and Development Laboratory

August 1974

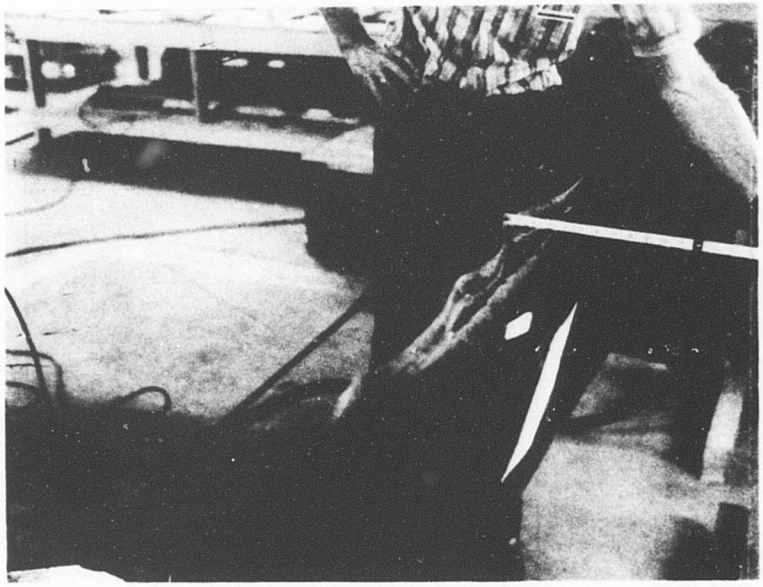
The blades were subjected to 150% of limit flapwise and chordwise bending and torsional loads except for the chordwise loading portion on Blade S/N 001. During the chordwise portion of the test on S/N 001, the blade failed at a loading of 1650 pounds. When the 1650-pound load was reached, audible cracking noises were heard coming from the general area toward the root end third of the blade. Application of the loading was stopped and the blade was observed. More cracking was heard and the trailing edge around Station 50 became unstable and took a serpentine shape. This condition progressed for about 5 seconds and then the trailing edge separated suddenly with a loud bang. Separation occurred in the material near the bond line and also in the foam beginning at 27.5 inches from the root end and extending to 84.5 inches from the root end. The total length of the split was 57 inches. The foam separation depth varied from very little at both ends of the split to a maximum of 15 inches at a point approximately 55 inches from the root end (midway between split ends).

Figure 27 is a photograph of the damage as seen during post failure flapwise static deflection tests.

Figure 27. Chordwise Proof Test Failure - S/N 001.

The blade was very simply repaired by pouring a mixture of resin into the separation area and then clamping the area closed using a vacuum bag around the blade. Resin was also injected into the fringes of the damaged area where the poured resin could not reach.

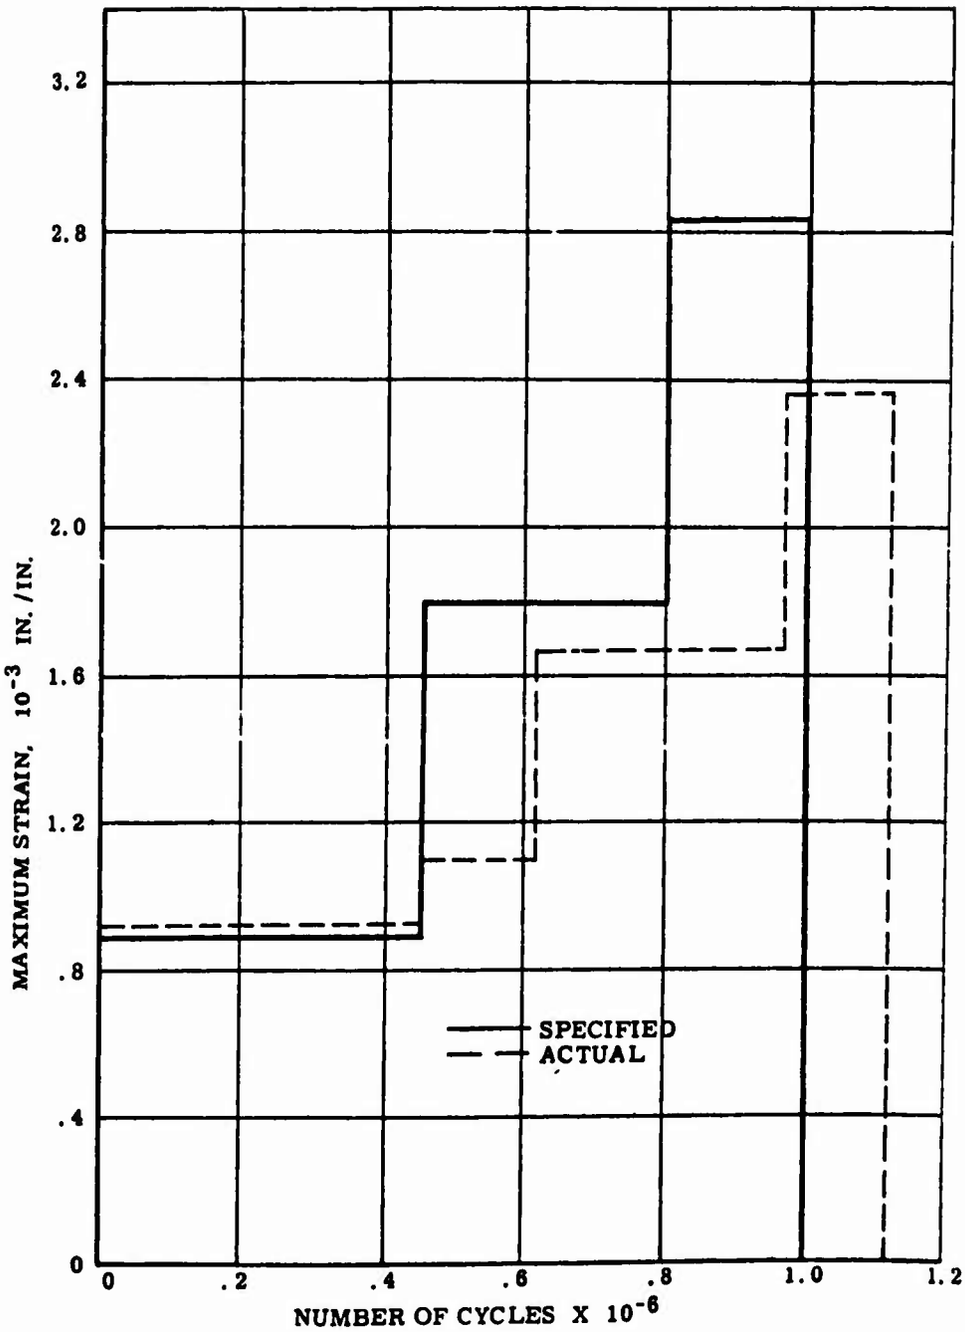
Blade S/N 002 withstood 450,000 cycles at a strain of ±.00920 in. /in., 167,076 cycles at a strain of ±.001200 in. /in., 350,000 cycles at a strain of ±.001670 in. /in., and 29,376 cycles at a strain of ±.002360 in. /in. The ±.001200 level was performed in error. At 29,376 cycles of the high level (±.002360 in. /in. strain) test, a fatigue falure appeared in the root end 5 inches from the center of the 2.5-inch pin hole toward the blade tip (see Figure 31). Testing was continued for an additional 116,000 cycles until failure progressed to the point where vibration could no longer be effectively induced. A total of 1.112×10^6 cycles was accumulated on the blade. The blade natural frequency in this mode was 17 Hz before the failure. After the failure, it was 15 Hz and gradually reduced to 13 Hz when the test terminated.

Figure 29. Fatigue Test Strain Levels Versus Number of Cycles - S/N 002.

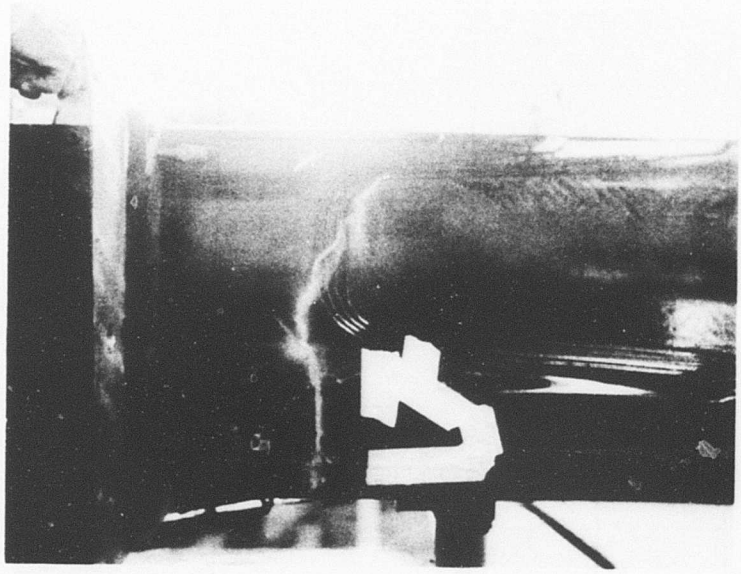
It was noted during the testing of S/N 002 that the laminated area around the large pin moved in a breathing motion relative to the pin. Displacement was approximately 0.25 inch. This motion probably occurred on all blades, at least to some extent. Reasons for this include the method of mounting the blade and also the fit of the large pin. A bolt instead of the pin allowing a clamping attachment would probably not have allowed damage to occur. The pin in Blade S/N 003 (blade not damaged) fitted tighter than the pins in the other two blades. The damage to the two blades is attributed to these two factors and the high strain test levels.

Figure 31. Fatigue Test Damage - S/N 002.

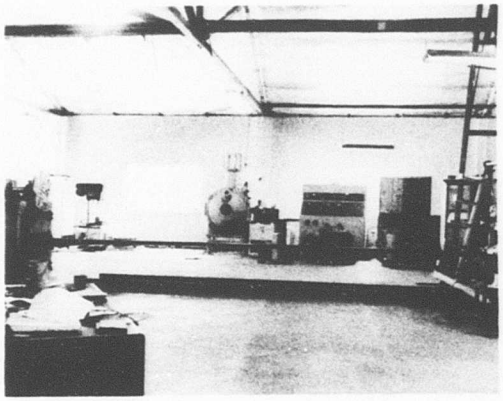
S/N 001 failed at a tip height (leading edge) of 10 feet above the zero position with a loading of 750 pounds. Failure occurred in the root end beginning at the damaged area incurred during fatigue testing. The failure line began at the center of the 2-1/2-inch-diameter hole, progressed straight to the leading edge, made an abrupt right angle turn at the seam in the leading edge, and progressed toward the tip for about 2-1/2 feet. The load after breakage dropped to 600 pounds (see Figures 33 and 36).

Figure 33. Ultimate Test - Typical Zero Position.

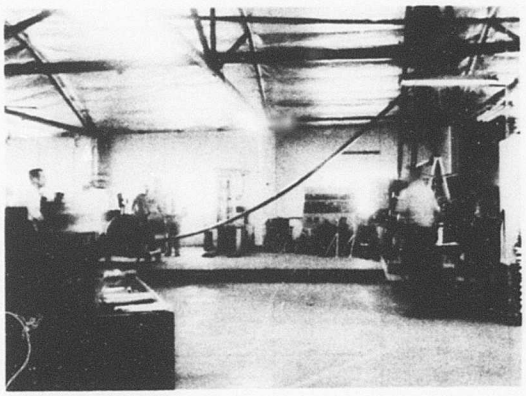
S/N 003's first major break occurred at a tip height of 120 inches and a loading of 975 pounds. The break consisted of skin compression failure at Station 84 and leading edge split from Station 35 to Station 76. When the break occurred, the load dropped immediately back to 850 pounds. Testing was continued to a height of 132 inches and 1100 pounds. At this time, the trailing edge split open from Station 48 to 96 and the load dropped to 950 pounds (see Figures 34 and 38).

Figure 34. Ultimate Test - Maximum Loading at Break - S/N 003.

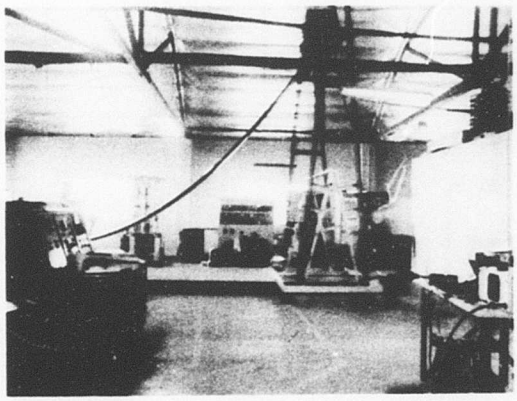
S/N 002 ultimate testing was terminated at a tip leading edge height of 144 inches above zero and a loading of 915 pounds. The test was terminated at this point because the blade was hinging at the damaged section of the root end sustained during fatigue testing (see Figures 35 and 37).

Figure 35. Ultimate Test - Maximum Loading at Break - S/N 002.

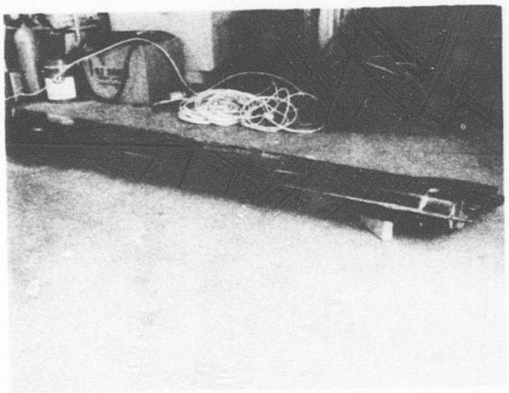
Figure 36. Ultimate Test Failure - S/N 001.

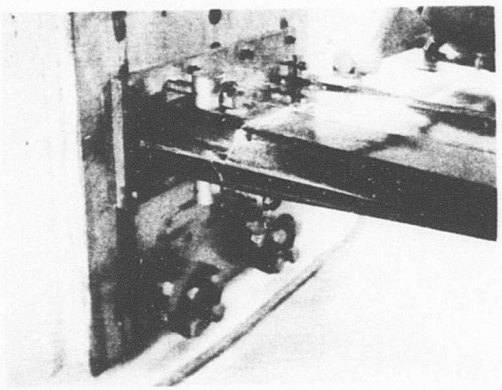
Figure 37. Ultimate Test Failure - S/N 002.

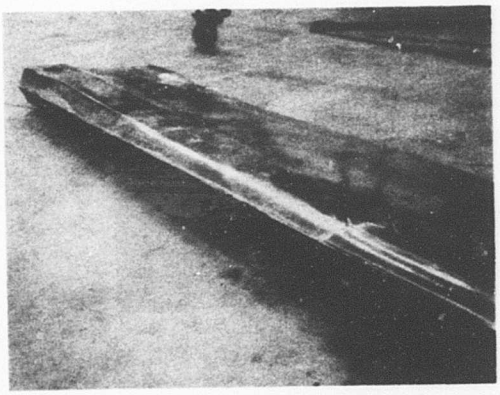
Figure 38. Ultimate Test Failure - S/N 003.

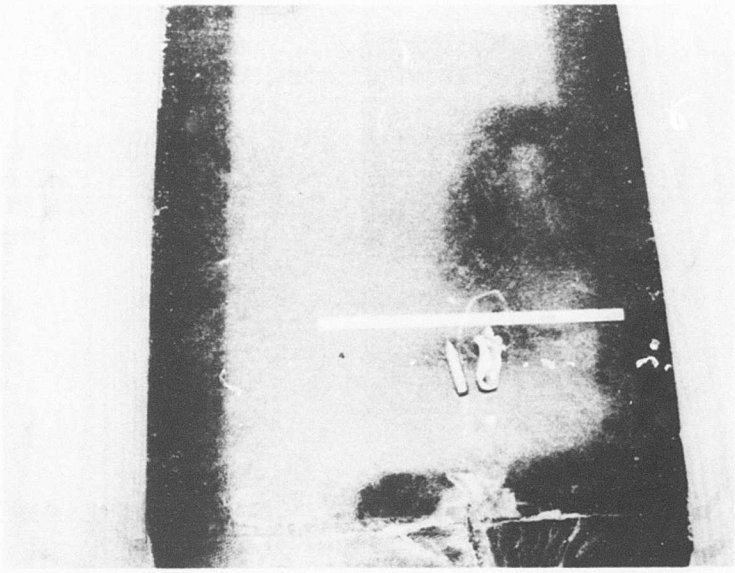
Figure 39. Bullet Impact, Leading Edge - S/N 002.

The bullet hit flat on the leading edge of the blade and glanced off into the sand. The damage to the blade was groove shaped, penetrating the skin and gouging out a small area in the surface of the longo material. The groove was approximately 1-1/2 inches long, 1/2 inch wide and 0.30 inch deep. Damage to the skin was approximately 2 inches chordwise and 3 inches spanwise.

1. All damaged material was removed by sanding with an air-operated hand-held rotary disc sander using 60-grit Jewelox paper. At the same time, the sides of the groove in the longo material were tapered out to 3 inches in the spanwise direction. The skin material was then stepped (2 steps, each 1/2 inch wide) past this point.

2. The longo material was replaced using plies of Style 143 fiber glass fabric and a resin system consisting of DOW DER 323 resin and APCO 320 hardener at a ratio of 17.4 parts by weight per hundred. The resin system was applied to each ply of fabric to assure full saturation. The first plies were cut small to fill the bottom of the groove, and each succeeding ply was cut increasingly larger to fill the groove evenly. Twenty plies were required to fill the groove in the longo material.

3. The skin material was replaced using six plies of Style 181 fabric with the fibers placed at an angle of $\pm 45^{\circ}$, and two plies of the same material with the fibers at 0° to the spanwise axis. Again, the same procedure was used of cutting smaller pieces at first and increasing the width and length to fill the hole evenly. The last two plies covered the entire hole, overlapping on each side 1 inch onto the outer surface of the original skin. The same resin system described in Step 2 above was used.

4. Next, the entire repaired area was covered with one ply of Style 113 fabric using the same resin system, and overlapping 2 inches on each side.

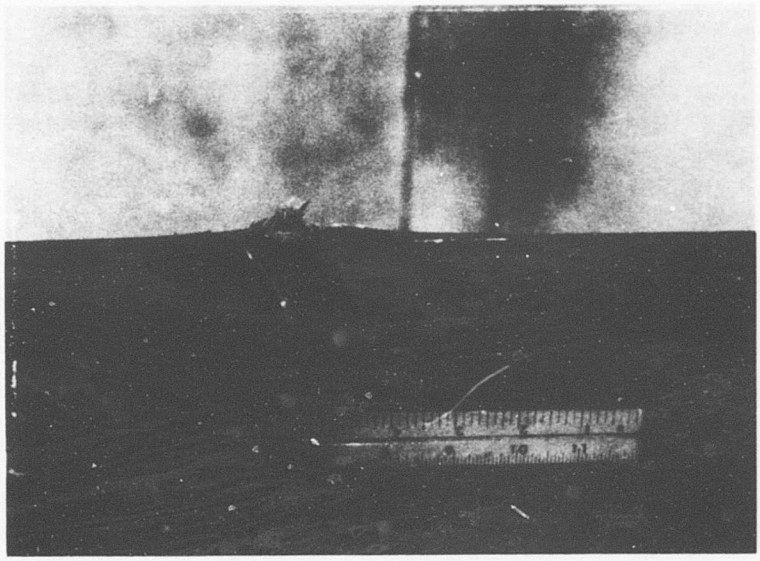
Figure 40. Bullet Impact, Trailing Edge - S/N 002.

The bullet penetrated the trailing edge of the blade and exited on the opposite side, leaving a groove running chordwise for about 1-1/2 inches long at the entrance and about 3 inches long on the exit side. The trailing edge split at the bond line approximately 4 inches on both sides of the bullet entrance. The bullet severed the trailing-edge longo material, and the damage extended forward into the foam area.

1. The skin was stripped away on both sides of the blade until the trailing edge longo material and foam were exposed for 7-1/2 inches on both sides of the damaged area and 1 inch in front. The resulting exposed areas were rectangular in shape. Using an air-operated disc sander with No. 60 grit paper, the skin was tapered back 1-1/2 inches on each side of the rectangles.

2. Again, using the sander, the damaged longo material was removed and the two severed ends were sanded to a knife edge taper on the ends with the taper extended back 2 inches on the bullet entrance side and 4 inches on the bullet exit side.

3. Voids in the damaged foam area were filled using a thick mixture of micro-balloons in a resin system composed of DOW DER 332 resin and APCO 320 hardener mixed to a ratio of 17.4 parts by weight per hundred.

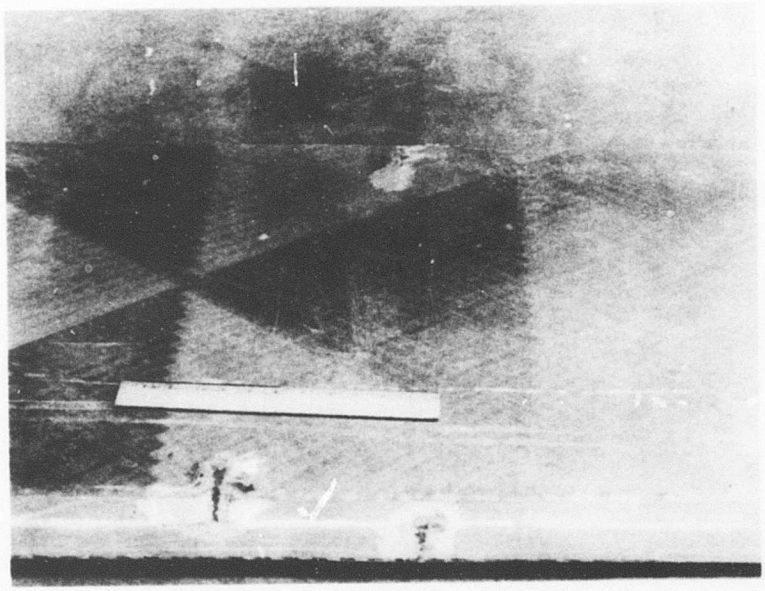
Two bullets were fired into the leading edge of S/N 003. This first round, fired at a velocity of 1800 feet per second, caused less damage than expected (see Figure 39) so a round was fired at 2500 feet per second. In both cases the bullets cut the skin and glanced off the longo material, leaving a shallow groove. The higher velocity round resulted in noticeably more damage to the surrounding skin (see Figures 41 and 42).

Figure 41. Bullet Damage,
Spar - S/N 003.

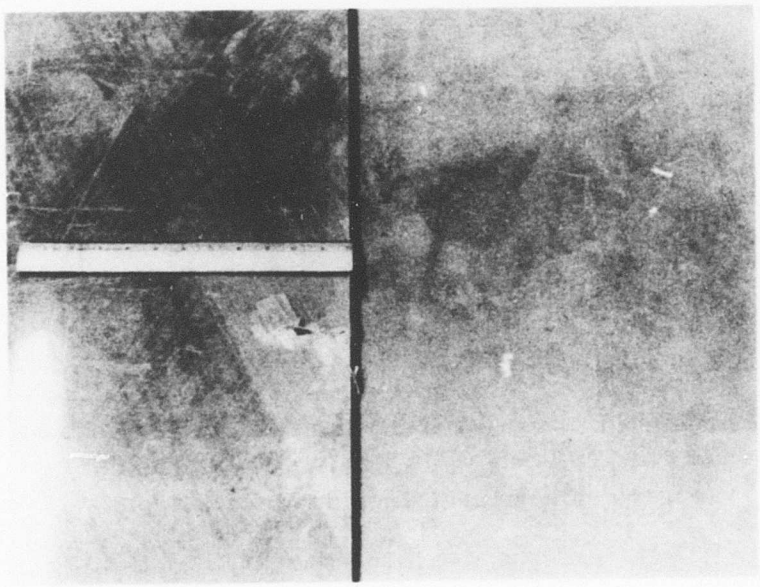
The bullet fired into the trailing edge on Blade S/N 003 penetrated through the blade and lodged, partially exposed, on the back side. The bullet hole was 3.3 inches long on the entrance side and 4.9 inches long on the exit side. The damage extended to a width of approximately 1.5 inches on each side of the hole.

Figure 42. Bullet Damage,
Trailing Edge - S/N 003.

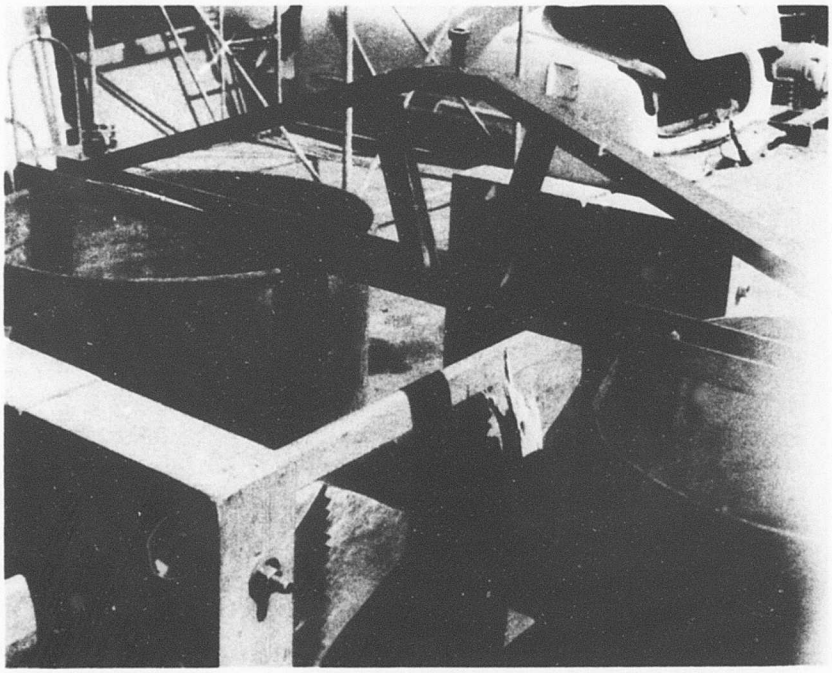
No damage was sustained by either of the two blades tested as a result of the tree strike tests (see Figure 43). The blades have excellent resistance to damage from simulated tree strikes.

Figure 43. Impact Tree Strike - S/N 003.

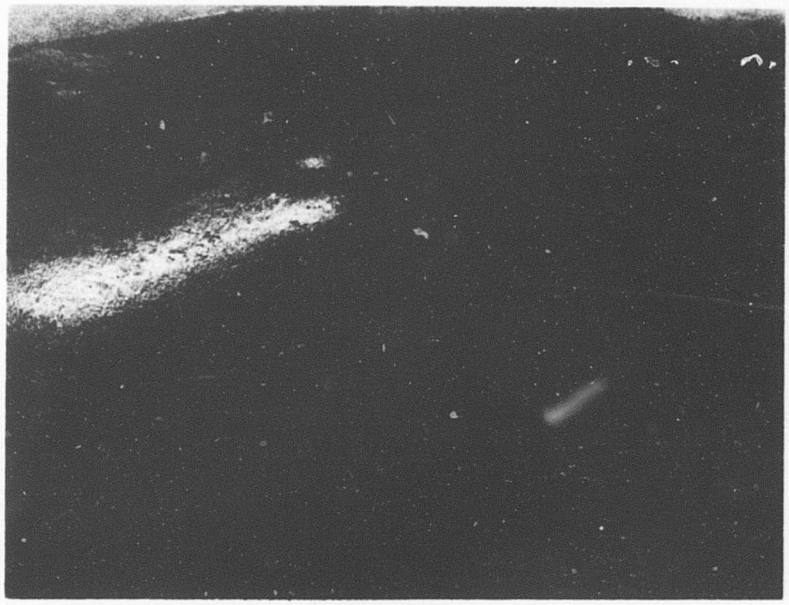
The fiberglass blade (S/N 002) withstood the impact of the steel ball with noticeably less effect than the PRD-49 (S/N003) blade. No damage was visible on the fiberglass blade after drops of up to 17 feet except for small dents resulting from the highest drops. These dents reached a maximum depth of .012 inch in the fiberglass blade and .025 inch in the PRD-49 blade. The largest dents resulted from drops close to the trailing edge. Drops on the PRD-49 blade resulted in minor fracturing of the skin at drop heights of 8 and 9 feet. In no case did the ball penetrate the skin. All damage was confined to the dented area where the ball hit. Figure 44 shows Blade S/N003 after the ball drop tests. The blades were found to have excellent resistance to ball drop impact damage.

Figure 44. Ball Drop Results - S/N 003.
