XRD-105

BUREAU OF SHIPS GROUP

GENERAL SUMMARY OF HULL DAMAGE

DETAILED DESCRIPTION OF HULL DAMAGE

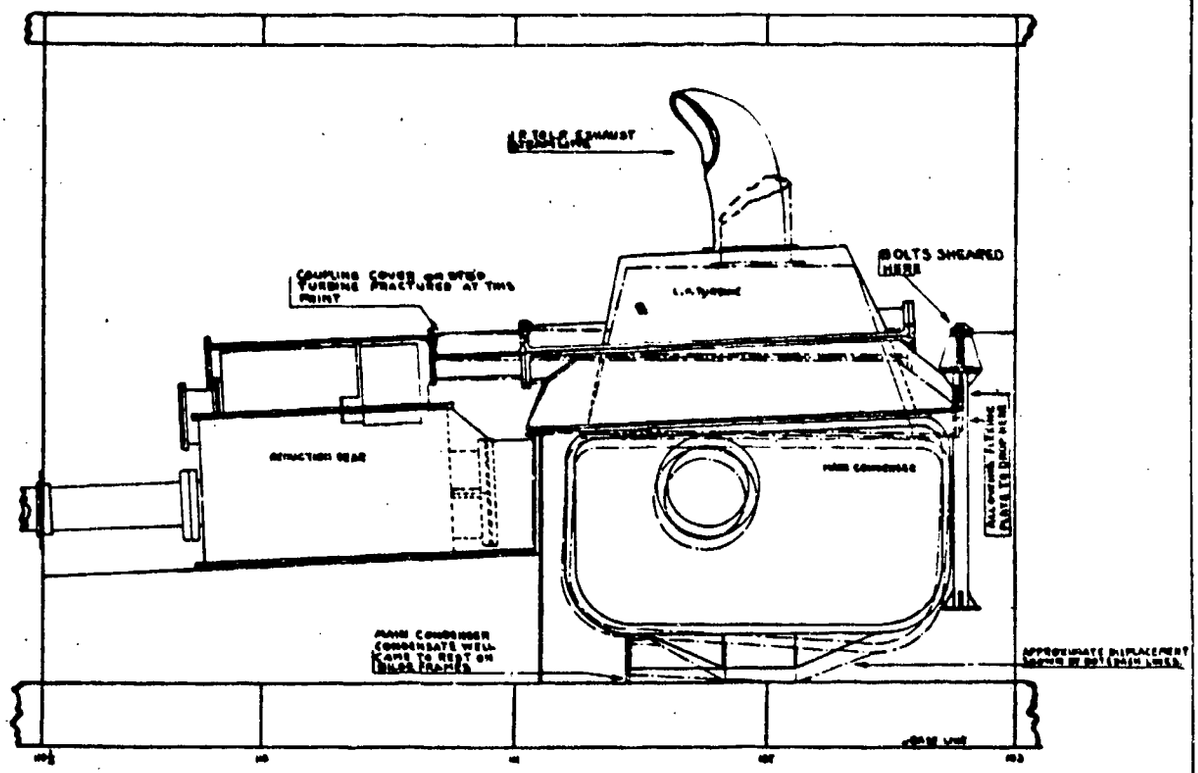
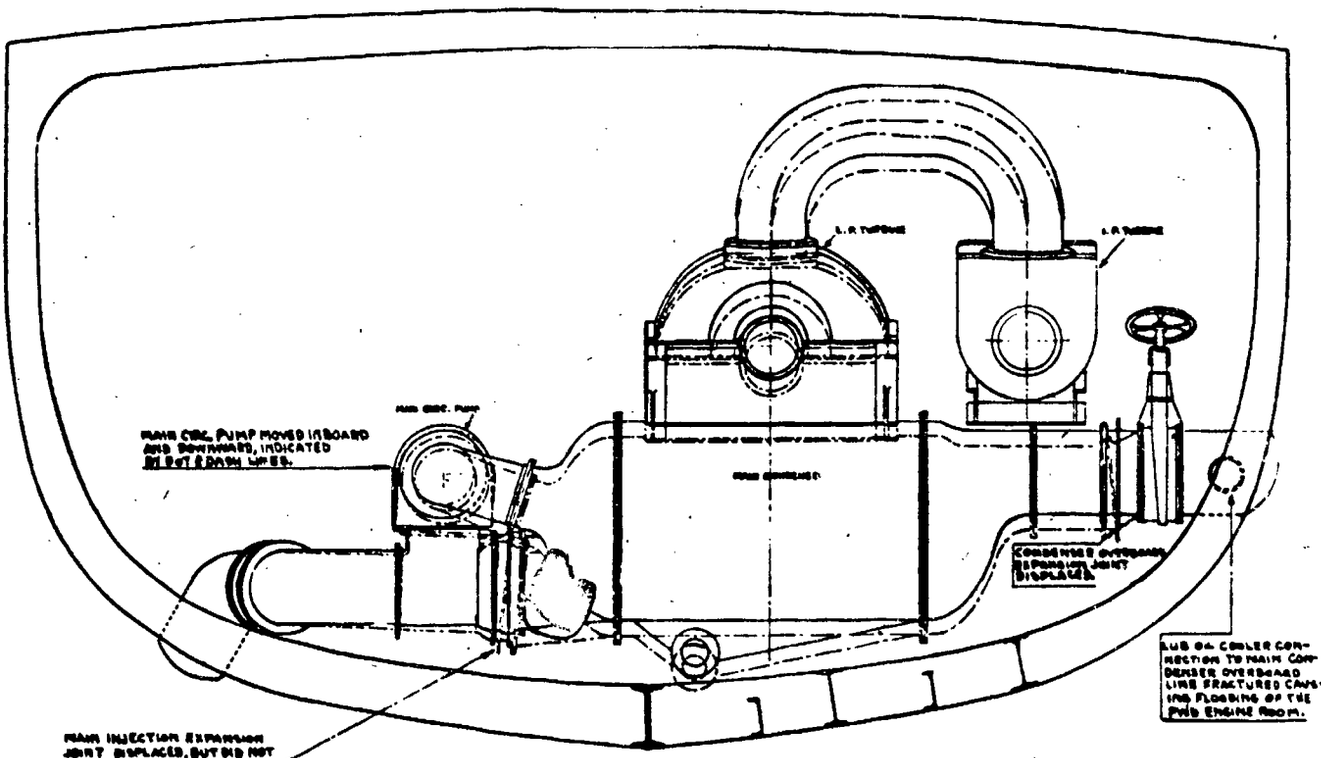
U.S.S. HUGHES
TEST BAKER
ORIGINAL POSITION SHOWN IN SOLID LINES. DISPLACEMENT SHOWN IN DOT & DASH LINES.
MACHINERY GROUP
CROSSBOARD
DD 465-61-5.

STARBOARD LOW PRESSURE TURBINE, LOOKING TO PORT.
SCALE ½" = 1 FOOT.

SECTION AT FR. 111
LOOKING FOR'D.
SCALE ½" = 1 FOOT.

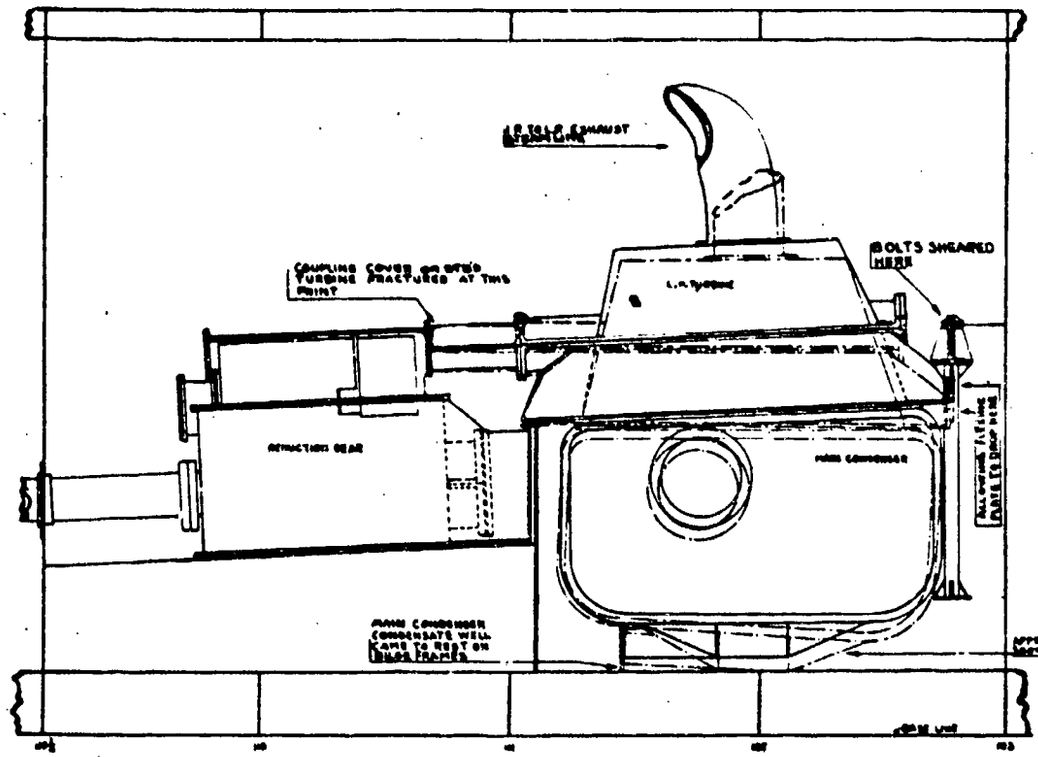
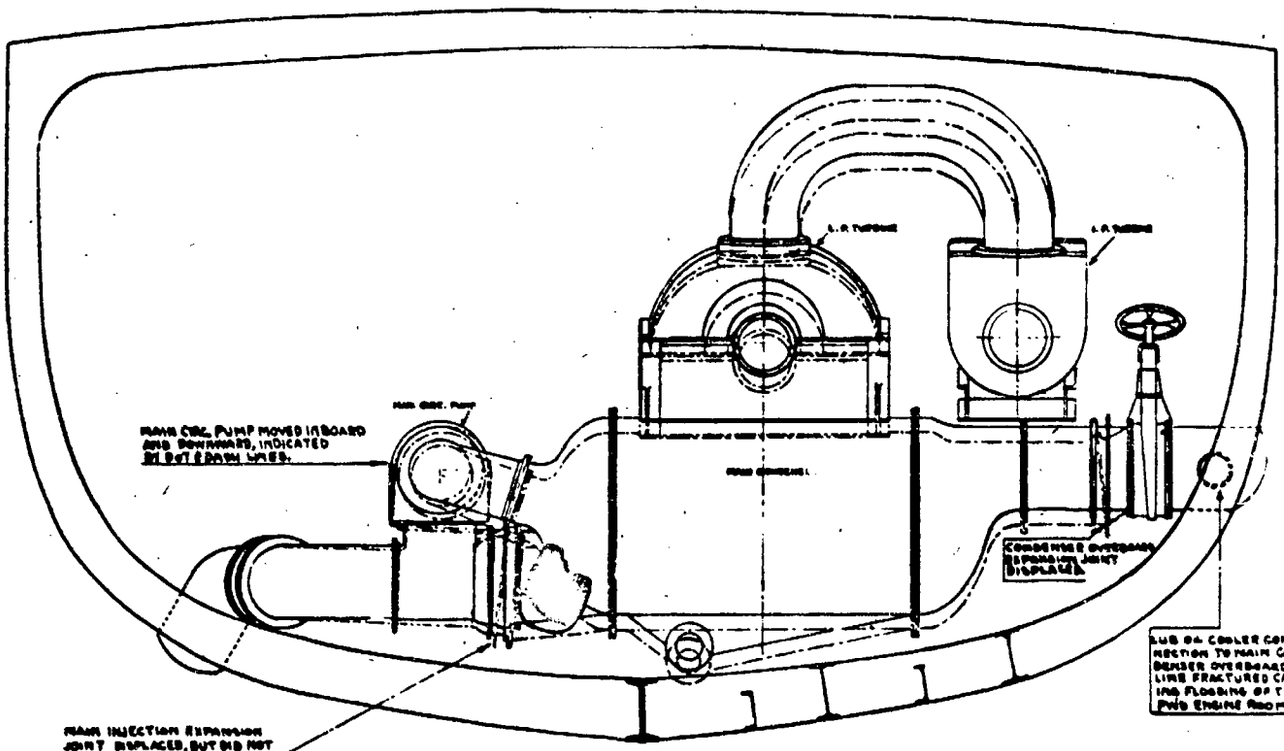
U.S.S. HUGHES
TEST BAKER
ORIGINAL POSITION SHOWN IN SOLID LINES. DISPLACEMENT SHOWN IN DOT & DASH LINES.
MACHINERY GROUP
CROSSBOARD
DD 465-61-5.

STARBOARD LOW PRESSURE TURBINE, LOOKING TO PORT.
SCALE 1/16" = 1 FOOT.

SECTION AT FR. 111
LOOKING FOR'D.
SCALE 1/4" = 1 FOOT.

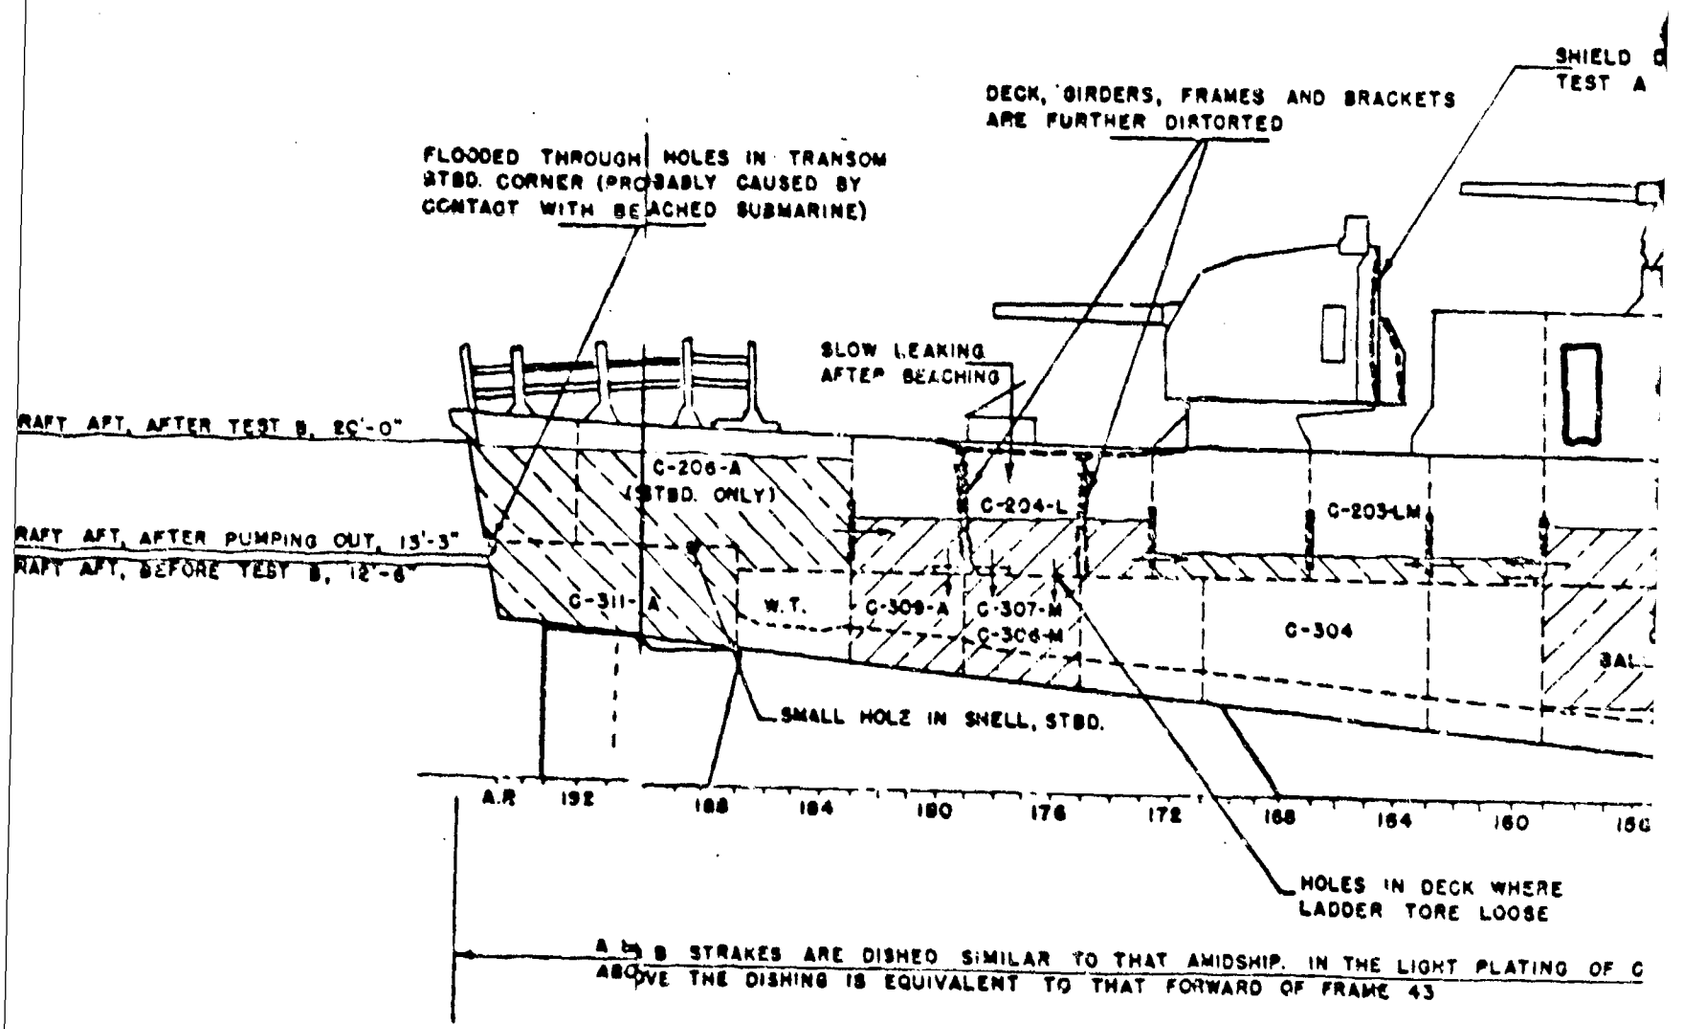
SHIP DAMAGE DIAGRAM

SHIELD
TEST A
DECK, GIRDERS, FRAMES AND BRACKETS ARE FURTHER DISTORTED
FLOODED THROUGH HOLES IN TRANSOM STBD. CORNER (PROBABLY CAUSED BY CONTACT WITH BEACHED SUBMARINE)
SLOW LEAKING AFTER BEACHING
RAFT AFT, AFTER TEST B, 20'-0"
RAFT AFT, AFTER PUMPING OUT, 13'-3"
RAFT AFT, BEFORE TEST B, 12'-6"
C-206-A (STBD. ONLY)
C-204-L
C-203-LM
C-311-A
W.T.
C-309-A
C-307-M
C-306-M
C-304
SMALL HOLE IN SHELL, STBD.
A.R
192
188
184
180
176
172
168
164
160
HOLES IN DECK WHERE LADDER TORE LOOSE
A & B STRAKES ARE DISHED SIMILAR TO THAT AMIDSHIP. IN THE LIGHT PLATING OF C ABOVE THE DISHING IS EQUIVALENT TO THAT FORWARD OF FRAME 43

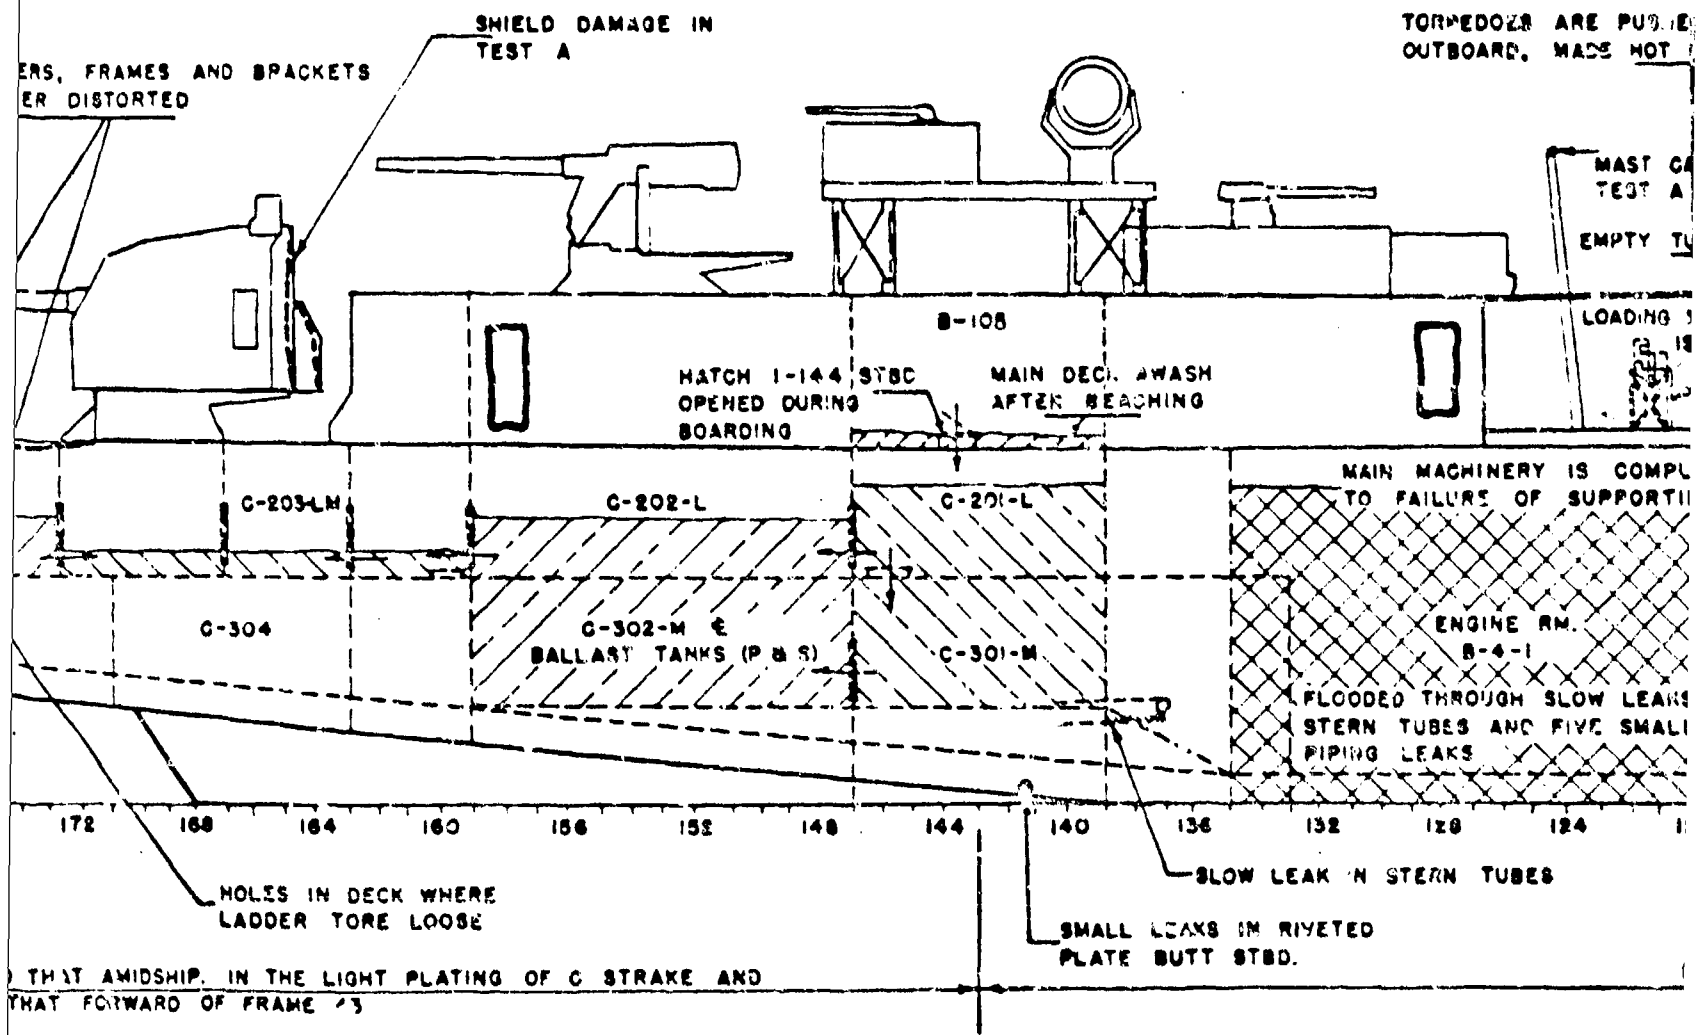
SHIELD DAMAGE IN TEST A
ERS, FRAMES AND BRACKETS ER DISTORTED
TORPEDOES ARE PU
OUTBOARD, MADE HOT
MAST C TEST A
EMPTY T
LOADING
B-108
HATCH 1-144 STBD OPENED DURING BOARDING
MAIN DECK AWASH AFTER BEACHING
MAIN MACHINERY IS COMPL TO FAILURE OF SUPPORTI
C-203-LM
C-202-L
C-201-L
C-304
C-302-M ℄ BALLAST TANKS (P & S)
C-301-M
ENGINE RM. B-4-1
FLOODED THROUGH SLOW LEAKS STERN TUBES AND FIVE SMALL PIPING LEAKS
172
168
164
160
156
152
148
144
140
136
132
128
124
HOLES IN DECK WHERE LADDER TORE LOOSE
SLOW LEAK IN STERN TUBES
SMALL LEAKS IN RIVETED PLATE BUTT STBD.
THAT AMIDSHIP. IN THE LIGHT PLATING OF C STRAKE AND
THAT FORWARD OF FRAME

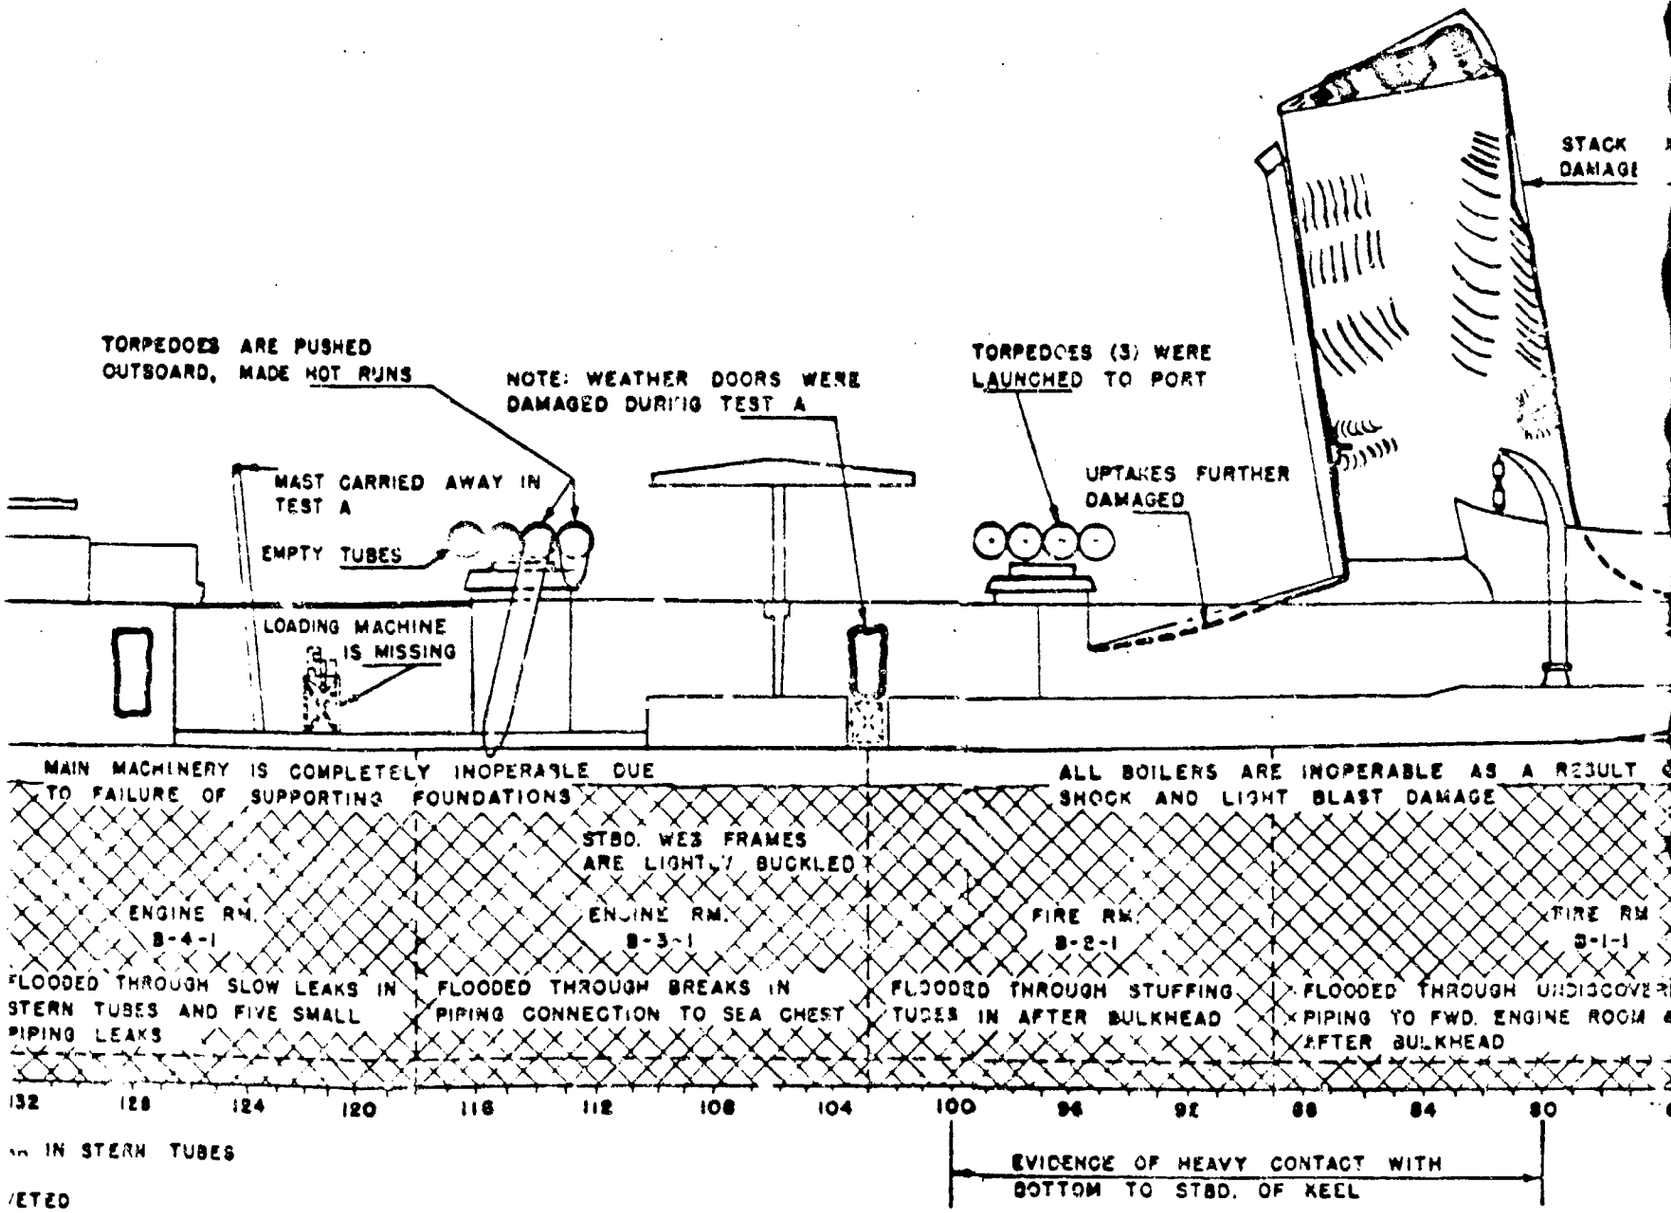
PLATING IS LIGHTLY DISHED IN LONG CONCAVE SECTIONS BETWEEN LONGITUDINALS BELOW TURN OF THE

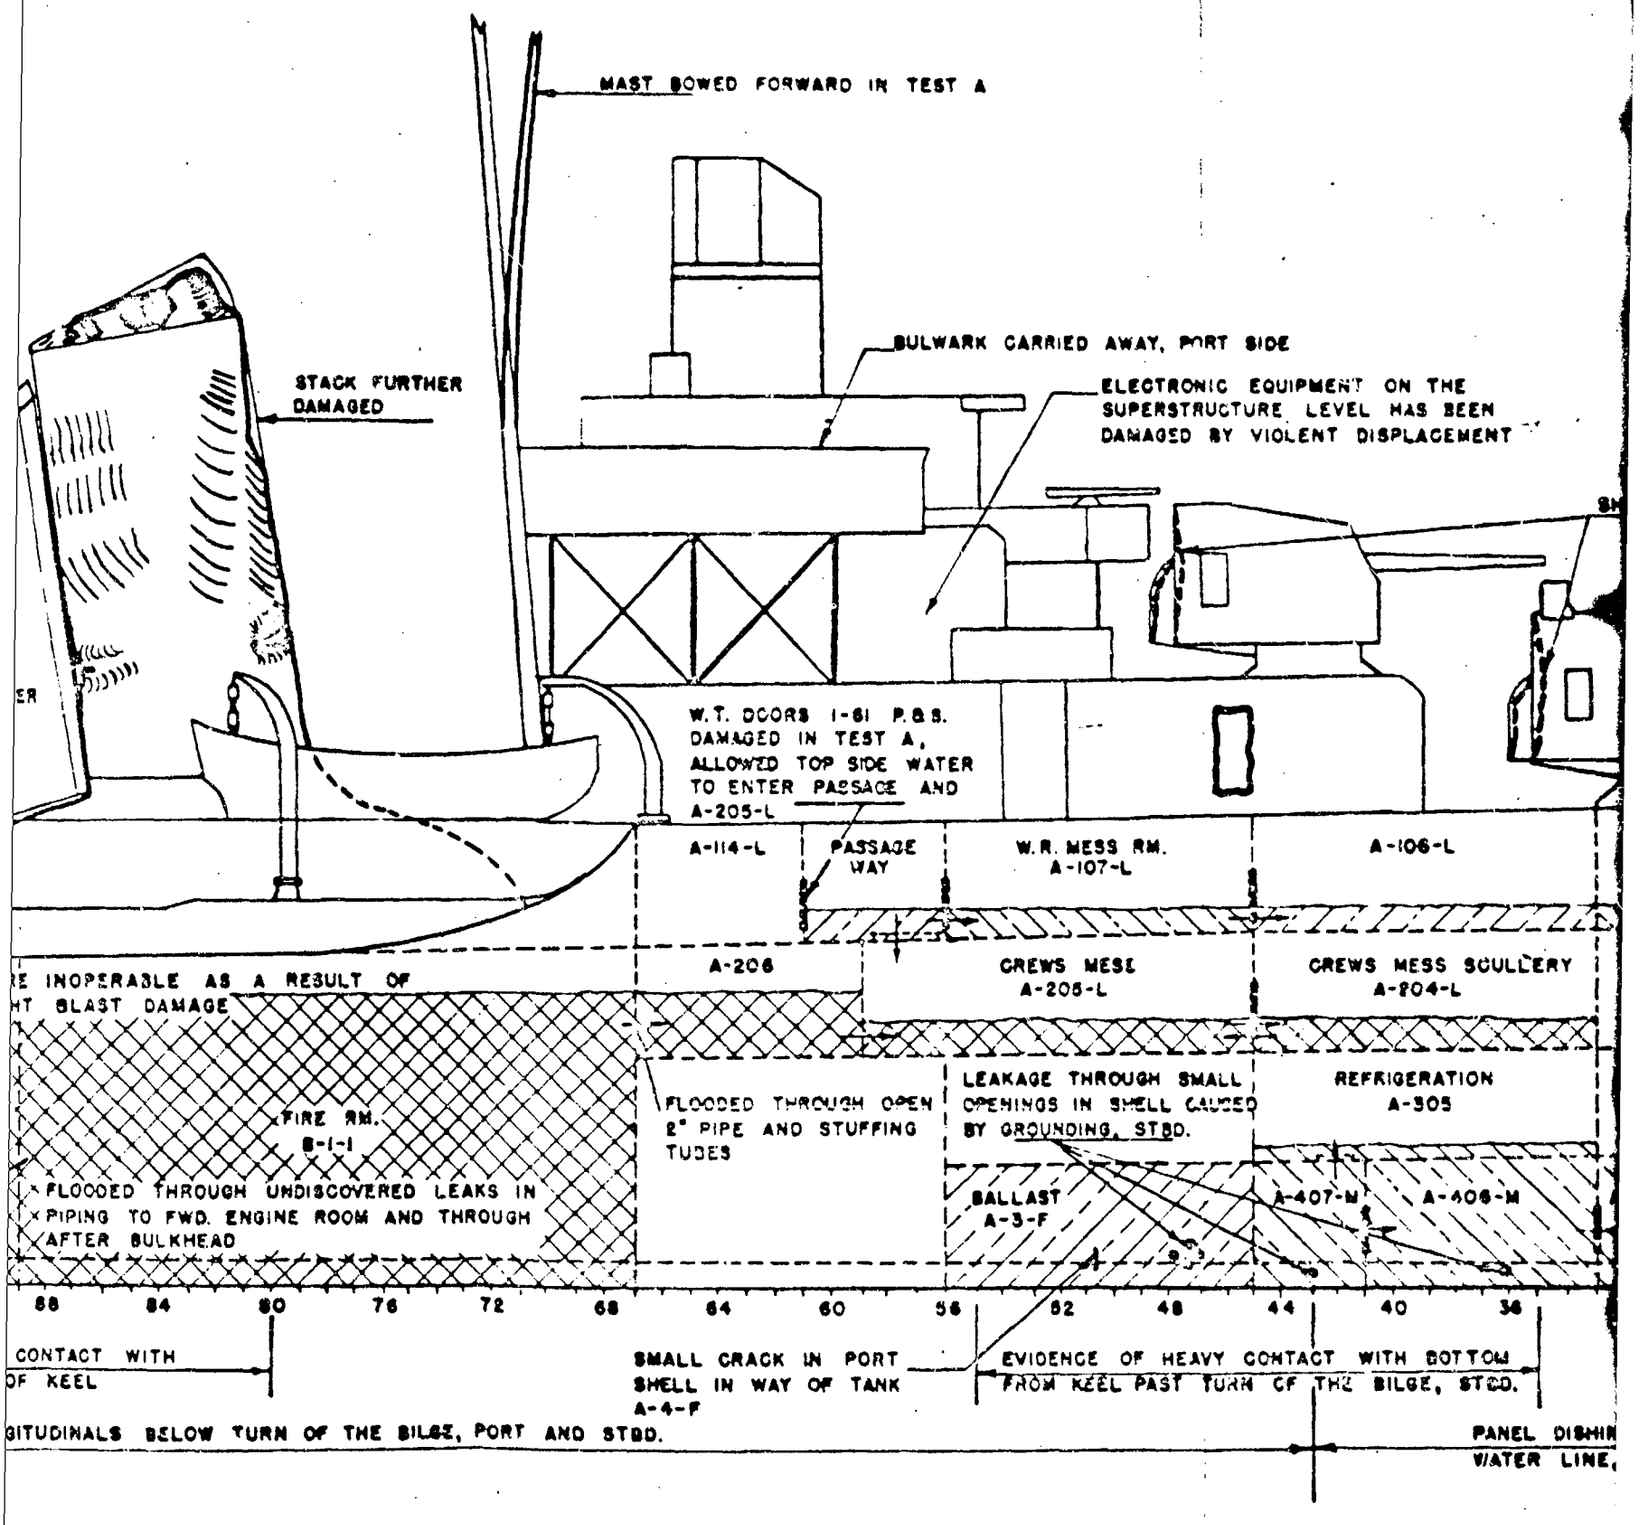
MAST BOWED FORWARD IN TEST A
STACK FURTHER DAMAGED
BULWARK CARRIED AWAY, PORT SIDE
ELECTRONIC EQUIPMENT ON THE SUPERSTRUCTURE LEVEL HAS BEEN DAMAGED BY VIOLENT DISPLACEMENT
W.T. DOORS 1-61 P.&S. DAMAGED IN TEST A, ALLOWED TOP SIDE WATER TO ENTER PASSAGE AND A-205-L
A-114-L
PASSAGE WAY
W.R. MESS RM. A-107-L
A-106-L
A-206
CREWS MESS A-205-L
CREWS MESS SCULLERY A-204-L
INOPERABLE AS A RESULT OF BLAST DAMAGE
FIRE RM. B-1-1
FLOODED THROUGH UNDISCOVERED LEAKS IN PIPING TO FWD. ENGINE ROOM AND THROUGH AFTER BULKHEAD
FLOODED THROUGH OPEN 2" PIPE AND STUFFING TUBES
LEAKAGE THROUGH SMALL OPENINGS IN SHELL CAUSED BY GROUNDING, STBD.
REFRIGERATION A-305
BALLAST A-3-F
A-407-M
A-406-M
88
84
80
76
72
68
64
60
56
52
48
44
40
36
CONTACT WITH OF KEEL
SMALL CRACK IN PORT SHELL IN WAY OF TANK A-4-F
EVIDENCE OF HEAVY CONTACT WITH BOTTOM FROM KEEL PAST TURN OF THE BILGE, STBD.
GITUDINALS BELOW TURN OF THE BILGE, PORT AND STBD.
PANEL DISHIN
WATER LINE,

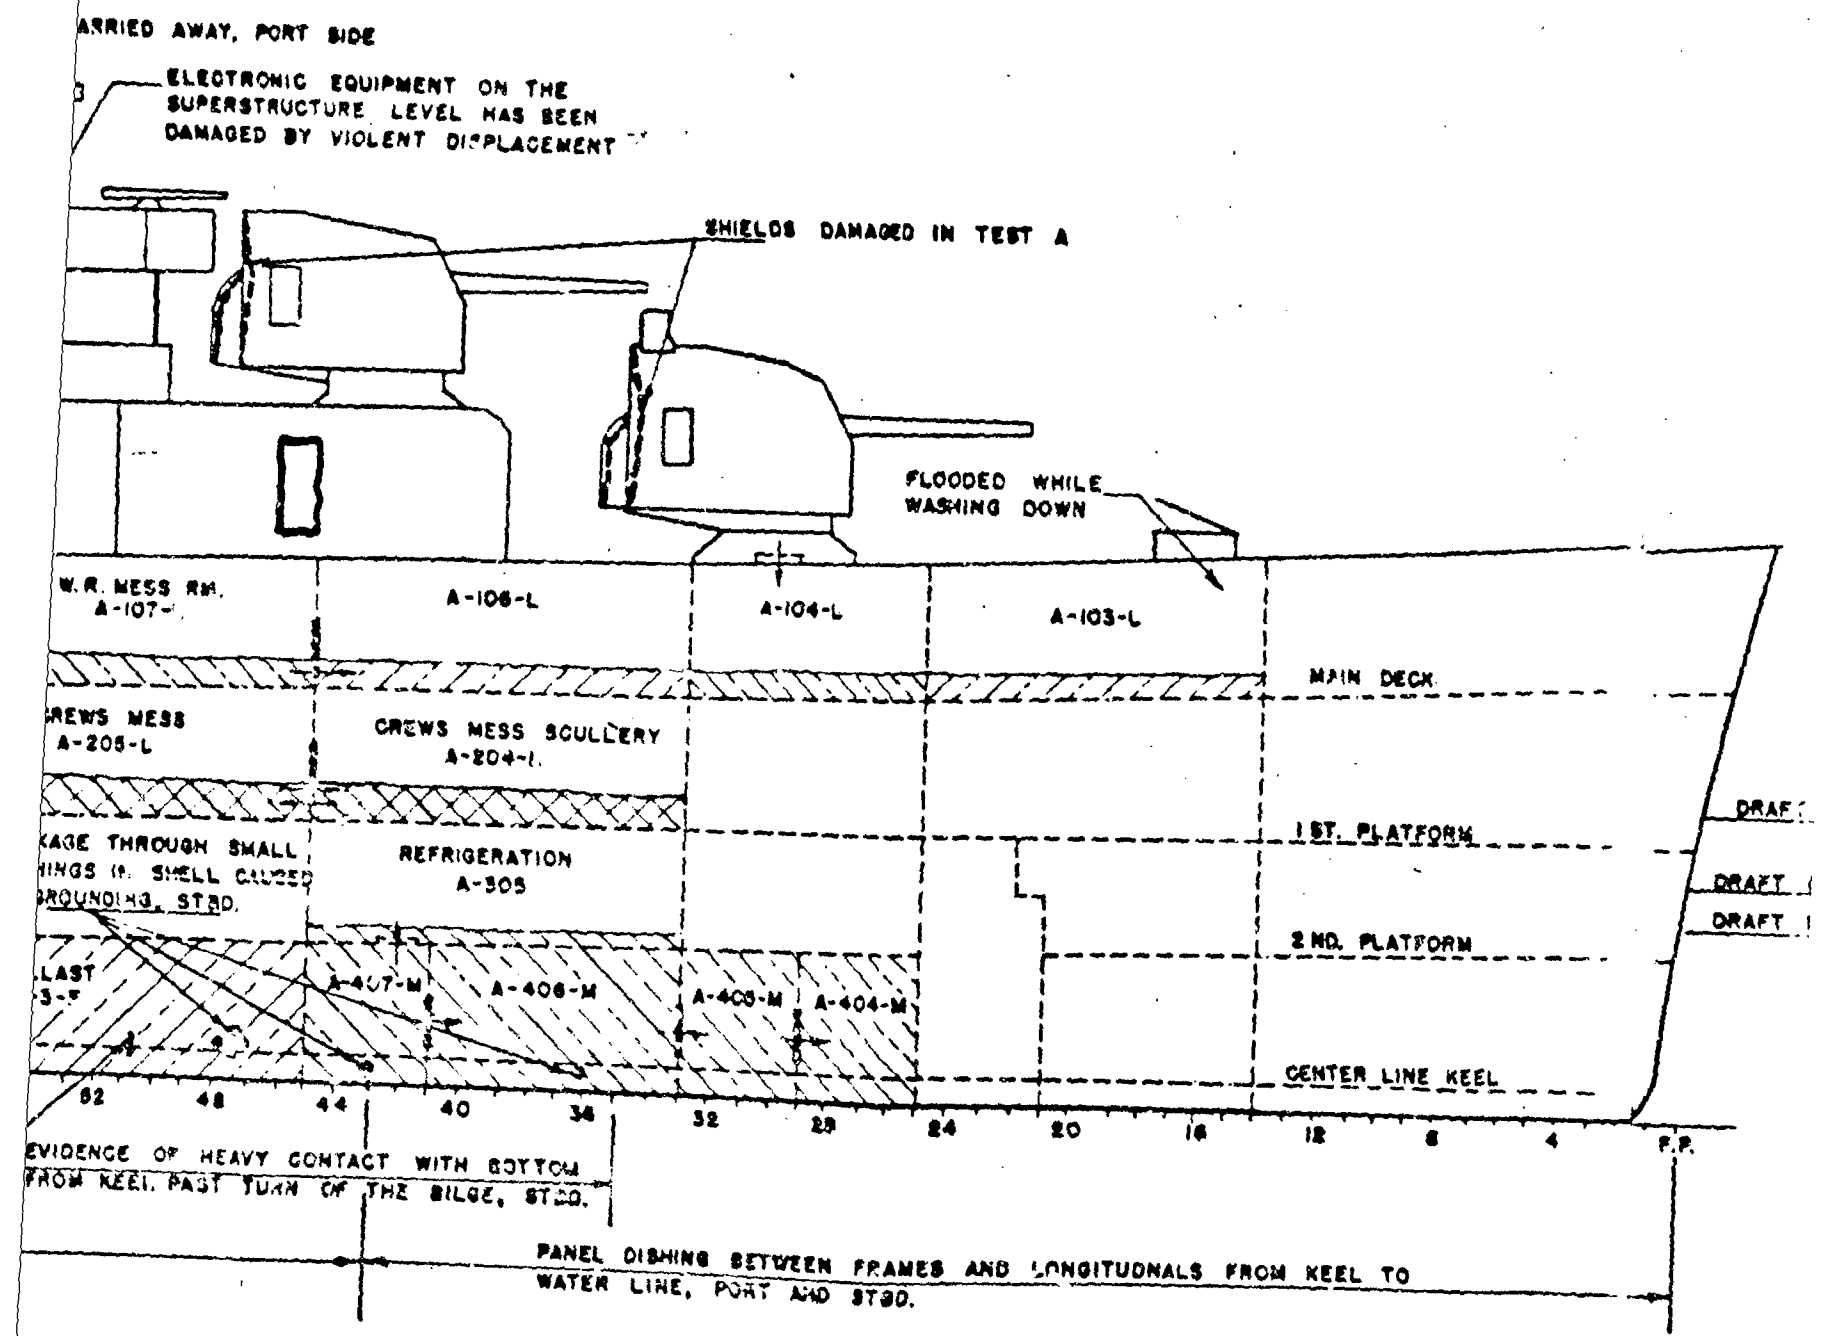
ARRIED AWAY, PORT SIDE
ELECTRONIC EQUIPMENT ON THE SUPERSTRUCTURE LEVEL HAS BEEN DAMAGED BY VIOLENT DISPLACEMENT
SHIELDS DAMAGED IN TEST A
FLOODED WHILE WASHING DOWN
W.R. MESS RM. A-107-
A-106-L
A-104-L
A-103-L
MAIN DECK
REWS MESS A-205-L
CREWS MESS SCULLERY A-204-L
1ST. PLATFORM
KAGE THROUGH SMALL INGS IN SHELL CAUSED GROUNDING, STBD.
REFRIGERATION A-305
DRAFT
DRAFT
DRAFT
2ND. PLATFORM
LAST 3-F
A-407-M
A-406-M
A-405-M
A-404-M
CENTER LINE KEEL
52
48
44
40
36
32
28
24
20
16
12
8
4
F.P.
EVIDENCE OF HEAVY CONTACT WITH BOTTOM FROM KEEL, PAST TURN OF THE BILGE, STBD.
PANEL DISHING BETWEEN FRAMES AND LONGITUDNALS FROM KEEL TO WATER LINE, PORT AND STBD.
