(6) PRODUCT IMPROVEMENT TEST OF

MODIFIED AR15 RIFLES

(14) ~~REPORT NO.~~ DPS-1276

12 NOVEMBER TO 5 DECEMBER 1963

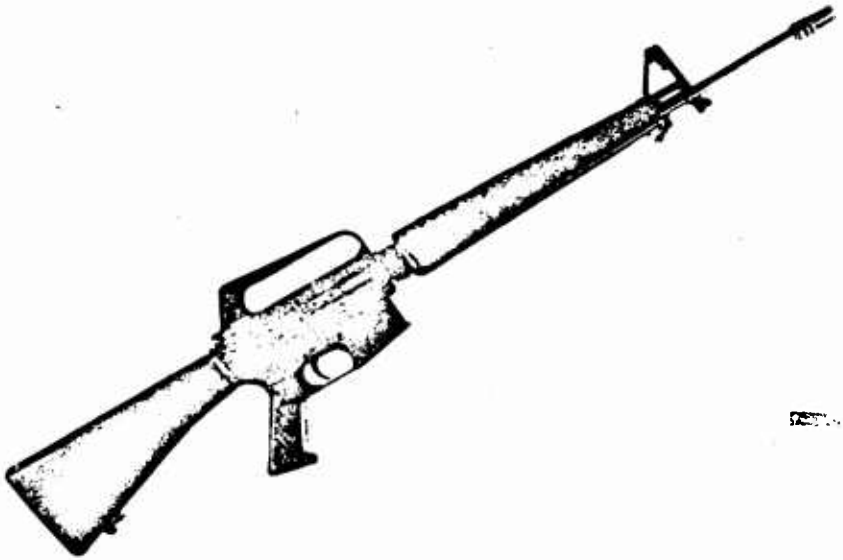
Modifications to the AR15 rifle (Figure 1) were as follows:

Figure 1: Modified AR15 Rifle.

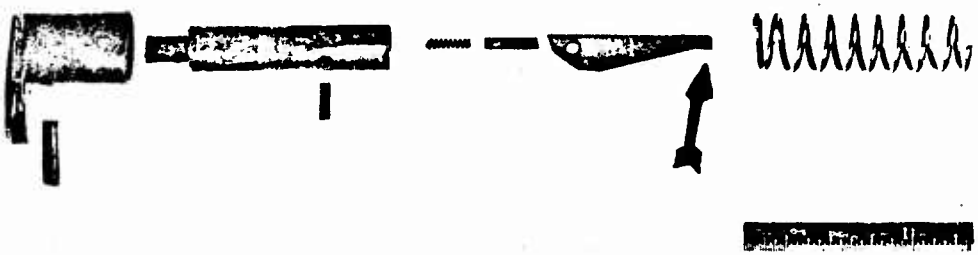
a. The size of the plunger cap of the bolt closure device was increased. Figures 2 and 3 show the first and second designs of this device. The second design incorporated a stronger plunger spring and the pawl tip was straight instead of beveled. The pawl hardness was increased from Rockwell C 43 to C 51 at the tip.

Figure 3: Second Design of Bolt Closure Pawl Assembly. The Pawl Tip and Plunger Spring Have Been Redesigned.

Weakness of the bolt closure plunger spring permitted the bolt closure pawl to interfere with rearward travel of the bolt carrier during firing. This resulted in damage to the pawl and pawl retaining pin in each weapon. Failure of the pawl and the retaining pin occurred after firing an average of 1993 rounds in each weapon. A second design incorporating a stronger bolt closure plunger spring and a redesigned bolt closure pawl corrected the problem of short parts life. Figure 8 compares pawl tip deformation after completion of all firing. The bolt closure device successfully assisted the chambering of all rounds which failed to completely

a. The frequency of feeding and chambering malfunctions indicates the necessity of a positive method of manually assisting the forward movement of the bolt and bolt carrier assemblies. The bolt closure device with 1.30-inch-long plunger spring and pawl with straight tip, hardened to Rockwell C 53, was adequate in performing its intended function (ref Figures 3 and 8 and Tables IV, V, and XV).

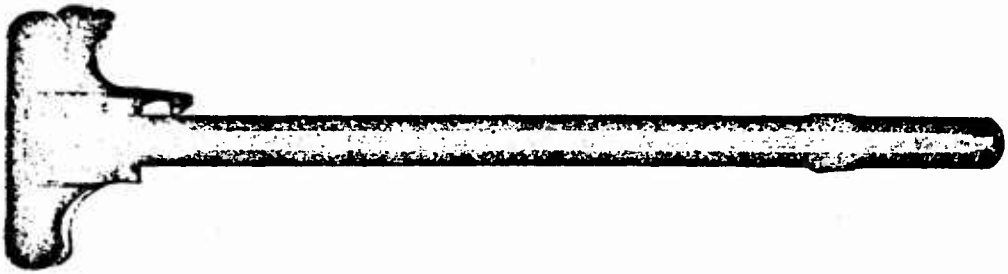
Figure 4: Charging Handle.

b. Modification of the charging handle (Figure 4) was made by enlarging the grip area so manual retraction of the bolt and carrier assemblies is easier.

During previous testing of the AR15 rifle, the charging handle did not provide sufficient gripping area for manual bolt retraction under all conditions. Also, since chambering of a round is dependent solely upon the energy delivered by the action spring to the bolt, incorporation of a manually assisted bolt closing device was desirable to enable the shooter to chamber slightly deformed or dirty rounds and aid in locking if the rifle failed to function properly.

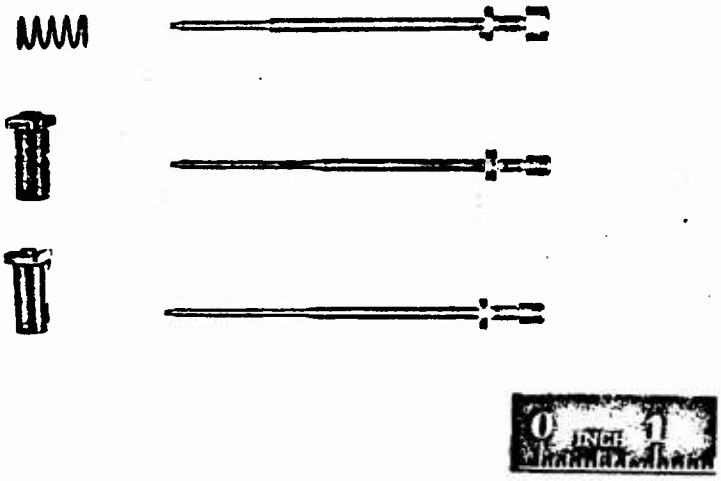
c. Firing pin modifications consisted of a firing pin with a lineally mounted helical compression spring, a bolt cam pin machined to accept a spring and plunger which protruded into the firing pin hole and exerted force on the 26° included angle of the firing body, and a bolt cam pin constructed similarly to the first design, but with the lower part of the firing pin hole modified by an eccentric relief cut, machined to a depth of 0.115 inch from both sides, leaving a narrow land midway of the hole, opposite the plunger. The retaining shoulder of the firing pin was reduced in thickness. Figures 5 through 7 compare the various retarding devices tested.

Figure 5: Three Modified Firing Pins for AR15 Rifle. TOP: Lineal Spring and Firing Pin. CENTER: First Friction Cam Pin and Firing Pin. BOTTOM: Second Friction Cam Pin and Firing Pin.

Although the firing pin with the helical compression spring performed satisfactorily, energy developed by this pin, when struck by the hammer, was reduced to a level below the present primer-sensitivity limit. The second bolt cam pin design permits greater impact energy when the firing pin is struck by the hammer and adequately controls inertial firing pin energy during chambering. Misalignment of the firing pin with the hole in the bolt face, caused by pressure of the bolt cam pin plunger on the firing pin, resulted in a damaged firing pin tip which caused pierced primers.

c. Test data do not indicate the need for a firing pin inertia retarding device. If it is determined that such a device is desirable, the firing pin with the helical compression spring appears more promising since damage to the firing pin tip is avoided. Additional development will be required to increase the striking energy of this type of firing pin when struck by the hammer (ref Figures 5, 6, and 7, Tables III, XIV, and XV, and Appendix C).

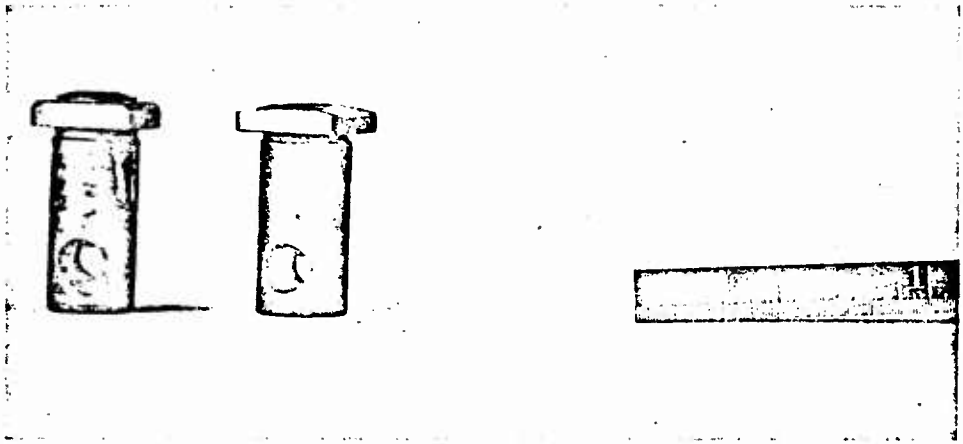
Figure 6: Two Modifications of Friction Cam Pins Showing Firing Pin Hole Differences.

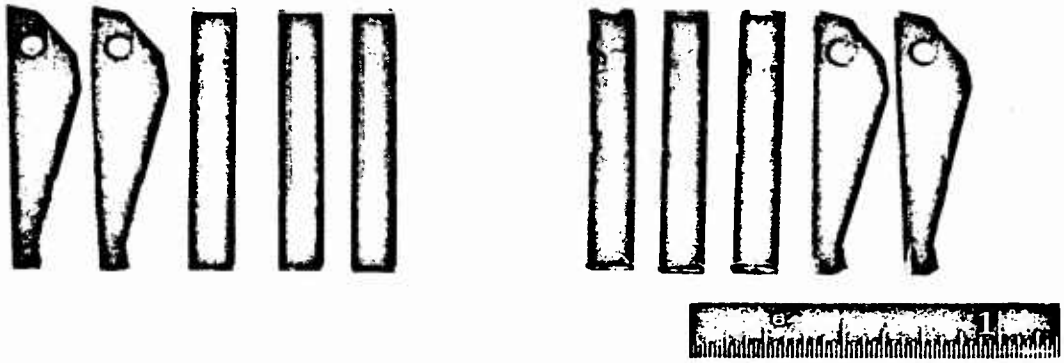
Figure 8: Bolt Closure Pawl Tip Deformation. Right, First Design. Left, Second Design.

a. The 1.30-inch-long bolt closure plunger spring and plunger pawl with straight tip, hardened to Rockwell C 53, be considered for adoption.

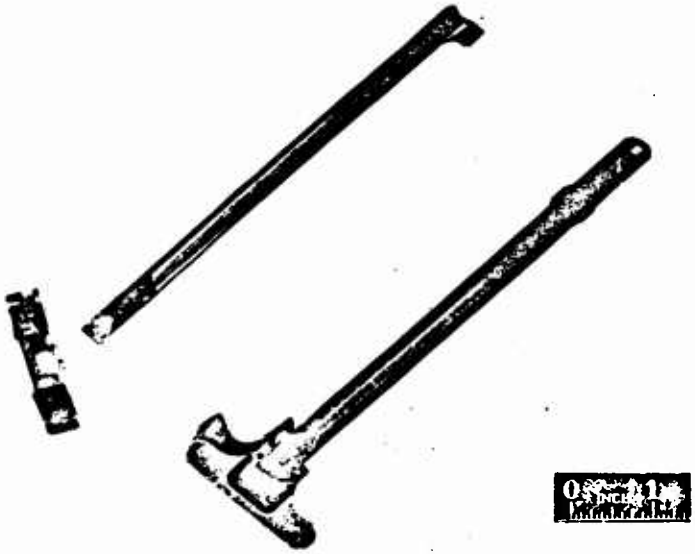
The charging handle provides adequate gripping area to facilitate retraction of the bolt and bolt carrier assemblies; however, the 2-piece fabrication of this charging handle is unsatisfactory because of separation of the tang from the handle at the weld (Figure 9).

Figure 9: Broken Charging Handles Showing Separation of Tang from Handle at Weld.

b. The modified charging handle design provides adequate means for retracting the bolt and bolt carrier assemblies; however, fabrication should be changed to avoid separation of the tang from the handle at the weld. No other malfunctions of the charging handle were observed (ref Figure 9 and Table XVII).

b. The configuration of the charging handle be considered satisfactory and that fabrication of this part be improved to exclude any possibility of separation of the handle from the tang.

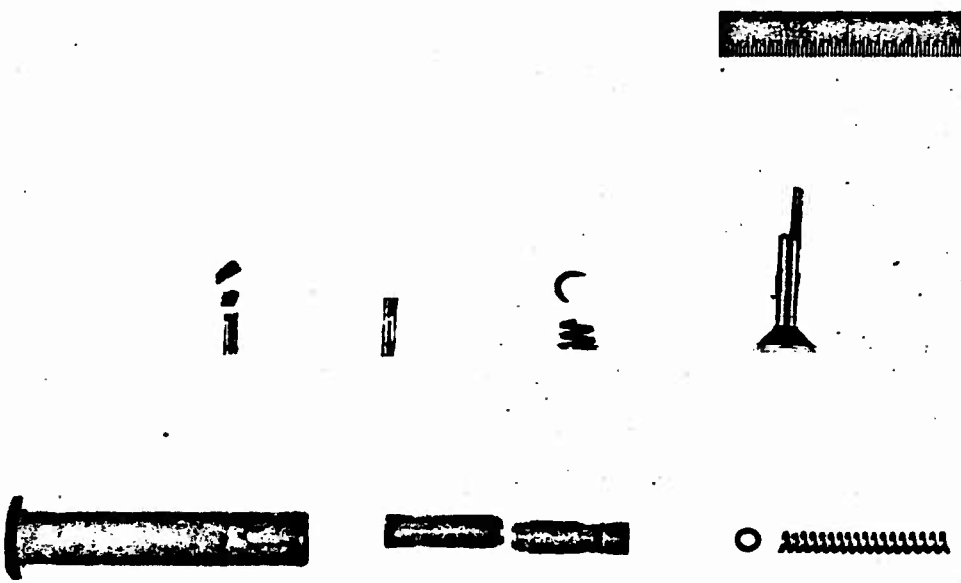
2.1.2 Results. All weapons were in operating order. Tables I through V contain the measurements discussed in the procedure. Figure 10 shows the various parts of the AR15 rifle which were damaged by firing. General characteristics of the modified AR15 rifle are given in Figure 11.

Figure 10: Broken Parts Encountered during Testing. TOP: Broken Bolt Closure Pawl Pin, Deformed Pawl Pin, Extractor Spring, and Firing Pin Retaining Pin. BOTTOM: Receiver Pivot Pin, Hammer Pin, and Ejector Spring.
