INVESTIGATION OF THE EFFECT OF STRESS RELIEVING ON THE TOUGHNESS (CHARPY V), AND MECHANICAL PROPERTIES OF HY 100 STEEL TEE BEAMS HOT ROLLED, EXTRUDED AND COLD FORMED

LAB. PROJECT 9300-1, TECHNICAL MEMORANDUM 33

28 June 1965

U.S. NAVAL APPLIED SCIENCE LABORATORY
NAVAL BASE
BROOKLYN, NEW YORK 11251

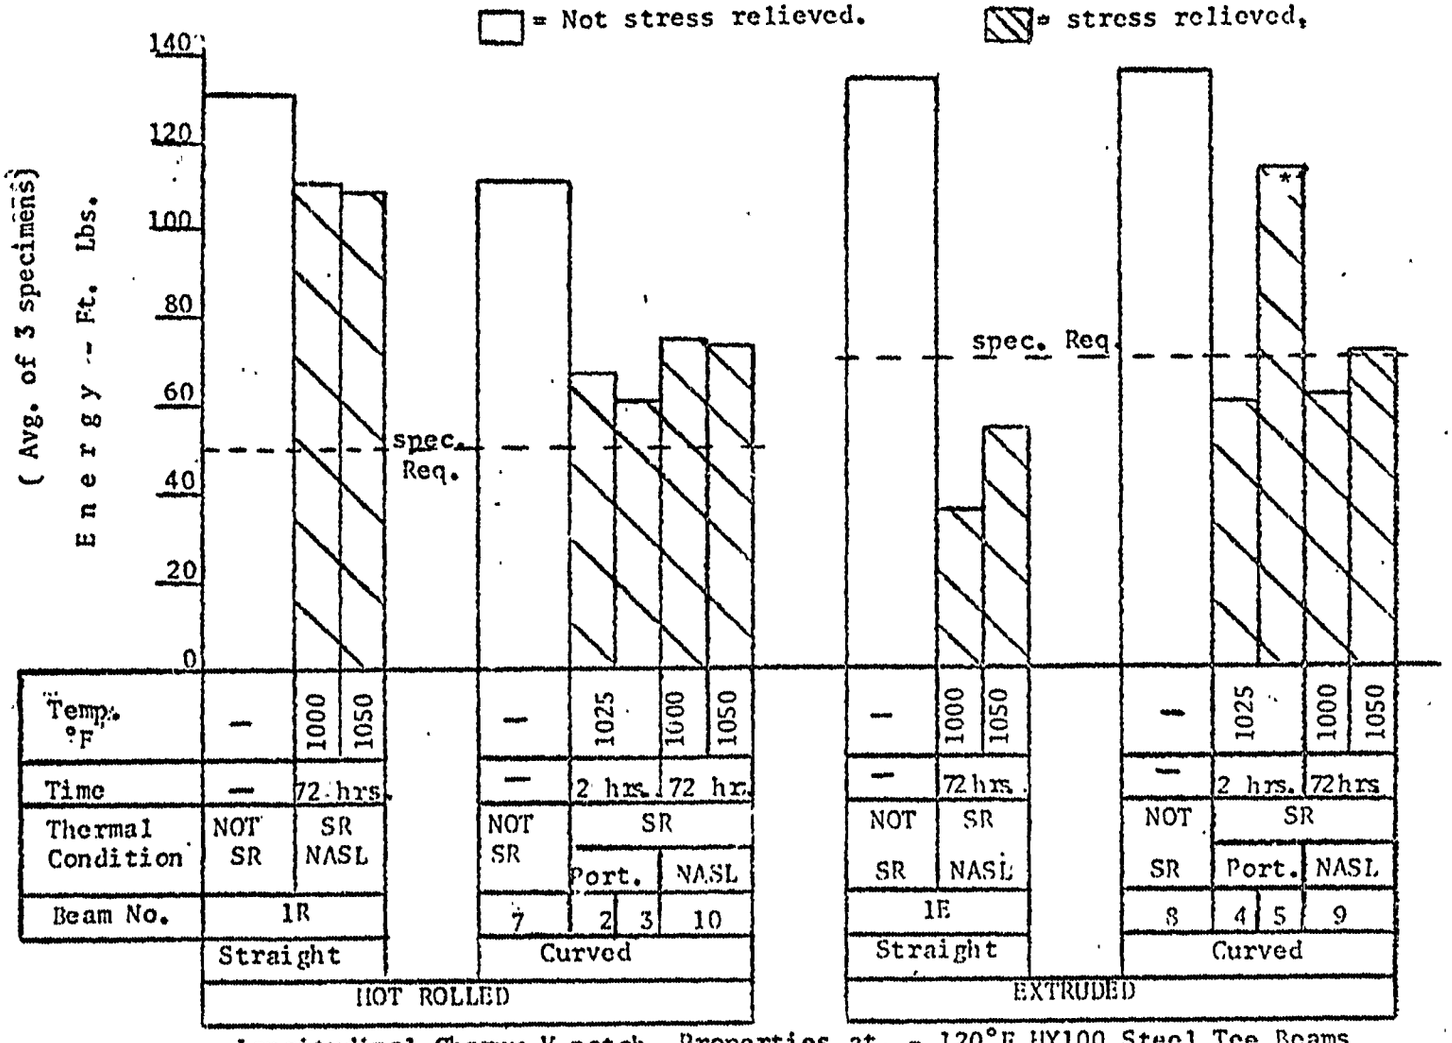
Figure 2

a. The pronounced deterioration in the toughness of extruded beams, resulting from stress relieving (as evaluated by Charpy V-notch properties) is shown in Figure 2. It will be noted that the straight beam (1E) shows a drop in average energy to below 40 ft. lbs. for 1000°F stress relief and below 60 ft. lbs. for 1050°F stress relief. Both of these values are below the specification requirement of 70 ft. lbs. minimum. The curved beams, with the exception of beam 5, show a similar loss in toughness.

b. It is believed that beam 5 was not effectively stress relieved. In this connection, it should be noted, that the structural behavior of beam 5 (to be reported in a future technical memorandum), was different from the other beams.

c. The average loss in toughness for the straight beam was 66 percent and for the curved beams 51 percent (#5 beam excluded).

9. Hot Rolled Tees - referring to Figure 2, it will observed that the straight beam (1R) showed a relatively small (average 20 ft. lbs.) loss in toughness as a result of stress relieving and the curved beams, a substantial loss in toughness (average 44 ft. lbs.). However, all averages were still above the specification requirement of 50 ft. lbs. minimum. The average loss in toughness (stress relieved) for the straight beam was 16 percent and for the curved beams 38 percent.

curved=cold-bent after heat treat & prior to stress-relieving
all beams originally tempered at 1080°F after quenching
* = appears not to have been effectively stress relieved

Longitudinal Charpy V-notch Properties at, - 120°F HY100 Steel Tee Beams

12. It is recommended that, the stress relieving of HY80 and HY100 steel tee beams, not be permitted, until a thermal treatment which does not cause toughness loss is demonstrated. In the interim, should the use of stress relieved material be required for a particular application, the toughness (Charpy V notch) of a sample representative of the particular stress relieved member (in its final worked form), should be determined. This procedure will selectively prevent the use of material of excessively low toughness.
