REPORT NO. 7A1425

PRESSURE RELIEF

VALVE NO. 7-0334

EVALUATION TEST OF

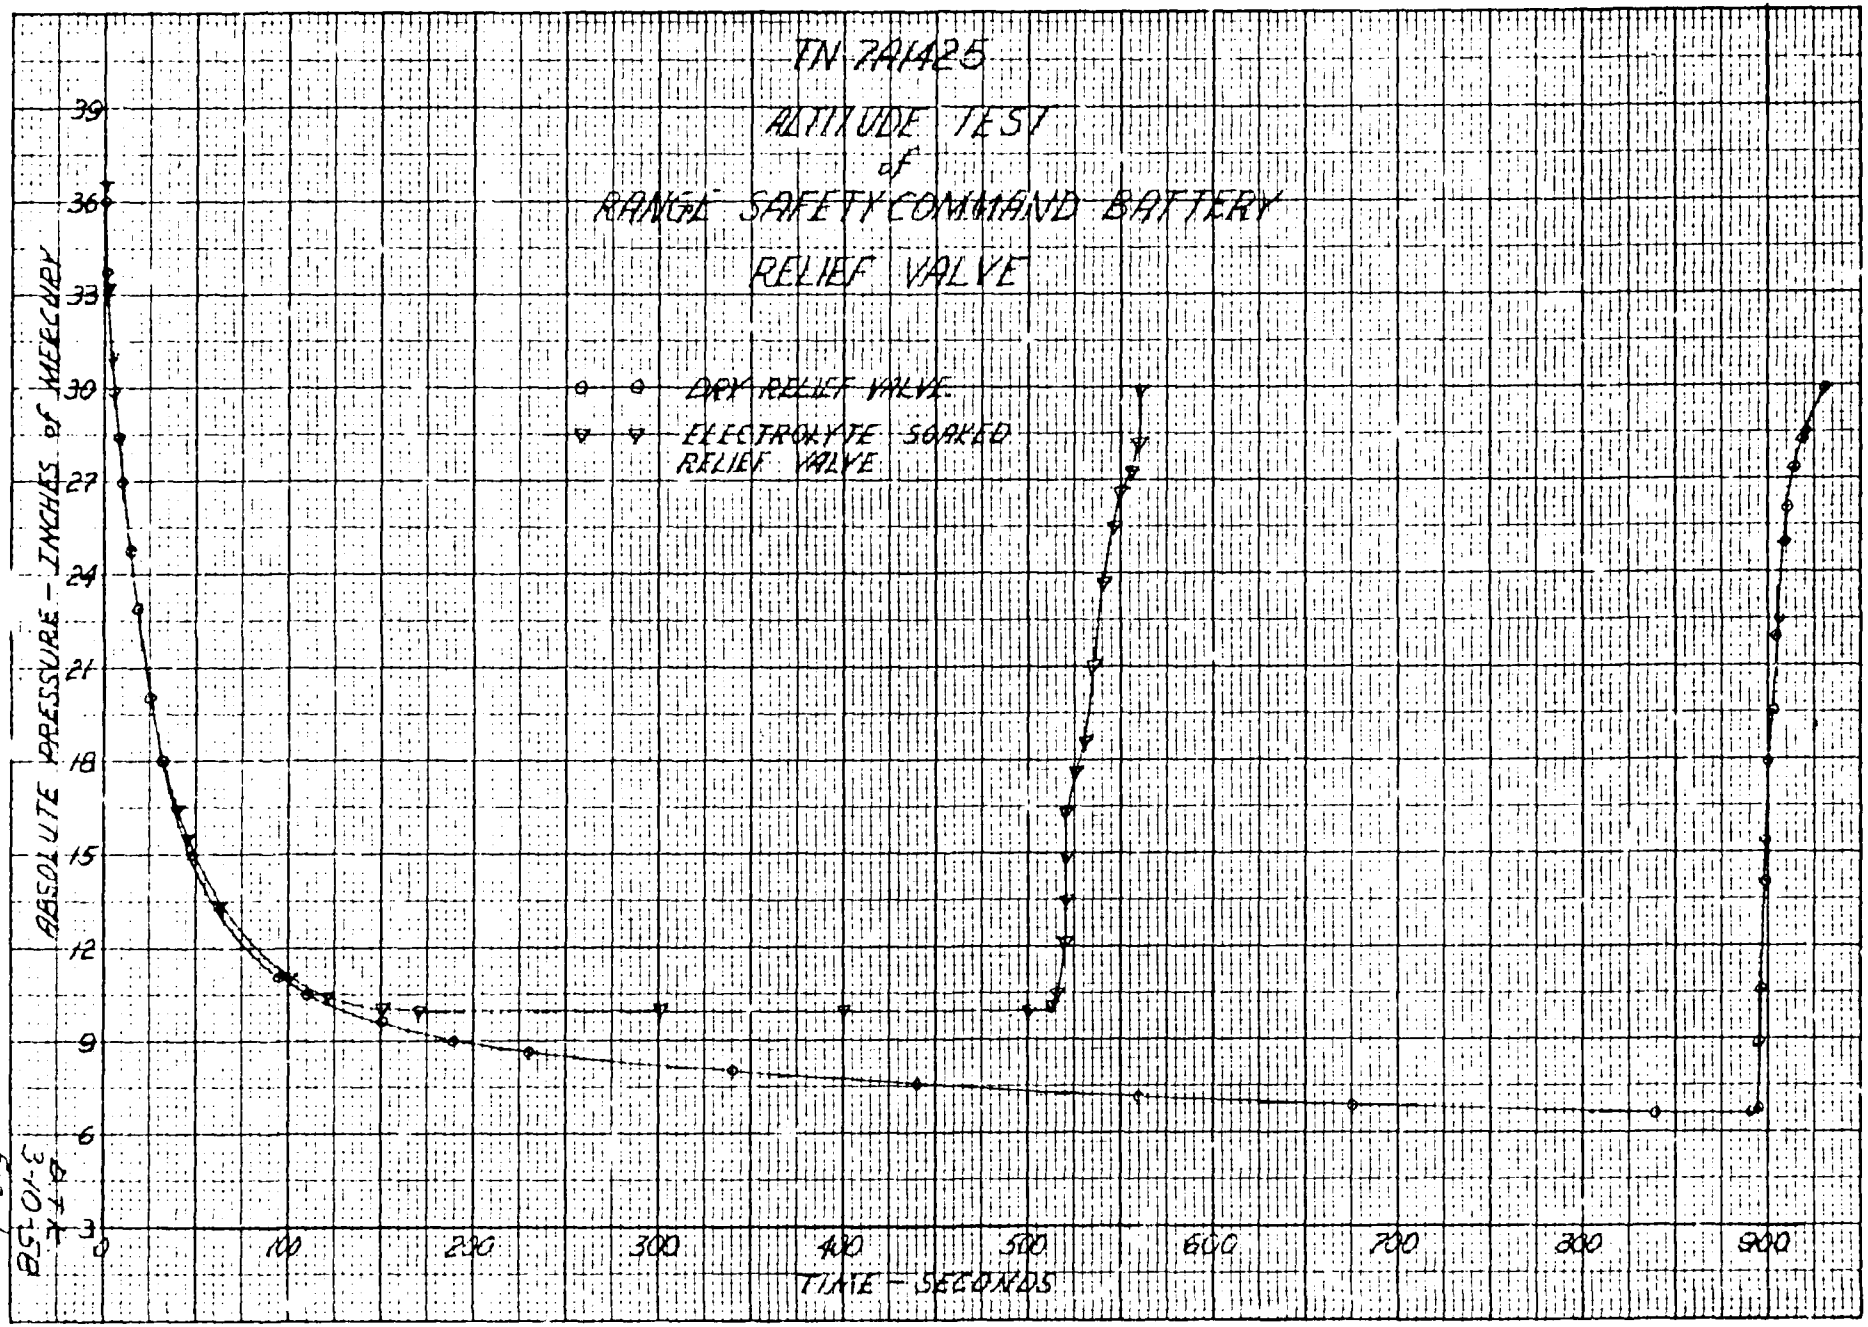
Fig 1

5.1 The graphic results of the canister pressure variation for the altitude tests are shown in Figure 1.

5.2 The altitude chamber attained 1 millimeter of mercury after seven minutes of operation for the dry relief valve altitude test. During this time, the battery canister pressure dropped at a varying rate directly related to the rate of chamber depressurization. After 1 mm of mercury was reached, the canister continued to lose pressure for nine minutes. The lowest pressure attained within the test specimen, before the altitude chamber was repressurized, was 6.6 inches of mercury or 3.2 psia. This continuous pressure drop after 1 millimeter of mercury was reached was probably caused by leakage at the relief valve seal since the canister pressure remained constant when the chamber pressure was increased. The canister pressure remained at 6.6 inches of mercury during chamber pressurization. The canister was allowed to return to ambient pressure within 40 seconds.

5.4 The chamber attained 1 millimeter of mercury after seven minutes of operation for the altitude test of the electrolyte soaked relief valve. During this time the canister pressure drop varied according to the rate of chamber depressurization. The canister pressure reached a low of 10.0 millimeters of mercury or 8.7 psia during the depressurization period and remained at this pressure during chamber repressurization. The canister was allowed to return to ambient pressure within 50 seconds.

5.6 The electrolyte soaked relief valve attained a higher differential pressure than the dry relief valve and remained at this pressure until the canister was repressurized. This variation in differential pressures at 1 millimeter of mercury indicates that the electrolyte caused the relief valve to maintain a tighter seal than the dry relief valve.

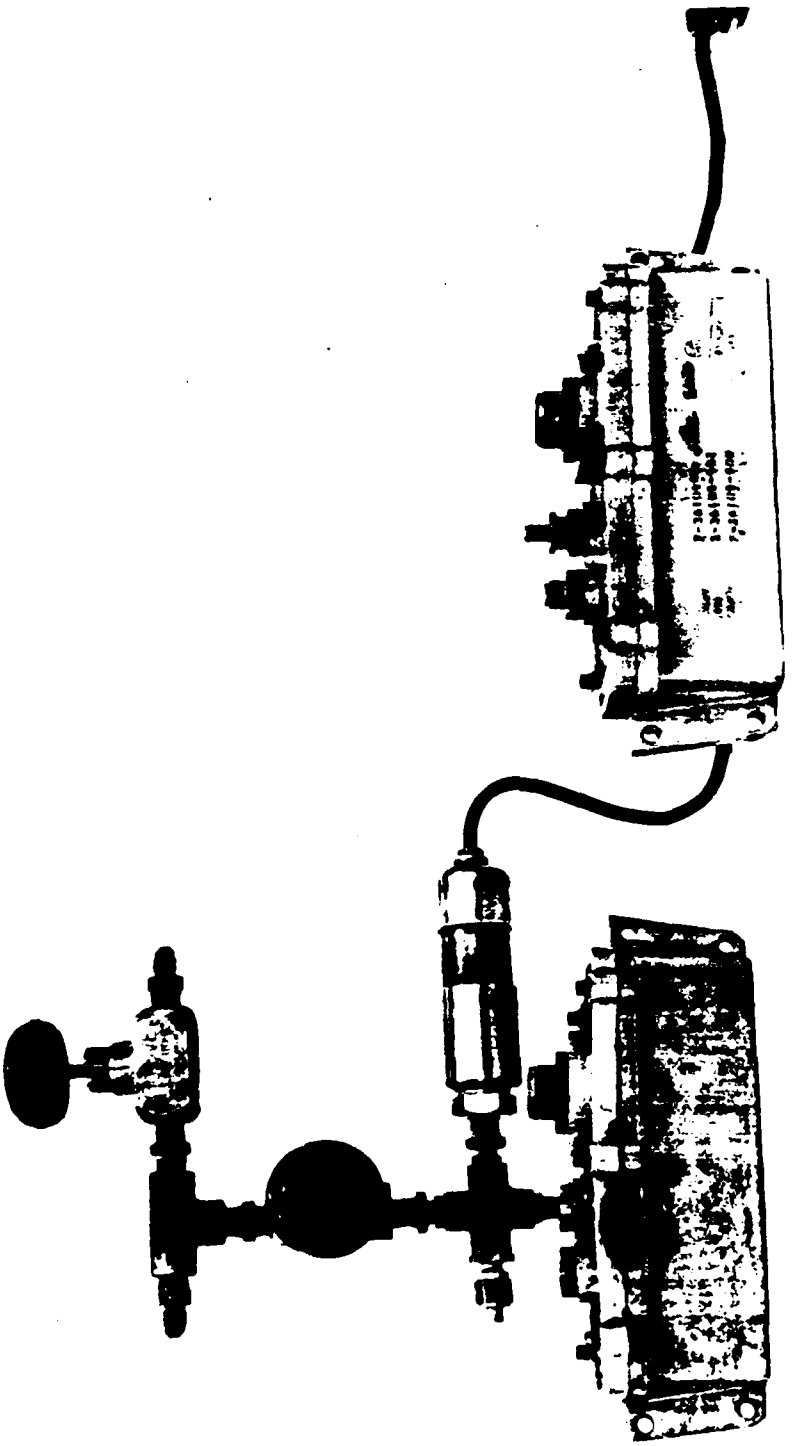
Fig. 4

5.8 The original internal leads from the batteries to the cannon plug burned out during the first short circuit test. Doubling the number of leads was necessary in order to discharge the battery for the test. Pictures of the battery canisters after the short circuit tests in the sealed and open positions are shown in Figures 4 and 5, respectively.

SHORT CIRCUIT TEST
RANGE SAFETY COMMAND
BATTERIES

SEALED POSITION
