Test Report AA 60-0054
18 July 1960

WS 107A-1 FLIGHT TEST WORKING GROUP

FLIGHT TEST REPORT

ATLAS MISSILE 60D

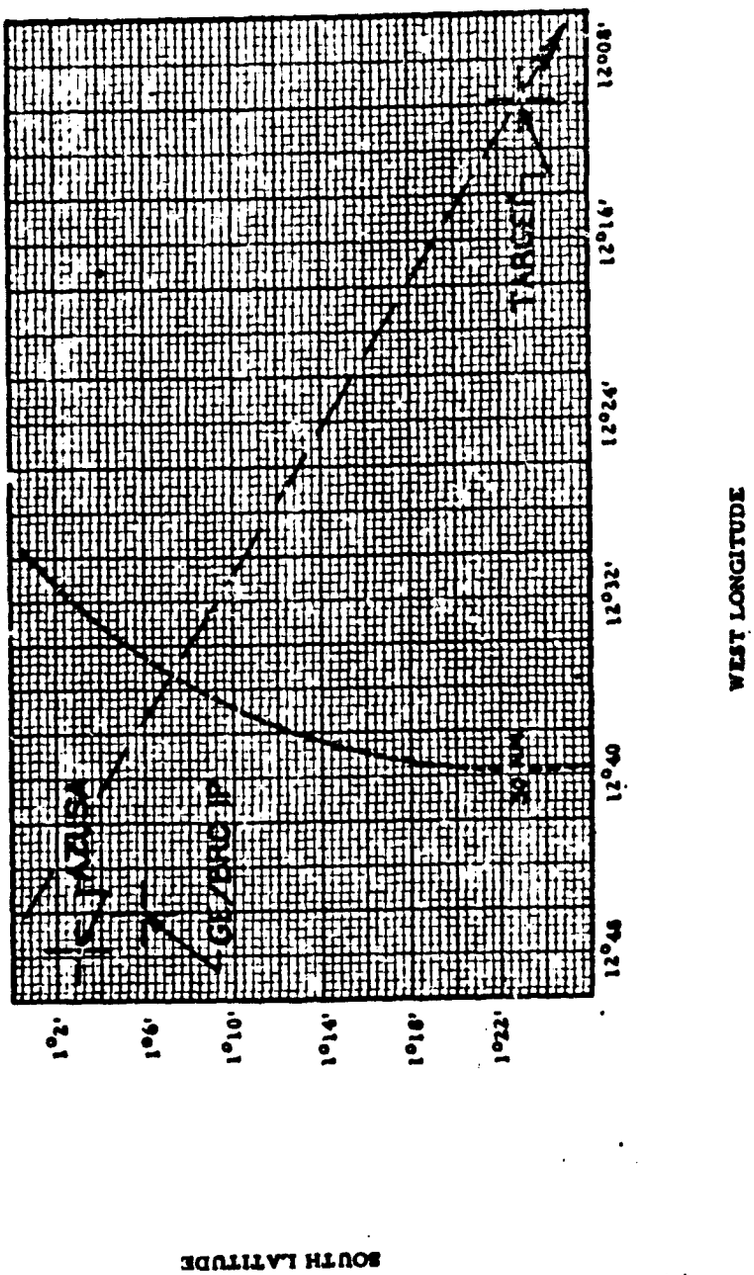
FIGURE I

IMPACT POINT COMPARISON

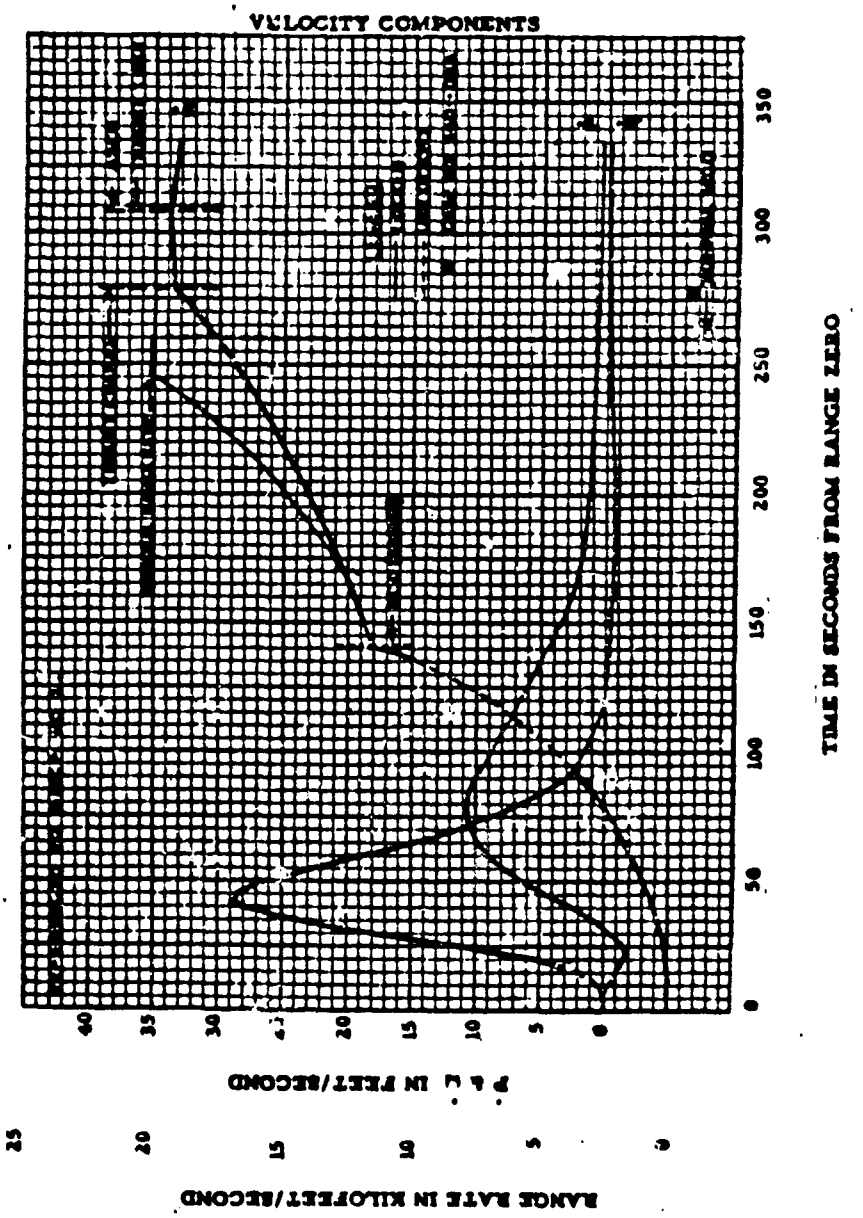
FIGURE II.

VELOCITY COMPONENTS
FROM PRELIMINARY I.P. INSTRUMENTATION SYSTEM

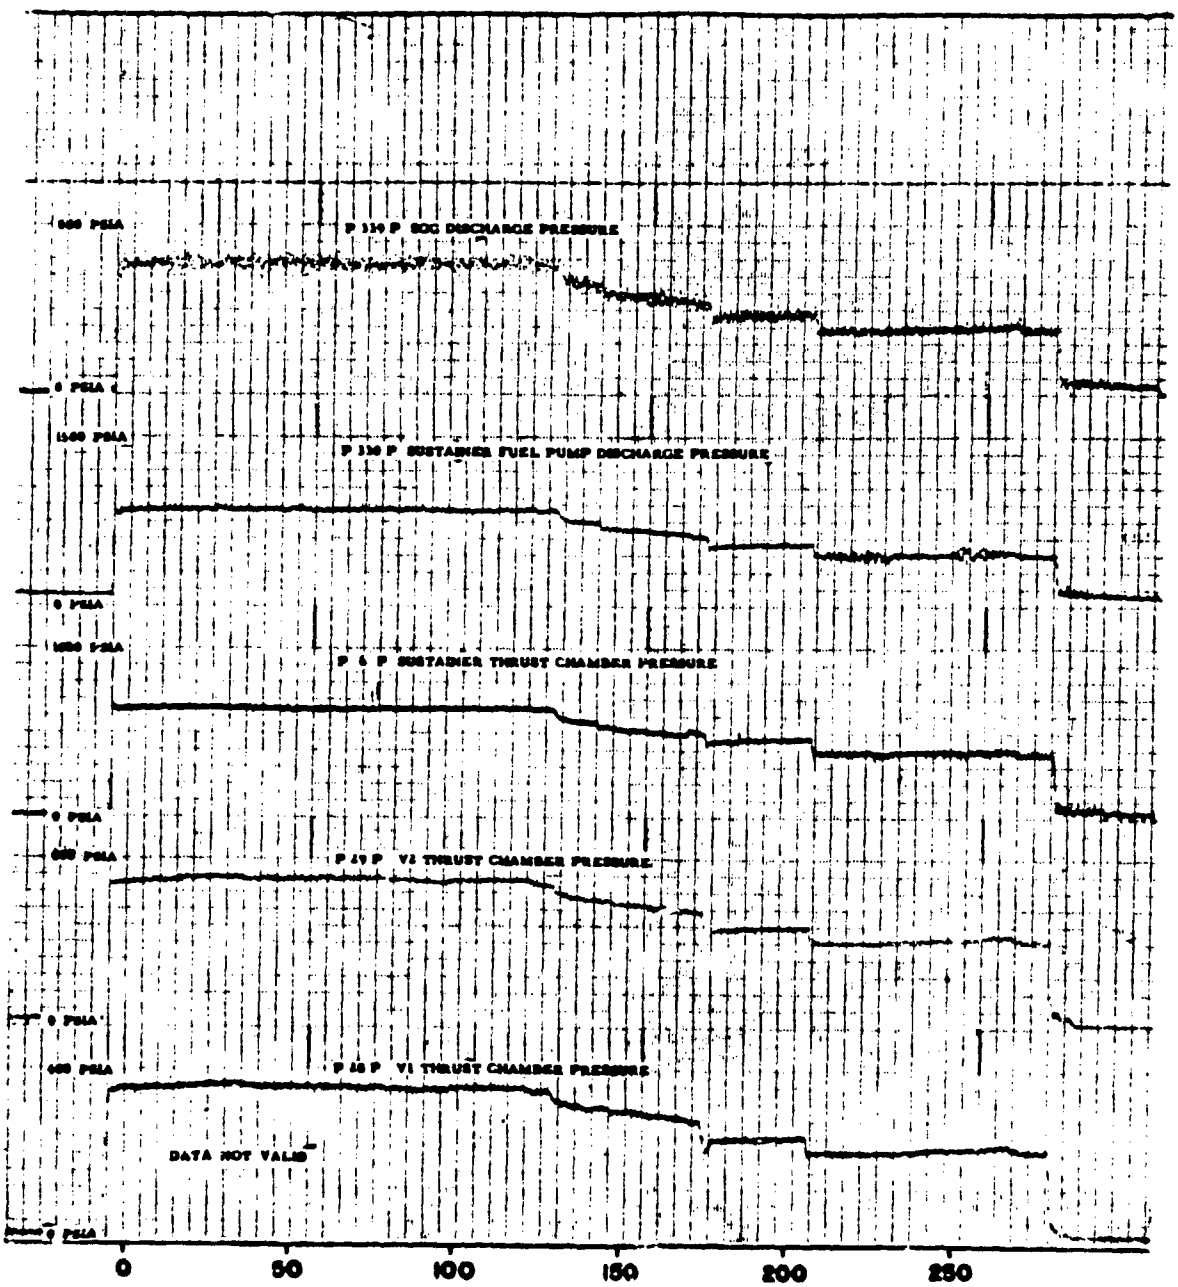
PROPULSION SYSTEM DECOMMUTATED DATA

Propulsion System performance was adversely affected as a result of erratic pressurization and venting of the engine start tanks, which caused depletion of the controls helium supply early in flight. The cause of these inadvertent pressurization cycles has not yet been determined. The nature of the pressurizing and venting of the tanks indicates that they were caused by spurious electrical signals, as opposed to a mechanical malfunction. The tank pressures were the only associated parameters instrumented during this flight. No associated electrical functions were instrumented. Booster engine performance was affected as indicated by reduced performance levels of the booster pump speeds and chamber pressures during the pressurization periods. Sustainer engine performance was normal through approximately 128 seconds of flight. After this time the sustainer gas generator LO2 reference pressure regulator was unable to maintain its preset level. This led to the deterioration of gas generator output and consequently engine performance. Vernier engine performance followed, generally, the decreasing trend of the sustainer engine performance.

Telemetry data indicate that the engine start tanks were pressurized at 16 seconds and vented at 34 seconds, pressurized at 98 seconds and vented at 123 seconds, and pressurized at 128 seconds and vented at 174 seconds. Normal repressurization time, as controlled by the autopilot programmer, is 64 seconds after booster cut-off and repressurization was noted at this time (205 seconds). Booster engine performance was affected only during the pressurization periods. This was indicated by reduced performance levels of the booster pump speeds and thrust chamber pressures, evidently caused by the booster gas generator reverting to tank-fed operation on the fuel side during these periods.

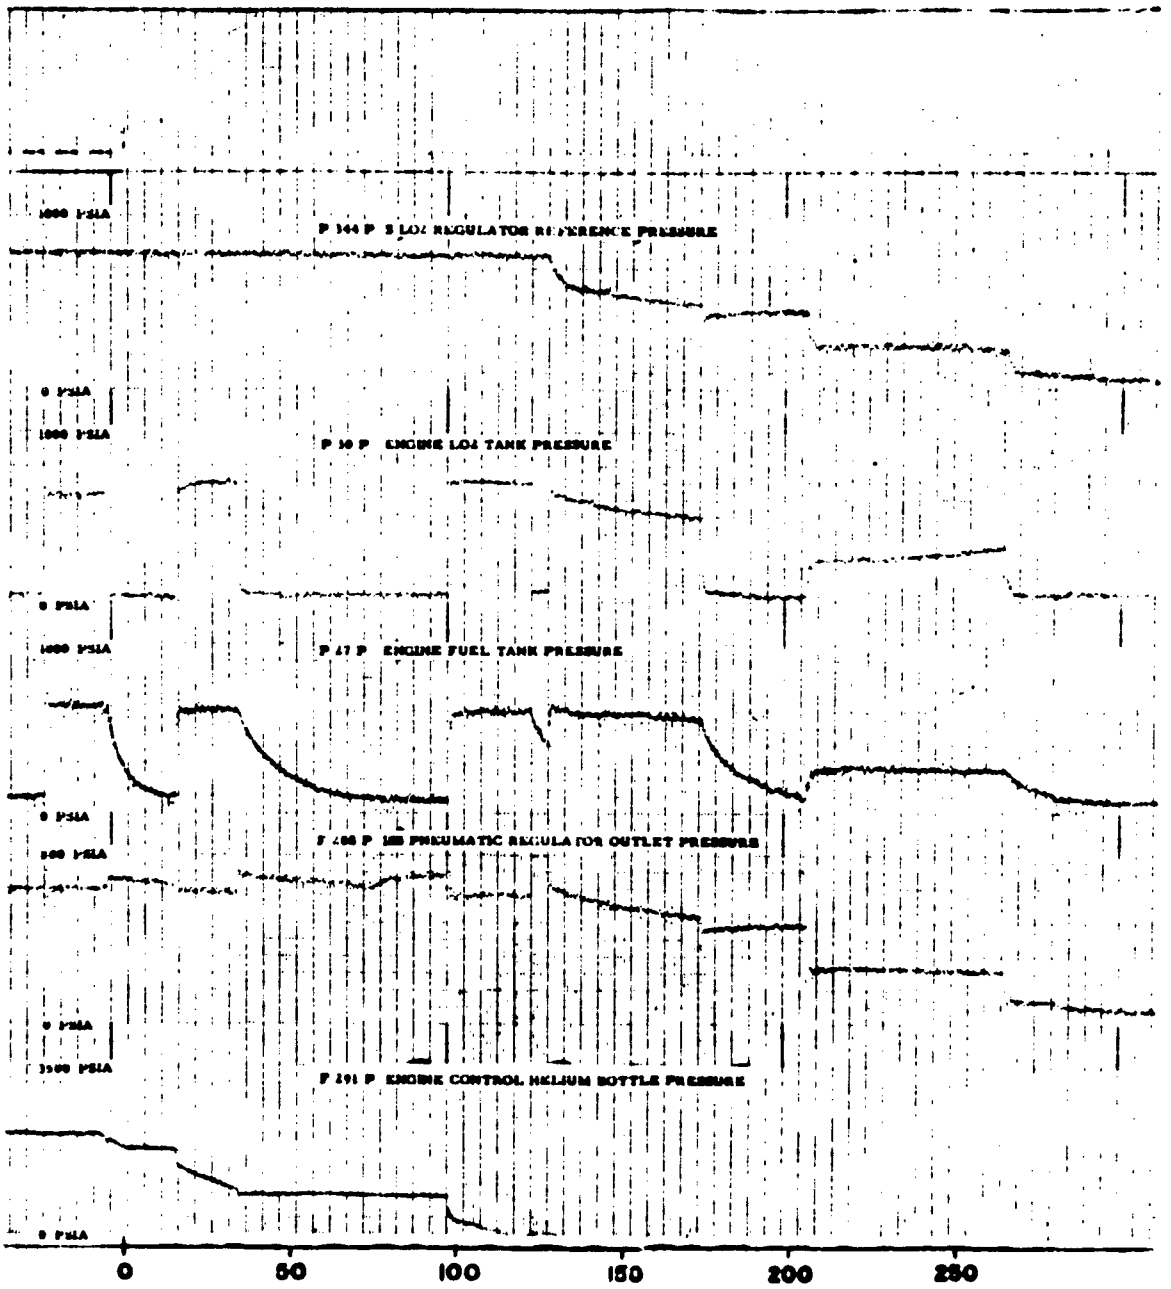
PROPULSION SYSTEM AND PNEUMATIC SYSTEM DECOMMUTATED DATA

Re-pressurization of the engine start tanks occurred three times during the booster phase of flight causing depletion of engine control helium pressure early in flight. The nature of the pressurizing and venting indicates that they were caused by spurious electrical signals rather than a mechanical malfunction. Propellant tank pressures were satisfactorily maintained throughout flight and all tanks and bottle pressures were within specifications at liftoff.

During the inadvertent repressurizations and venting of the start tanks, pressure lock-ups above the normal setting were noted in the ISS pneumatic regulator output pressure. After the second repressurization, lockup pressure decayed slowly back to the normal setting and then increased again before the third repressurization, for no apparent reason.

1. Investigate cause of inadvertent engine LO2 and fuel tank pressurization.
