The Deterioration of Stainless Steel Regeneratively Cooled Thrust Chambers

Prepared by J. K. STANLEY
Materials Sciences Laboratory

Air Force Report No.
SAMSO-TR-69-353

Aerospace Report No.
TR-0066(5250-10)-9
(Formerly TR-0200(4250-10)-1)

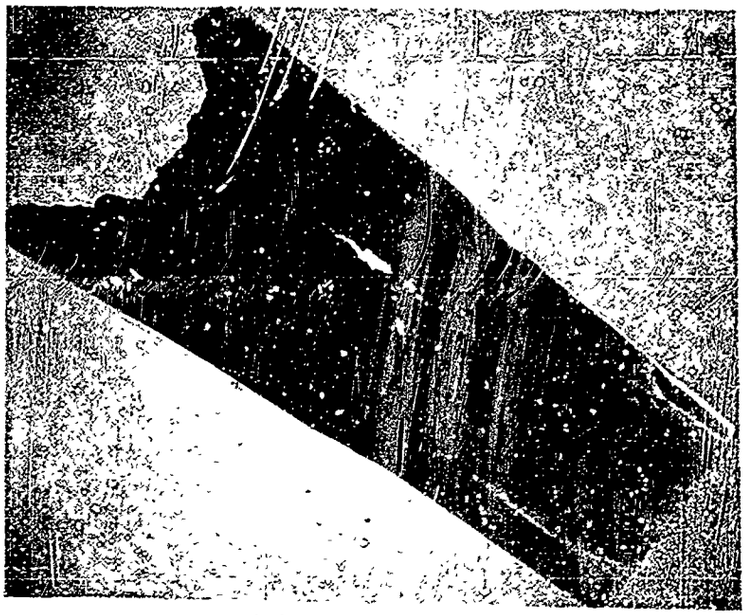
Figure 3. Failure of Type 347 Tubing Under Burnout Conditions

Figure 3 shows the nature of the failure of a Type 347 stainless steel tube under high heat flux conditions (16.88 Btu/in.^{2}-sec). Note slight flaring of the tube and carbonaceous deposit in the region of failure inside the tube. Flaring is caused by the biaxial stresses resulting from the internal pressure in the tube at the moment of rupture from high temperature. Carbonaceous deposit results from the decomposition of the Aerozine-50.

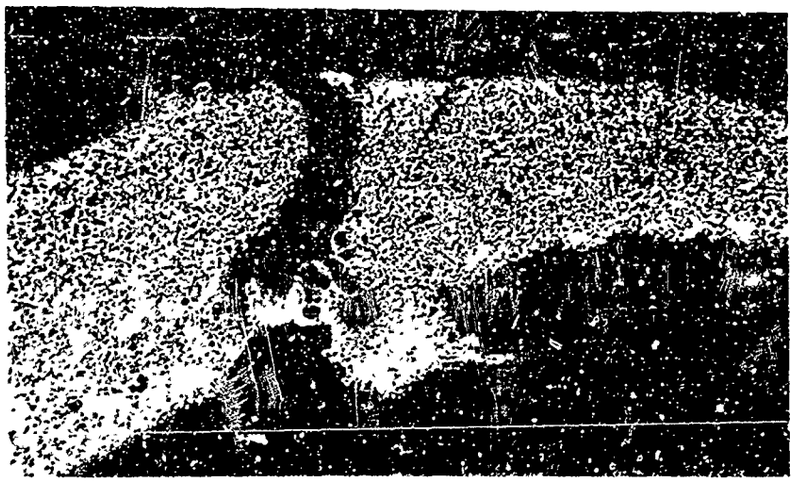
Figure 5(a) shows the microstructure in the vicinity of tube cracking. Wall thinning is probably explained by melting of the metal [1370°C (2500°F) to 1425°C (2600°F)]; Fig. 5(b) shows the resolidified steel (area with dendrites) adhering to the tube.

(a) Cracking and wall thining in area of burnout 100X

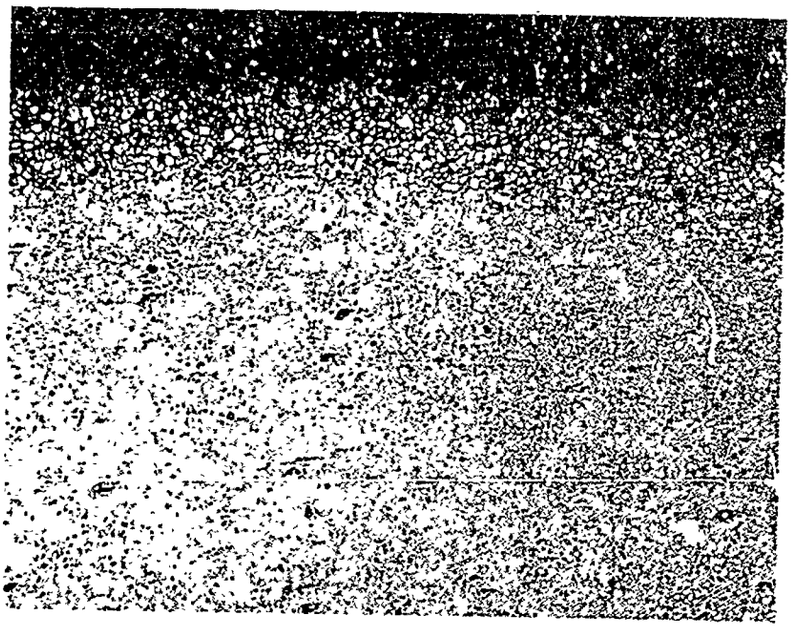
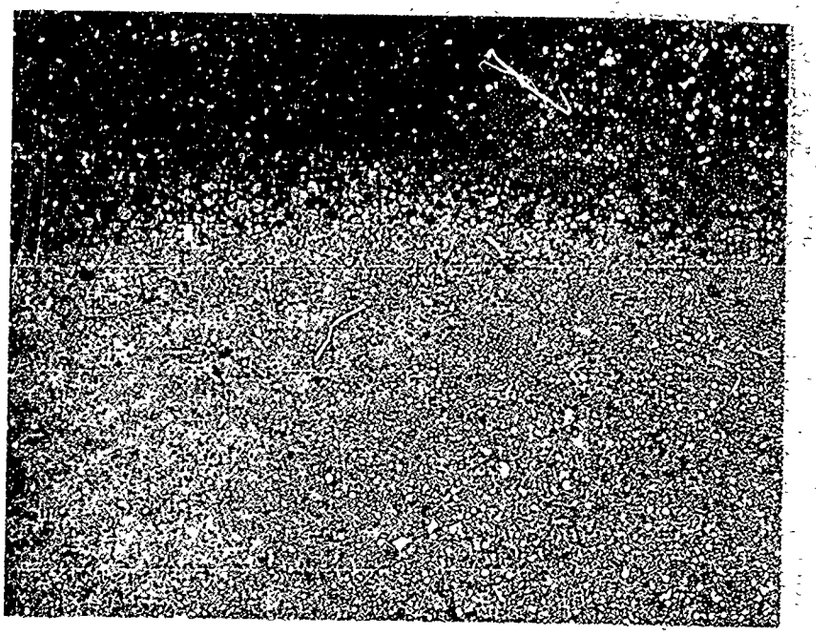
Figure 7. Micrographs of Rapidly Carburized Type 347 Stainless Steel

Carburization of Type 347 stainless steel only occurs above about 780°C (1530°F) (Ref. 7). Carburization at high temperatures can be quite rapid. As shown in Fig. 7(a) significant carburization of Type 347 can occur in 1 min at 1095°C (2000°F); Fig. 7(b) shows some of the carbide that has melted and resolidified (thin white layer). This is not an unreasonable temperature to be experienced by these tubes in this application. Note coarse grain size in Fig. 8, which attests to this temperature range. Also note the carburized (mottled) layer on the tube.

(a) Carburized 1 min @ 1095°C (2000°F)

(b) Carburized 1 min @ 1120°C (2250°F)

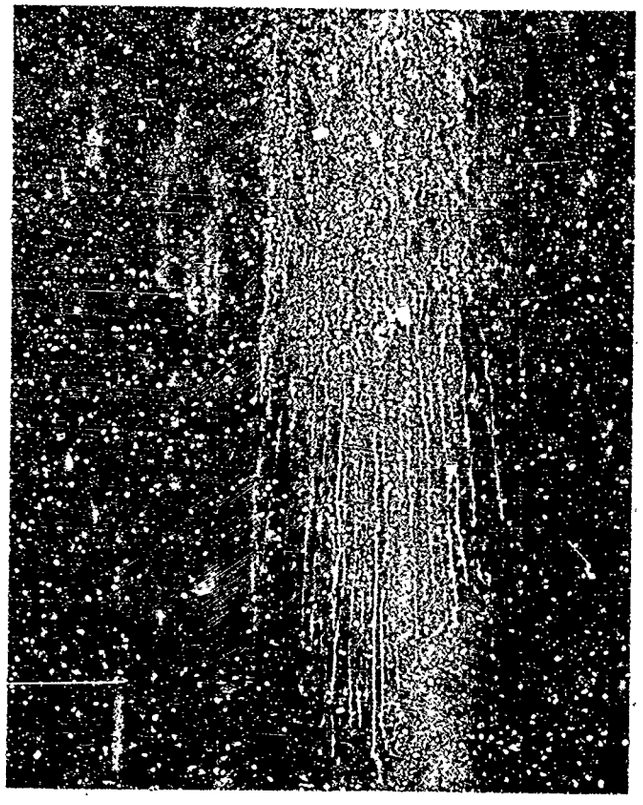
Various melting temperatures were observed for this carbide, some as low as 1095°C (2000°F) and some as high as 1260°C (3200°F). This variation in melting temperature is probably due to different carbon contents in the carbide.

(a) Beaded spray 4X

(b) Crystallized material 4X

Figure 9. Two Types of Deposits Found on Type 347 Thrust Chamber Tubes (Both are a carbide, Cr_7C_3)

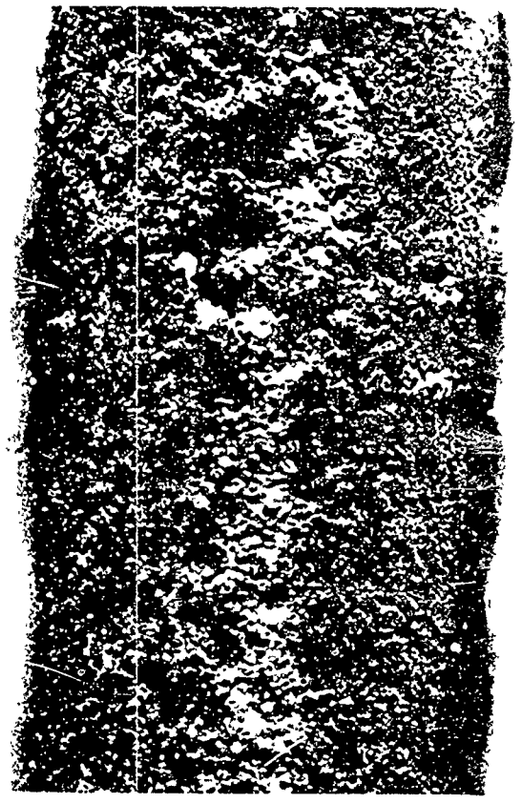
Pinholes (Fig. 10) are perforations of the tube wall. The holes always appeared in a roughened area, often in association with cracks.

Figure 10. Pinholes and Associated Roughness in Type 347 Tube Bundle

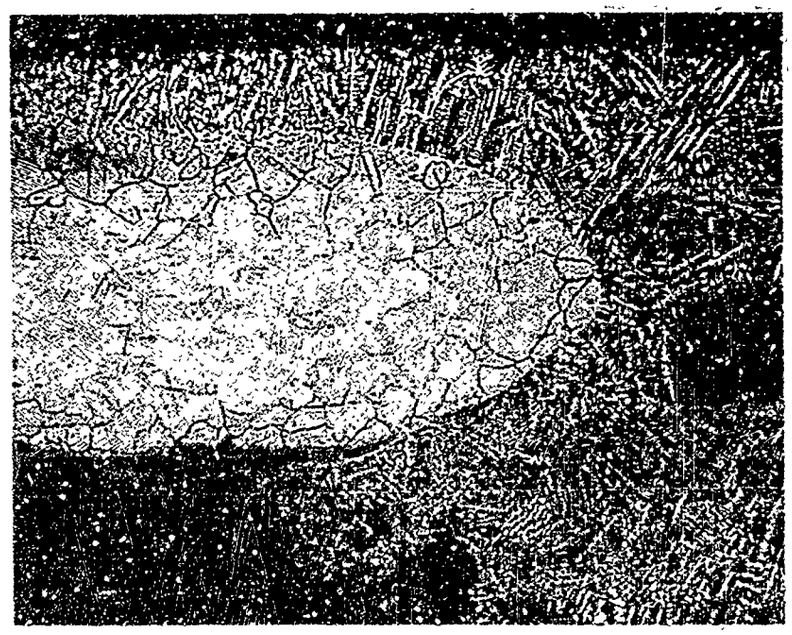
Figure 13. Microstructure of Distressed Type 347 Stainless Steel Tubes Etched in Aqua Regia and Oxalic Acid

Microprobe and metallographic analyses indicated two zones on the inside surface of the stainless steel tubes – a dark etching carburized structure consisting of carbide ($Fe \cdot Cr_7C_3$) and austenite, and a light etching constituent, superimposed on the carburized layer, consisting of nitride $(Fe \cdot Cr)N$.

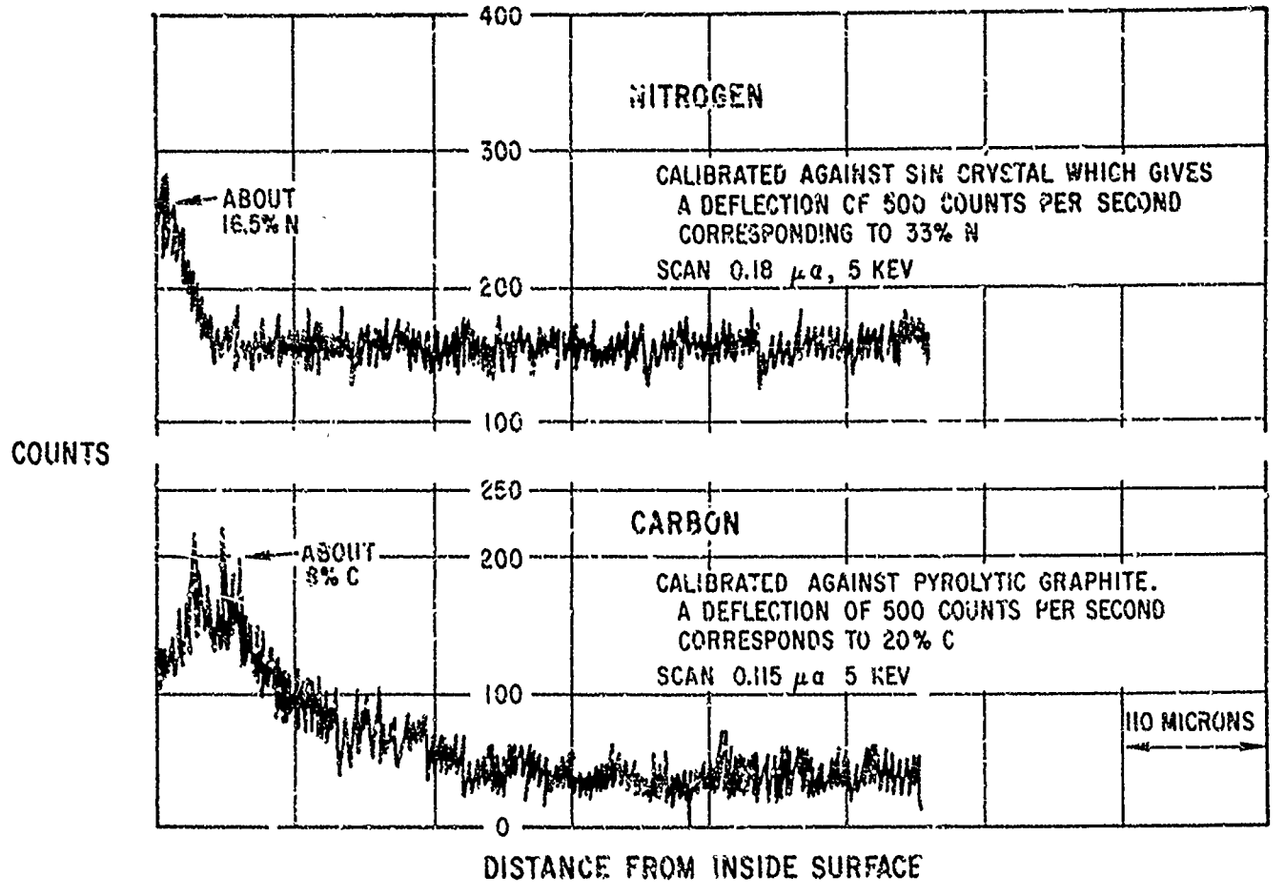
Figure 14. Microprobe Traverse on Inside of Distressed Type 347 Stainless Steel Tube

A microprobe traverse was made on the distressed tubes to identify the carburized and nitrided zones (Fig. 14).

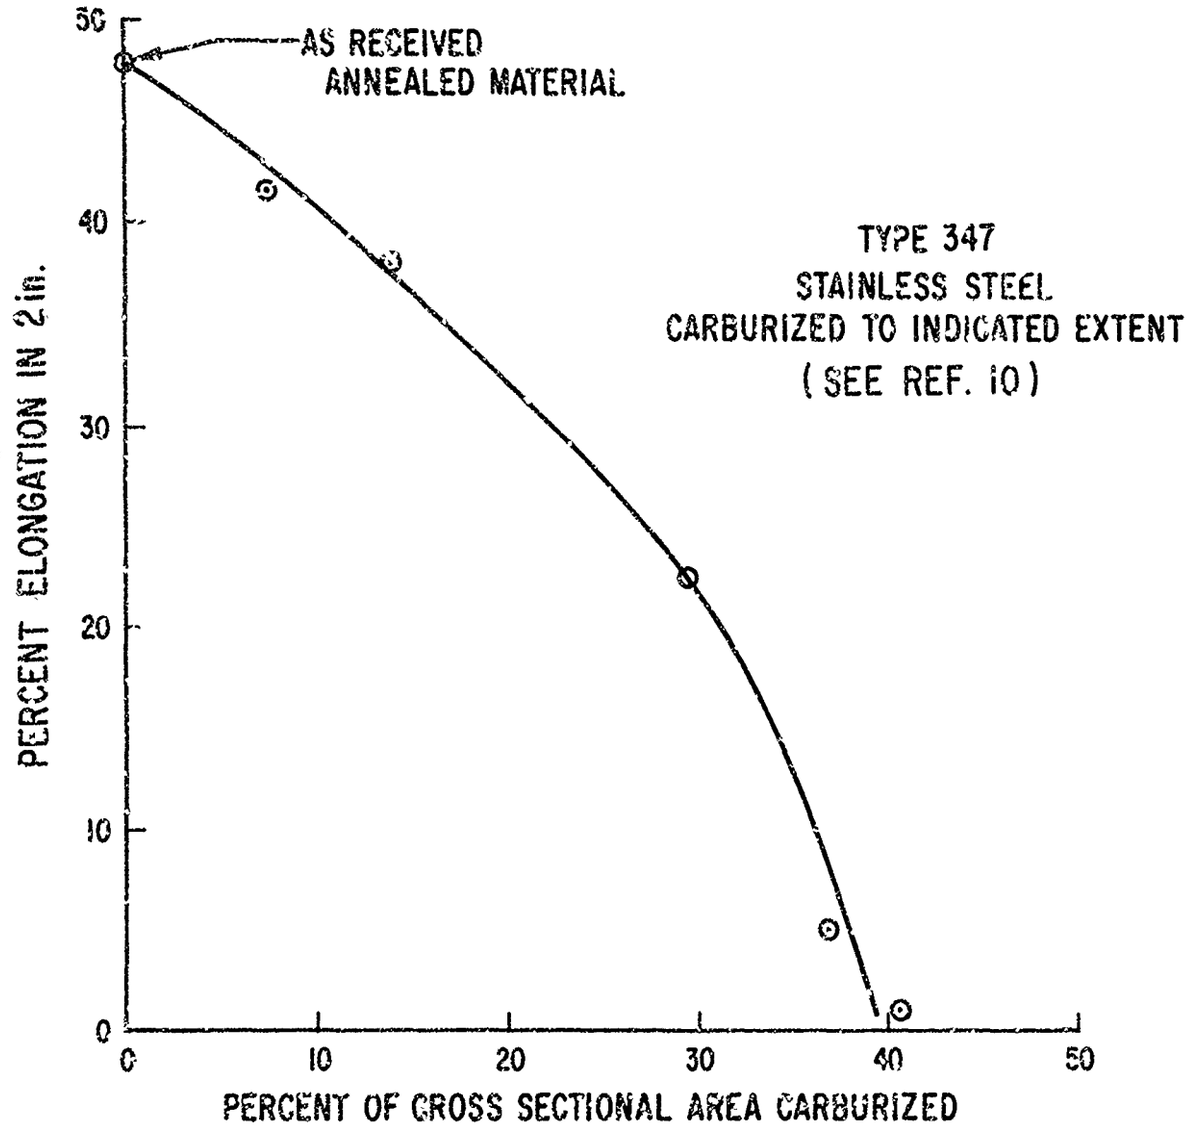
Figure 15. Decrease in Ductility in Relation to Carburization in Type 347 Stainless Steel

One unfortunate consequence of carburization in Type 347 stainless steel is the loss of ductility (Ref. 10). See Fig. 15. Figure 16 shows the cracking that develops when a carburized steel is pulled in tension. The specimen was originally carburized in 1-1/2 vol % methane in hyrogen for 1 hr at 980°C
