ADVANCED COMPOSITE JOINTS; DESIGN AND ACOUSTIC FATIGUE CHARACTERISTICS

W. J. JACOBSON

Northrop Corporation

TECHNICAL REPORT AFFDL-TR-71-126

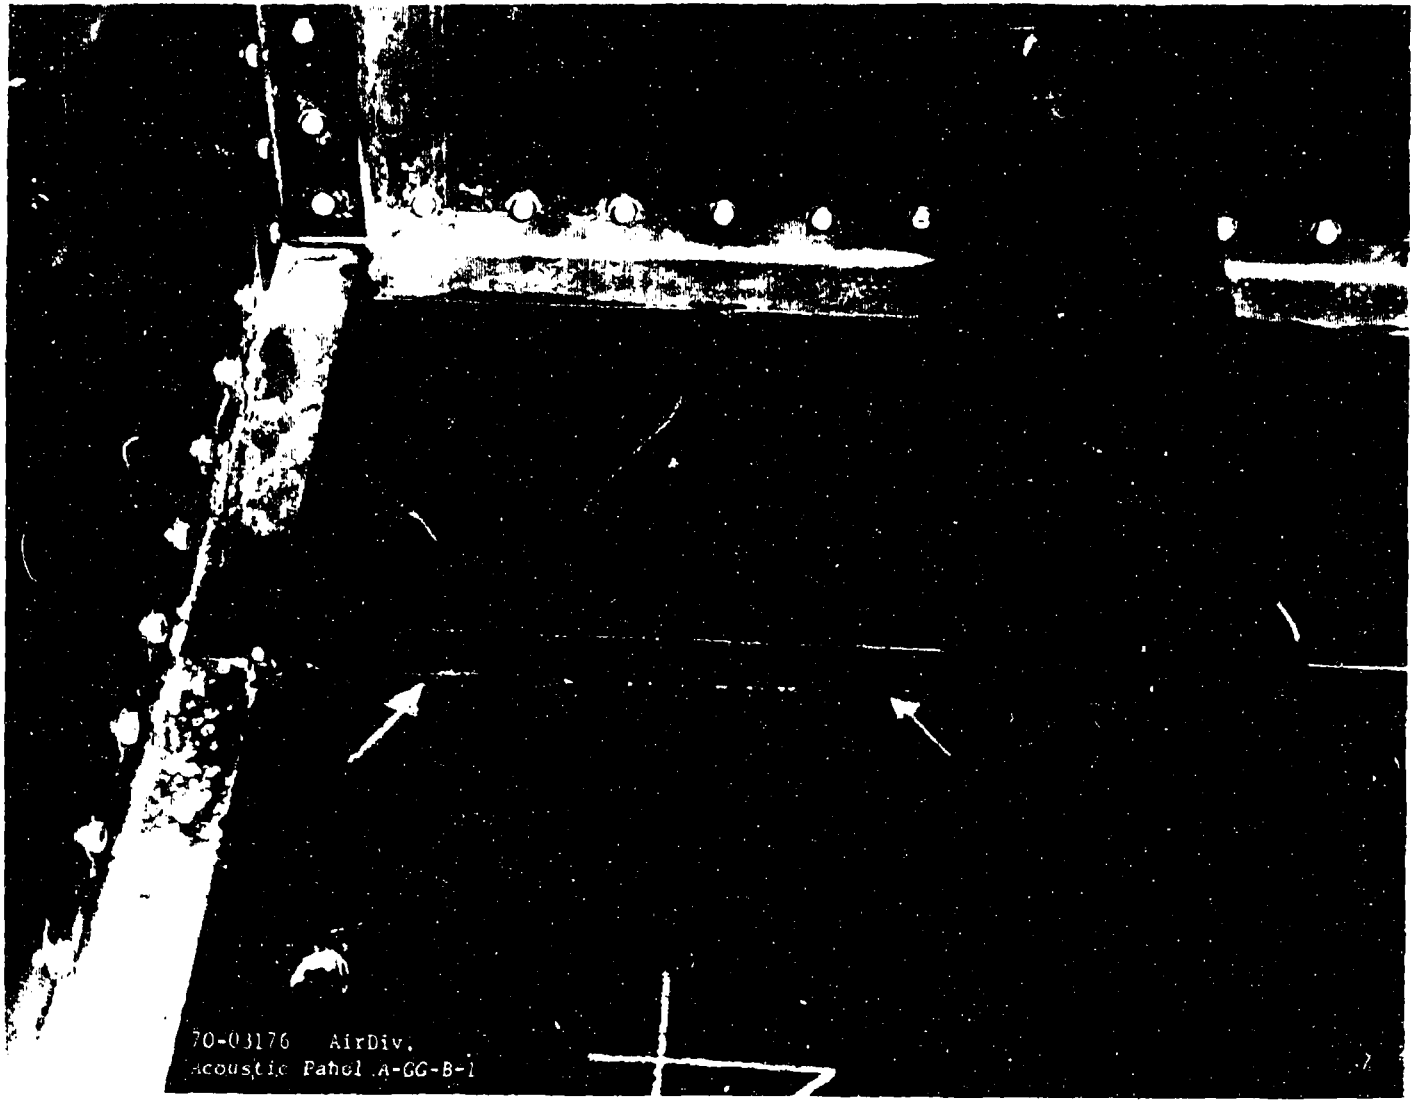
FIGURE 37. ADHESIVE FAILURE AT TEE SECTION SEPARATING BAYS 4 AND 7

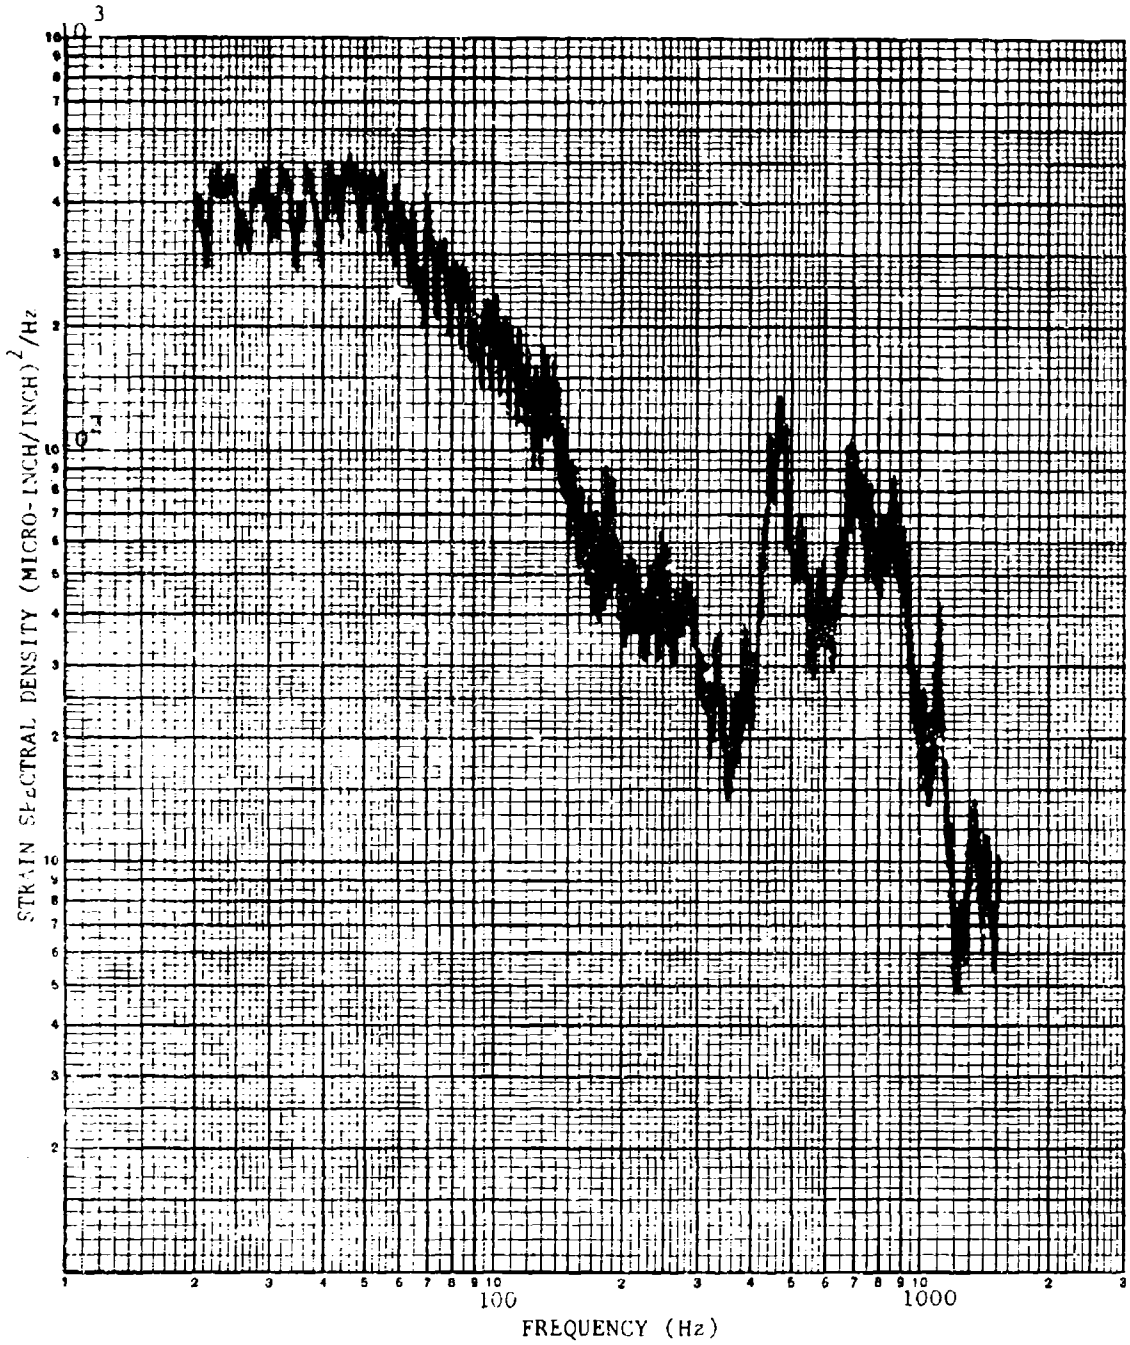
FIGURE 43. STRAIN GAGE NO. 2 RESPONSE WITH OIL CANNING AT 148 DB SPL

There was no oil canning until 148 db SPL was reached. Beginning at the 148 db SPL, the output of gages No. 1 and 2 indicated that the bay 5 vibration was about one of the two oil canned positions for a small time period, then bay 5 snapped thru the flat position to vibrate for a smaller time period about the other oil canned position, then snapped thru the flat position to begin a repetition of the oil canning phenomenon. The spectral analysis of strain at gage No. 2 at 148 db SPL when the vibration included oil canning is in Figure 43 and when the vibration did not include oil canning is in Figure 44. When the analysis included the oil canning, the rms strain was 320 micro-inch/inch (Figure 43) as opposed to a 210 micro-inch/inch without oil canning (Figure 44). Upon comparing Figures 43 and 44, it is noted that the oil canning increases the strain spectral density to a greater extent below 100 Hz than above 100 Hz.

Gage 2. Run 5 (148 db).
Rms strain = 320 micro-inch/inch

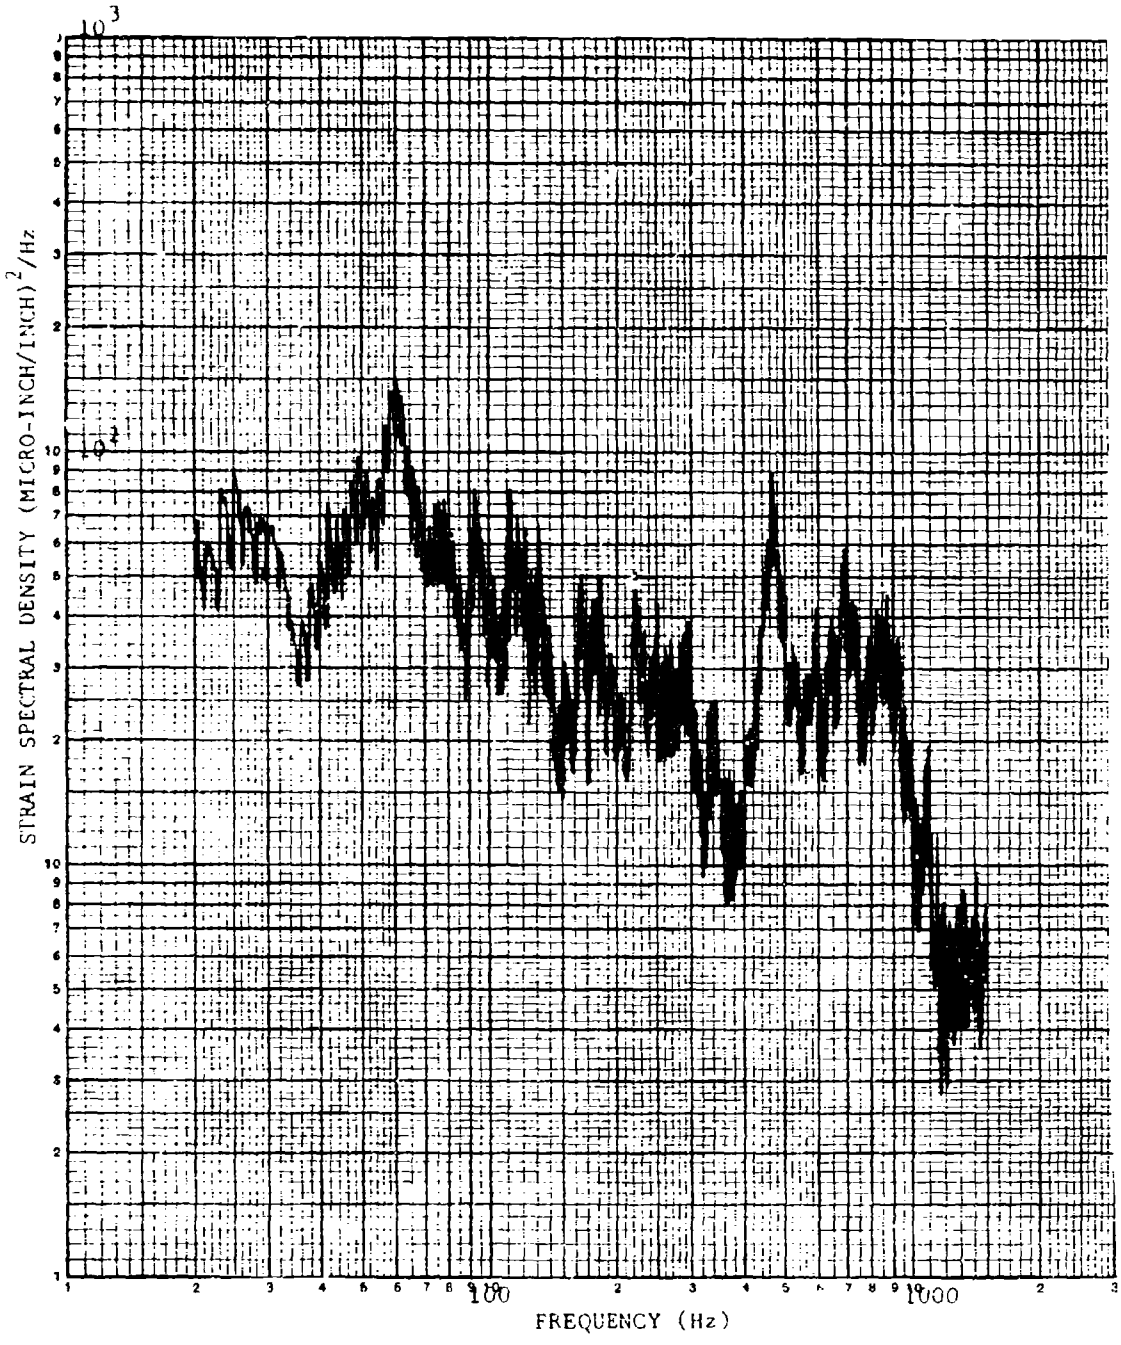
FIGURE 44. STRAIN GAGE NO. 2 RESPONSE WITHOUT OIL CANNING AT 148 DB SPL

The strain response of gage No. 2 at different levels is in Figures 44 and 45. The spectral shape of the response changes as the level is increased to give a larger percentage of the response in the lower frequency range. (Compare Figures 44 and 45).

Gage 2, Run 5 (148 db).
Rms strain = 210 micro-inch/inch.

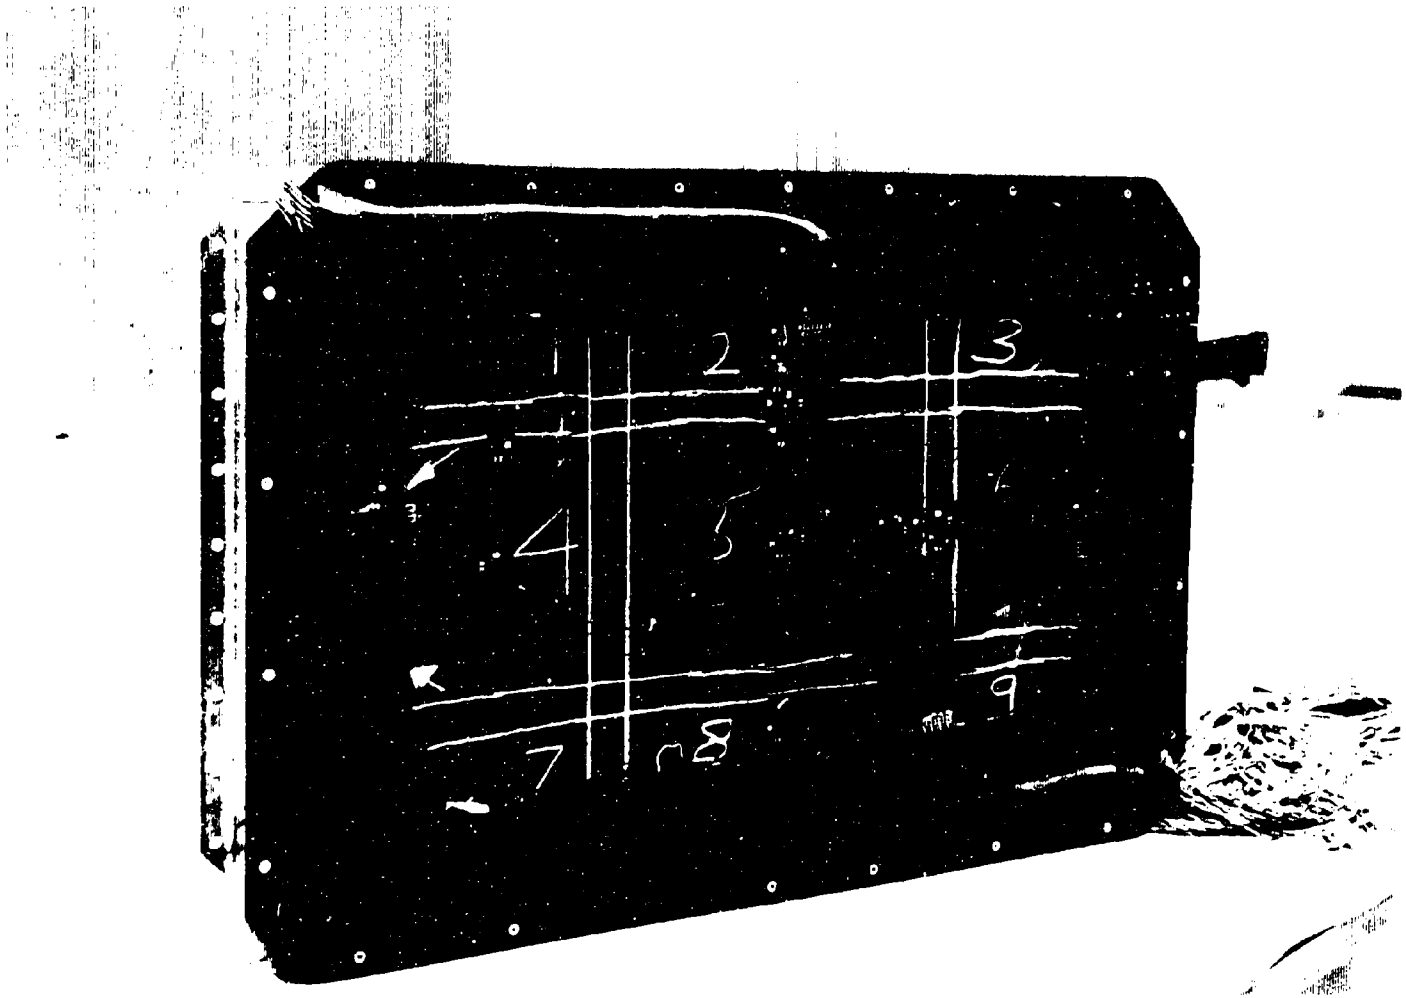
FIGURE 53. ADHESIVE FAILURE (BETWEEN ARROWS) IN BAY 4 OF PANEL A-GG-B-2

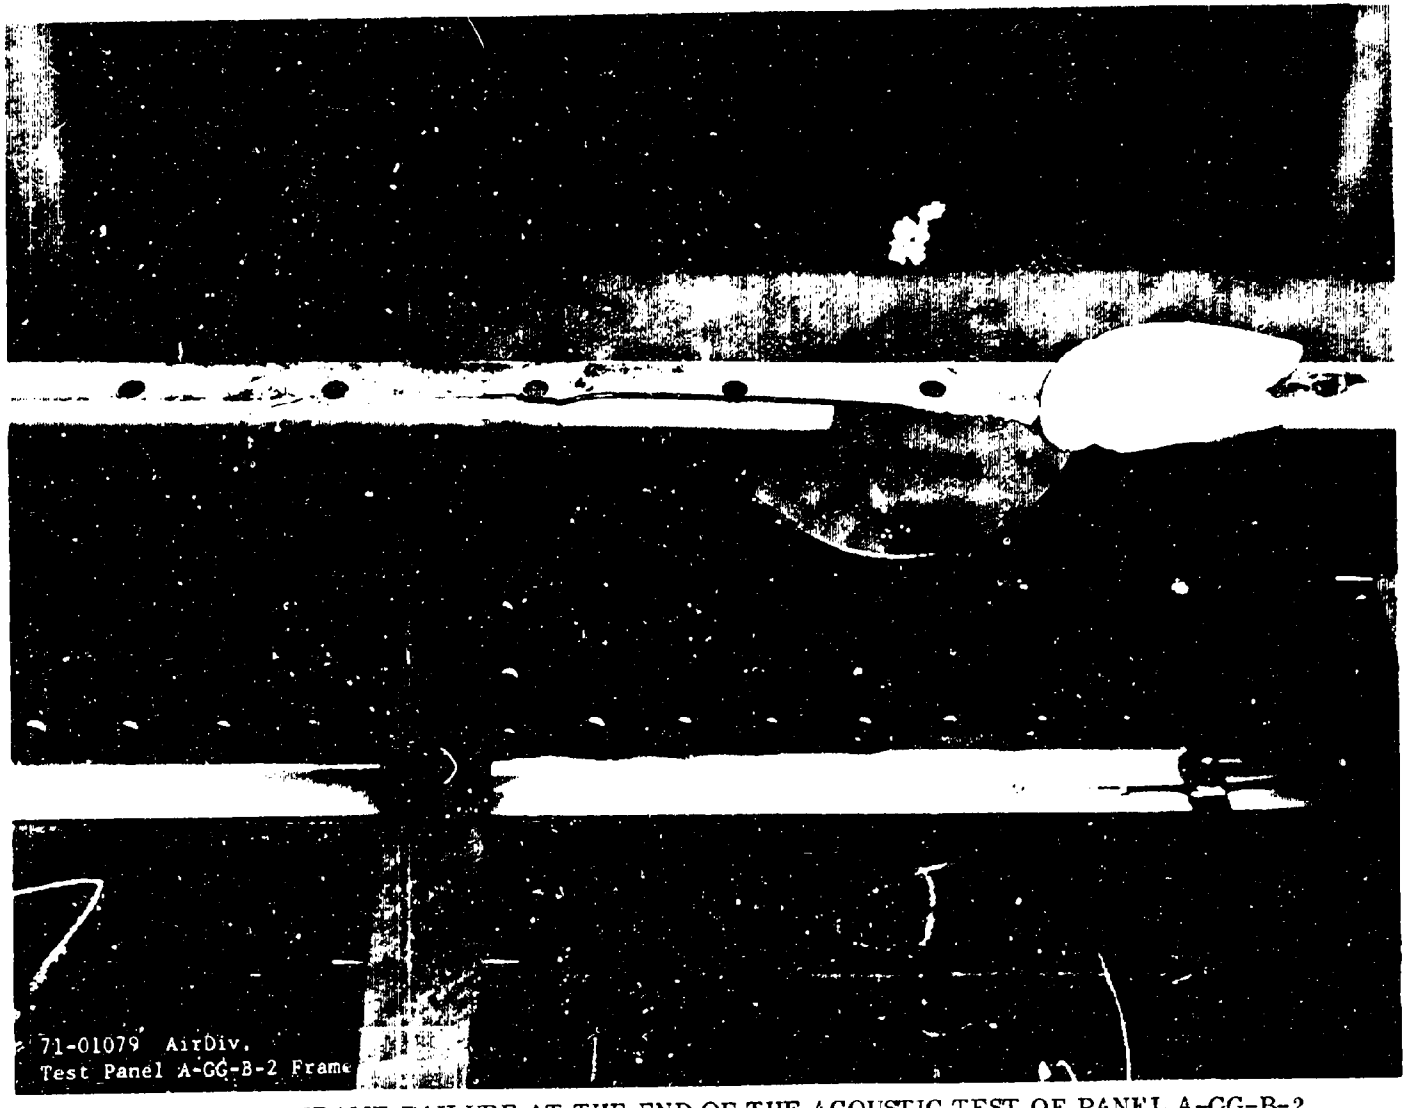
FIGURE 55. FRAME FAILURE AT THE END OF THE ACOUSTIC TEST OF PANEL A-GG-B-2

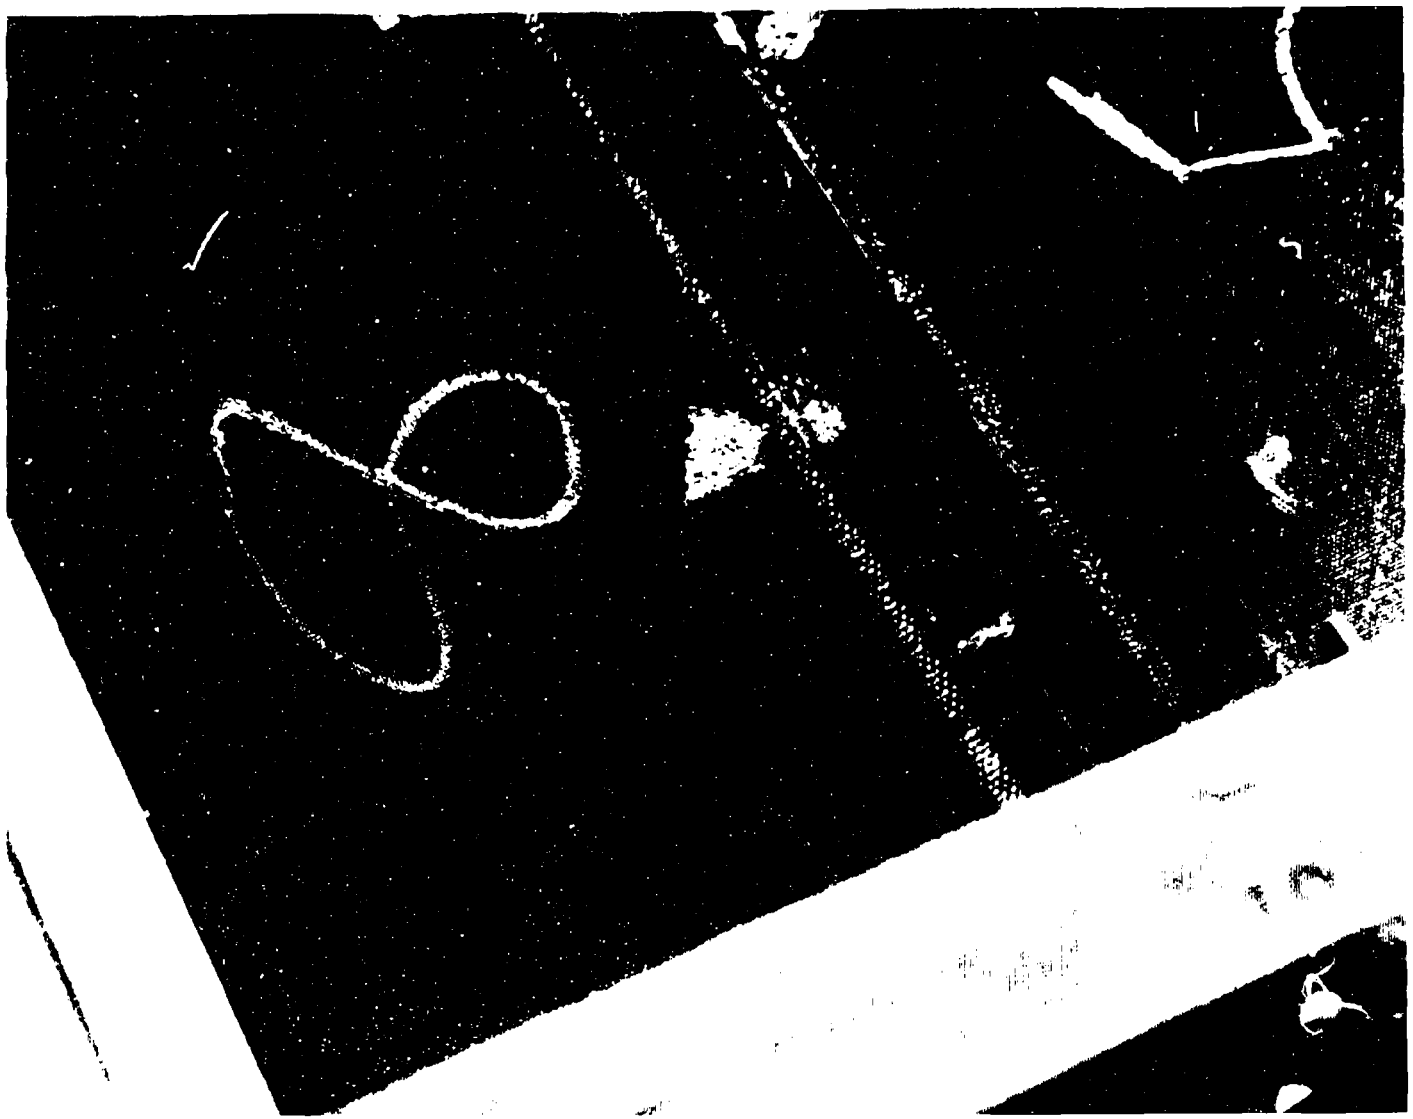
FIGURE 70. TEE SECTION DAMAGE DURING ACOUSTIC FATIGUE TEST OF PANEL A-GG-B-3

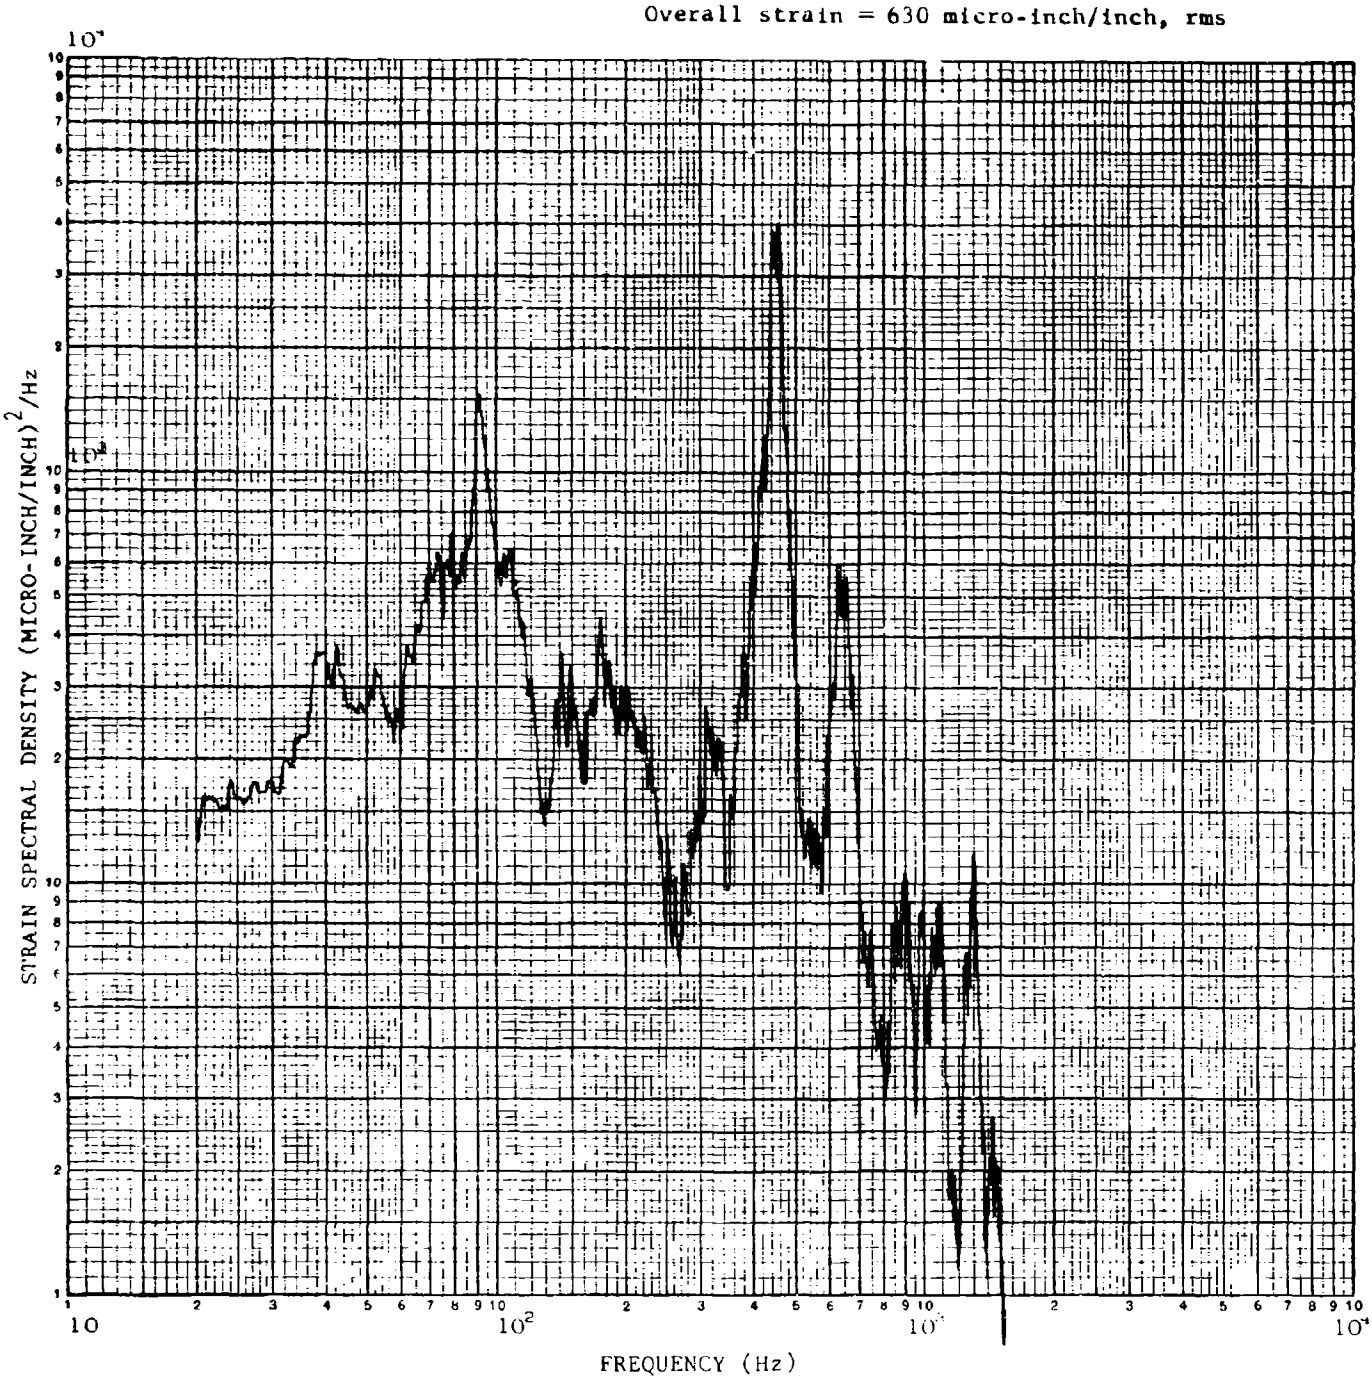
FIGURE 81. STRAIN SPECTRAL DENSITY

The PSD curves of strain of gages no. 17, 2, and 19 that are at the center of long edges of bays 4, 5, and 6, respectively, (see Figures 81, 76, and 80) indicate that there is significant strain response at different frequencies under 1000 Hz. In using the S-N data resulting from the test of panel A-GG-B-3, the overall rms strain, e, given in Figures 81, 76, and 80 was assumed to exist at an average frequency,

f_{av} = 408 Hz for gage 17 (from Figure 81) (3)

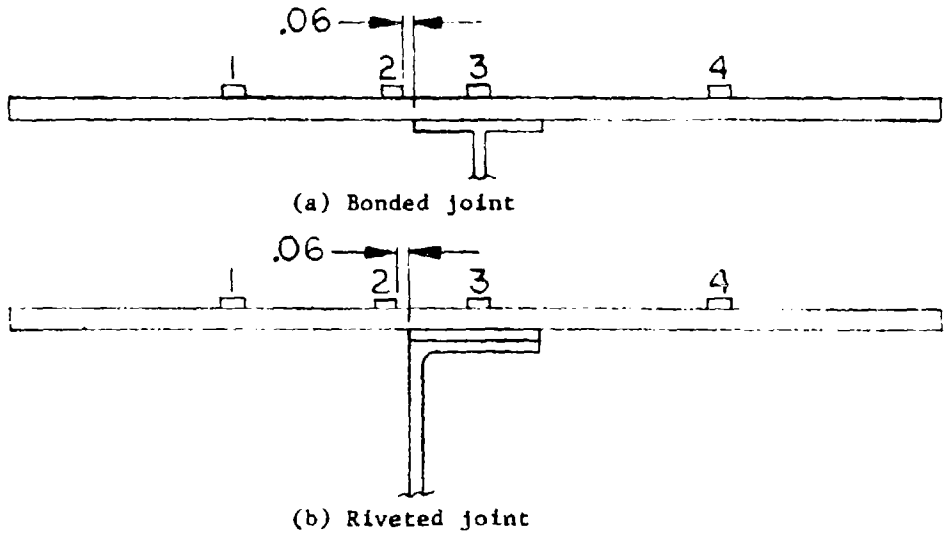
FIGURE 85. STRAIN GAGE LOCATIONS ON SHAKER SPECIMENS

8. At least four strain gages were installed on each shaker specimen and the location of the strain gages is shown in Figure 85. Strain gages No. 1 and No. 4 were useful in determining the response frequencies of the two sides of the shaker specimens. Strain gage No. 3 was used to monitor the strain after the other three gages had failed. Strain gage No. 2 was the reference gage for S-N data and was not directly above the supporting stiffener; the closest edge of the grid of strain gage No. 2 was 0.06 inch from the plane of the edge of the stiffener.

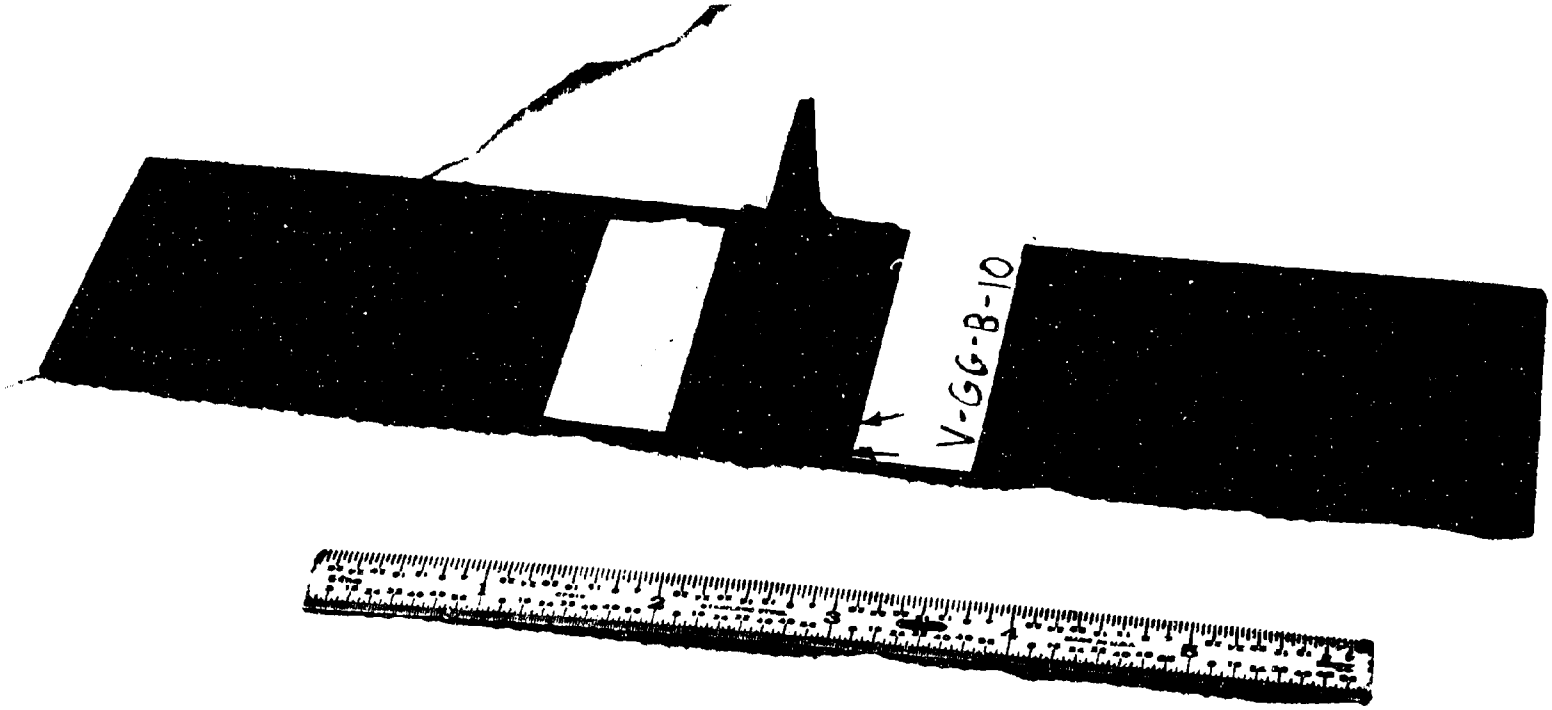
FIGURE 87. SKIN FATIGUE FAILURE (BETWEEN ARROWS) OF A SHAKER SPECIMEN WITH A BONDED JOINT

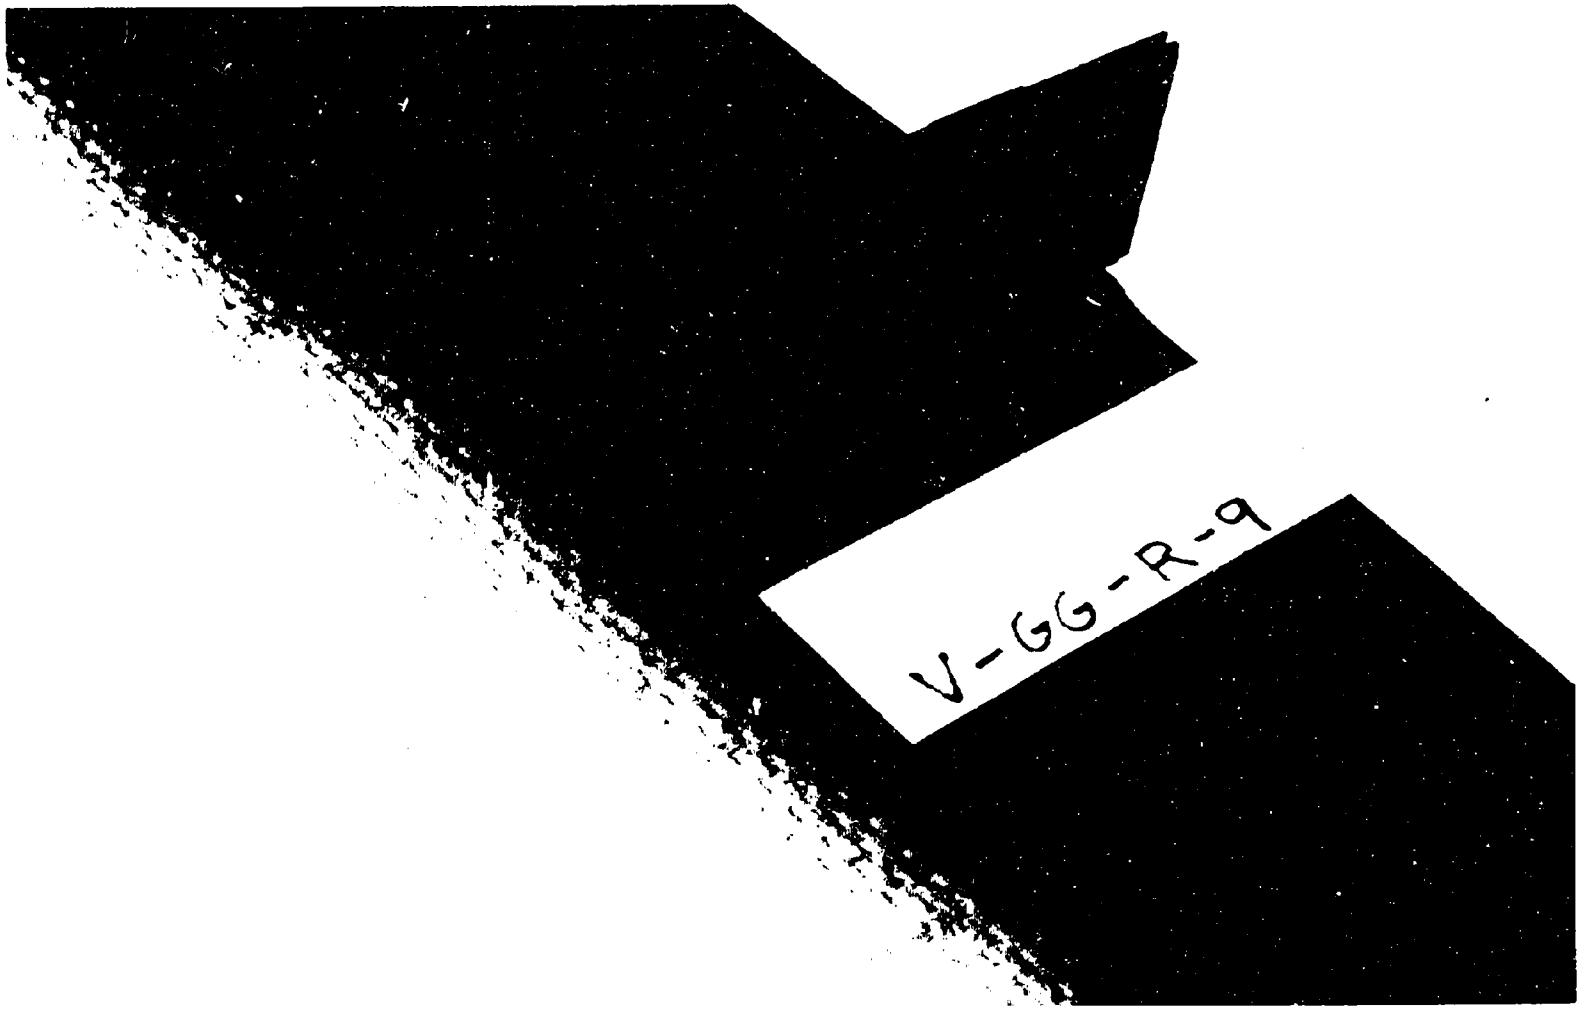
FIGURE 88. SKIN FATIGUE FAILURE ACROSS THE WIDTH OF A SHAKER SPECIMEN WITH A RIVETED JOINT

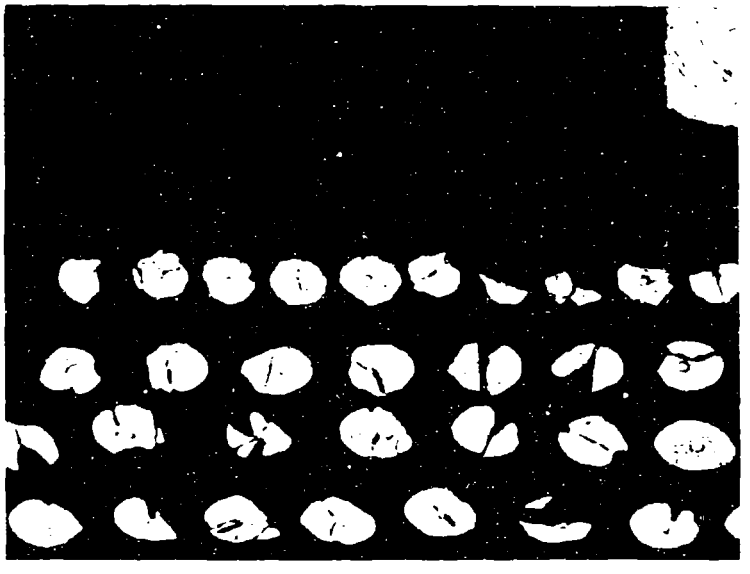
Specimens V-GT-R-2 and V-BT-R-2 were sectioned and photomicrographs were taken (Figures 89 and 90). The photos give detail indicative of the types of failures experienced in the shaker tests. Typical magnification in the photomicrography was 50X and standard encapsulation/mounting techniques were employed.

FIGURE 90. PHOTOMICROGRAPH OF FATIGUE FAILURE OF VIBRATION SPECIMEN V-BT-R-2

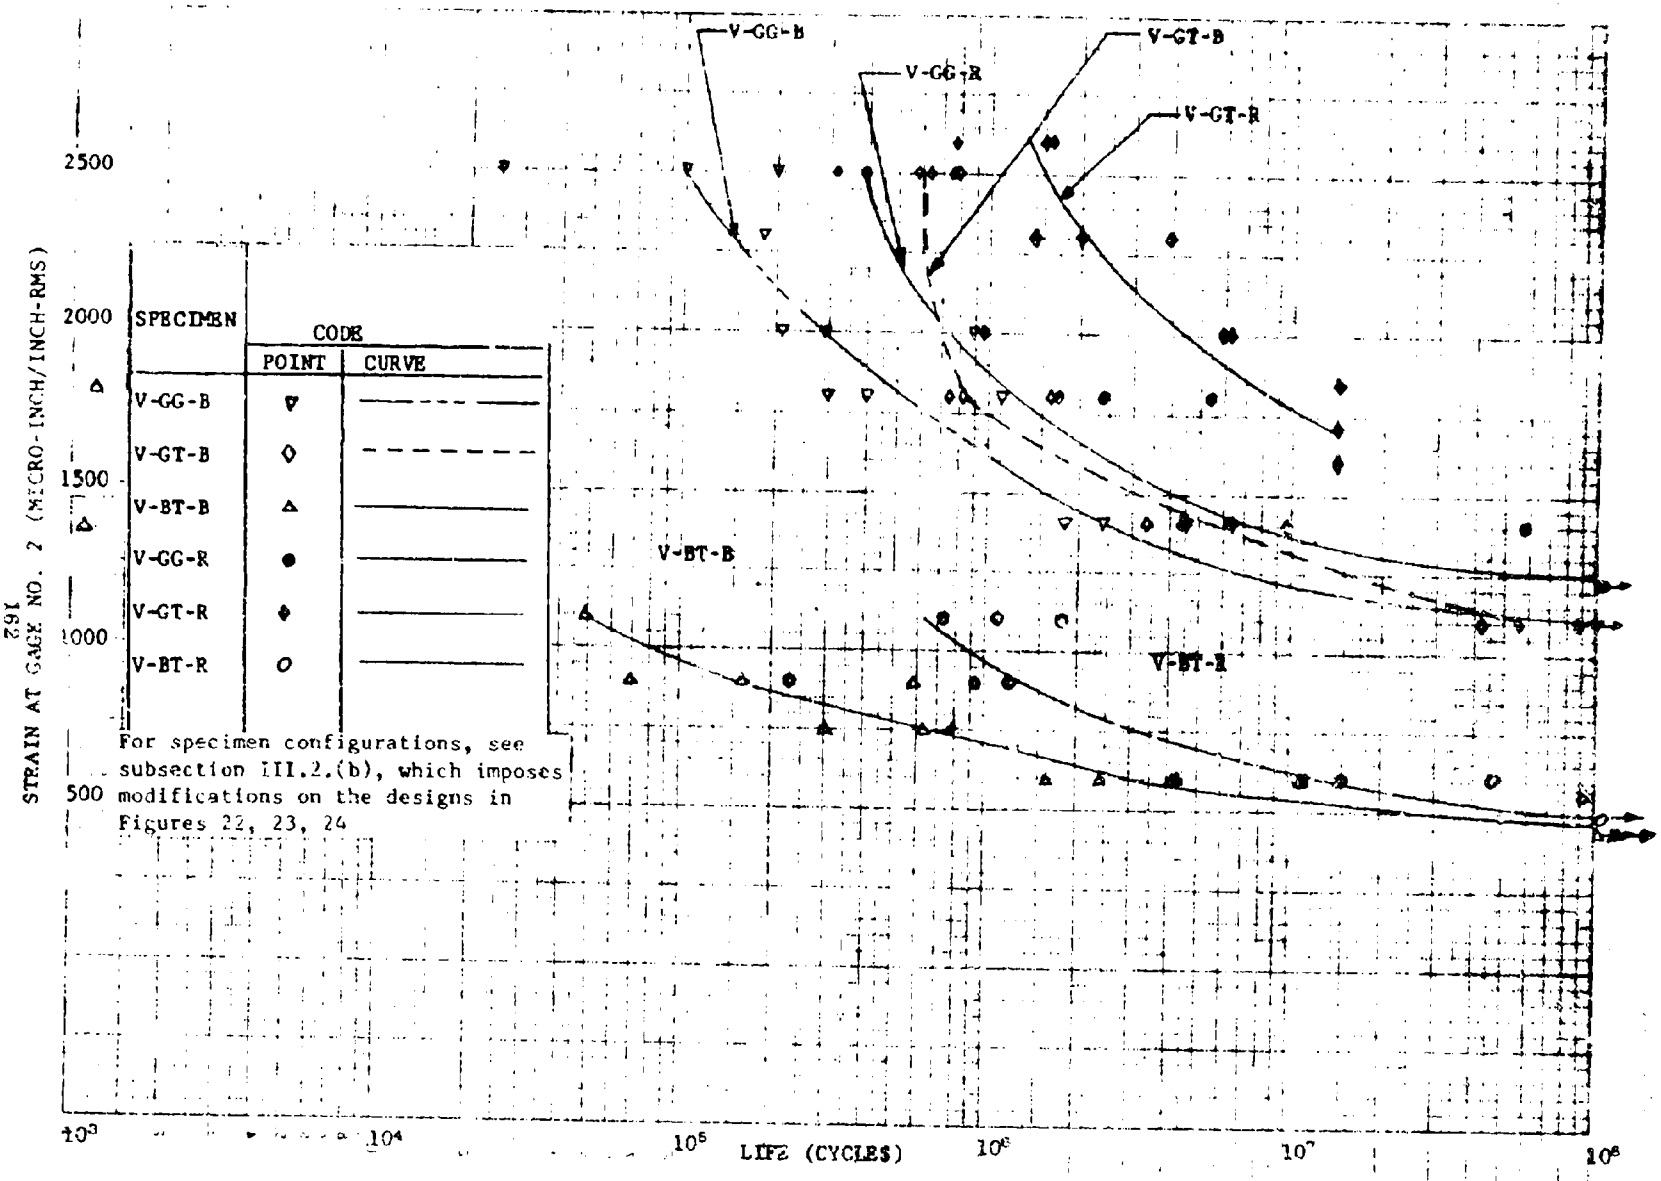
FIGURE 98. SUMMARY OF SHAKER S-N DATA AND PRELIMINARY S-N CURVES

A summary of the shaker S-N data is in Table XIV and Figure 98. The strains in Table XIV (and also in the acoustic test program) were estimates of rms strains obtained visually from true rms voltmeters, with 1 second averaging times and the accuracy of the strains is estimated to be within ten percent.

The static ultimate tensile strains from Table A-2 of Appendix A are 9300 micro-inch/inch for the six-ply $[90 \ \pm 45]_S$ graphite-epoxy specimens and are 4100 micro-inch/inch for the six-ply $[90 \ \pm 45]_S$ boron-epoxy specimens. From Figure 98, it appears that the rms fatigue strain at 10^8 cycles under the narrow band random loading that was exciting the second symmetric bending mode is at least ten percent of the static ultimate tensile strain of the six-ply laminates.

One objective of the shaker test program was to obtain S-N curves with sets of six-ply specimens (one of the sets simulates a portion of the bonded joints of the acoustic test program). The S-N curves of Figure 98 are useful because they indicate life that can be expected from a larger population of different types of test specimens. However, because of the few specimens in each set, the confidence levels associated with life predictions based on the S-N shaker specimen test results are significantly lower than the confidence levels associated with material allowables for the design of metallic aircraft structural elements. However, it does appear that the rms fatigue strain at 10^8 cycles under the narrow band random loading of the six-ply $[90, \pm 45]_S$ graphite-epoxy and boron-epoxy laminates is at least ten percent of the static, ultimate tensile strain of the six-ply laminates.

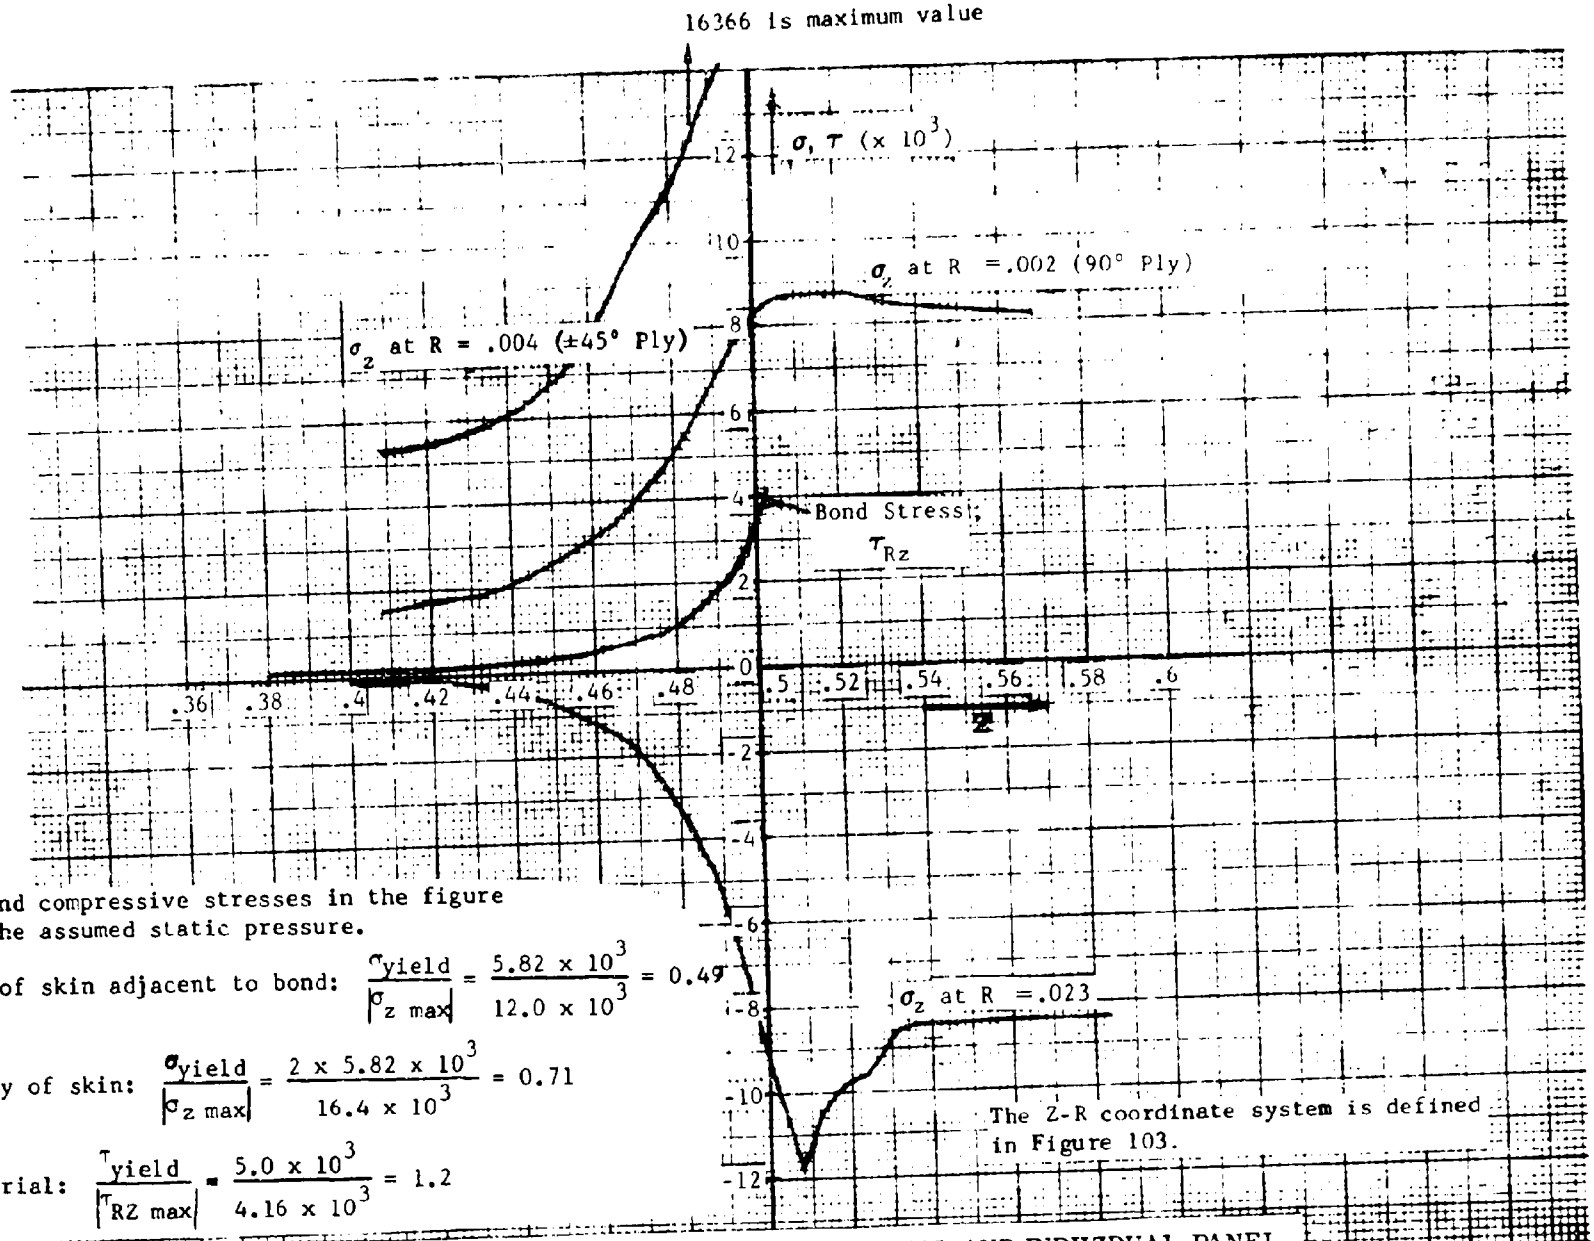
FIGURE 105. STRESSES IN THE BONDING MATERIAL AND INDIVIDUAL PANEL PLIES FOR CASE 1

2. The ratios of yield stresses to developed stresses show that for Case 1 the first fatigue failure is expected to occur in the 90 degree ply of the skin and for Case 2 the first fatigue failure is expected to occur in the bond (see the discussion below).

Based on these results and the assumption that the material stress-strain curves were linear to the ultimate stress, it was concluded that for the acoustic test panels, the initial acoustic fatigue failure should be expected at or near the tee section stiffeners rather than at or near the I-beam stiffeners, since the most severely stressed (relative to yield stresses) finite element was in the 90 degree ply of the skin adjacent to the adhesive bond (see Figure 104 with the ratio $\frac{\sigma_{yield}}{\sigma_{z\,max}} = 0.49$ being the critical stress ratio). The results of this bonded joint analysis was a key factor in the selection of the Candidate A-2 type shaker specimen. Subsequently, in the fatigue tests of the shaker test specimens, the fatigue failures did occur in the skin of the 90 degree plies (Figure 87 and 88) as predicted by the analysis in this subsection.

90° - ply of skin adjacent to bond: $\frac{\sigma_{yield}}{|\sigma_{z\ max}|} = \frac{5.82 \times 10^3}{12.0 \times 10^3} = 0.49$
