SUBJECT: ASD Addendum Report to FTC-TR-71-39 26 Jan 72

This report presents the results of the propulsion system evaluation conducted during the UH-1N Category II systems evaluation program. The propulsion system was adequate for accomplishment of mission objectives, but several improvements should be made. Flight Manual changes were considered necessary for engine starting, manual fuel control operation, engine topping parameters, and engine deterioration. Rotor overspeed occurred when the beep switch was actuated to increase rotor speed and when the collective pitch control was lowered. The fuel system should be redesigned to provide tank isolation in the event of combat damage. The fuel system should also be crashworthy. Operation, functional adequacy, accessibility, and ease of servicing of the drive and transmission components were acceptable.

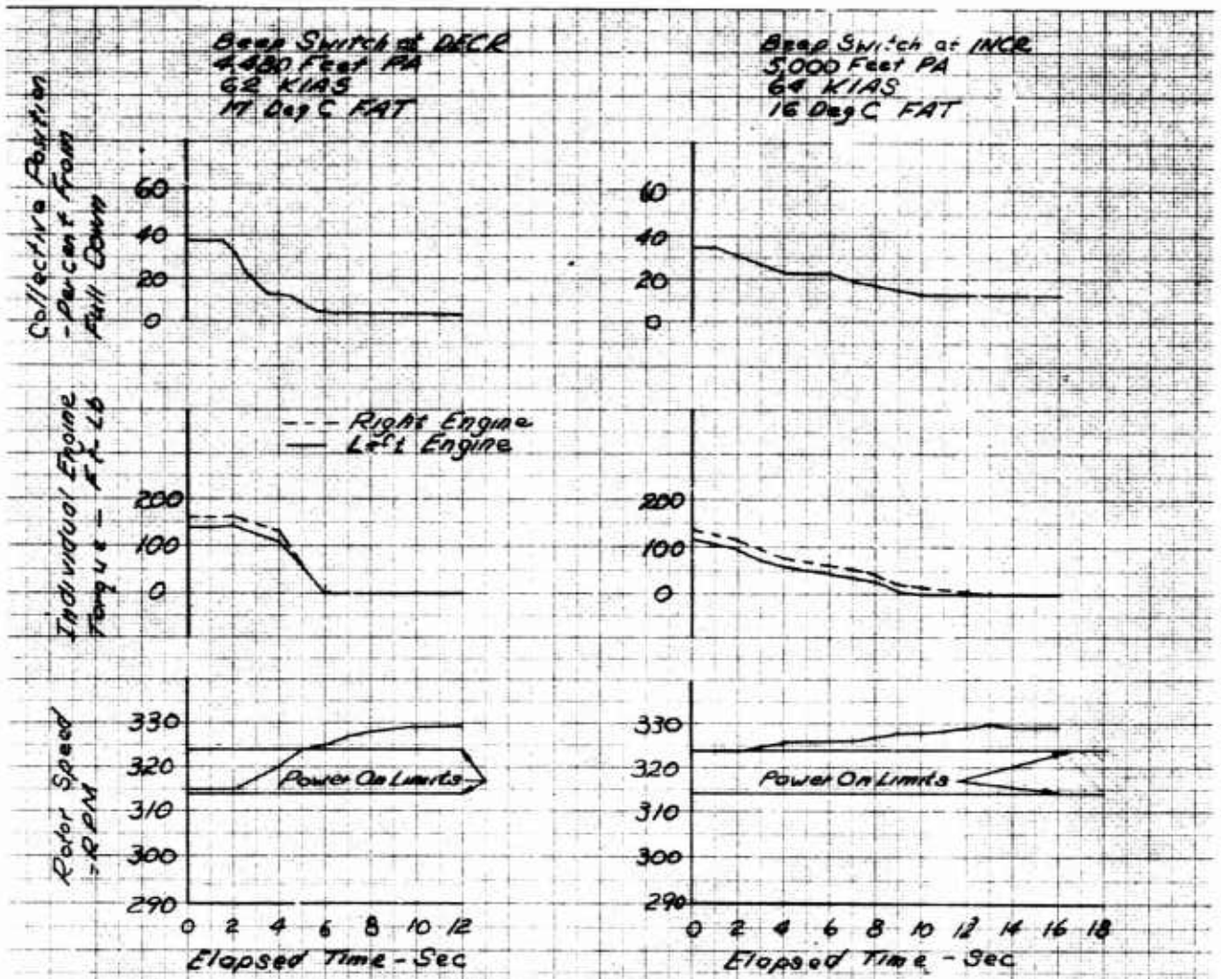
Figure 8 presents time histories of N_R, engine torque, and collective pitch control position for two typical engine transient tests in which the collective pitch control was lowered, first with minimum beep and then with maximum beep. In both cases rotor speed exceeded the power on limit of 324 rpm, even though the rate of collective pitch control movement was slow (5 and 9 seconds, respectively). Although not tested due to safety reasons, rotor speed could be expected to exceed even the maximum transient power-on limit of 338 rpm in the event the collective pitch control was lowered rapidly (one second or less) from a high power setting. These data indicate that rotor compensation characteristics were inadequate to maintain rotor speed within power-on limits even when minimum beep was applied. Rotor speed compensation should be improved to prevent rotor overspeed during engine transients induced by lowering of the collective pitch control. (R 9)

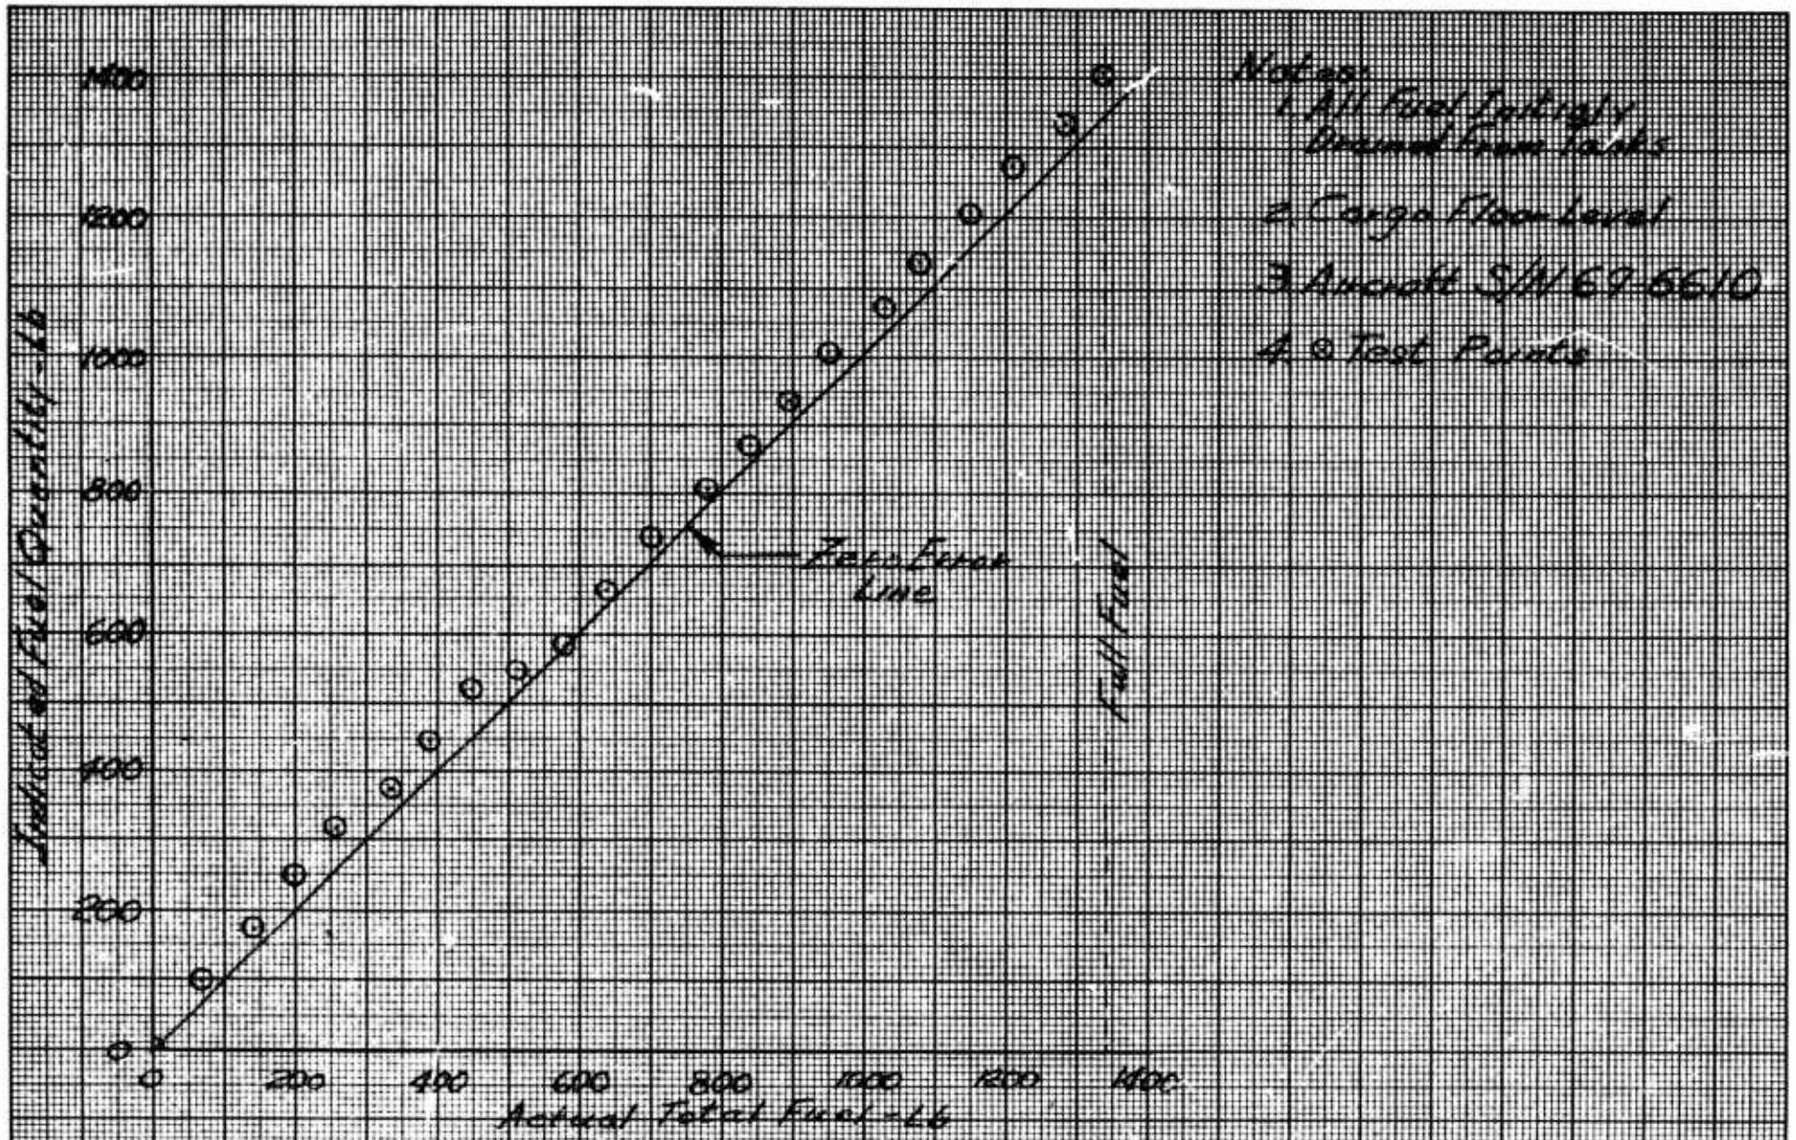
Figure 18

Data presented in figure 18 indicate that the gauge accuracy was approximately linear, indicating about 30 pounds (4.7 gallons) above actual weight. Irregularities during the first 600 pounds of fuel added were probably due to the fuel settling characteristics through the foam--filled tanks (from top to bottom). A total of 210 gallons was added with the aircraft in a level attitude on jacks. About 1 gallon was vented
