RADC-TR-71-81
Technical Report
December 1971

BEARING IMPROVEMENT PROGRAM FOR LARGE ROLLING ELEMENT BEARINGS

Rome Air Development Center
Air Force Systems Command
Griffiss Air Force Base, New York

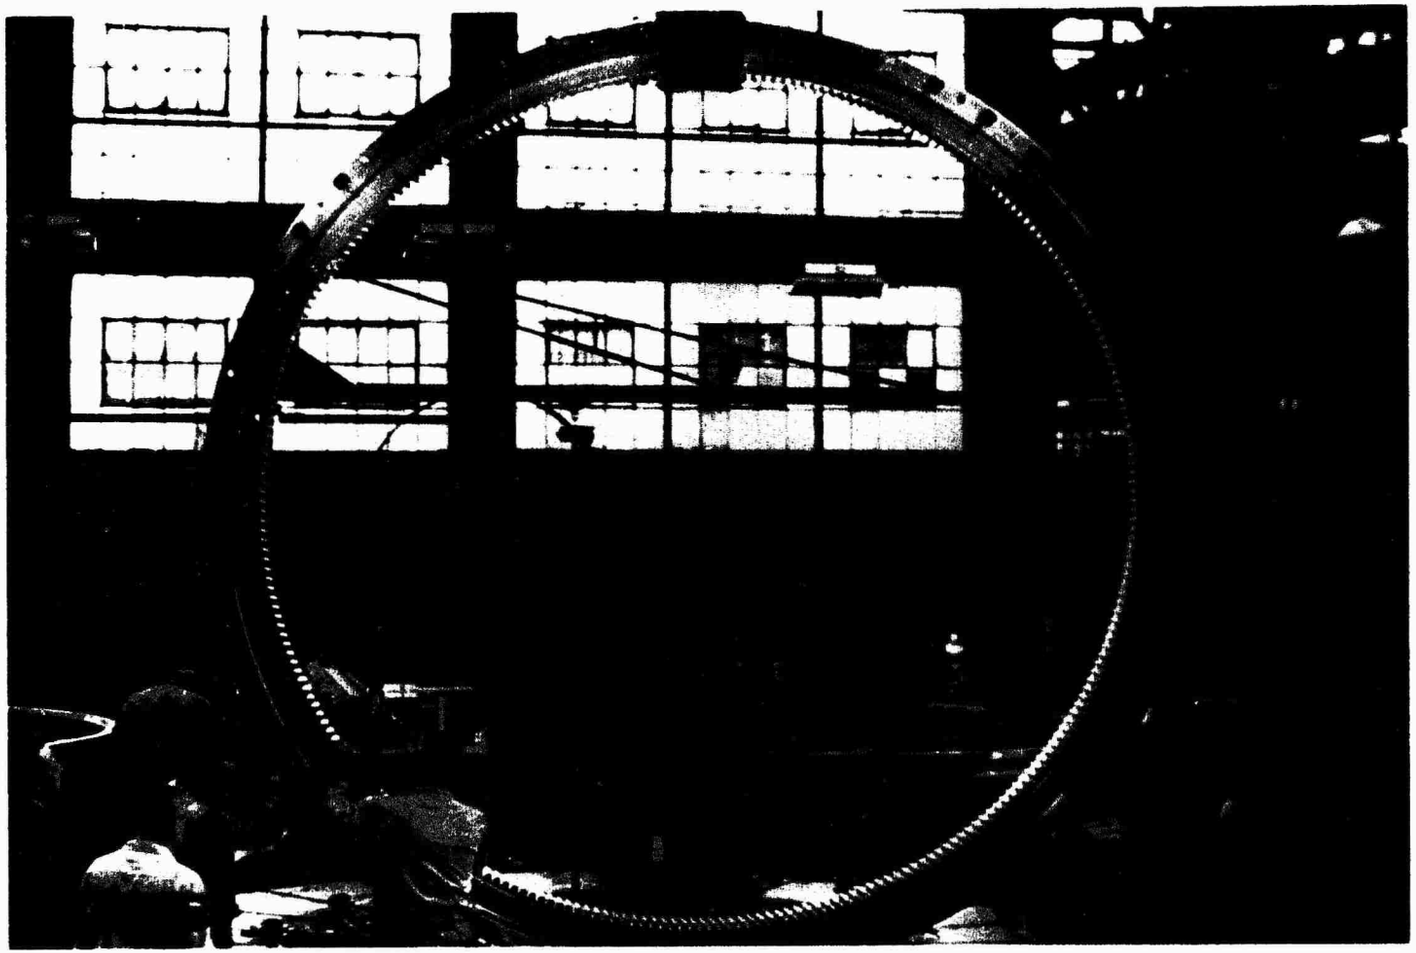
Figure 3. AN/FPS-35 Azimuth Bearing

Figure 3 shows the size of the bearings, while Figures 4 and 5 are examples of the type of damage which has occurred as the result of fatigue failure.

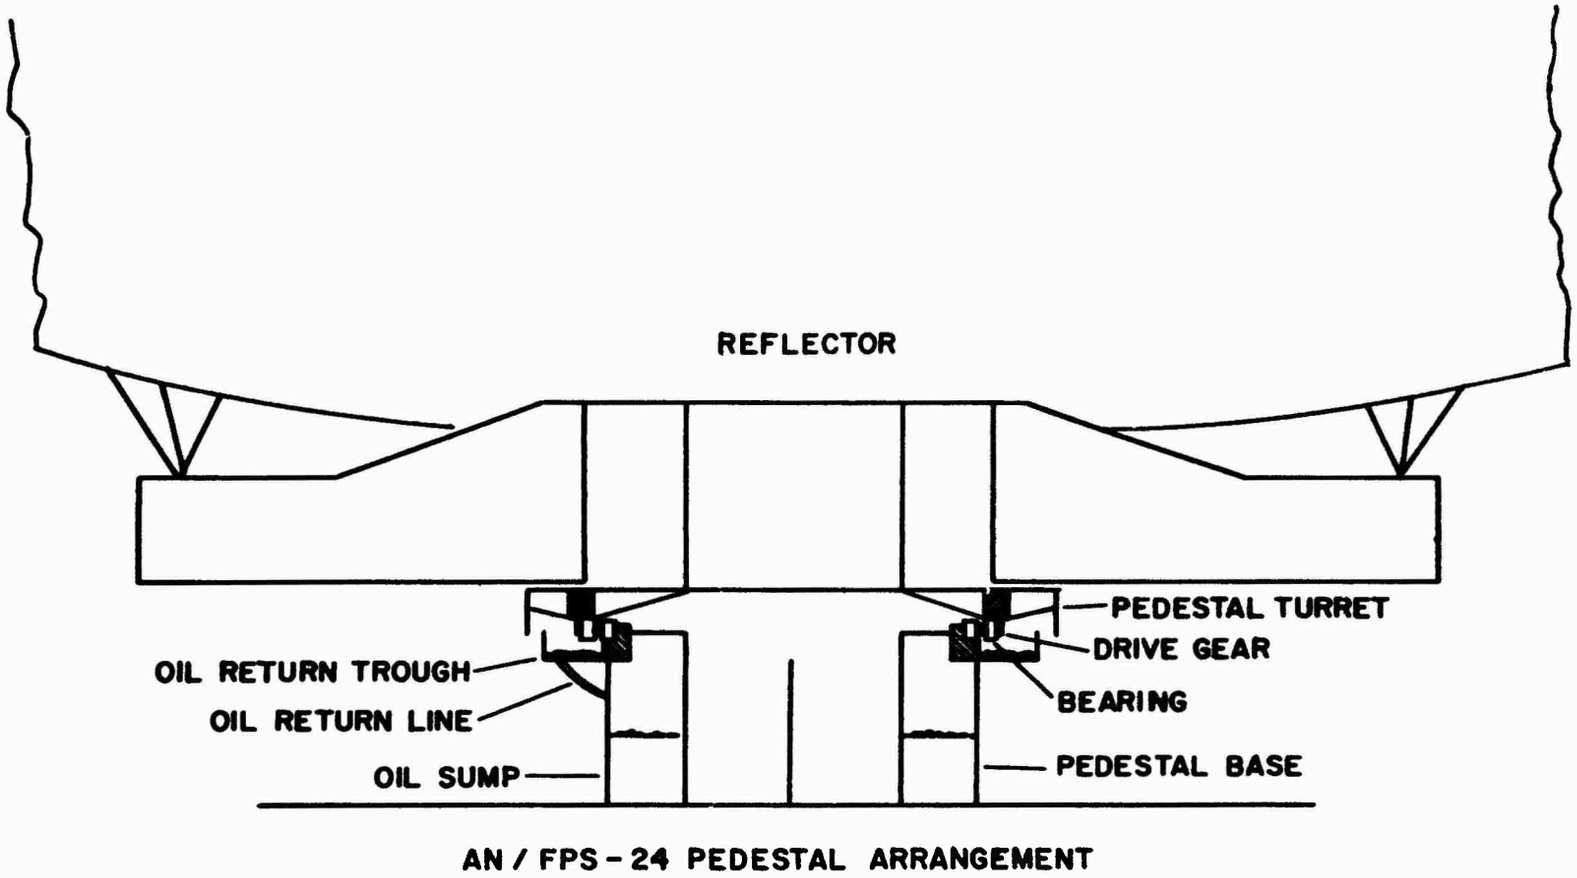
Figure 6. AN/FPS-24 Pedestal Arrangement

With reference to the determination of internal load distribution, the pedestal configurations selected for the AN/FPS-24 and 35, shown schematically in Figures 6 and 7, require that the one bearing simultaneously provide restraint to resist downward thrust, radial loads, and moment loads. The downward thrust is due to the dead weight of the antenna system, and the radial and moment loads are due to wind acting through the center of the antenna high above the bearing. Load distribution for such a system is highly indeterminate. Methods used by the several experts varied in their exactness and therefore contributed to the differences in final results.

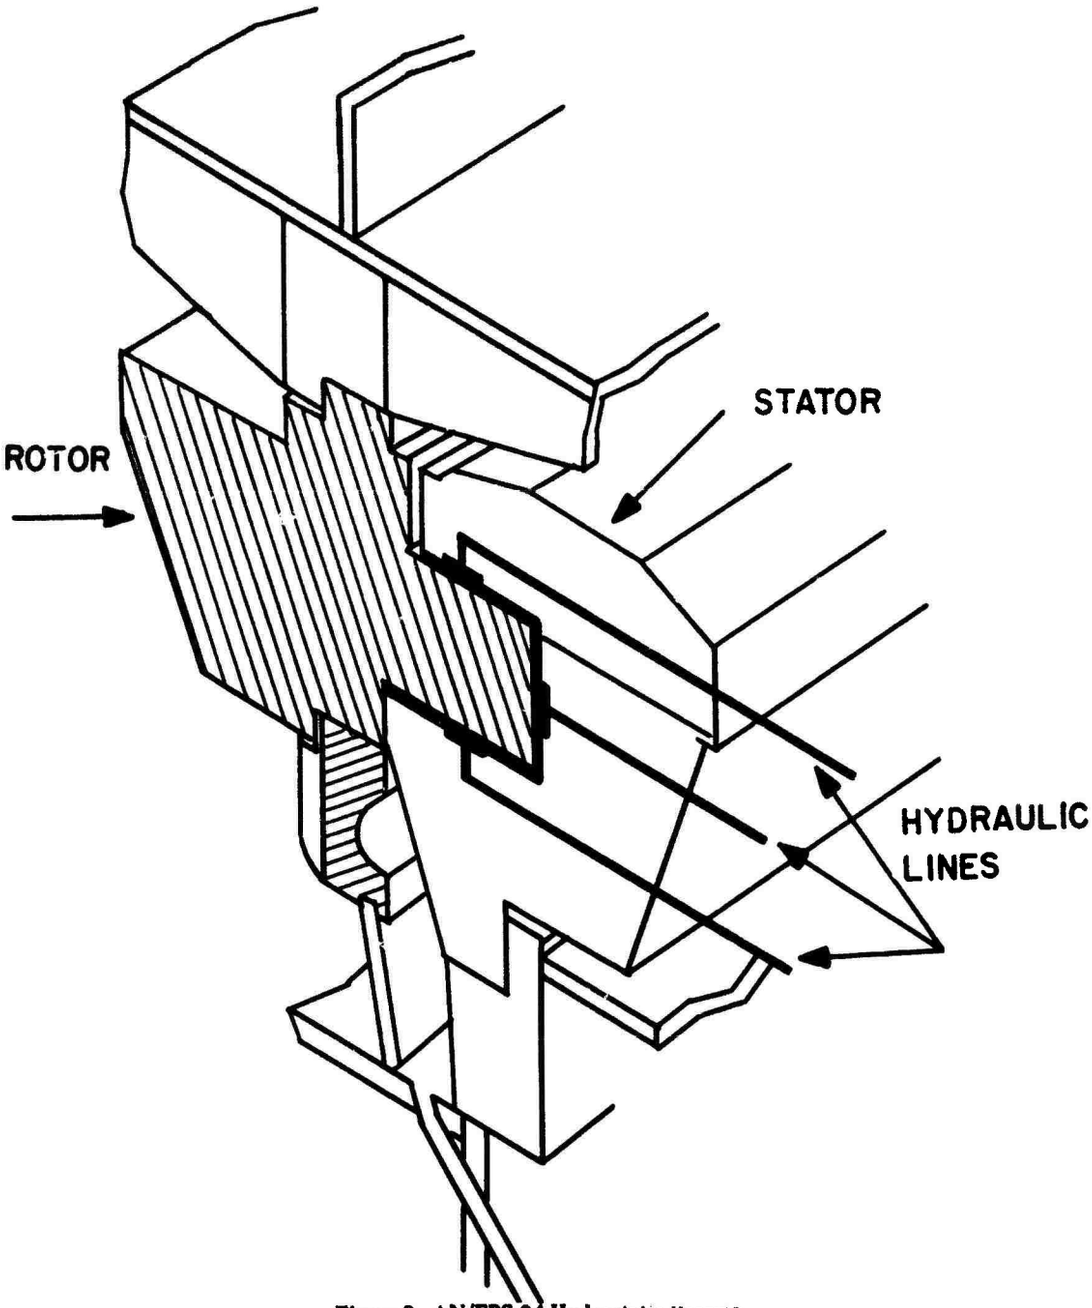
Figure 8. AN/FPS-24 Hydrostatic Bearing

The AN/FPS-24 hydrostatic bearing which was developed by Goodyear Aerospace Corporation was installed, tested, and successfully operated in the AN/FPS-24 radar at Oakdale, Pennsylvania. The test was terminated by catastrophic failure after 7821 hours of operation. The failure was due to human error which caused fail-safe drive brakes to be disabled, followed by interruption of prime power to the site. The details of this effort are contained in Reference (1).

The third effort was the development of a hydrostatic bearing for the AN/FPS-24. Because of the relatively high rotating weight and small bearing diameter in the pedestal for this radar, it was unlikely that satisfactory life could be achieved with a rolling element bearing. A different type of bearing was therefore considered. It consists of rotating and stationary surfaces which are separated completely by a thin film of flowing oil which is continuously supplied by an external pressure source. The surfaces were arranged to combine two thrust and one journal bearing in one unit. A cross-section of the bearing is shown in Figure 8. The advantages of this type of bearing for this application are:

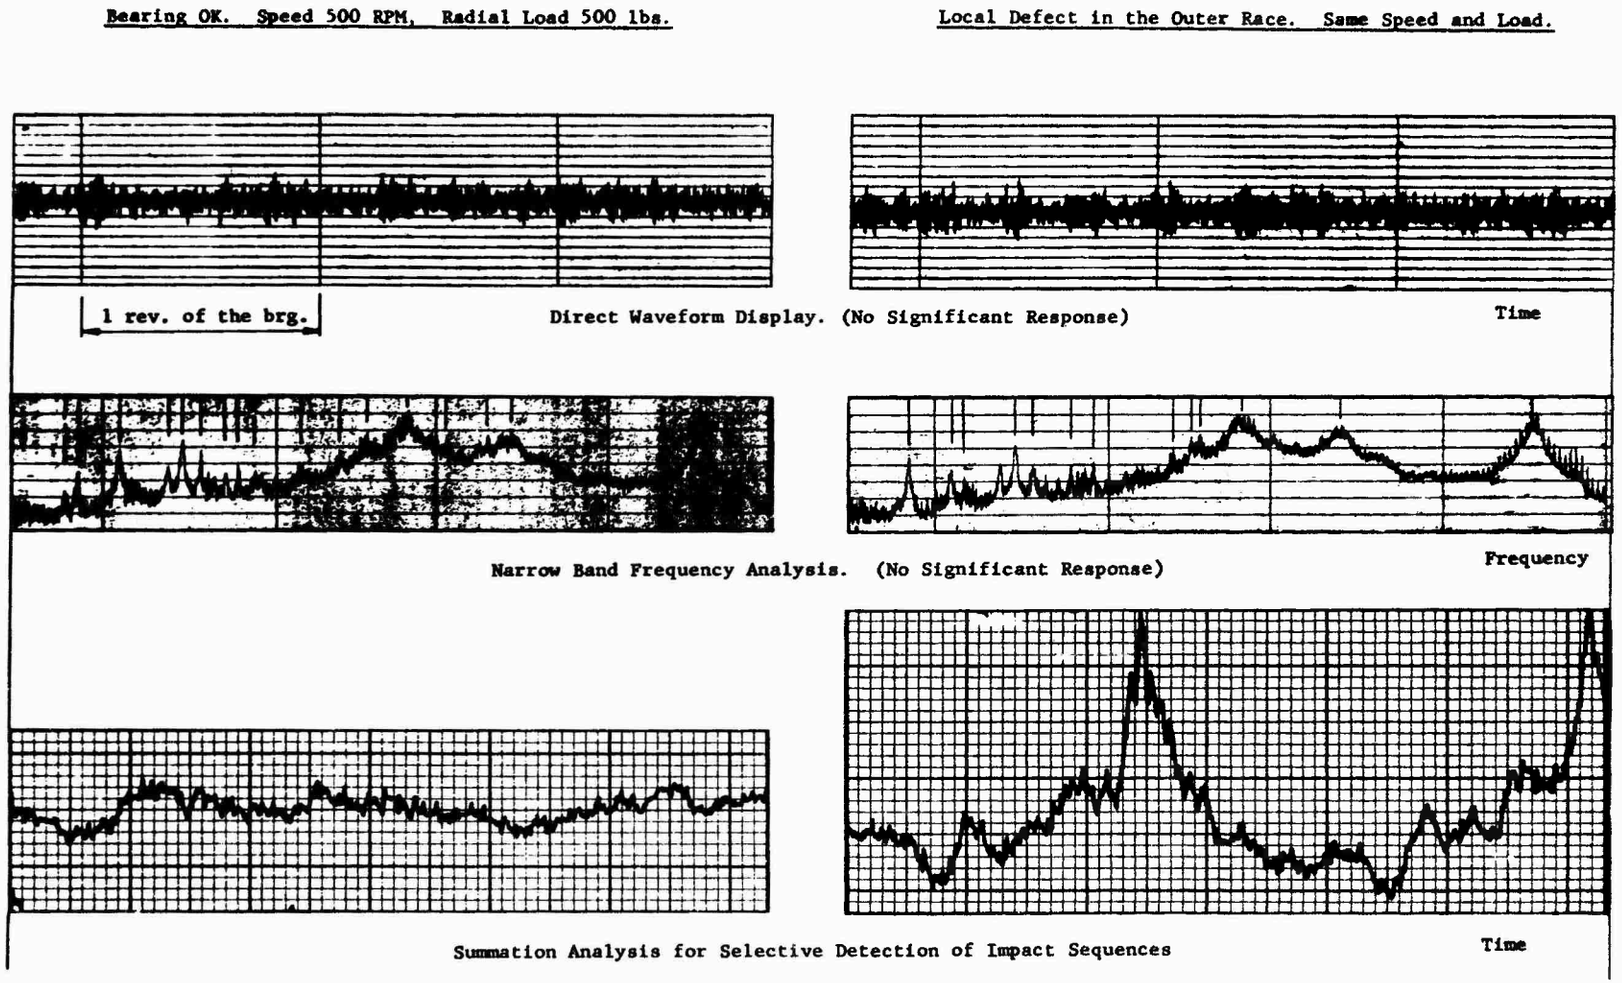
Figure 22. Comparison of Three Methods of Vibration Analysis

The third technique that was used was a summation analysis. The vibration signal is divided into several segments of a length which corresponds to the period of the defect impacts, T_S. The segments are then summed. The effect of this summation is an enhancement of the signal-to-noise ratio of disturbances having periodicity T_S over the signal-to-noise ratio of the raw signal. Figure 21 shows the summation technique and a block diagram of the analysis equipment. Figure 22 shows the results of a comparison of the three detection methods for detection of a small defect.

disassembled, it was found to have two small spalls distributed over an area approximately ¼ inch by ¼ inch on the stationary ball race. The fact that the two spalls did not generate a measurable vibration signature can probably be traced to the following reasons:
