UH-1N

CATEGORY II AIRFRAME AND SUBSYSTEMS EVALUATION

TECHNICAL REPORT No. 71-37

AIR FORCE FLIGHT TEST CENTER
EDWARDS AIR FORCE BASE, CALIFORNIA
AIR FORCE SYSTEMS COMMAND
UNITED STATES AIR FORCE

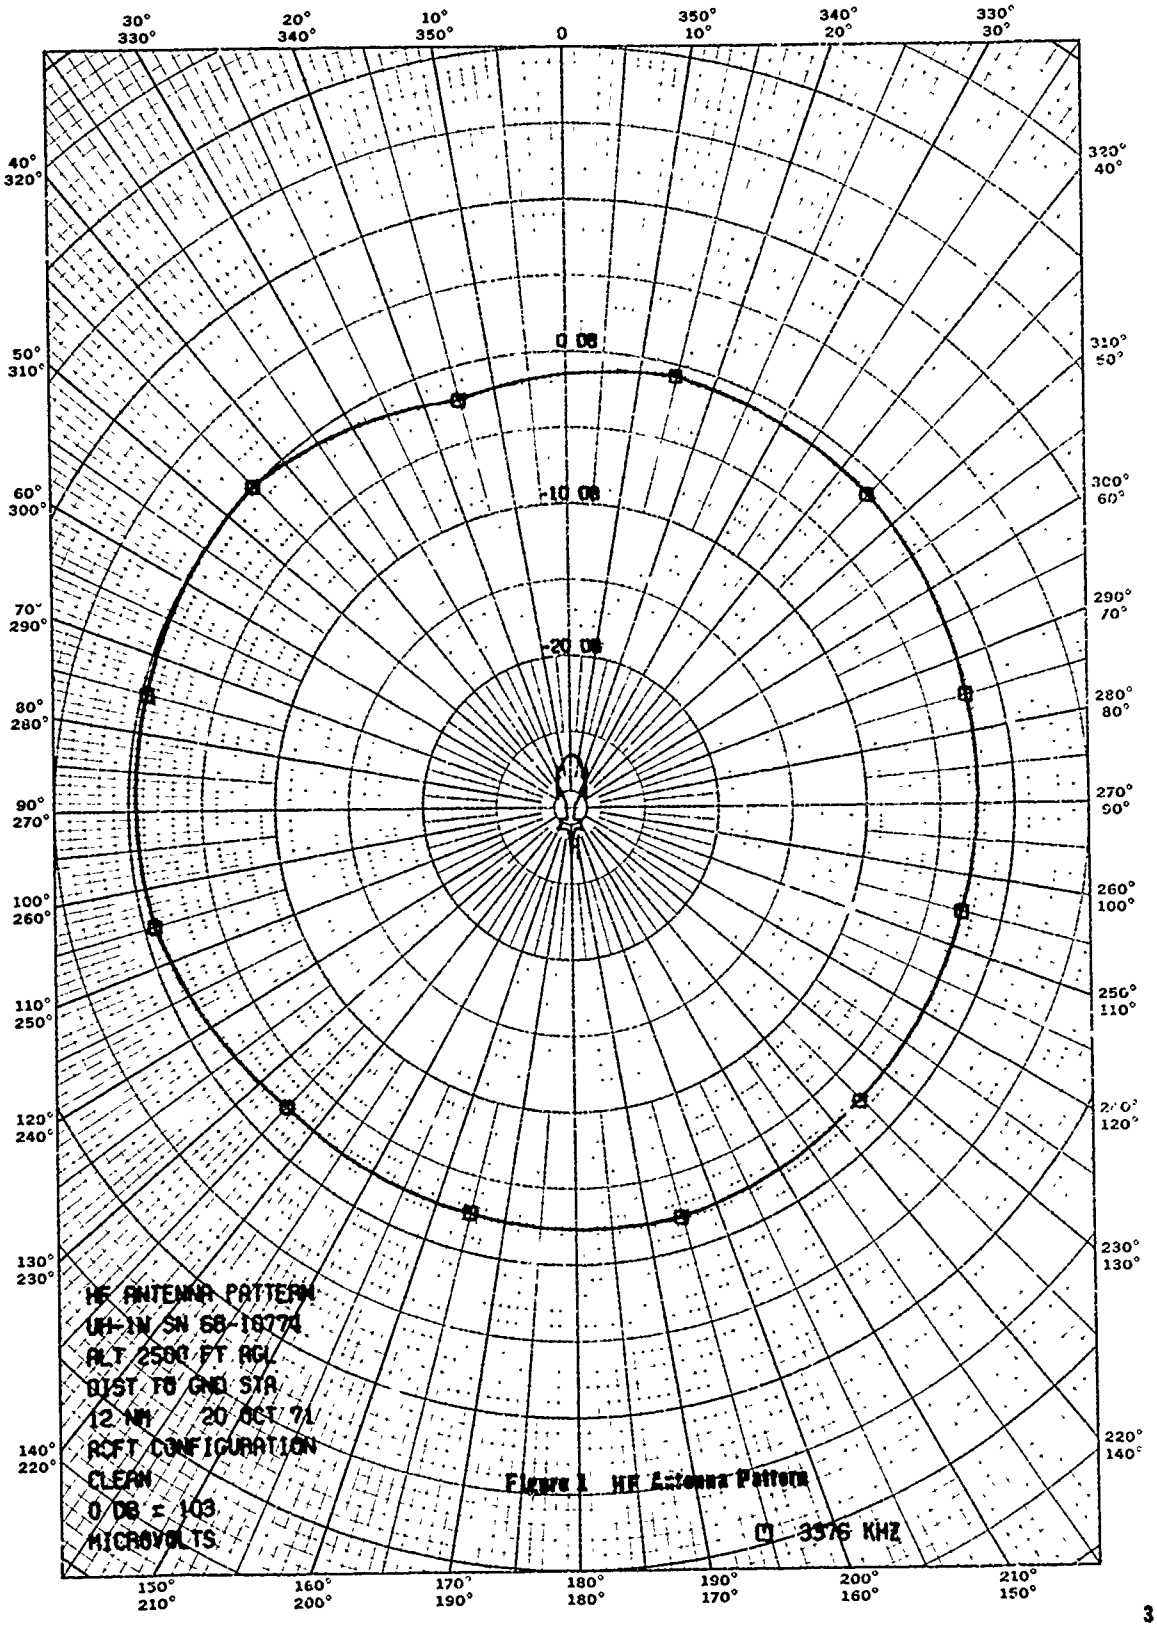
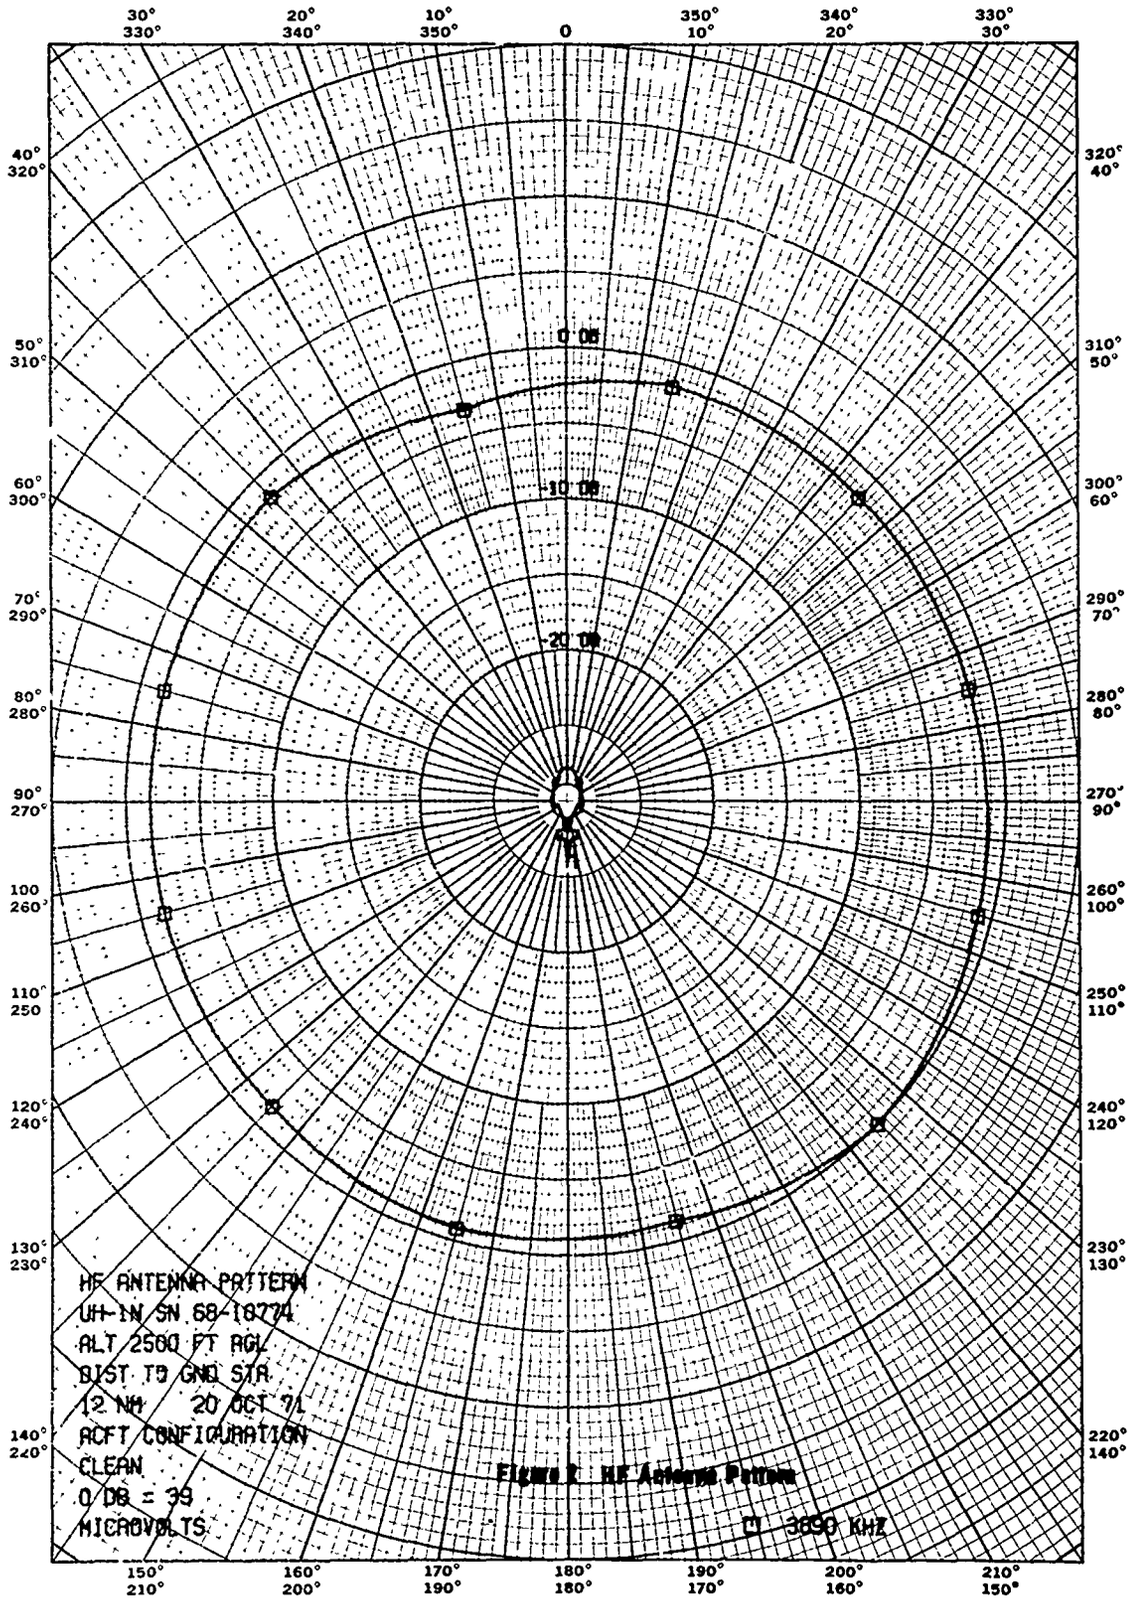
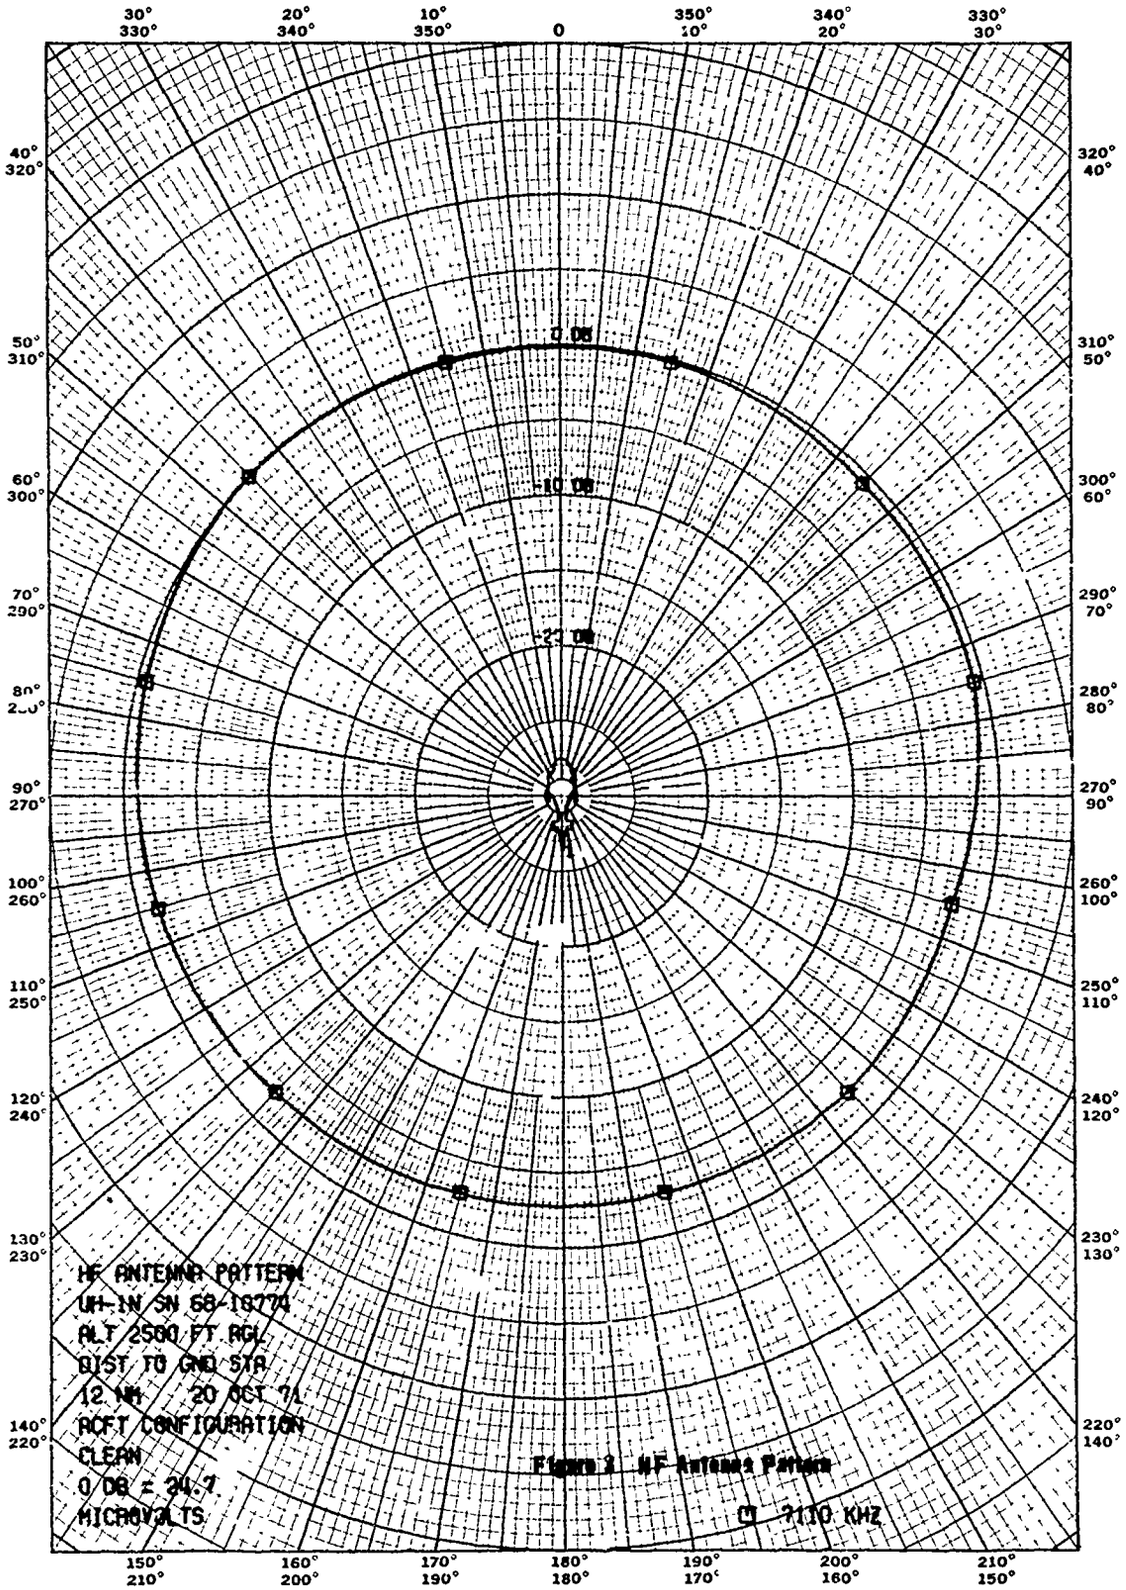
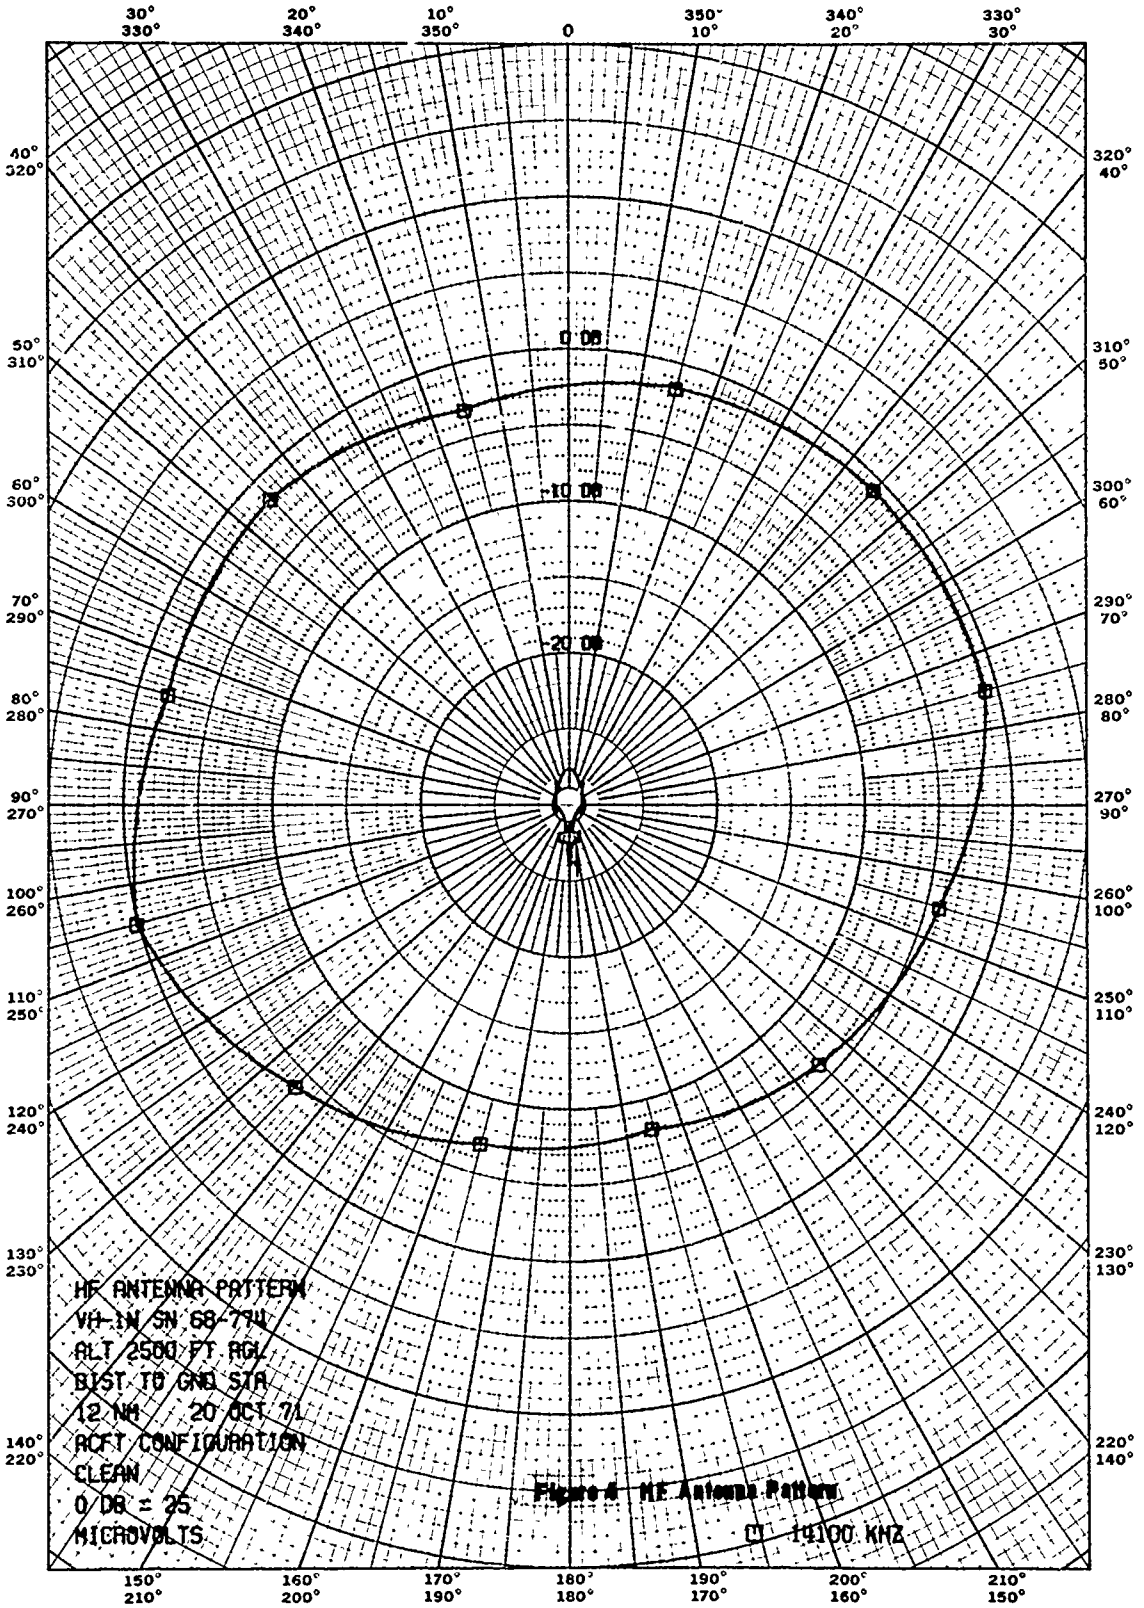
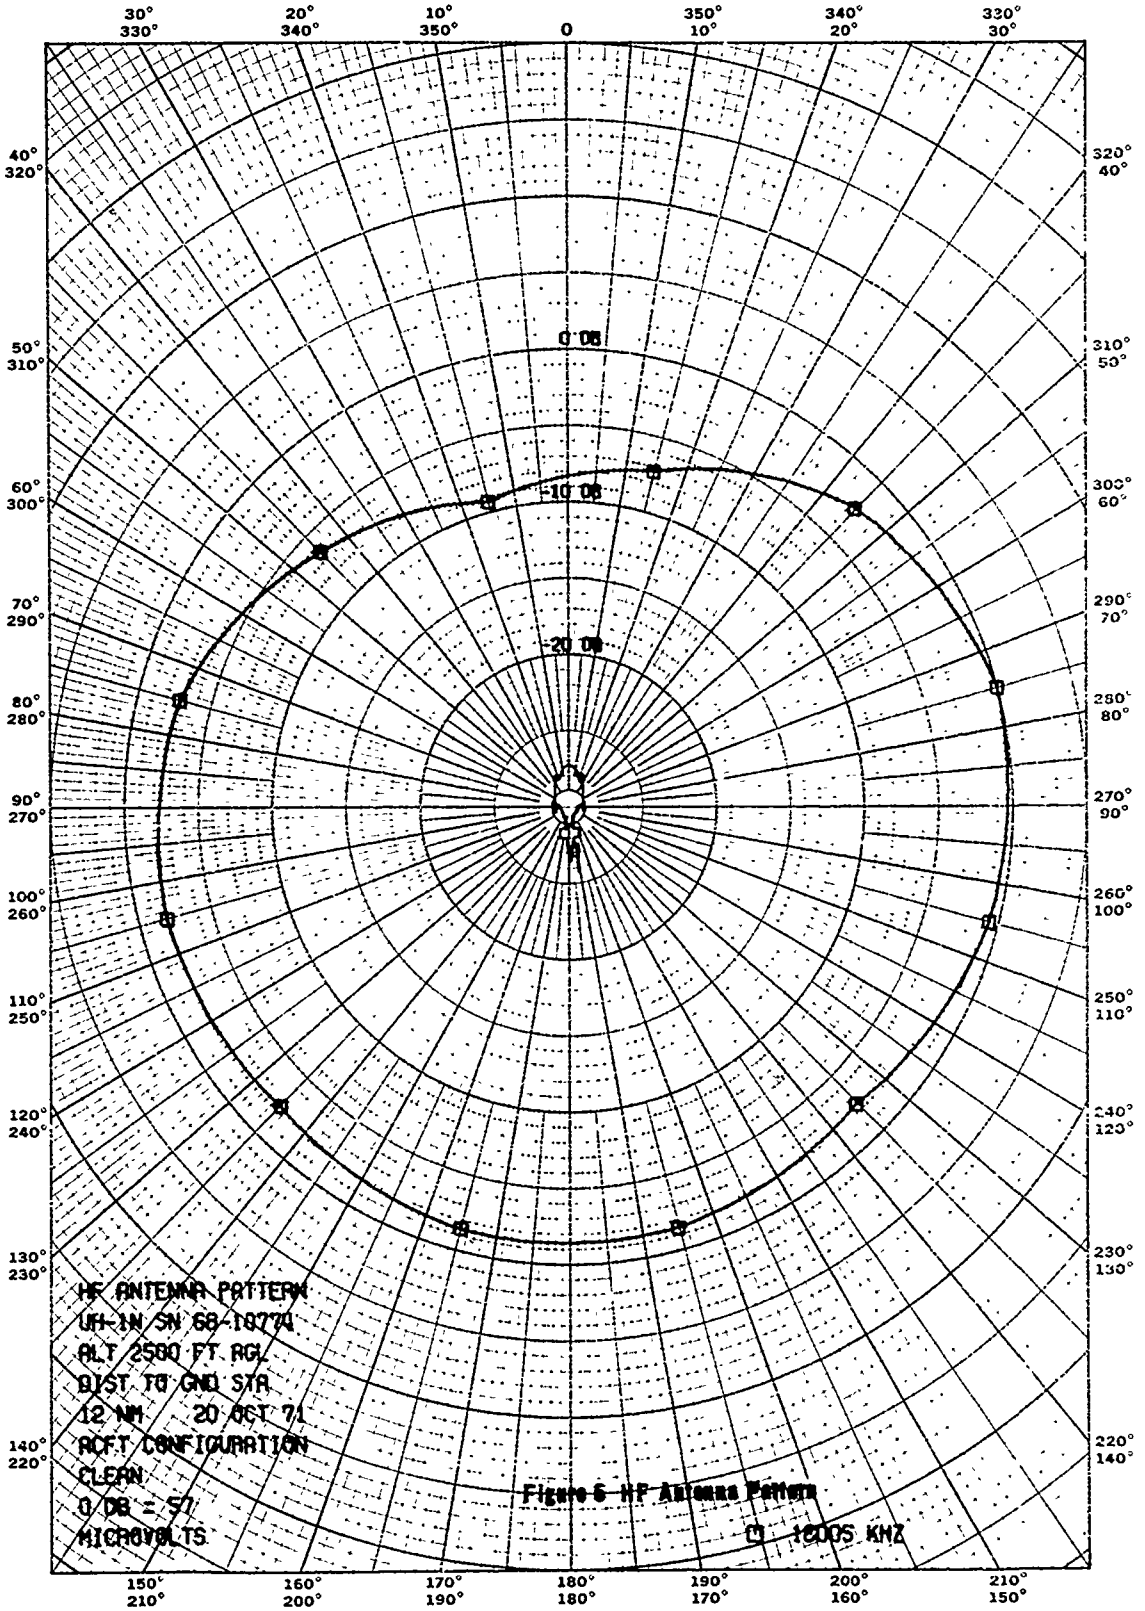
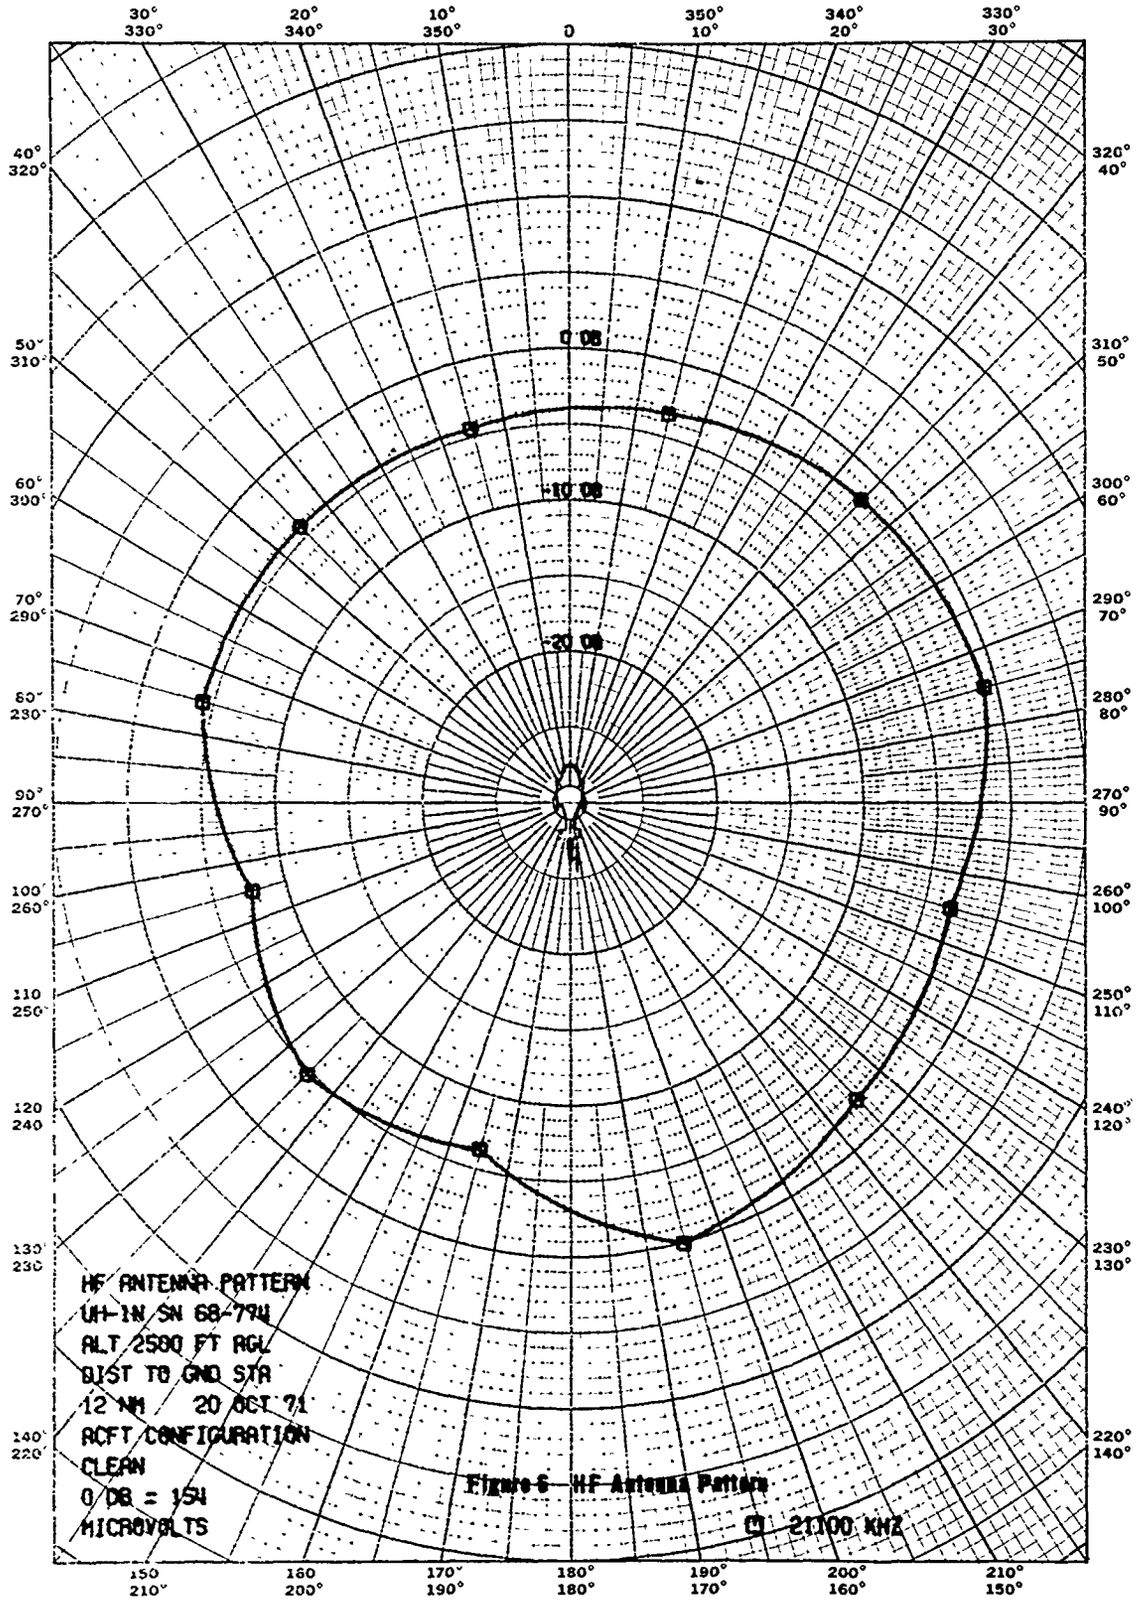
The signal strength recorded at the ground receiving station was a function of aircraft transmitter power, transmitter antenna directional characteristics, and the frequency selected. The transmitter power was assumed constant on any frequency; however, it varied when the test frequency changed. The efficiency of the transmitting antenna was a function of frequency and bearing of the ground receiving station from the aircraft. On any test, the frequency was constant and aircraft heading was the controlled test variable. The ground receiving station was not calibrated for field intensity and thus could give only relative signal strength information. For these reasons the maximum signal strength (microvolts) for each frequency was used as a zero db reference, and the patterns were plotted in db below this maximum level as shown in figures 1 through 6.

The antenna radiation patterns were essentially non-directional with pattern nulls of 2.67, 3.35 and 2.86 db, respectively, on frequencies 3,376, 3,890, and 7,110 kHz. More pronounced pattern nulls of 8.09, 9.40, and 7.75 db, respectively occurred on frequencies 14,100, 18,005 and 21,100 kHz. The bearing of antenna pattern nulls were different for each frequency tested. However, in all cases the signal strength improved at a bearing of 90 degrees from the pattern nulls.

The overall antenna patterns were acceptable on all frequencies tested. However, the nulls on the higher frequencies were significant and could cause communication difficulties (weak signal strength) if the station was on the same relative bearing from the aircraft as the pattern null.

1. If communication difficulties (weak signal strength) are encountered, changing the aircraft heading by 90 degrees may improve the transmitter and receiver signal strength. This information should be included in T.O. 1H-1(U)N-1, the UH-1N helicopter Flight Manual.

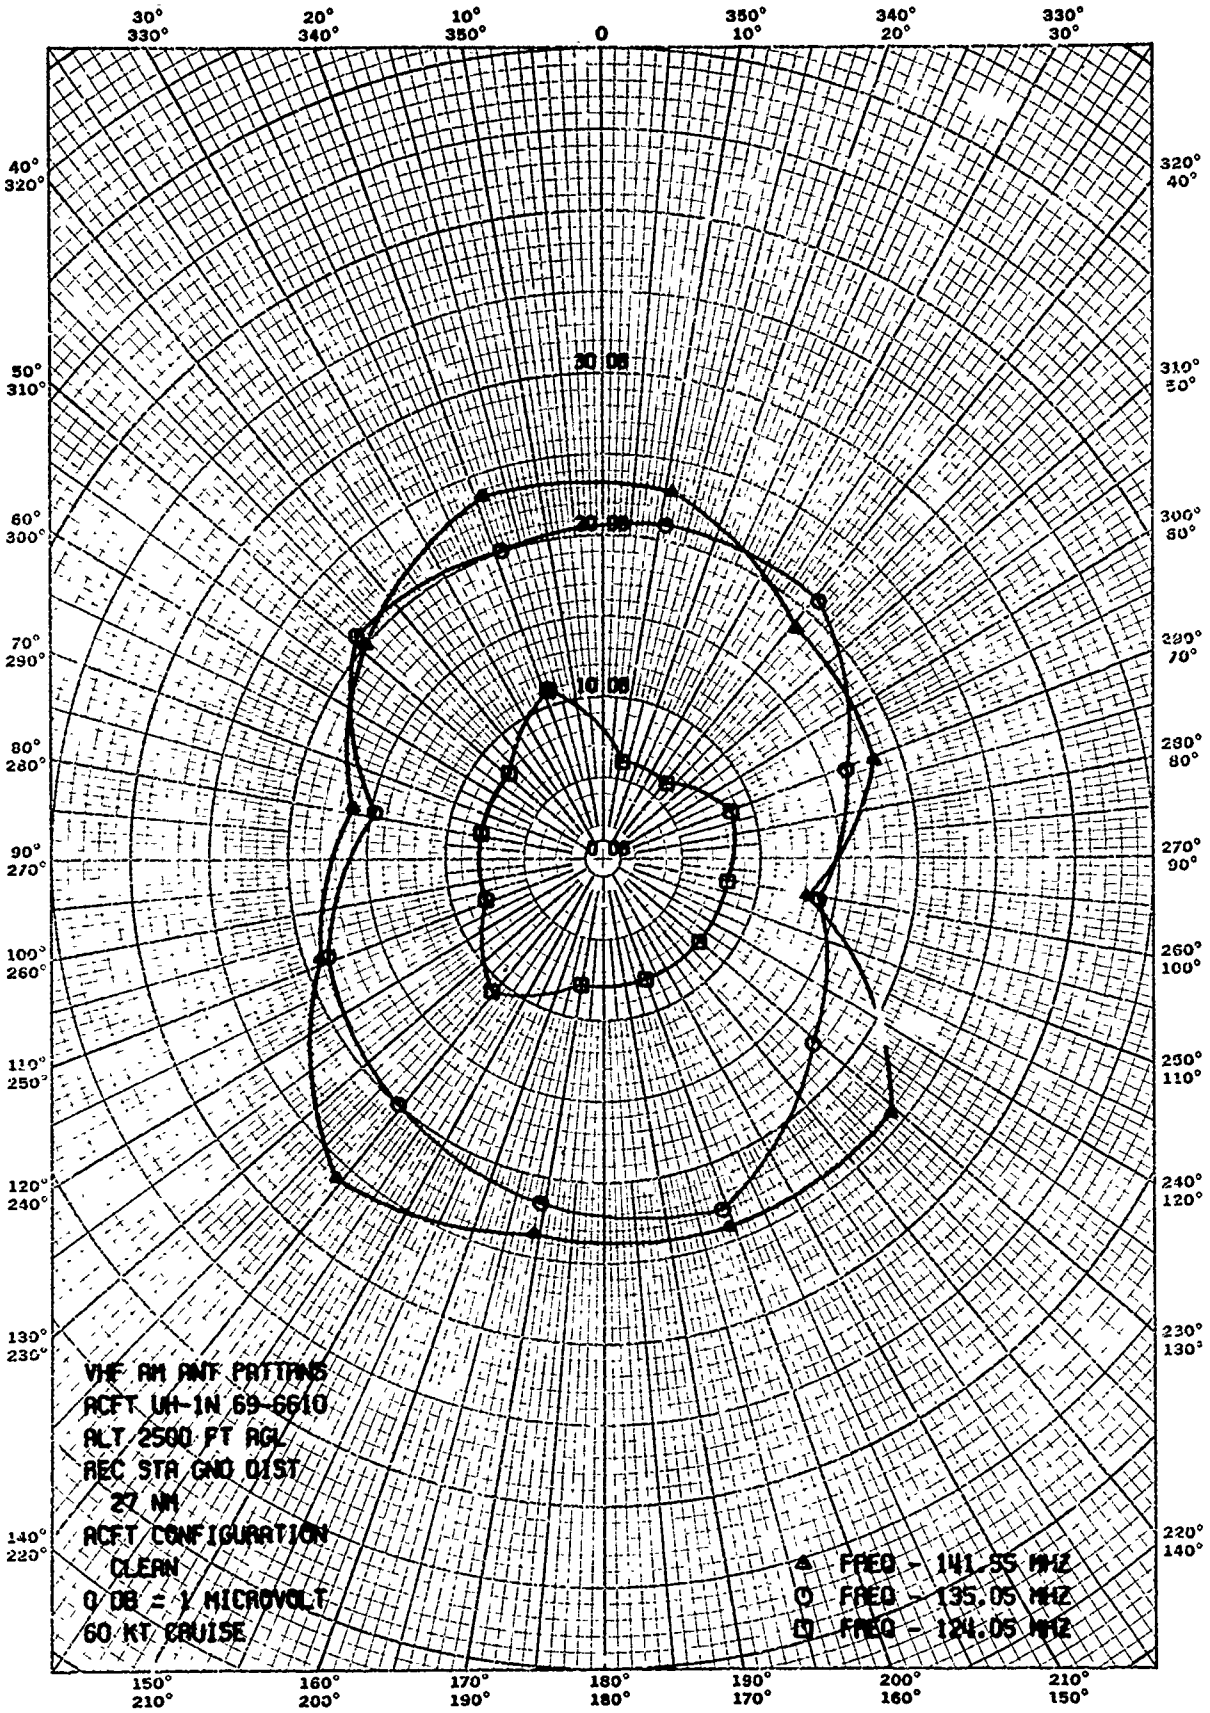
Figure 7 Post-ECP VHF-AM Antenna Patterns

Specification SCL-T-0045B required that no more than one half of the VHF-AM pattern nulls may be more than 6 decibels below the maximum signal strength. Figures 7 and 8 show the antenna radiation patterns obtained. It was noted that at the 2-NM distance the nulls were considerably less pronounced and coverage was excellent in all quadrants.

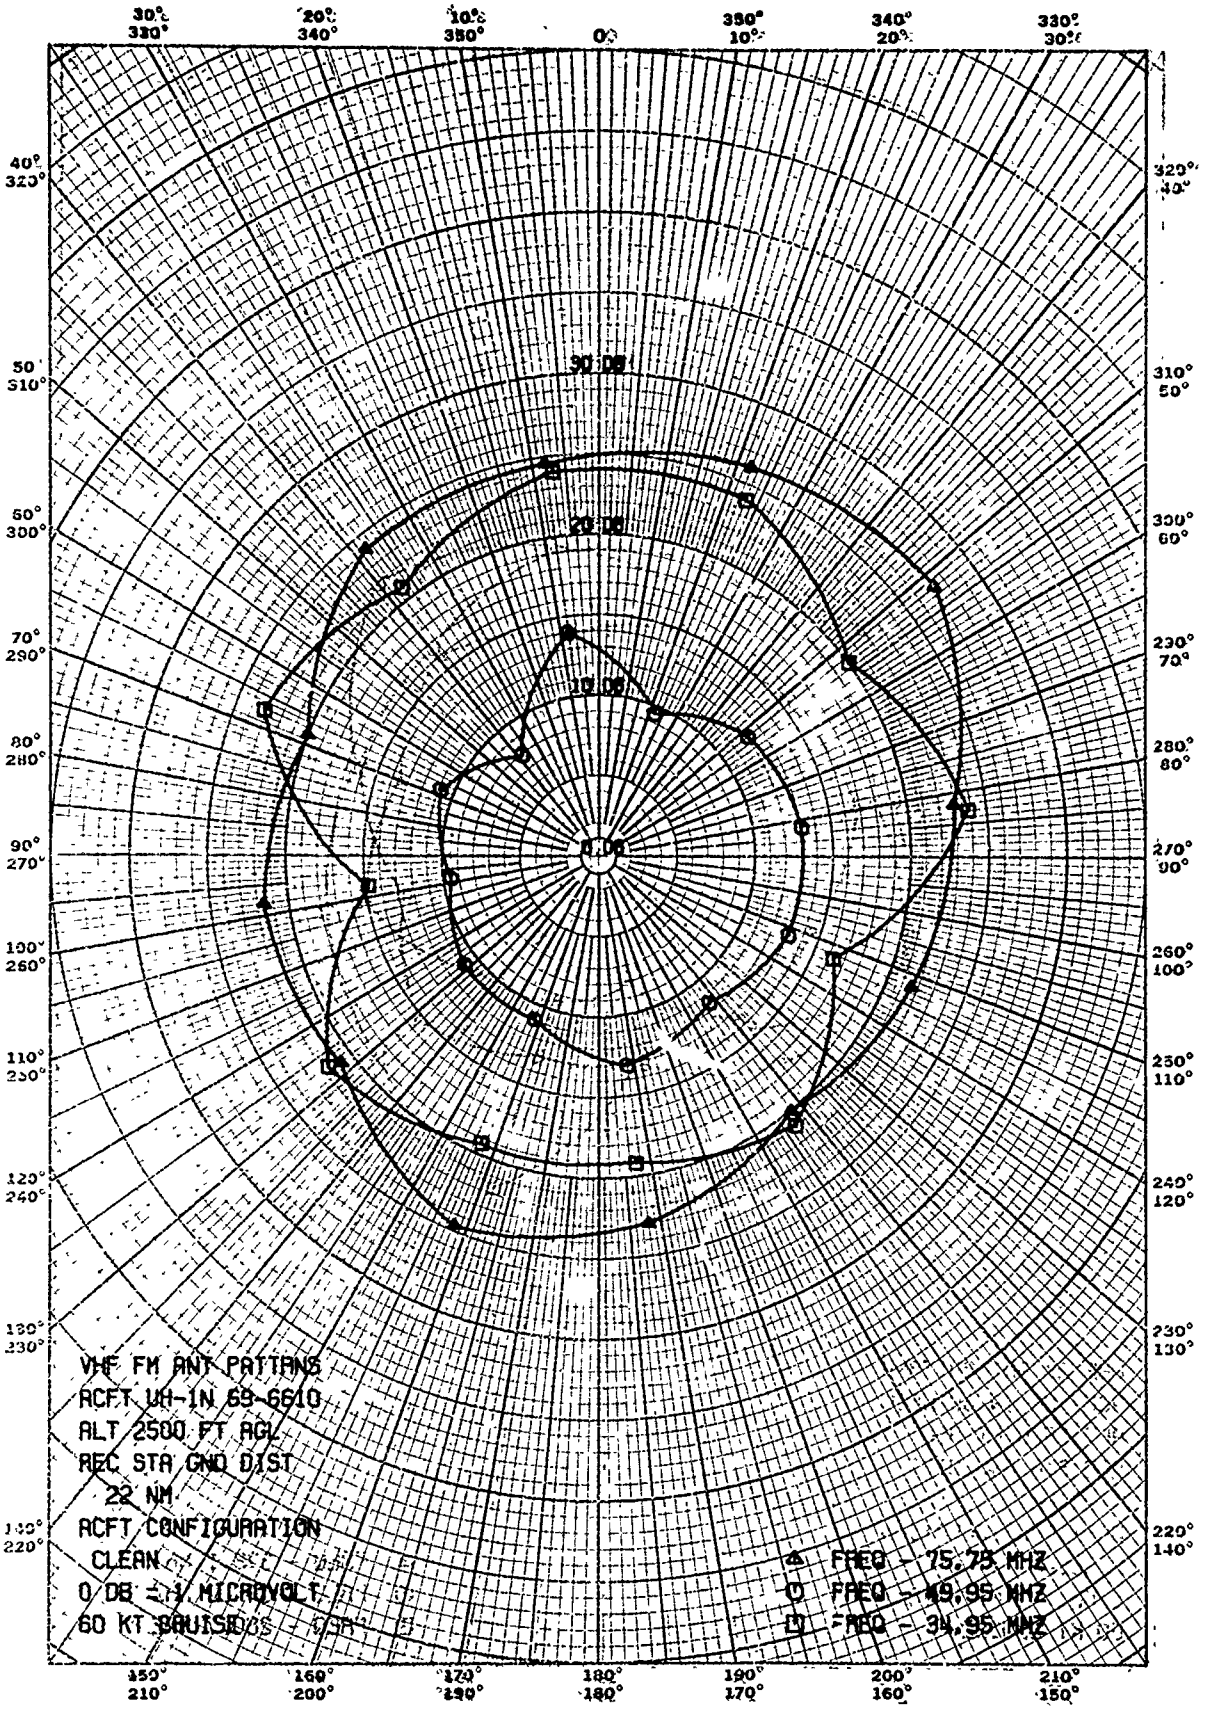
Figure 10. VHF-FM Antenna Patterns

Figure 10 shows the antenna radiation pattern obtained at 22 NM and 2,500 feet AGL for 34.95 mHz, 49.95 mHz, and 75.75 mHz. The radiation patterns met specification criteria and were acceptable.

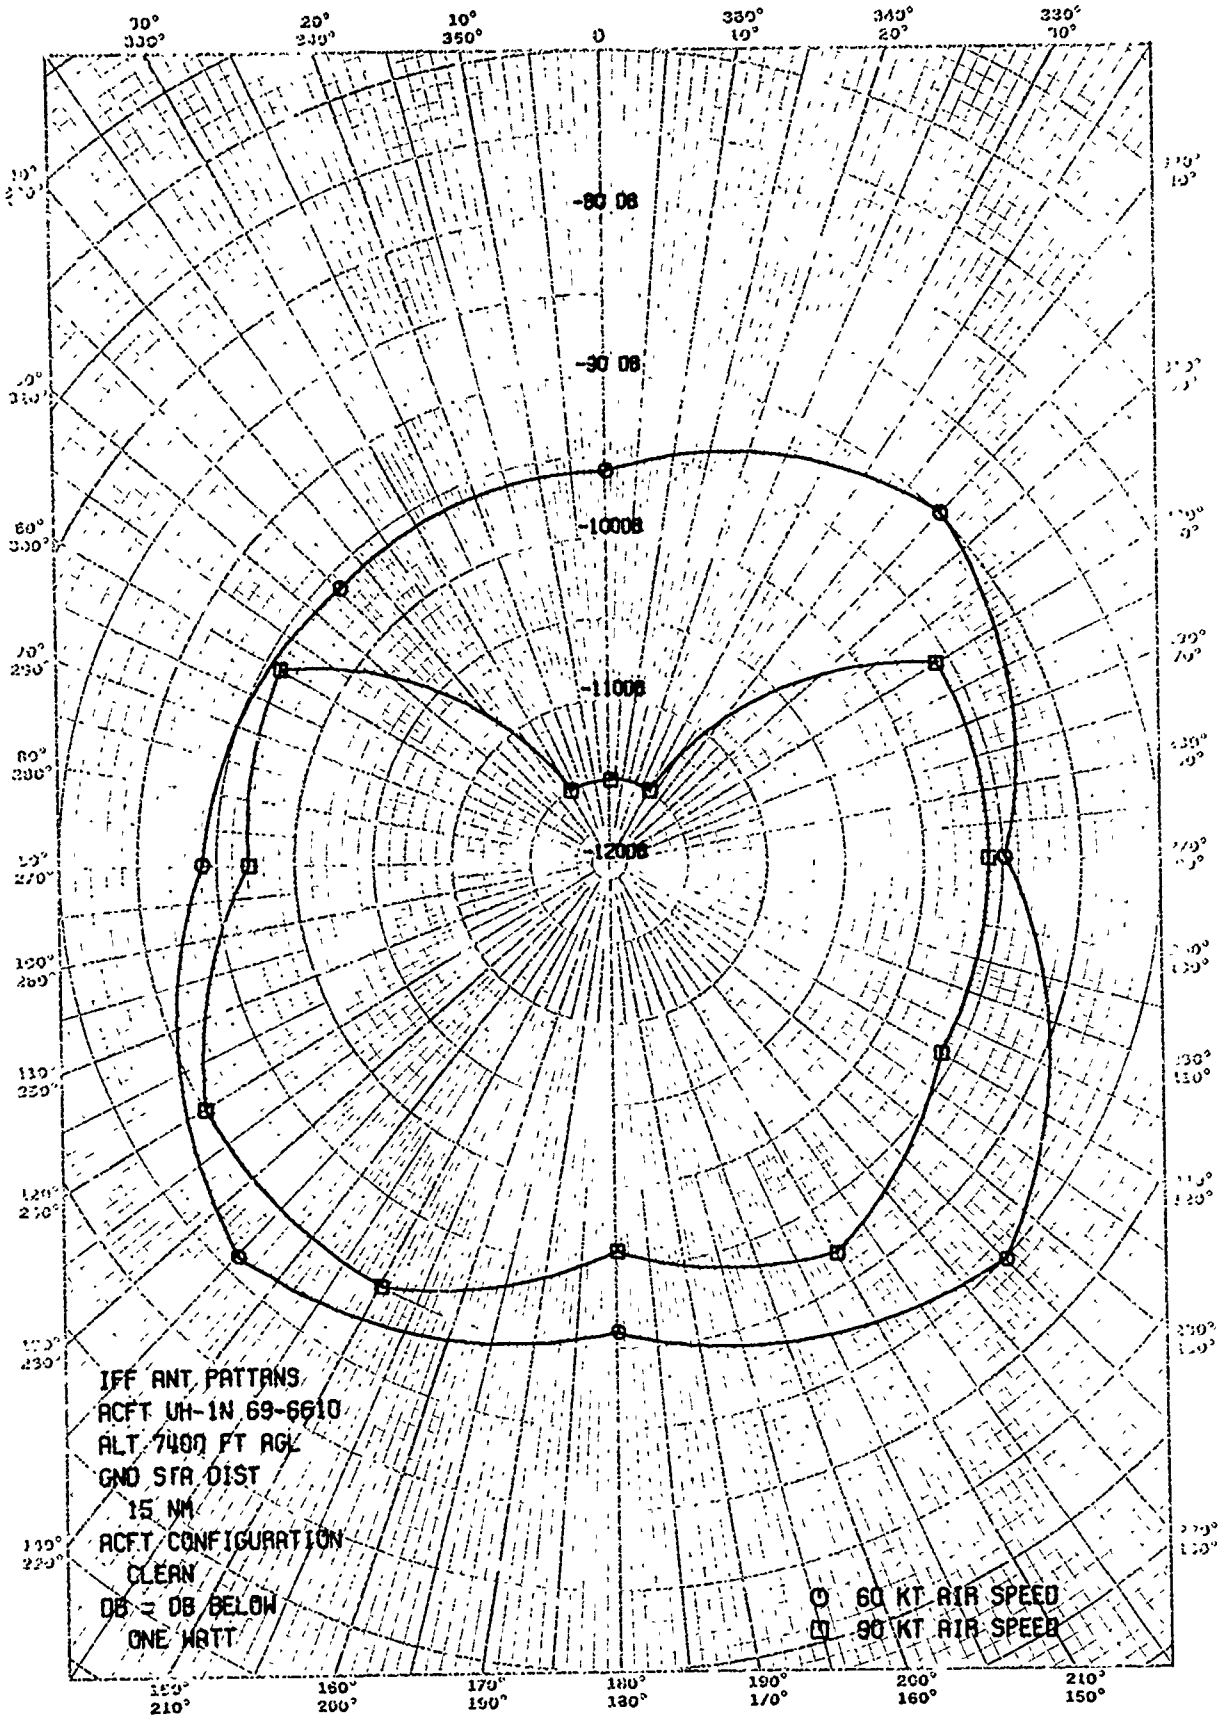
Figure 21 IFF Antenna Patterns

The radiation pattern of the AT-741A Antenna was measured by flying cloverleaf patterns over a point 15 NM from the PACF, at 10,000 feet pressure altitude. Radar tracking was used to vector the aircraft over the reference point on each heading. The relative signal strength was measured while interrogating the transponder in mode 2. The UH-1N aircraft used one IFF antenna located on the bottom of the aircraft near the rear of the fuselage. The antenna radiation pattern obtained at 90 KIAS (figure 21) was unacceptable due to the deep null off the nose of the aircraft. This null was not observed at 60 KIAS, when the nose-down attitude of the aircraft decreased approximately 4 degrees. An additional top-mounted fuselage antenna with an antenna switching unit should be installed to improve the radiation pattern. (R 31)

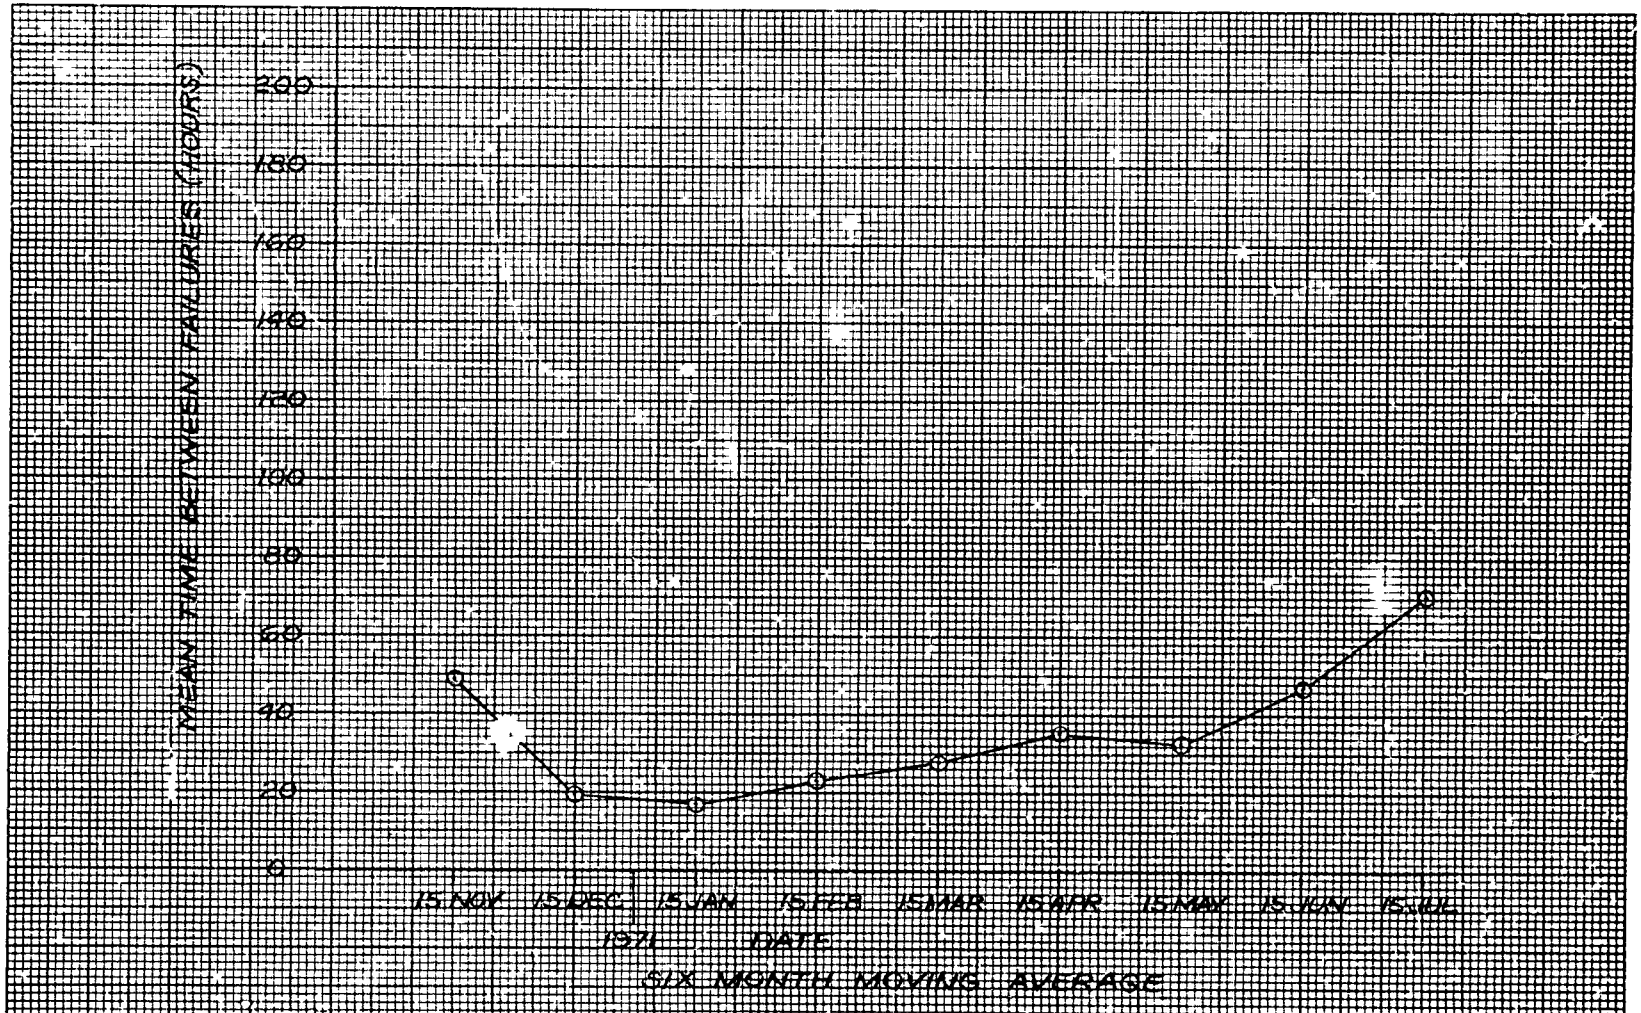
FIGURE 22. MEAN TIME BETWEEN FAILURES - TURBOSHAFT POWERPLANT

The trends in measured subsystem MTBF's for several work unit code (WUC) groups are shown in figures 22 and 23. The data presented in these graphs are averages for the previous 6 months, except for the first 4 months; that is, the MTBF shown for 15 December 1970 includes all data from 16 October 1970 through 15 December 1970. WUC groups not shown had an insufficient number of failures to develop any type of trend. Figure 24 presents the trend in mean time between subsystem failures for the overall UH-1N aircraft.

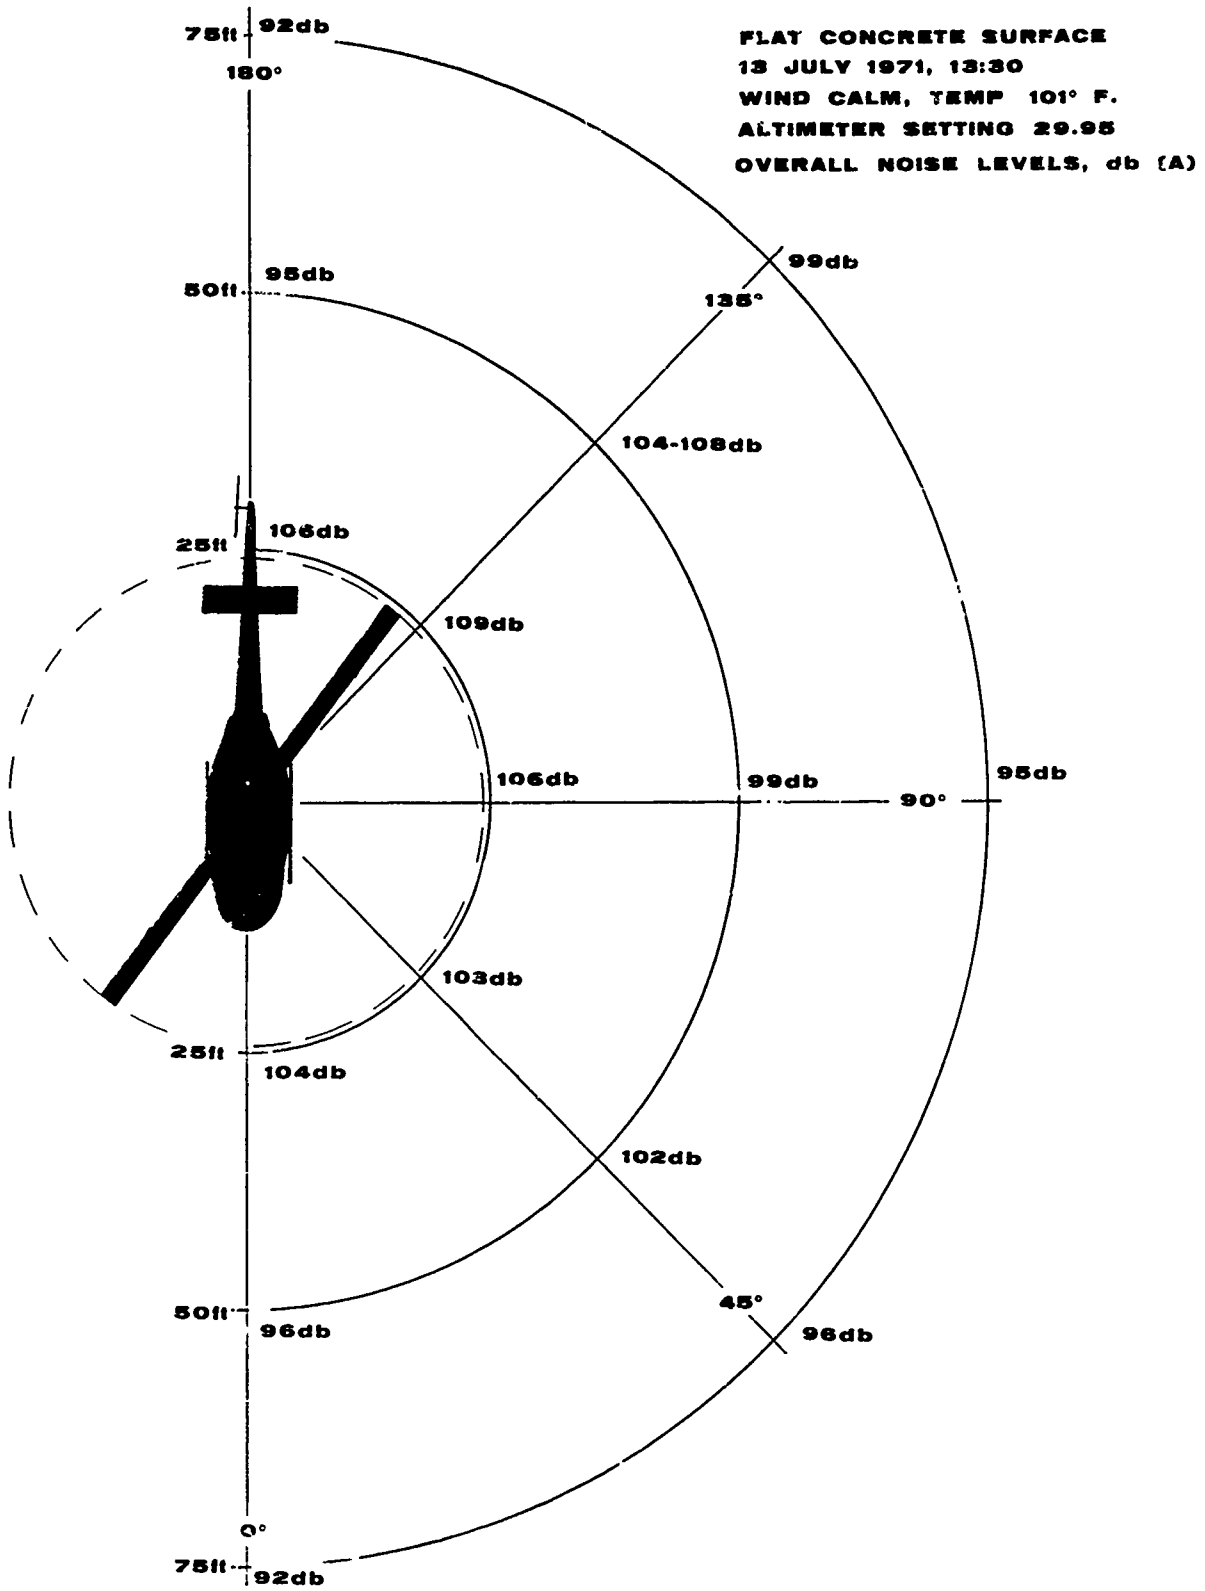
Figure 38 External Aircraft Noise Levels, Low Hover

Figure 38 illustrates overall noise levels in the area surrounding the aircraft during low level hover operations. The measurements were made with a General Radio Model 1551C overall noise level meter using the A-weighted scale. The results reflect the sound environment to which ground personnel are exposed during approach, departure, and hover conditions such as hoist operations.
