UH-1N

CATEGORY II AIRFRAME AND SUBSYSTEMS EVALUATION

TECHNICAL REPORT No. 71-37

AIR FORCE FLIGHT TEST CENTER
EDWARDS AIR FORCE BASE, CALIFORNIA
AIR FORCE SYSTEMS COMMAND
UNITED STATES AIR FORCE

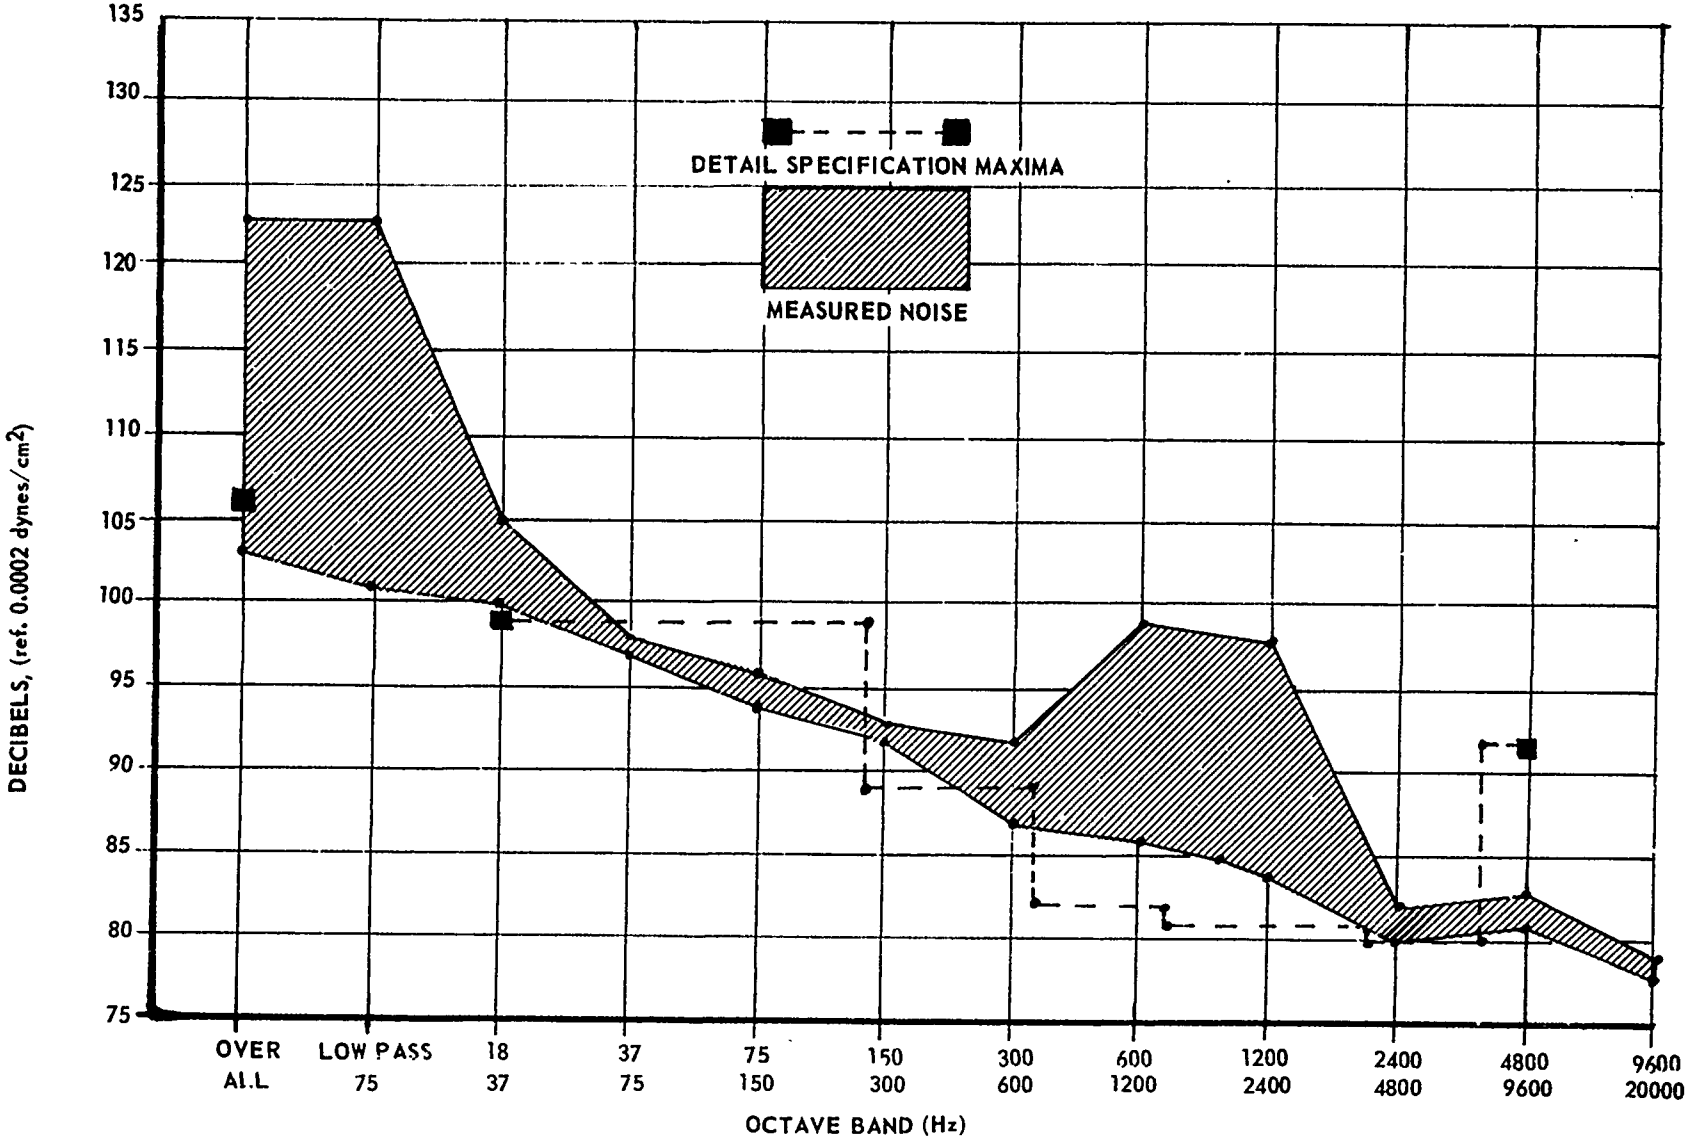
Figure 39 Comparison of Measured and Specified Noise Levels, Hover Operations

Figures 39 and 40 were prepared from the data in table XXXII to illustrate the internal noise levels compared with those in reference 27. Although internal noise levels exceeded those specified, the condition was not significant with respect to aircraft mission requirements and was not considered serious enough to warrant attempts to reduce noise levels in the aircraft. Noise levels in the 75 to 9,600 Hz frequency bands indicated that for all operations ground and flight crews should use hearing protectors in the form of sound suppressing flight helmets, earplugs, or ear muffs. The noise environment of the UH-1N was generally comparable to that of other aircraft and standard hearing conservation practices currently in use provided adequate personnel protection. (R 54)

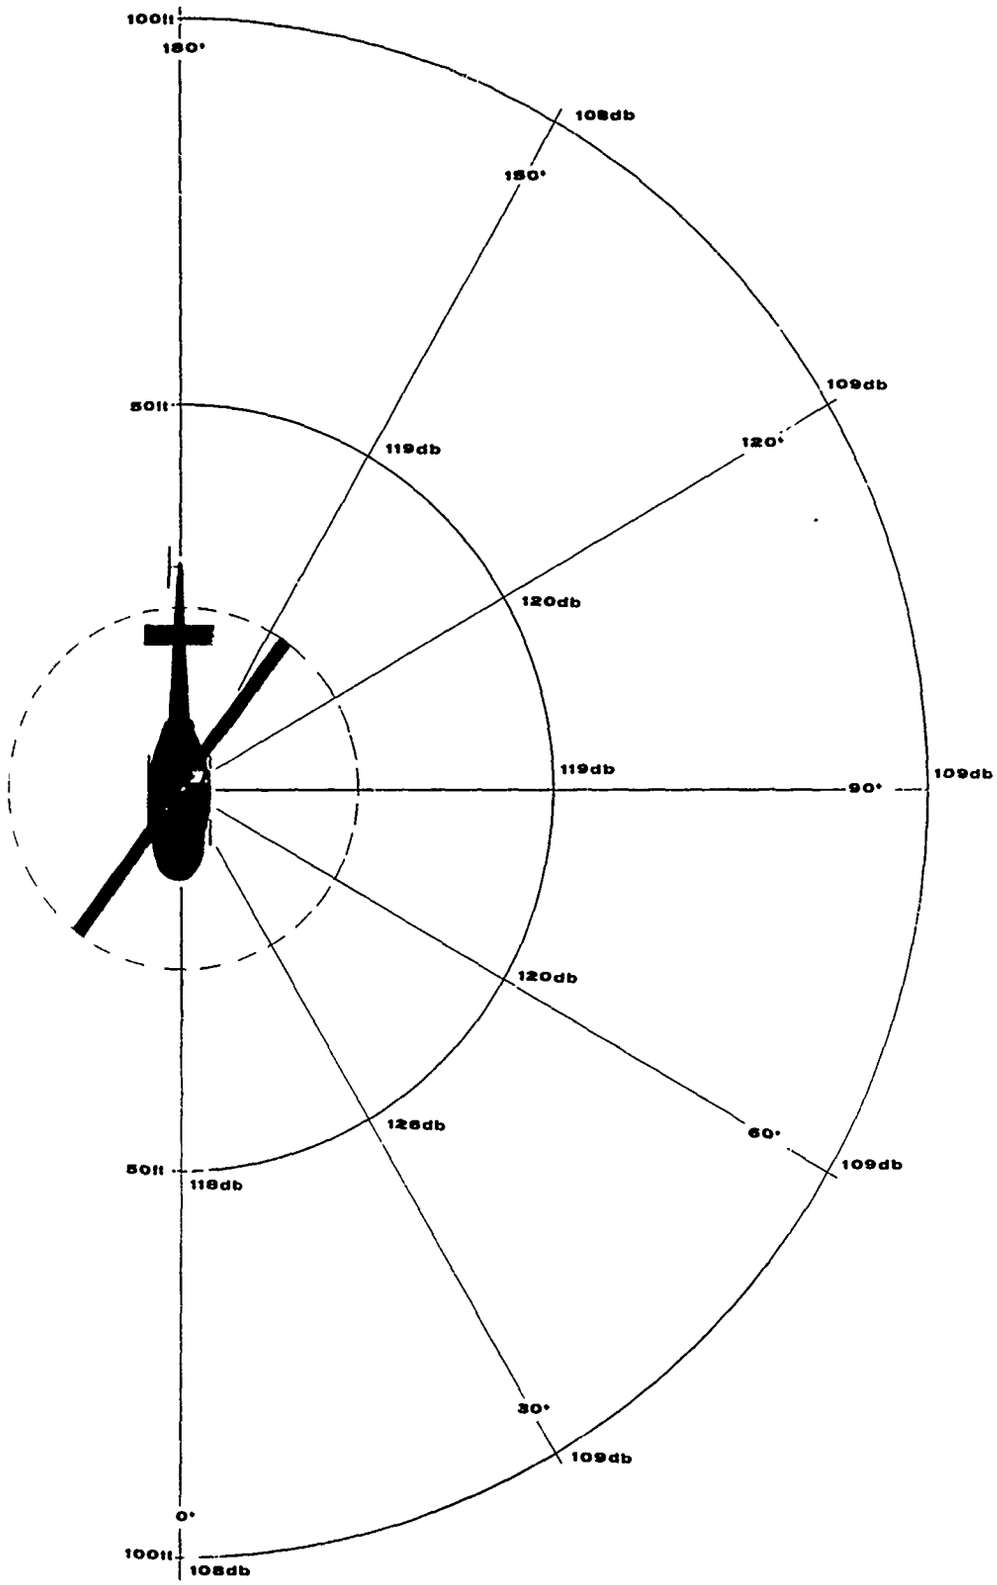
Figure 41 Loudspeaker Acoustical Energy Radiation Pattern

Figure 41 illustrates the relative power radiation pattern. The measurements were made at ground idle with a background noise level near the speaker of 115 decibels. The power setting employed was that required to produce 135 decibel signal and noise at the speaker. The sound radiation pattern close to the aircraft was most intense in the forward diagonal quadrant; however, at 100 feet no differences were observed. Inflight measurements of this type were not performed.
