FTC-TR-72-39

UH-1N SALT WATER SPRAY INGESTION TESTS (CATEGORY II FOLLOW-ON TEST PROGRAM)

TECHNICAL REPORT No. 72-39

OCTOBER 1972

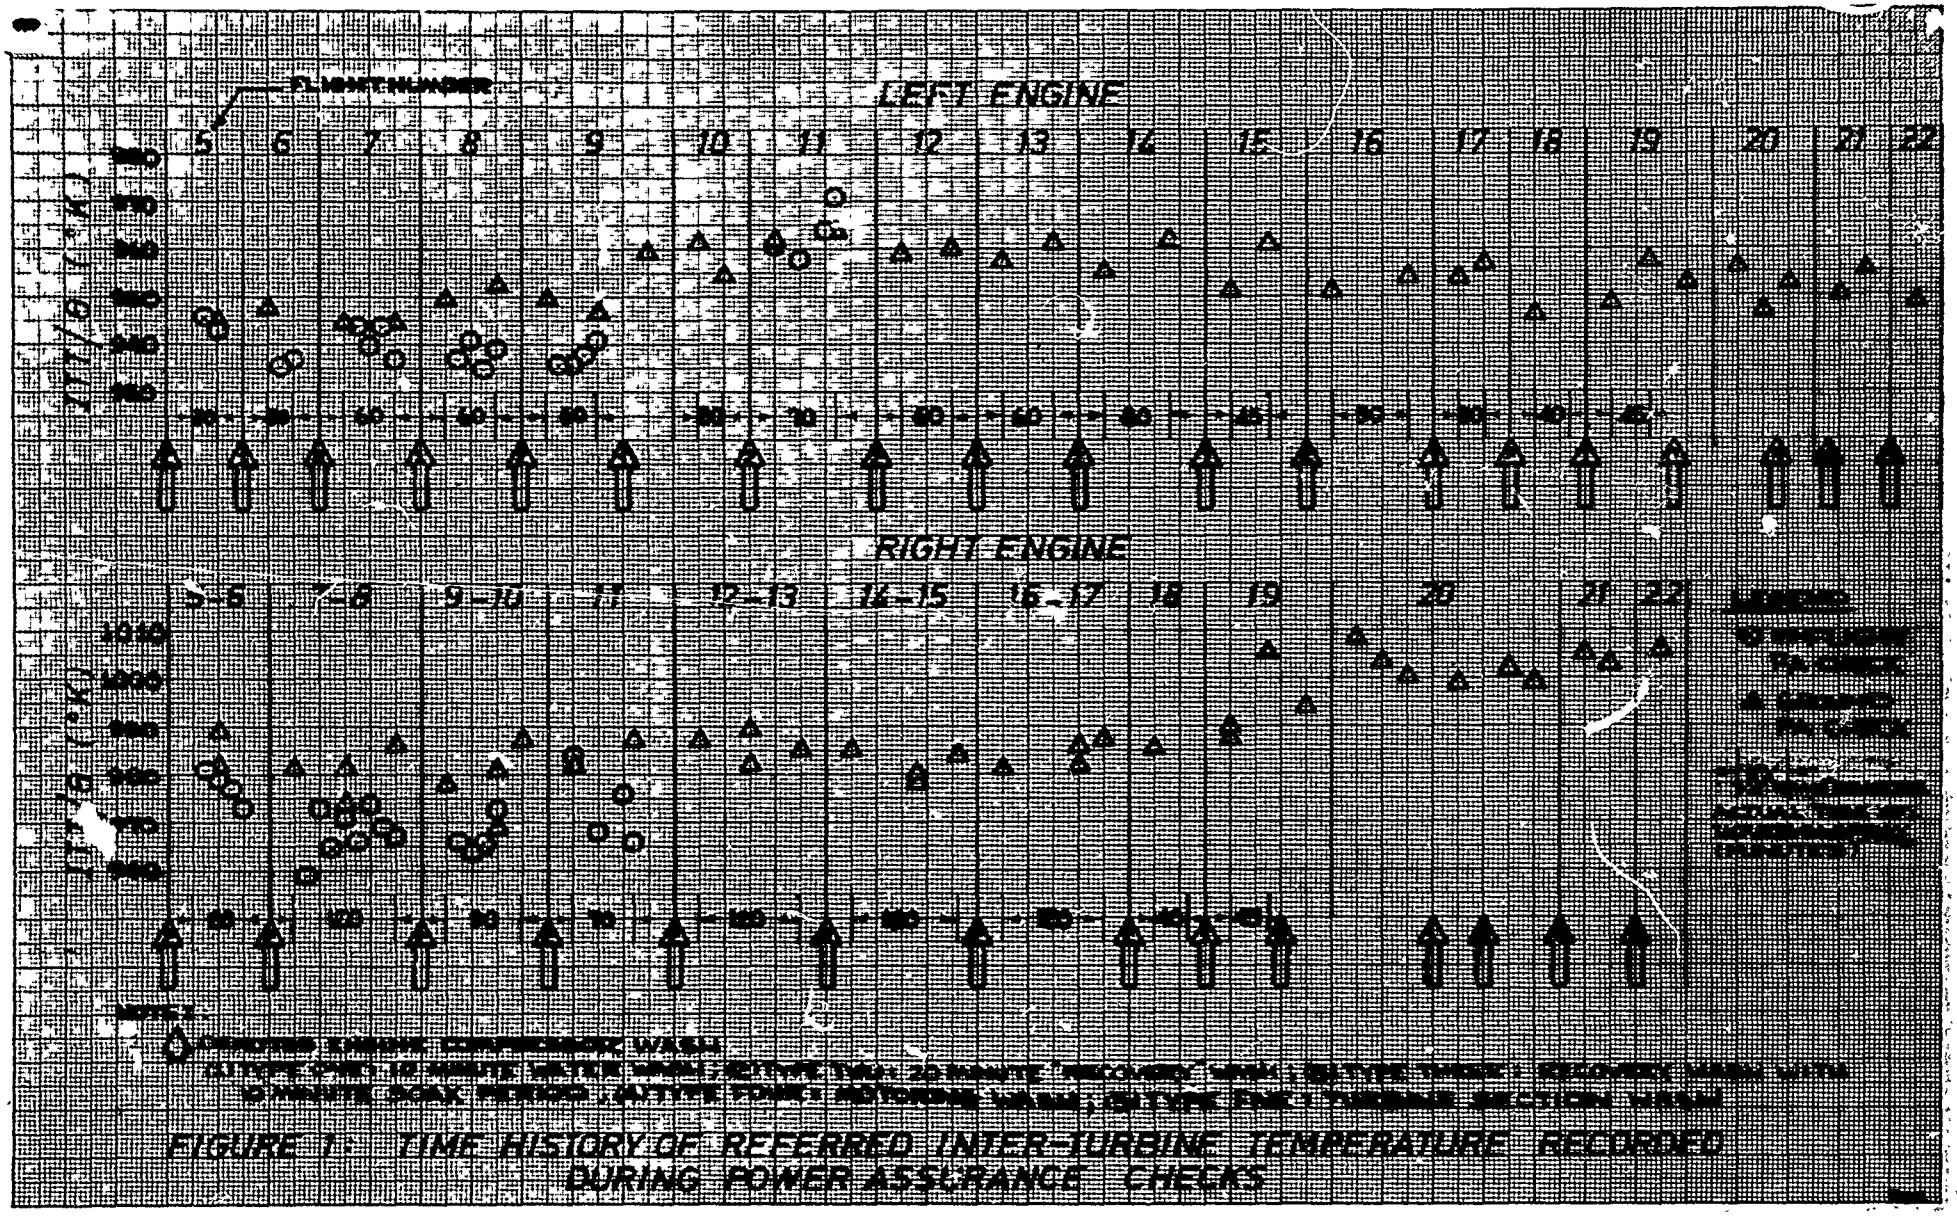
FIGURE 1: TIME HISTORY OF REFERRED INTER-TURBINE TEMPERATURE RECORDED DURING POWER ASSURANCE CHECKS

Figure 1 presents a time history of the performance parameter, ITT, for both engines during power assurance checks. Data from flights 1 through 4 have been omitted for both engines because these flights were of short duration and were troubled with a malfunctioning left engine ITT limiter.

Power assurance checks performed on both engines on the ground generally produced 10 to 20 degrees higher indicated ITT than those performed in flight. This made it impossible to compare the initial ground check with any of the subsequent inflight power assurance checks. A comparison was possible, however, between the pre-hover and the post-hover ground power assurance checks and between successive inflight checks.

Inflight power assurance checks did not correlate with the inflight topping power checks. During flight 7, the left engine lost approximately 1 percent torque during successive topping checks while the ITT decreased approximately 7 degrees C during power assurance checks. During flight 9, the left engine ITT increased 5 degrees C while topping checks showed almost a 2 percent loss in topping power torque. Flight 11 was flown almost entirely in wind conditions insufficient to cause salt water spray impingement on the helicopter. During this flight the left engine showed no torque degradation, but the ITT increased 10 degrees C during successive power assurance checks.

A similar lack of correlation existed on the right engine. During flights 7 and 8, the right engine exhibited no power loss for the first 1 1/4 hours, then showed a decrease in torque of almost one percent after 1 1/2 hours and almost 2 percent after 1 3/4 hours. The inflight power assurance checks did not reflect the same marked change in ITT during the second hour of the hover, but showed an increasing/decreasing variation within a 10-degree C band for almost the entire flight and a consistent decreasing trend during the last 30 minutes of the hover. During flight 11, the right engine also showed no loss of topping torque; however, the right engine ITT decreased almost 20 degrees C during power assurance checks.

For these reasons, the practice of performing inflight power assurance checks was abandoned. Power assurance checks performed on the ground appear to be more reliable. Figure 1 shows the post-hover power assurance check generally yielded a higher value of ITT than the pre-hover check. The increase is, however, generally small, being on the order of 5 to 10 degrees C.

Successive power assurance checks were not adequate indicators of engine power degradation resulting from the ingestion of salt spray. Power assurance checks should not be used as a basis for engine rejection due to power deterioration below minimum acceptable values. **(R 1)**[1]

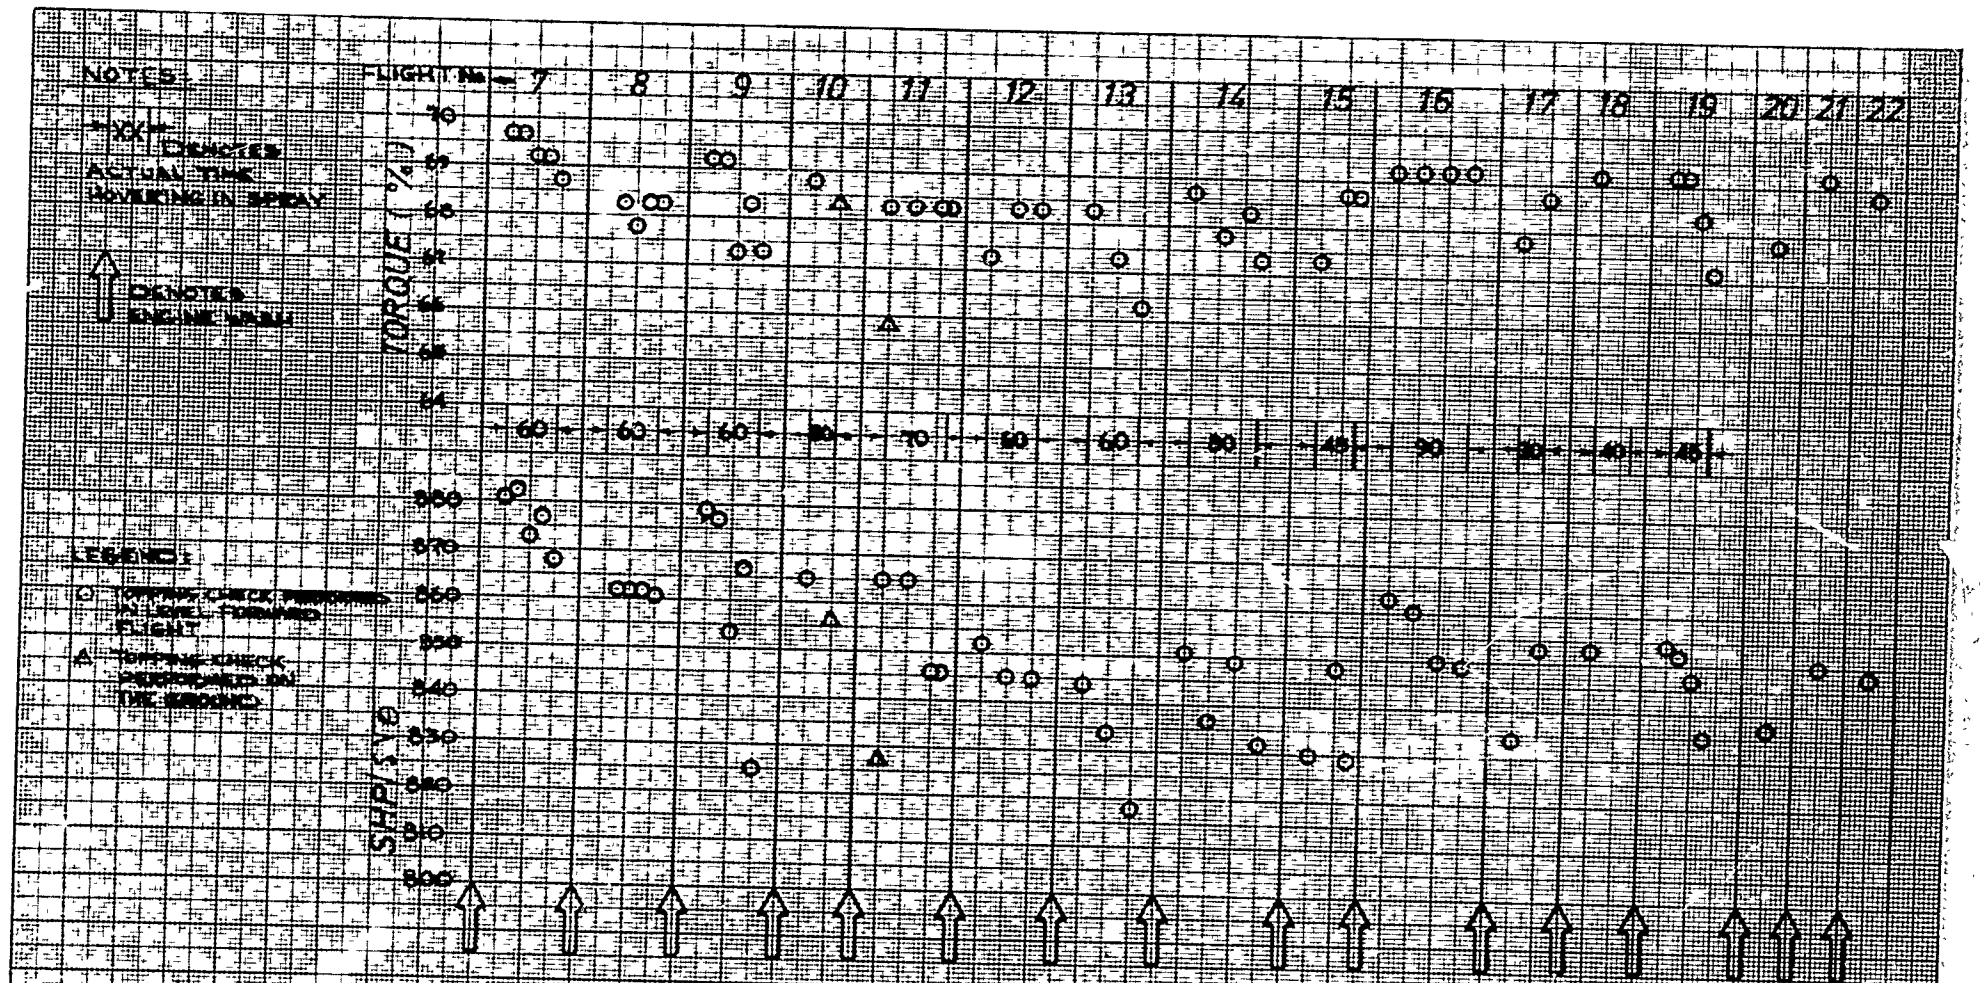
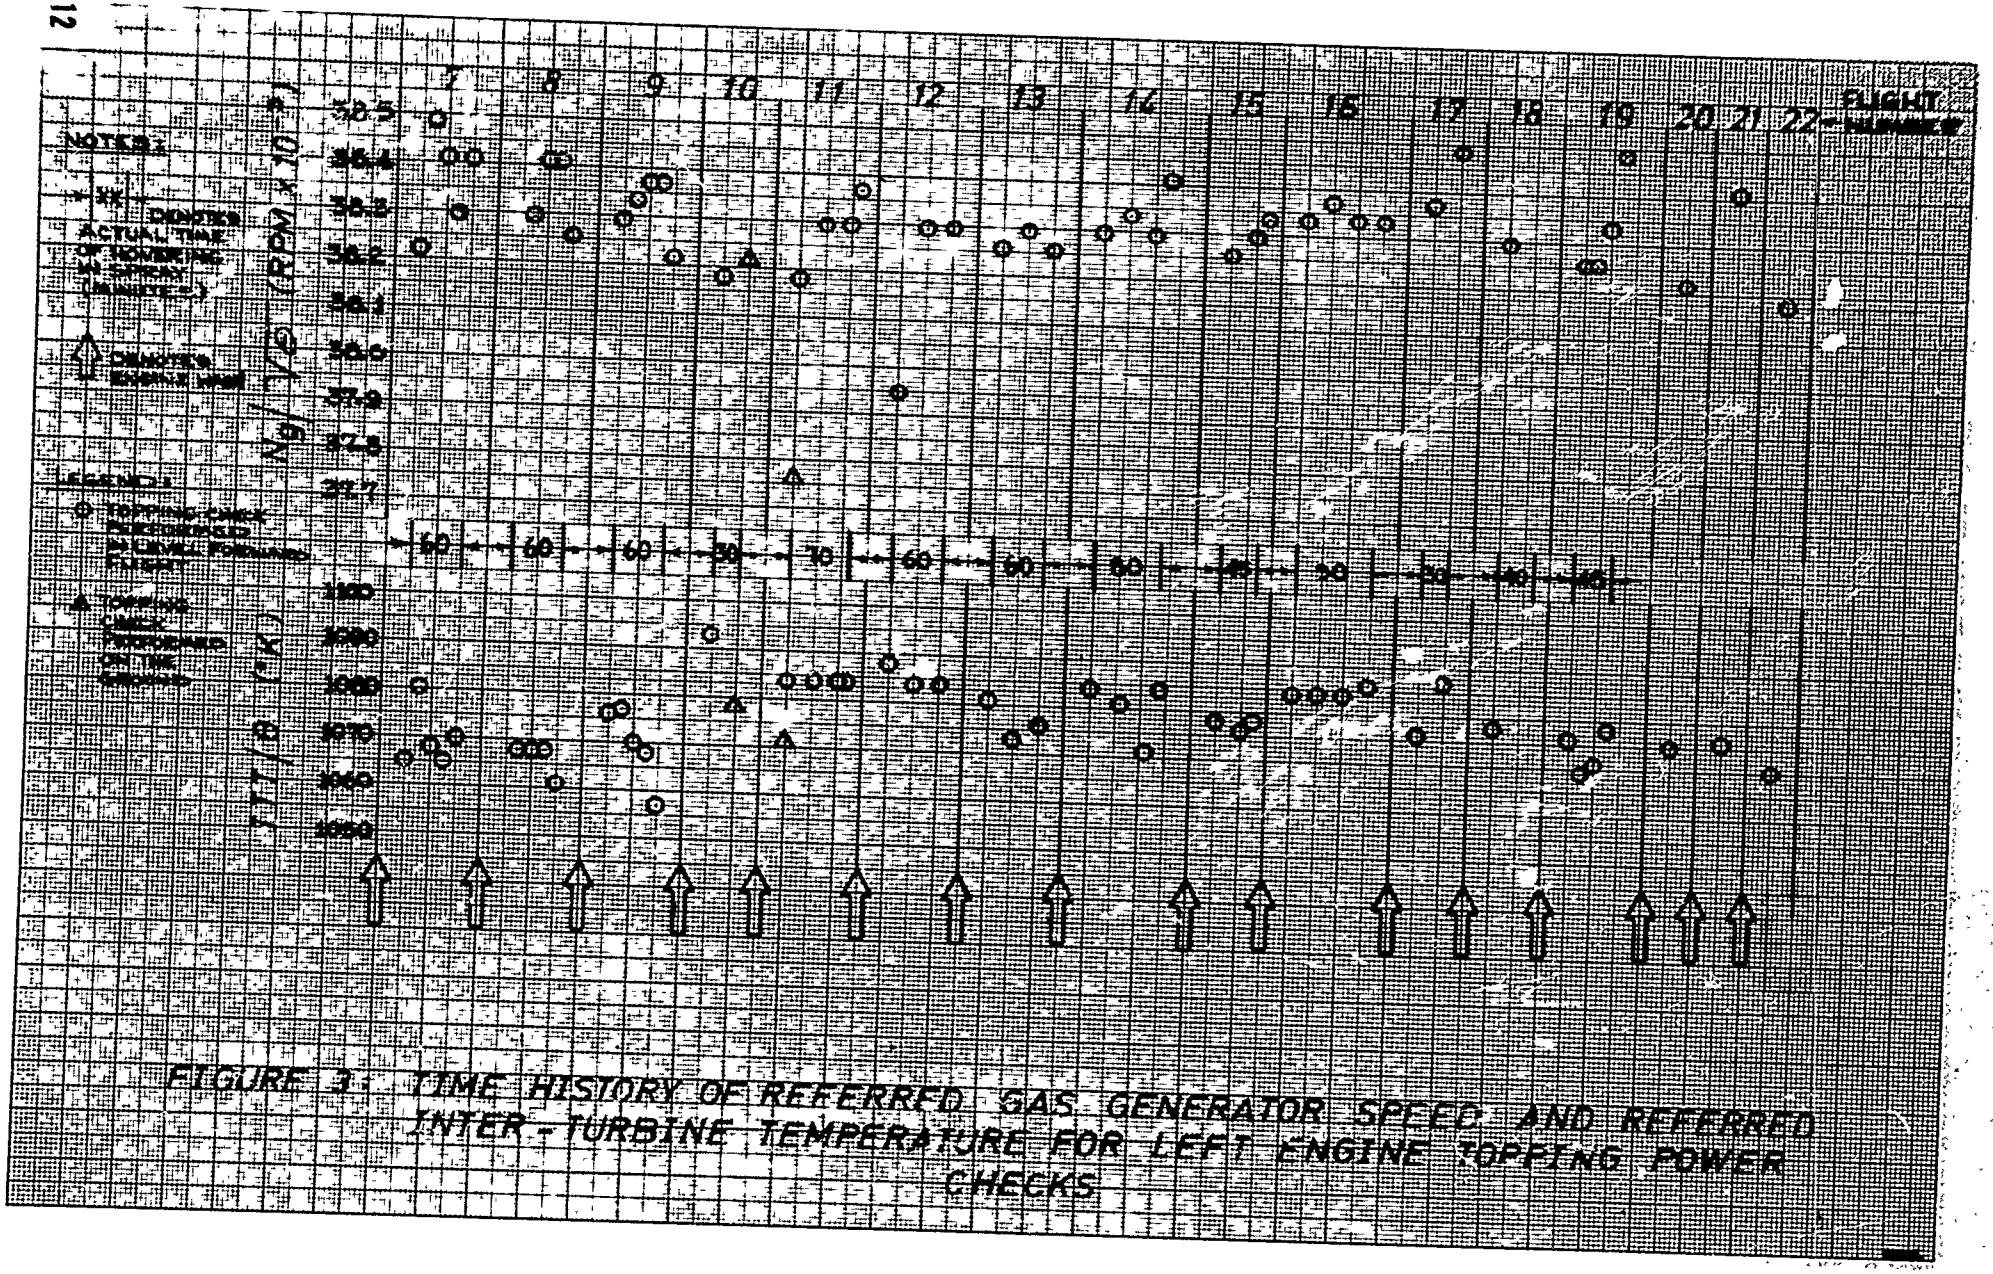
The left engine experienced a 2 percent torque loss after 1 hour during flight 13 and a similar loss after only 45 minutes during flight 19. A 1.4 percent loss was noted during the 80-minute flight 14. Torque losses of approximately 1 percent were experienced during the 60 minutes of flight 7 and 45 minutes of flight 9. Torque losses of 0.6 percent and 0.5 percent were experienced during flights 10 and 18, respectively.

FIGURE 2: TIME HISTORY OF CALIBRATED TORQUE AND REFERRED SHAFT HORSEPOWER FOR LEFT ENGINE TOPPING POWER CHECKS

FIGURE 3: TIME HISTORY OF REFERRED GAS GENERATOR SPEED AND REFERRED INTER-TURBINE TEMPERATURE FOR LEFT ENGINE TOPPING POWER CHECKS

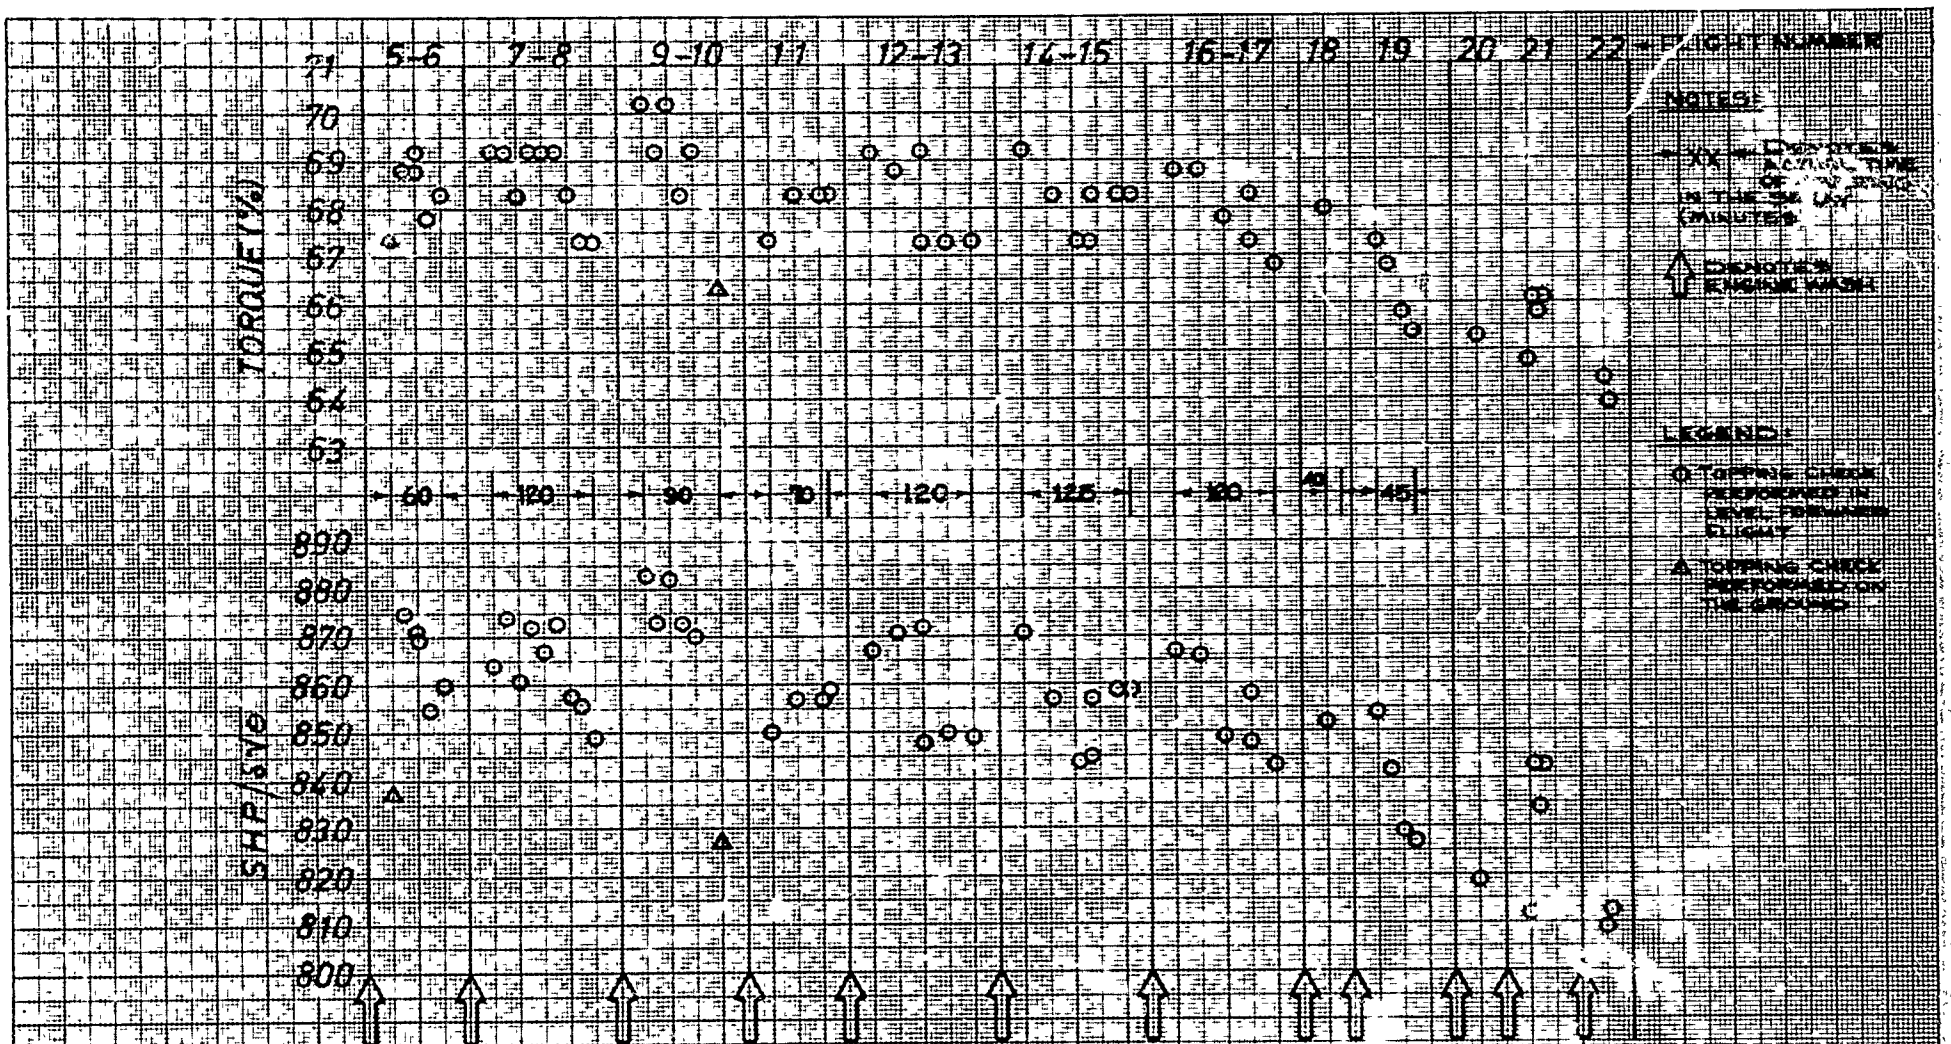
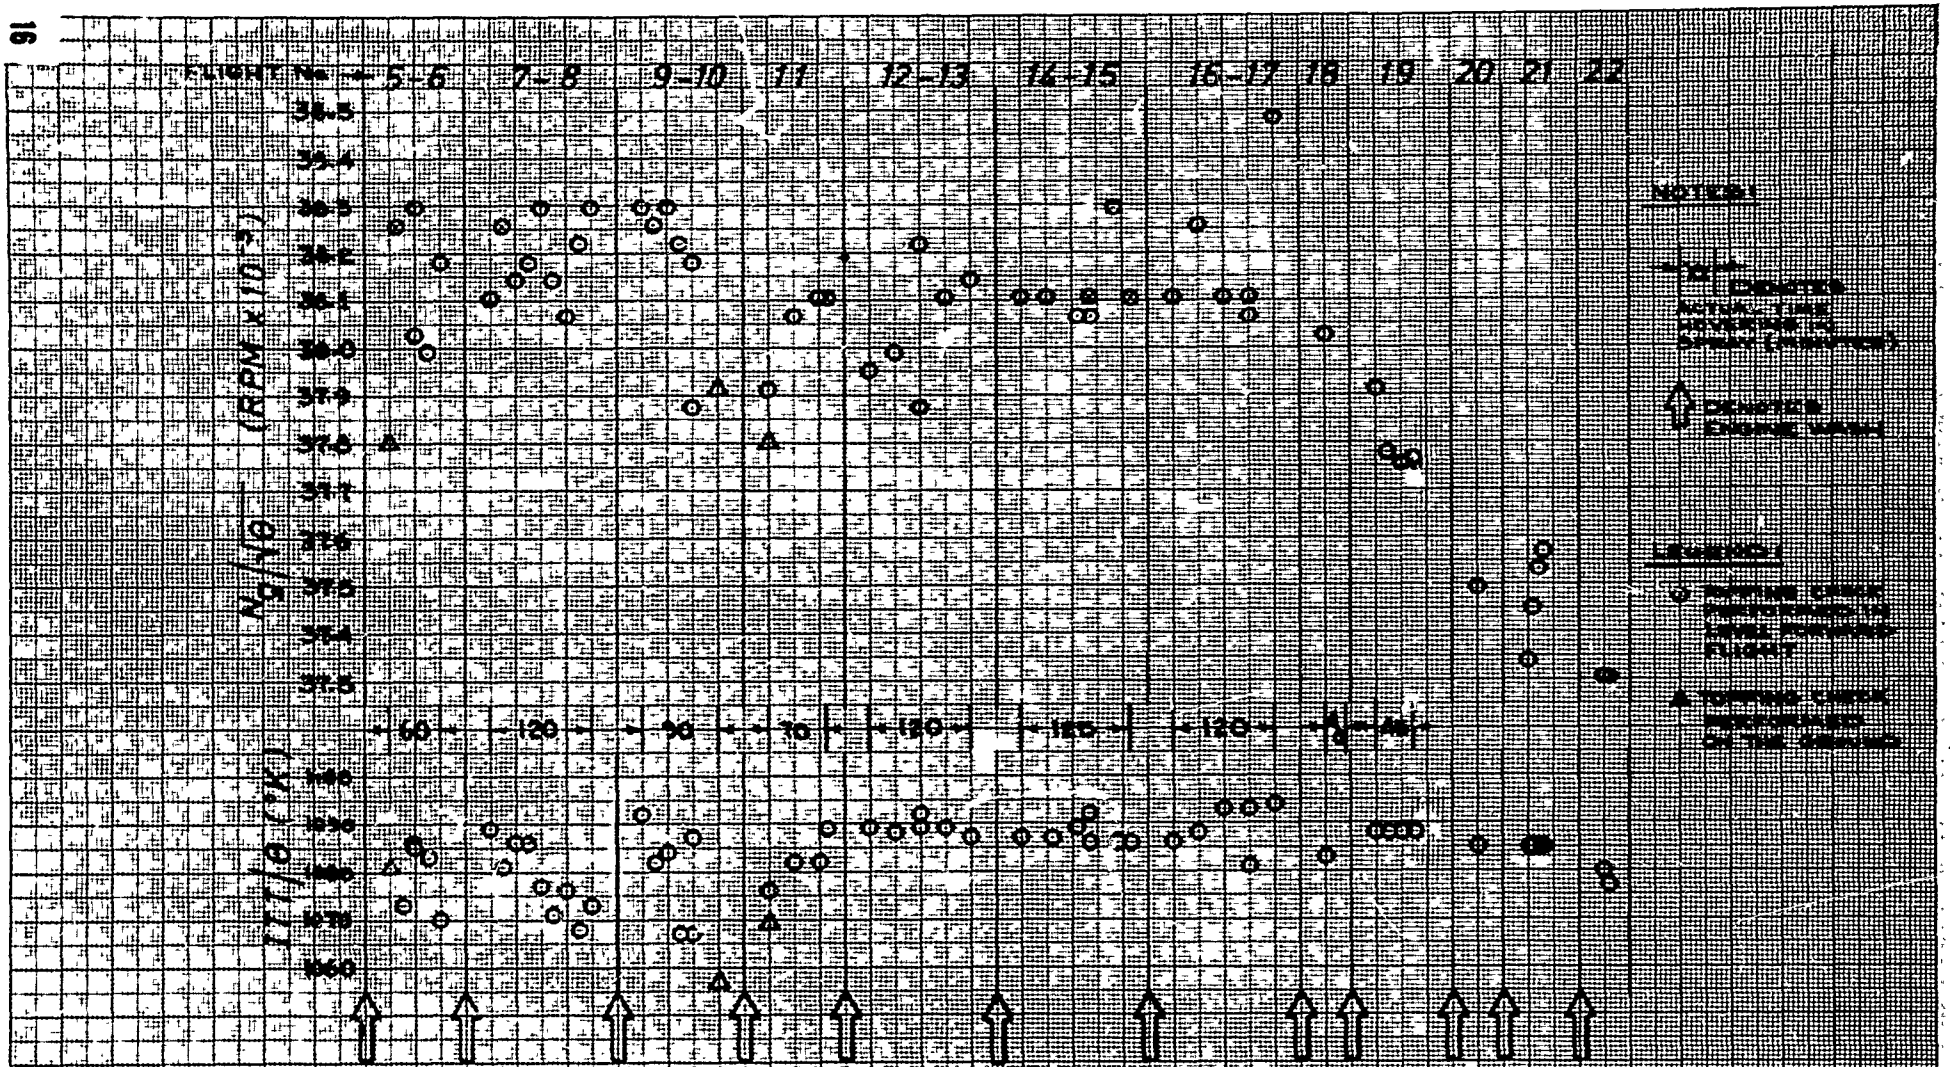
Only 0.9 percent was lost during a 2-hour hover at 15 feet during flights 14 and 15. A torque loss of approximately 1 percent was experienced after 1 hour during flights 5 and 6 and flights 9 and 10. A similar 1 percent loss was noted by the pilot during flight 18 which was inadvertently not recorded on the photopanel. During flight 19, a 2 percent torque loss was experienced after only 45 minutes.

FIGURE 4: TIME HISTORY OF CALIBRATED TORQUE AND REFERRED SHAFT HORSEPOWER FOR RIGHT ENGINE TOPPING POWER CHECKS

FIGURE 5: TIME HISTORY OF REFERRED GAS GENERATOR SPEED AND REFERRED INTER - TURBINE TEMPERATURE FOR RIGHT ENGINE TOPPING POWER CHECKS

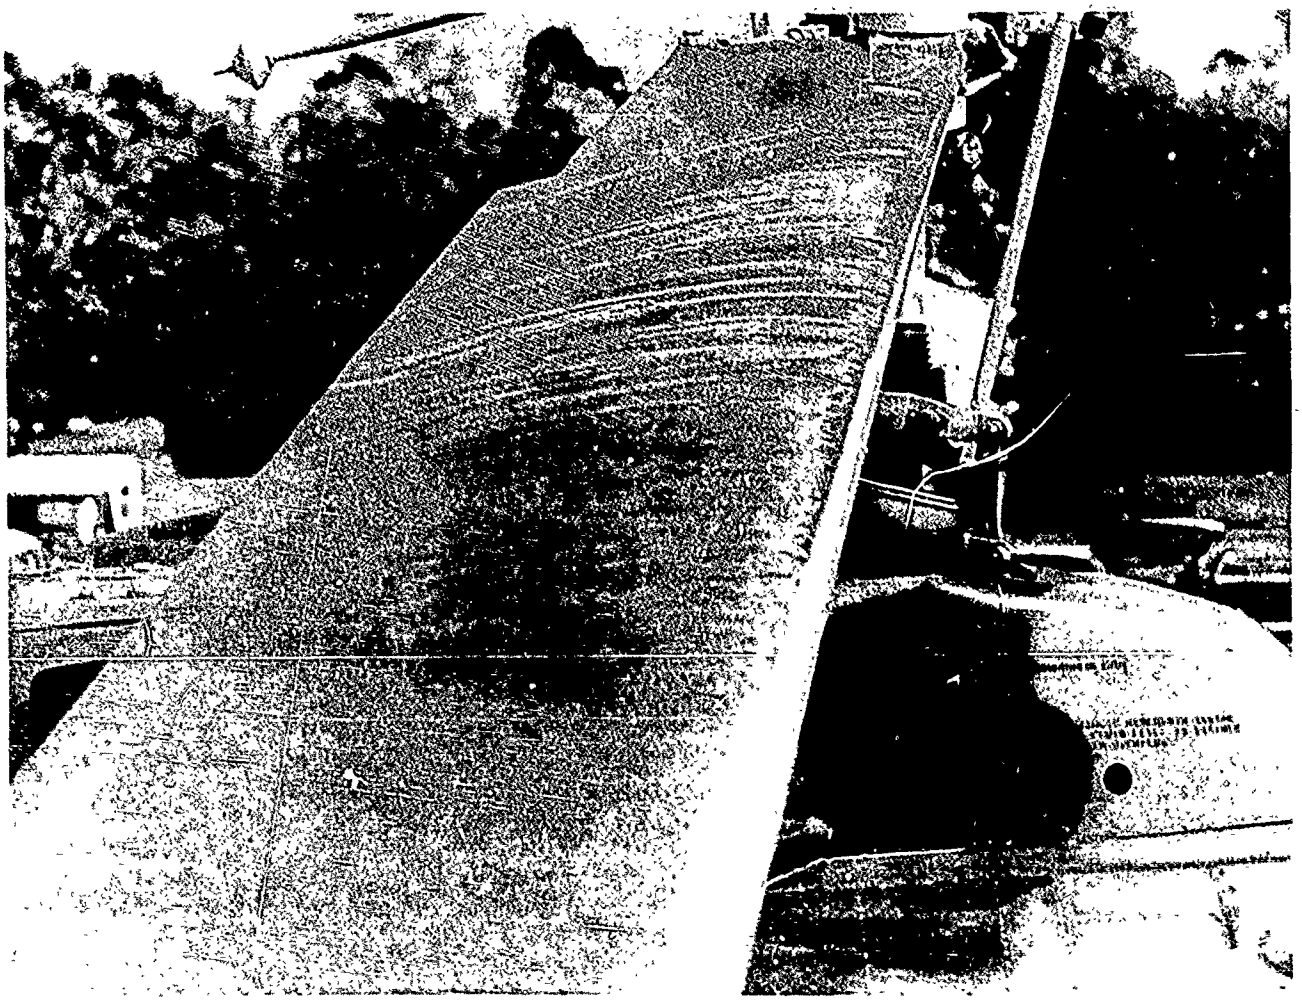
No attempt was made to determine the effects of blade incrustation on the performance and flying qualities of the test aircraft. It appears reasonable, however, that the buildup of salt on the blade surfaces would reduce blade efficiency, and the out-of-track condition, once encountered, could reduce the cruise speed of the aircraft. Tail rotor vibrations, while annoying to the pilot, did not appear to restrict the operational capability of the helicopter.

Figure 8 Salt Deposits on Main Rotor

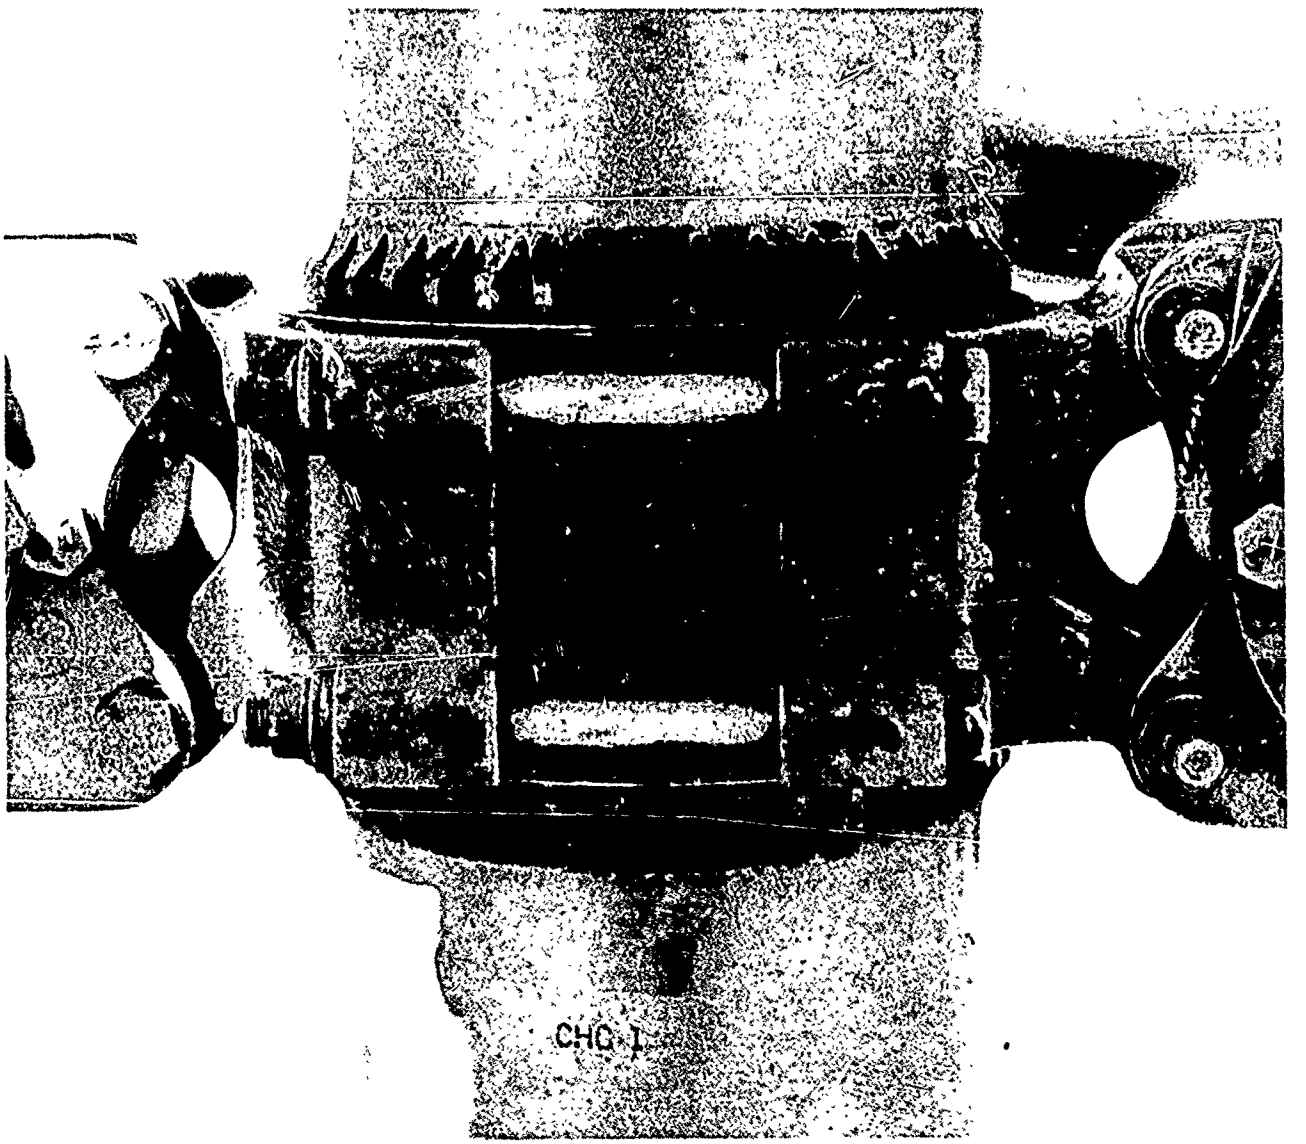
Zip Aerosol Corrosion Shield reduced the total corrosion which did occur on the aircraft, but it was not totally effective in preventing corrosion. Appendix III presents a corrosion summary by aircraft section of the corrosion events which occurred at NAS North Island. Figure 10 illustrates the corrosion formed on the mast spline shaft at the damper mounts.

Figure 10 Corrosion of the Mast Spline Shaft at Damper Mounts

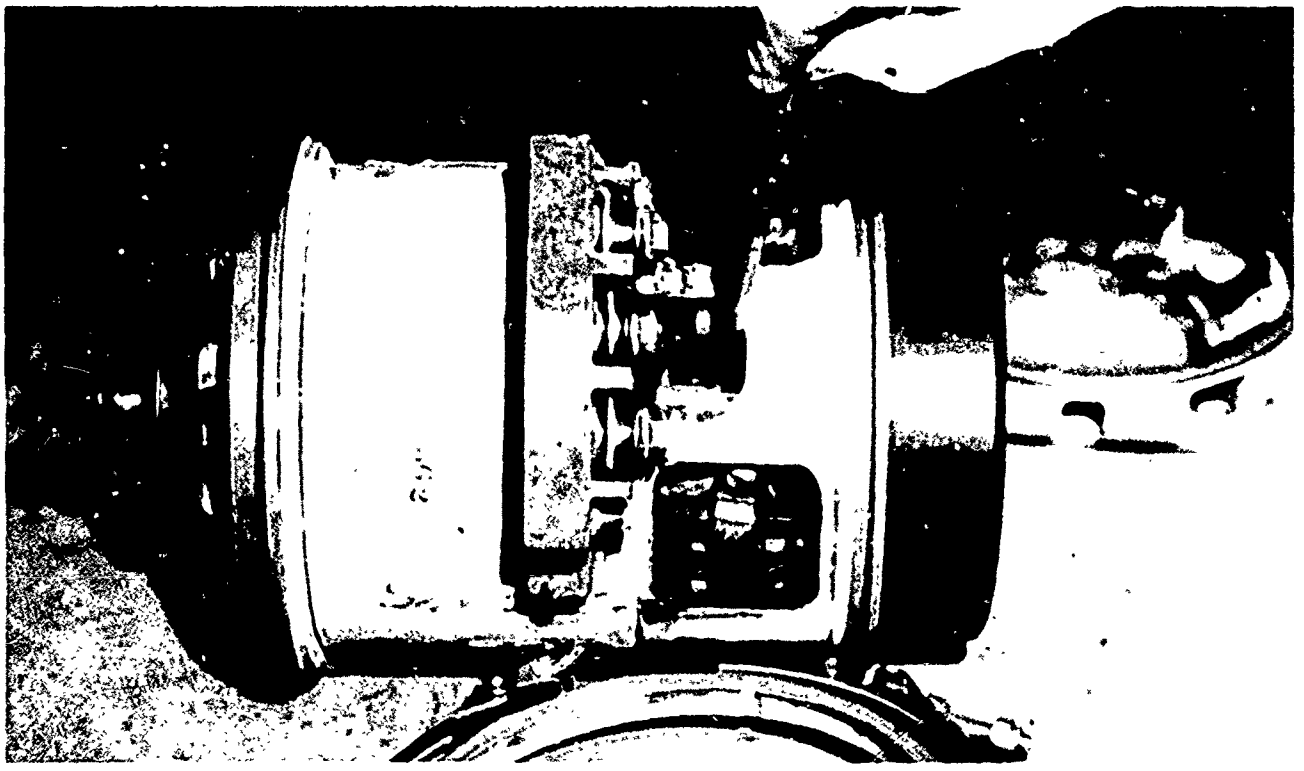
The exact condition of the generator prior to initiation of the test program is not known. It cannot be positively concluded, therefore, that the corrosion found on the generator was caused by hovering in salt spray. However, the possibility that this was the case is strong enough that it cannot be ignored.

Figure 11 Corrosion of Left Engine Starter-Generator

It can be positively concluded that hovering in salt spray will cause extensive aircraft corrosion unless adequate corrosion control is practiced on a daily basis. This corrosion may be obvious or insidious and may prove to be a more serious problem than engine power degradation resulting from sustained hovering in salt spray. Hovering in salt spray should be kept to the minimum time required to accomplish an operational mission and hover altitude should be as high as is practical for that mission. (R 10)
