CEEDO-TR-78-10

An Investigation Into the Use of Polymer-Concrete for Rapid Repair of Airfield Pavements

FINAL REPORT FOR PERIOD JUNE 1977-DECEMBER 1977

7. AUTHOR(s): Captain Michael T. McNerney

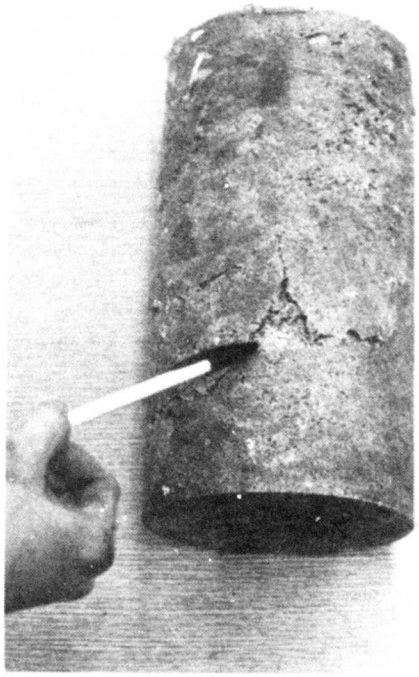
Just as portland cement concrete depends largely on the strength of the aggregate for the strength and modulus of elasticity so does polymer-concrete. Polymer-concrete can be made from dense, lightweight, and normal aggregates just like portland cement concrete. The stronger the aggregate the stronger the PC. In most cases, the failure plane in PC tends to pass through the large aggregate (Figure 13). In tensile tests, it is common to see the failure plane pass through more than half of the large aggregate (Figures 14 and 15).

Figure 13. Failure Plane Through Large Aggregate

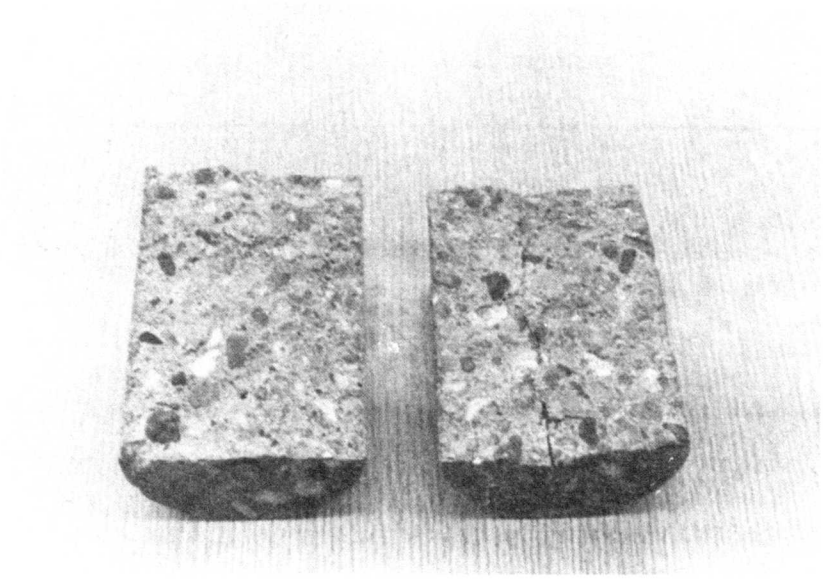
Figure 14. Failure Plane of PC Cylinder

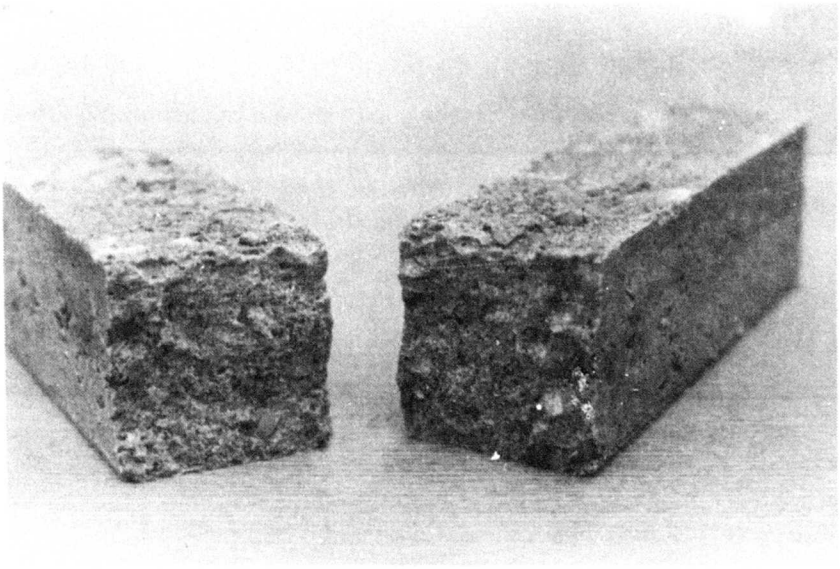
Figure 15. Failure Plane of PC Beam

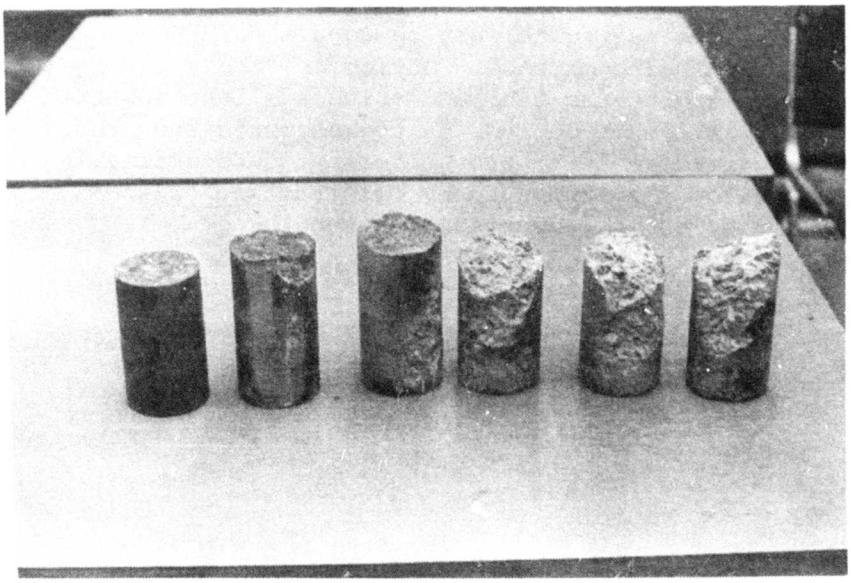
Figure 16. Specimens at 1.64 Percent Moisture Content

seemed as moisture content increased the specimens bonded to the steel molds even though the molds were well coated with the most effective mold release agent tested.

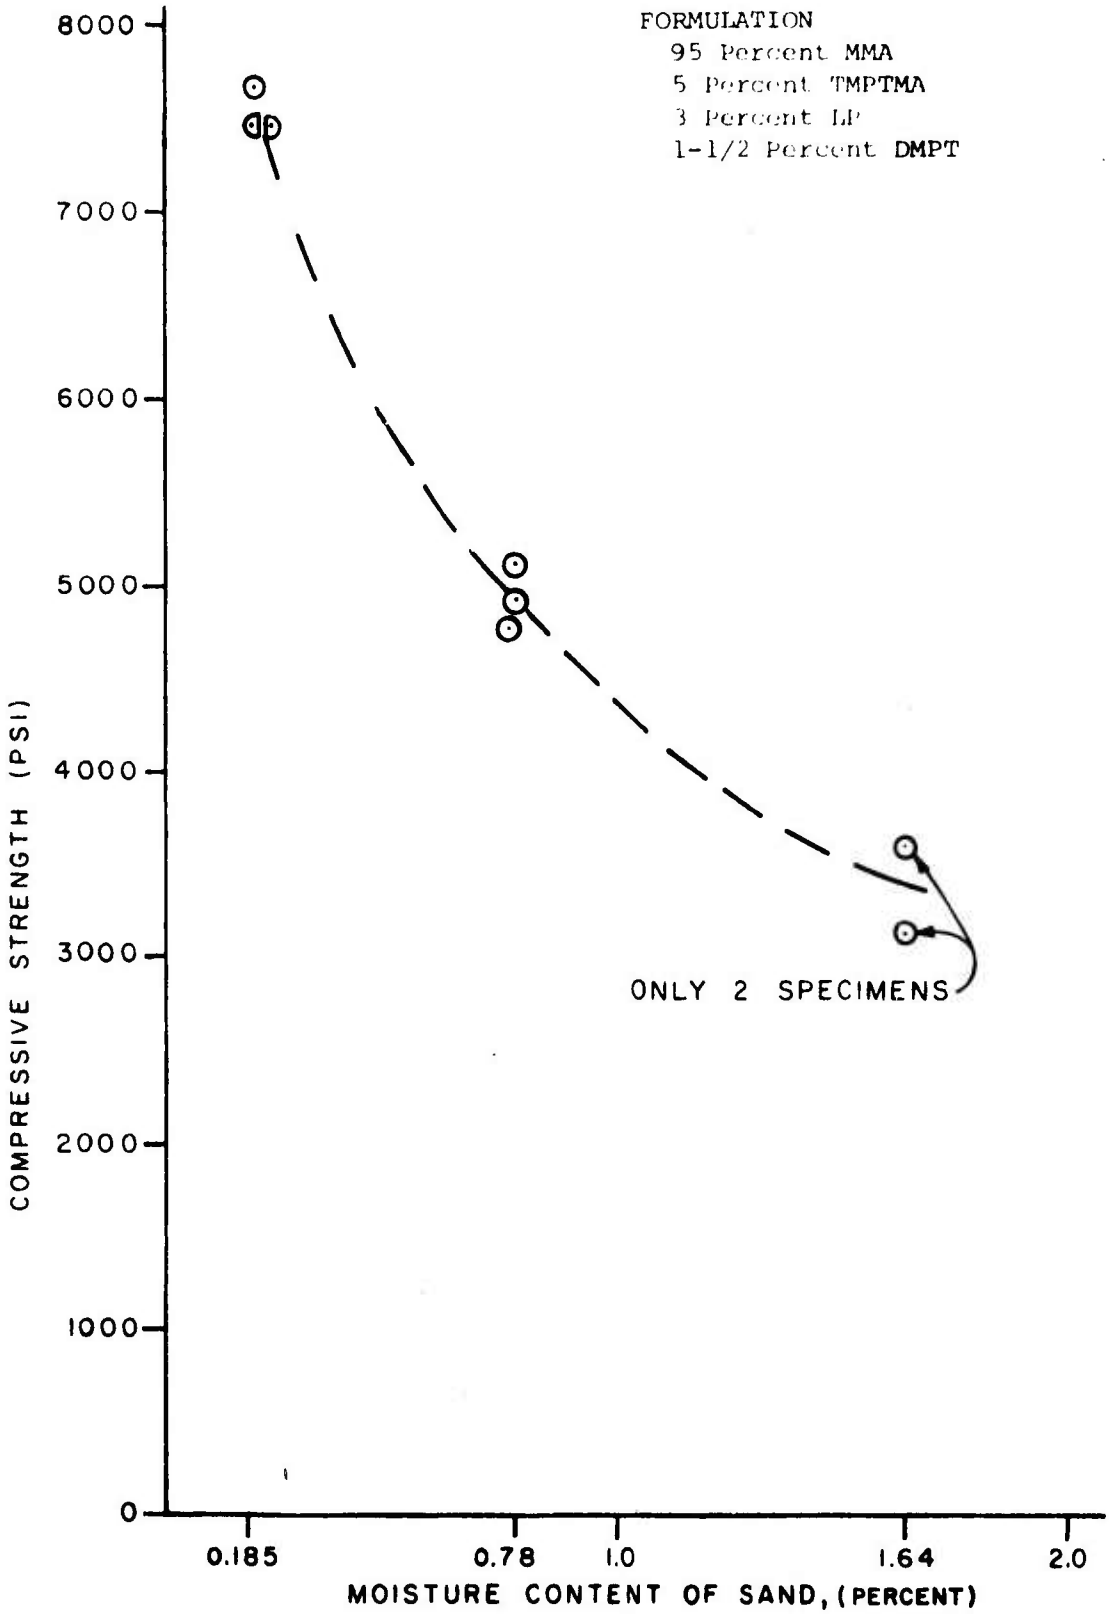
Results of the test show that relatively small amounts of moisture reduce the compressive and tensile strengths by as much as 40 percent (Figure 17 and 18). At a moisture content of 0.78 percent the sand was noticeably wet yet good strengths were obtained. This indicates that if the sand can be dried until it has the appearance of dry sand, the moisture content will be low enough to produce good results. The driest sand used (0.185 percent moisture content) had been oven-dried approximately one month earlier and stored in an air conditioned laboratory.

Figure 17. Effect of Moisture Content of Sand on Compressive Strength

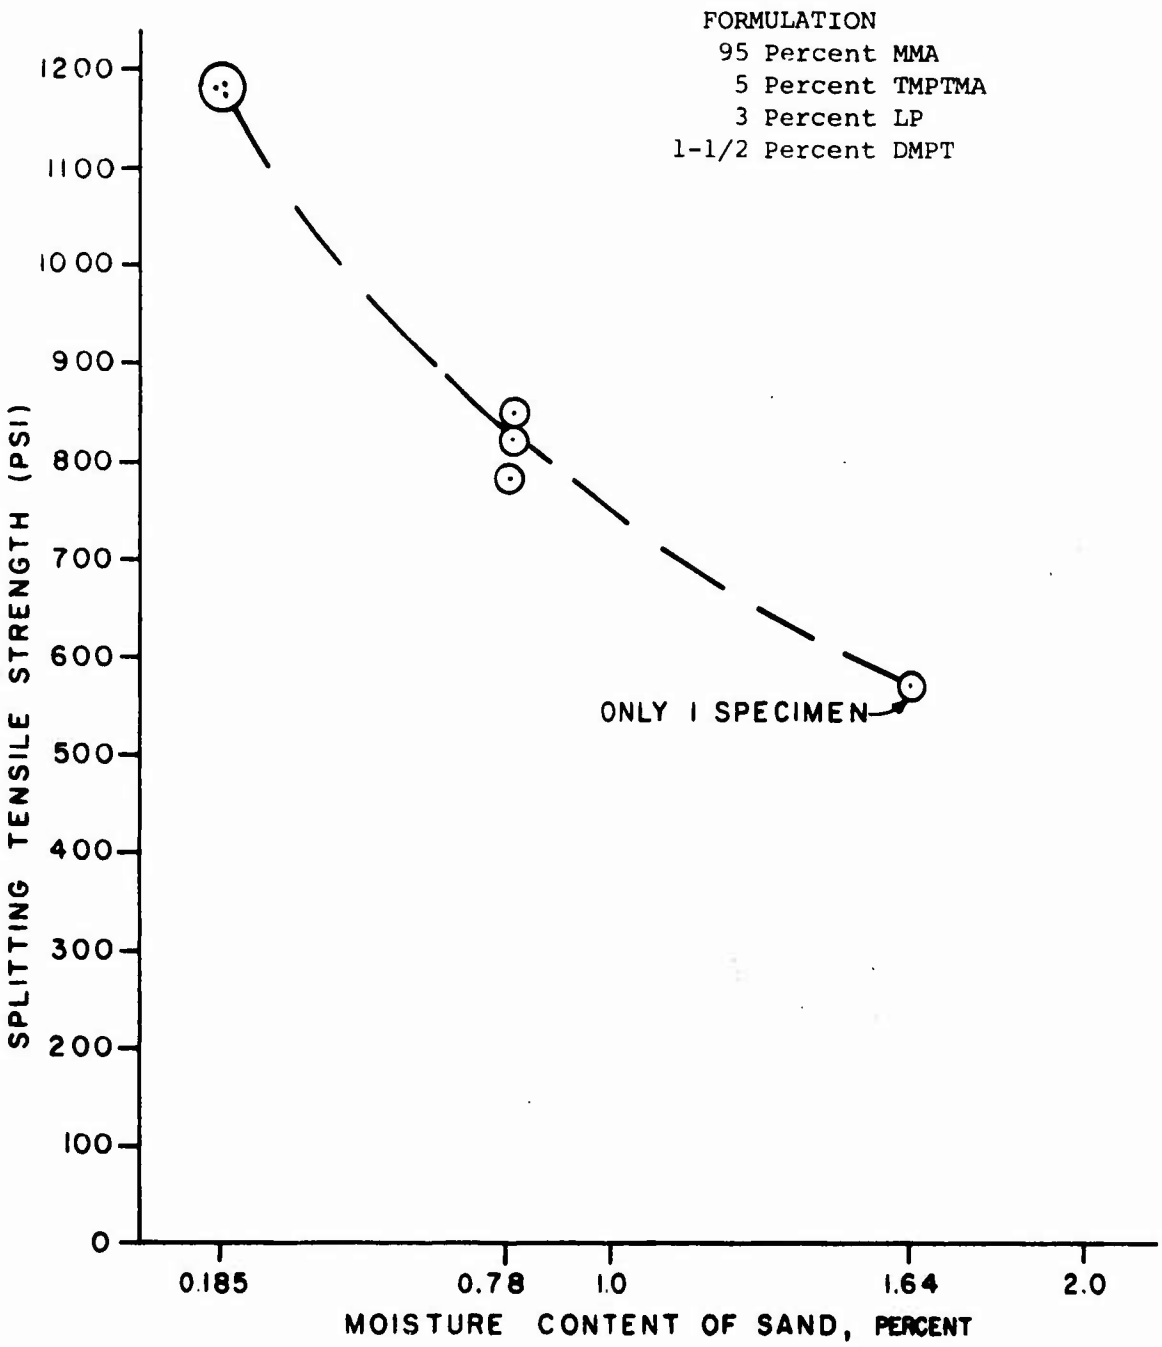
Figure 18. Effect of Moisture Content of Sand on Splitting Tensile Strength

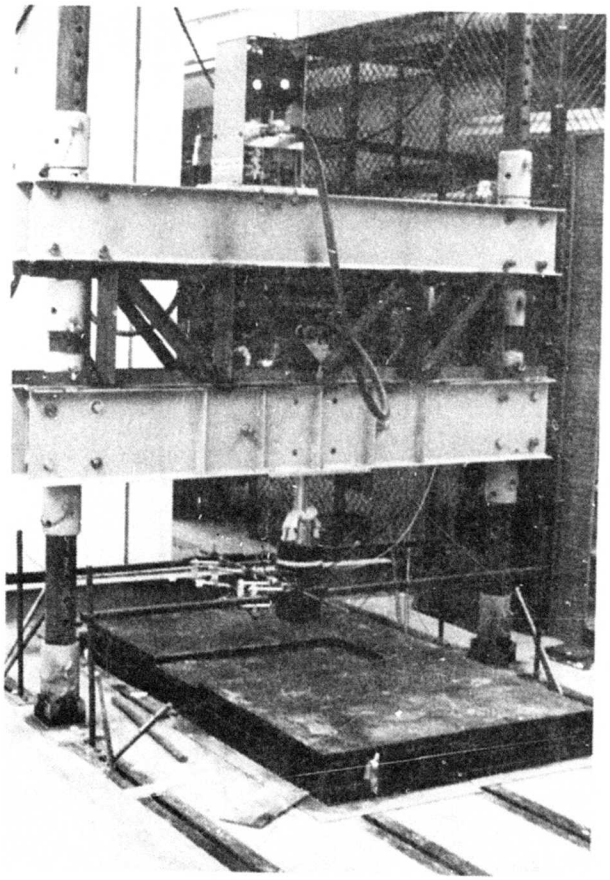
(Note void in rubber subgrade)

Figure 21. Loading Frame After Reinforcing

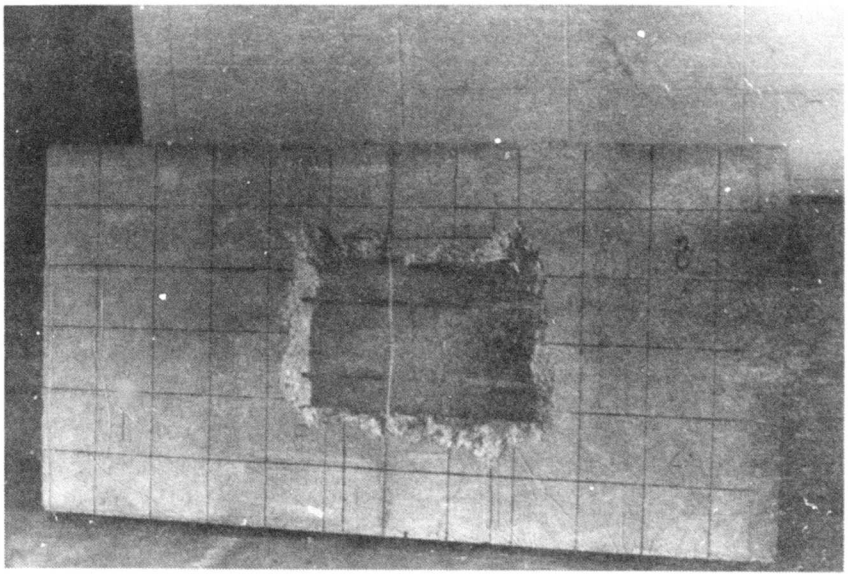
Slab 177-2 was a 4-inch thick concrete slab with apparent cracking. To test the bond strength of PC and the bearing capacity of small PC patches, a hole 24 x 16 inches was jackhammered into Slab 177-2 (Figure 24). The repaired slab is hereafter designated Slab 1. The slab was 36 x 72 inches with a 20 gauge, 1-inch strip of sheet metal placed vertically along the bottom surface dividing the slab into two equal halves. The metal strip was used in the concrete slab to preform a crack in the original test program. The metal strip was left in the PC repair and coated with mold-release agent to create a weakened section. A double thickness of polyethylene was placed over the rubber subgrade as a bond breaker and a commercial sealant was applied around the perimeter of the repair.

Figure 24. Slab 1 With Concrete Removed

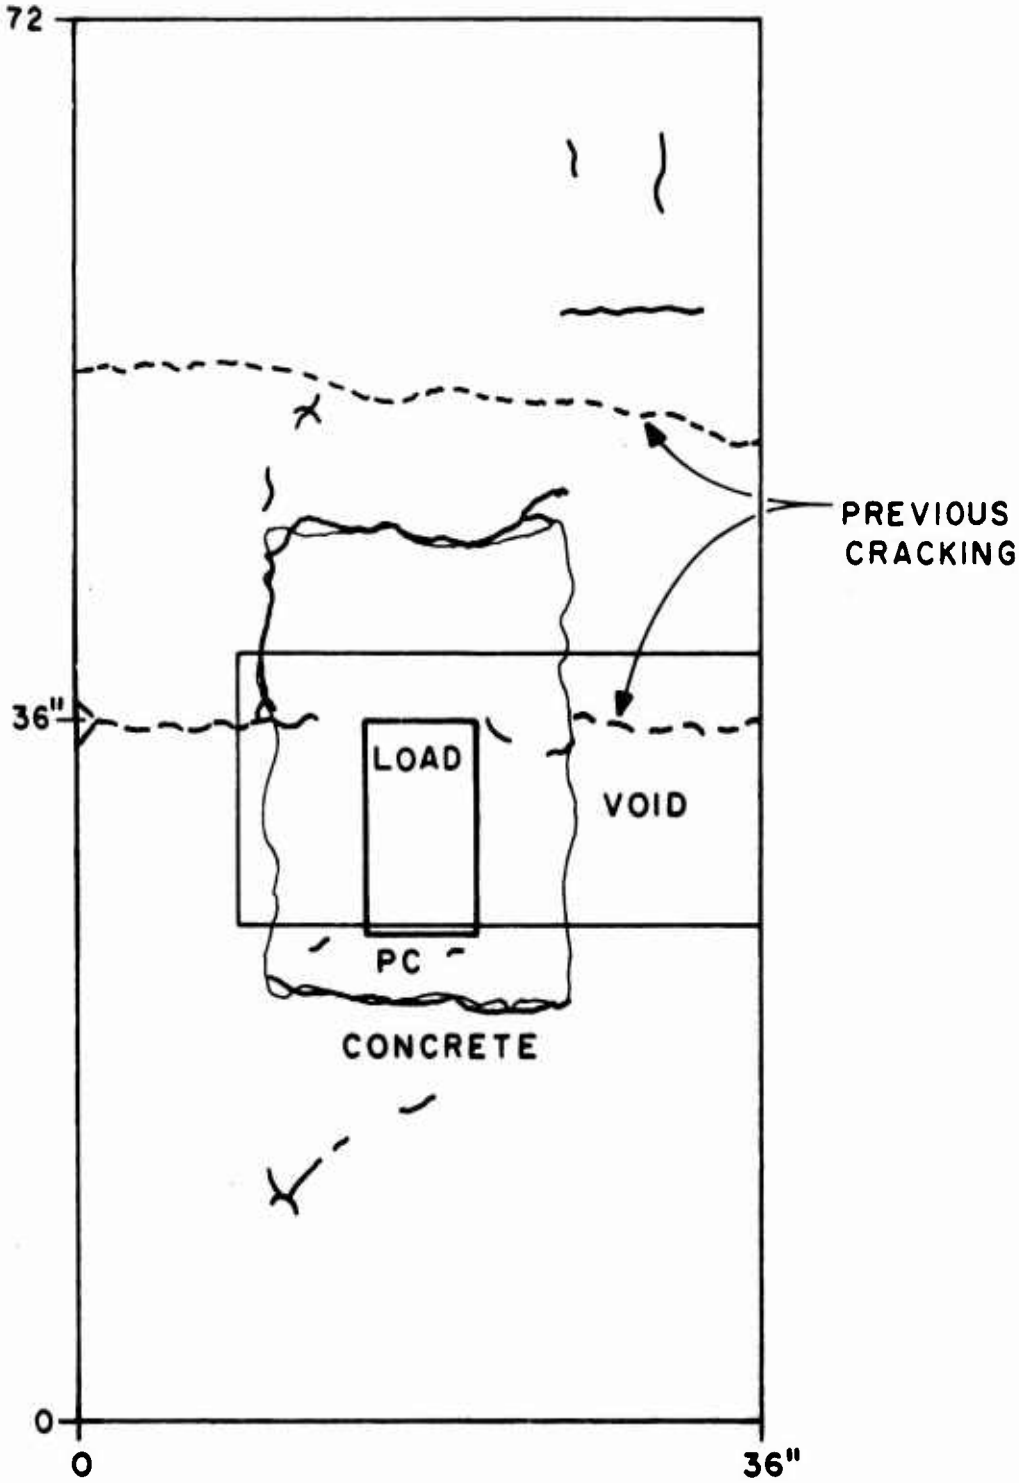
Figure 28. Crack Development on the Top of Slab 1

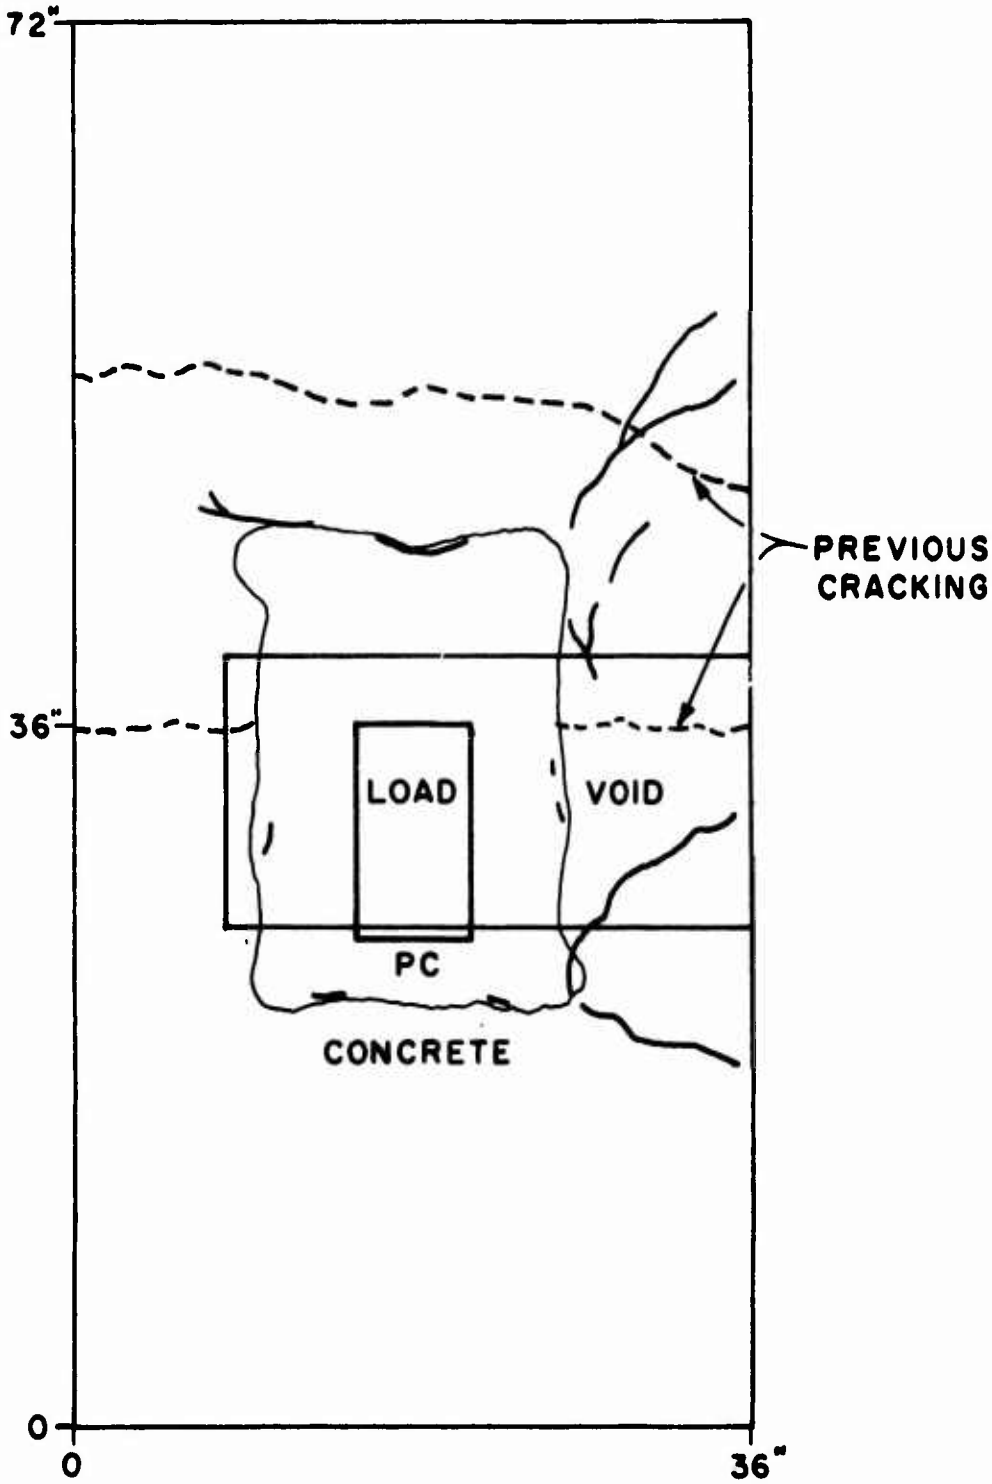
Figure 29. Crack Development on the Bottom of Slab 1

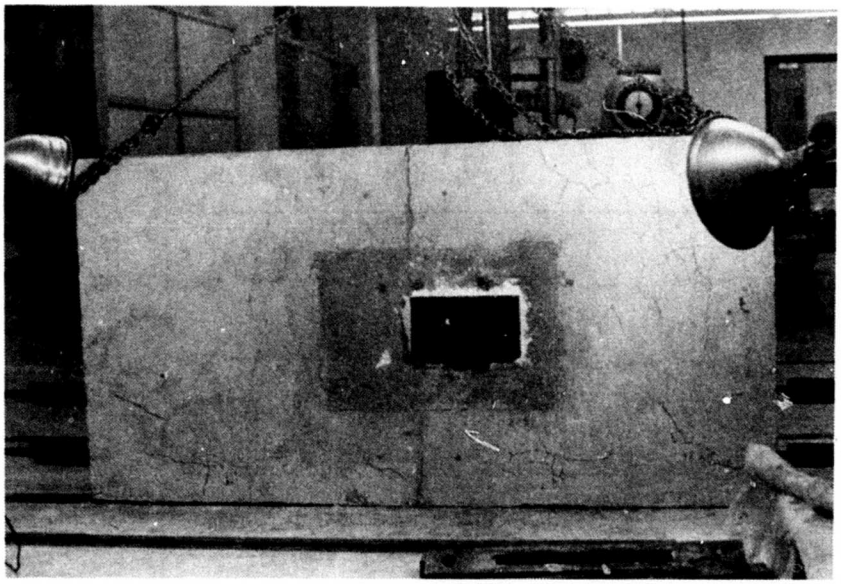
Slab 1 was generally in excellent condition and the PC repair showed no signs of failing (Figure 30). It is felt that the slab could have taken many more applications of 18-kip loading without cracking the effectively 3-inch section across the middle.

Figure 30. Top of Slab 1

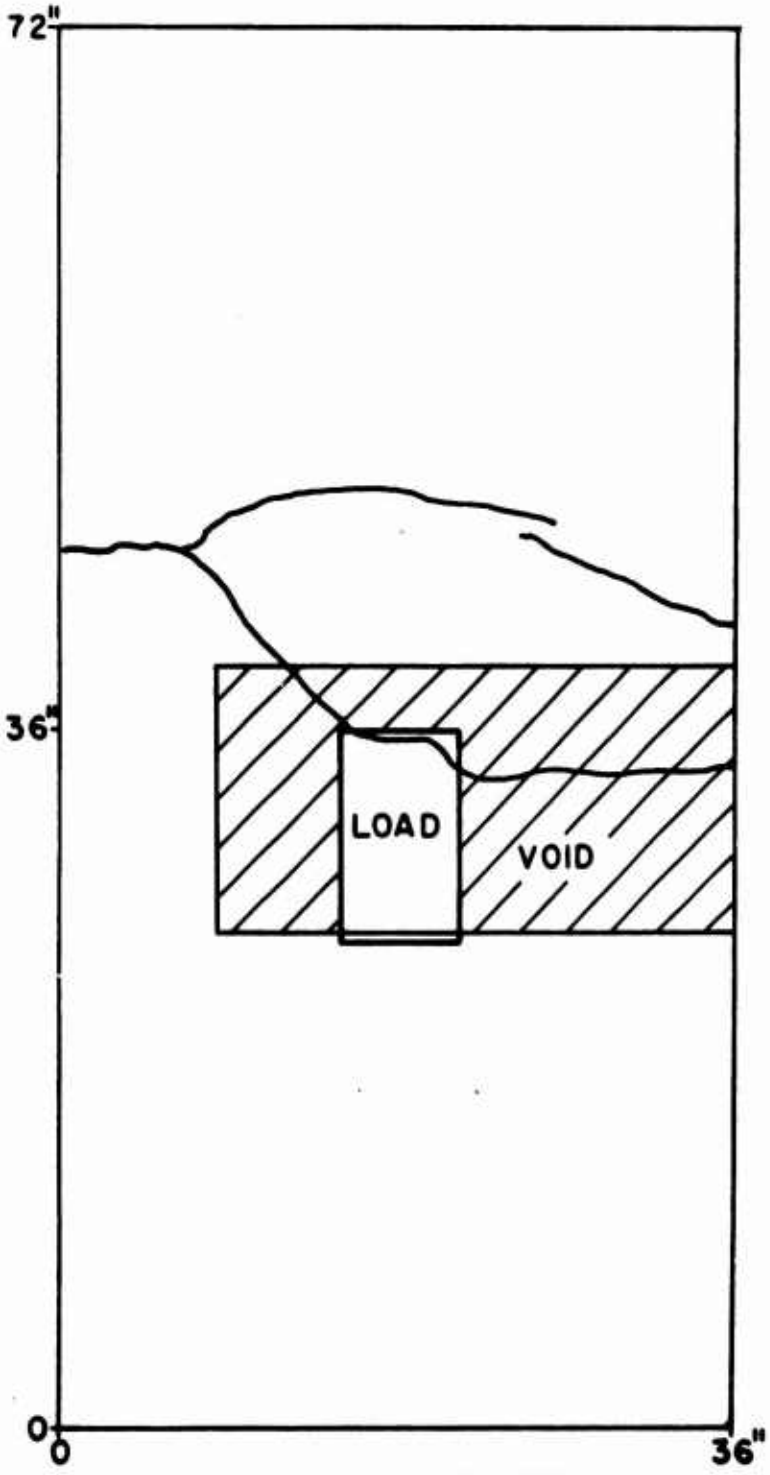
Figure 31. Crack Development on the top of Slab 2 After Application of 21 Kip Load

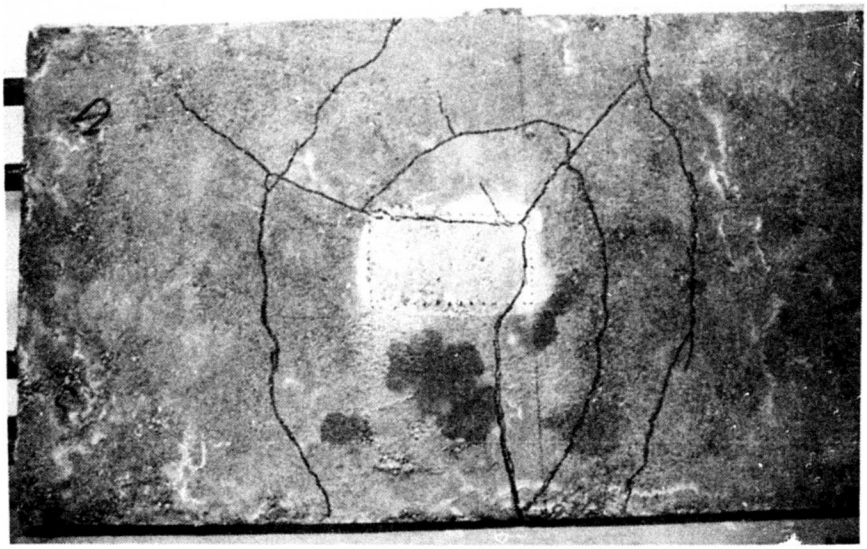
After 3 cycles of 18-kip loading, there was still no sign of microcracking although the deflections were excessive and partly non-recoverable. When the load was increased to 21 kips a loud noise was heard and within seconds two cracks were observed across the top of the slab (Figure 31). After cracking had occurred, an 18-kip cyclic load was applied for 17 cycles. At this point cracking was severe and the steel failed (Figures 32 and 33).

Figure 32. Top of Slab 2

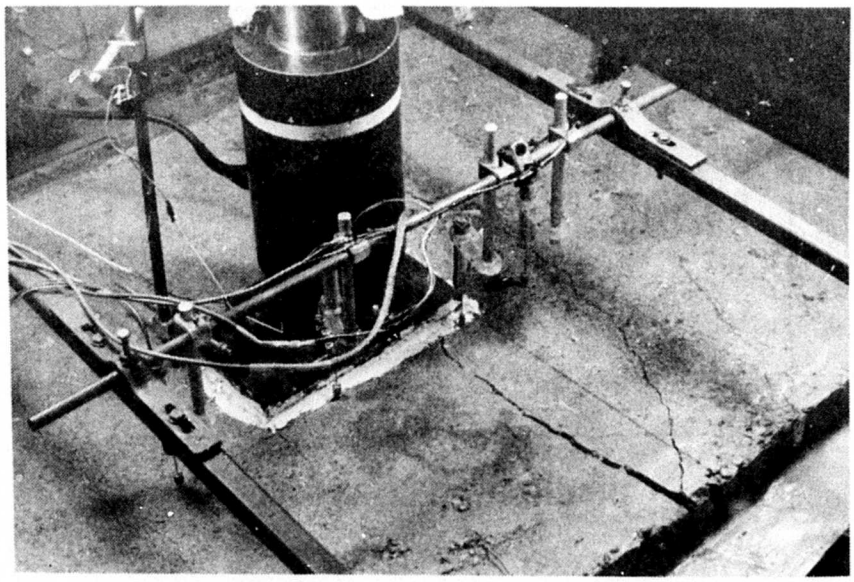
Figure 33. Cracking on Top of Slab 2

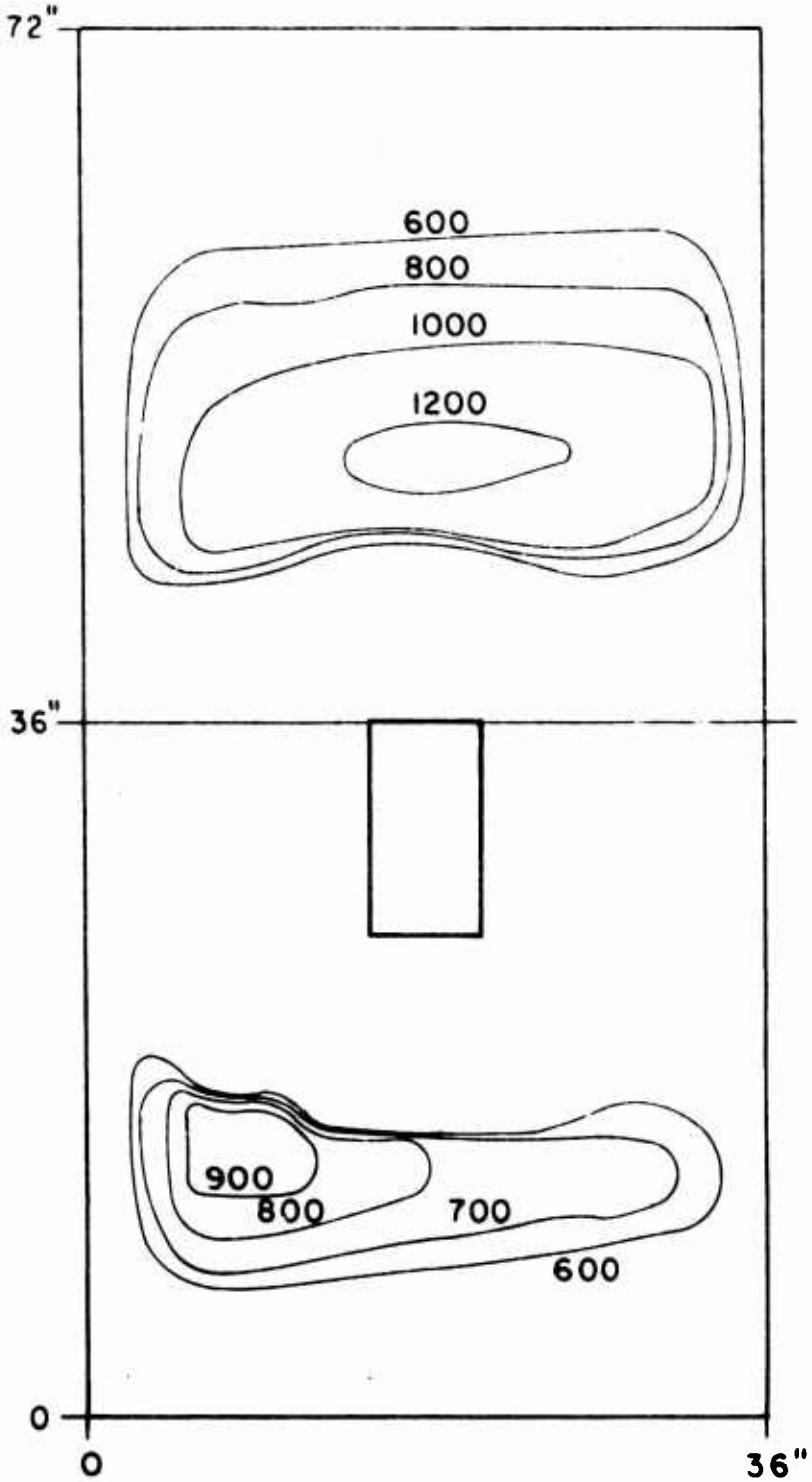
Previous slabs of Study 177 were analyzed using a computer program developed at the University of Texas called Slab 49 (Reference 16 and 17). The analyses of Slabs 1 and 2 were also performed with Slab 49. Figures 34 and 35 show the stress concentrations in the top and bottom of Slab 2 predicted by Slab 49 using elastic theory.

Figure 34. Tensile Stress Contours on the Top of Slab 2: 21 Kip Load

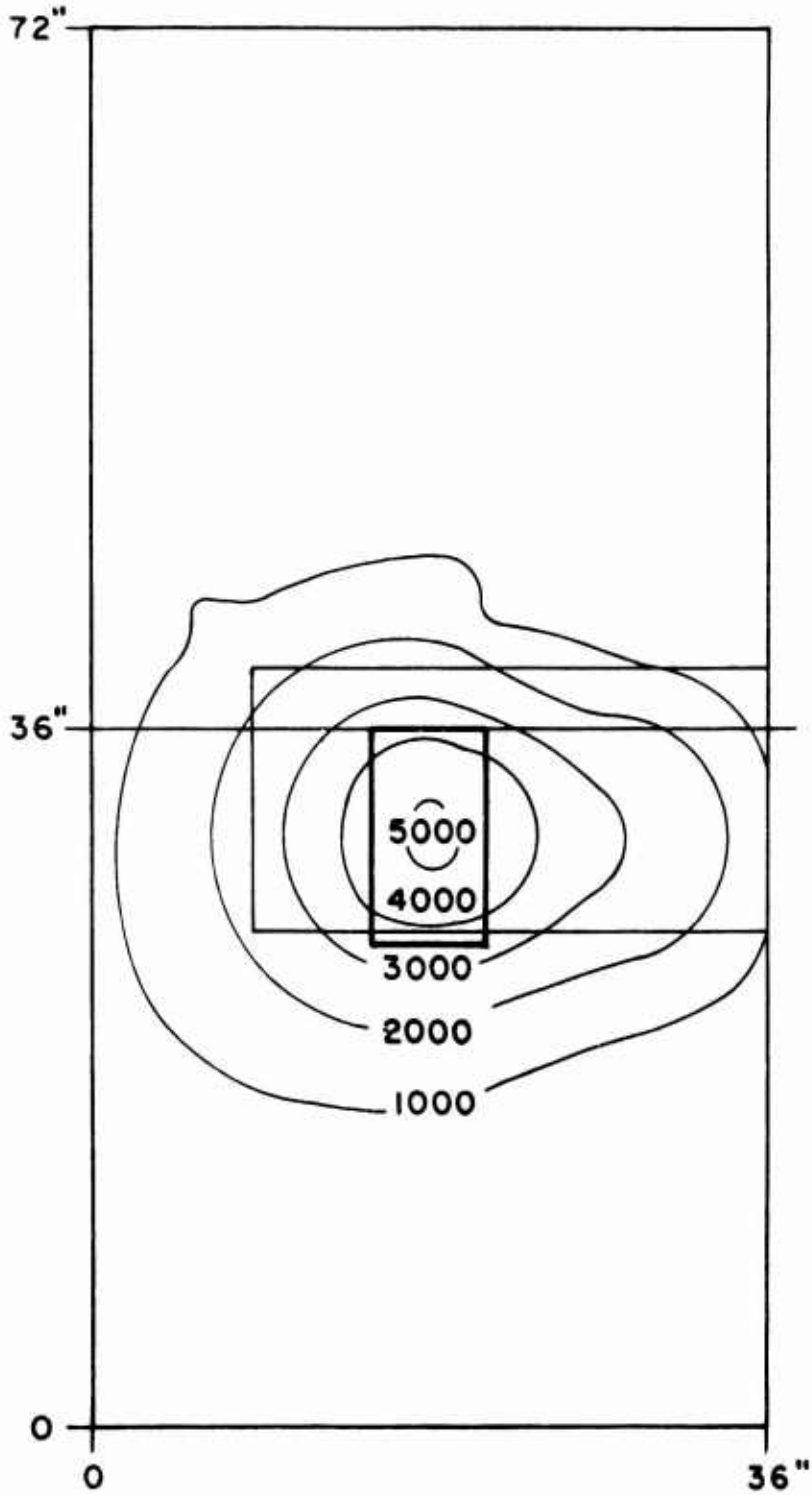
Figure 35. Tensile Stress Contours on the Bottom of Slab 2: 21 Kip Load

The 5000 psi tensile stress in the bottom of Slab 2 (Figure 35) predicted by the computer program was verified using the Westergaard corner equation on a uniform support. It seems inconsistent that the PC slab could withstand a 5000 psi tensile stress when the modulus of rupture was found to be 1500 psi from beam tests (Table 12).

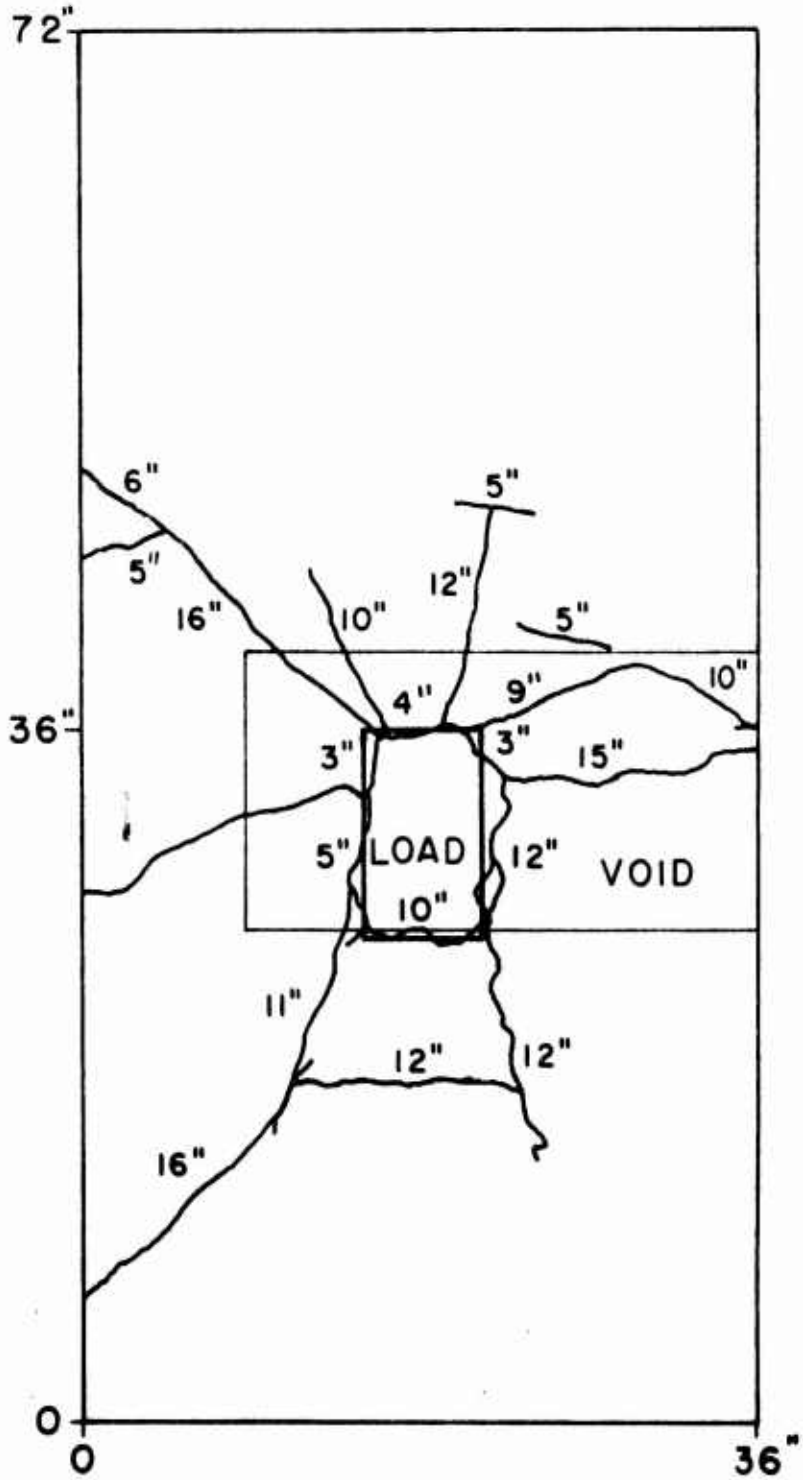
Figure 36. Crack Development on the Bottom of Slab 2

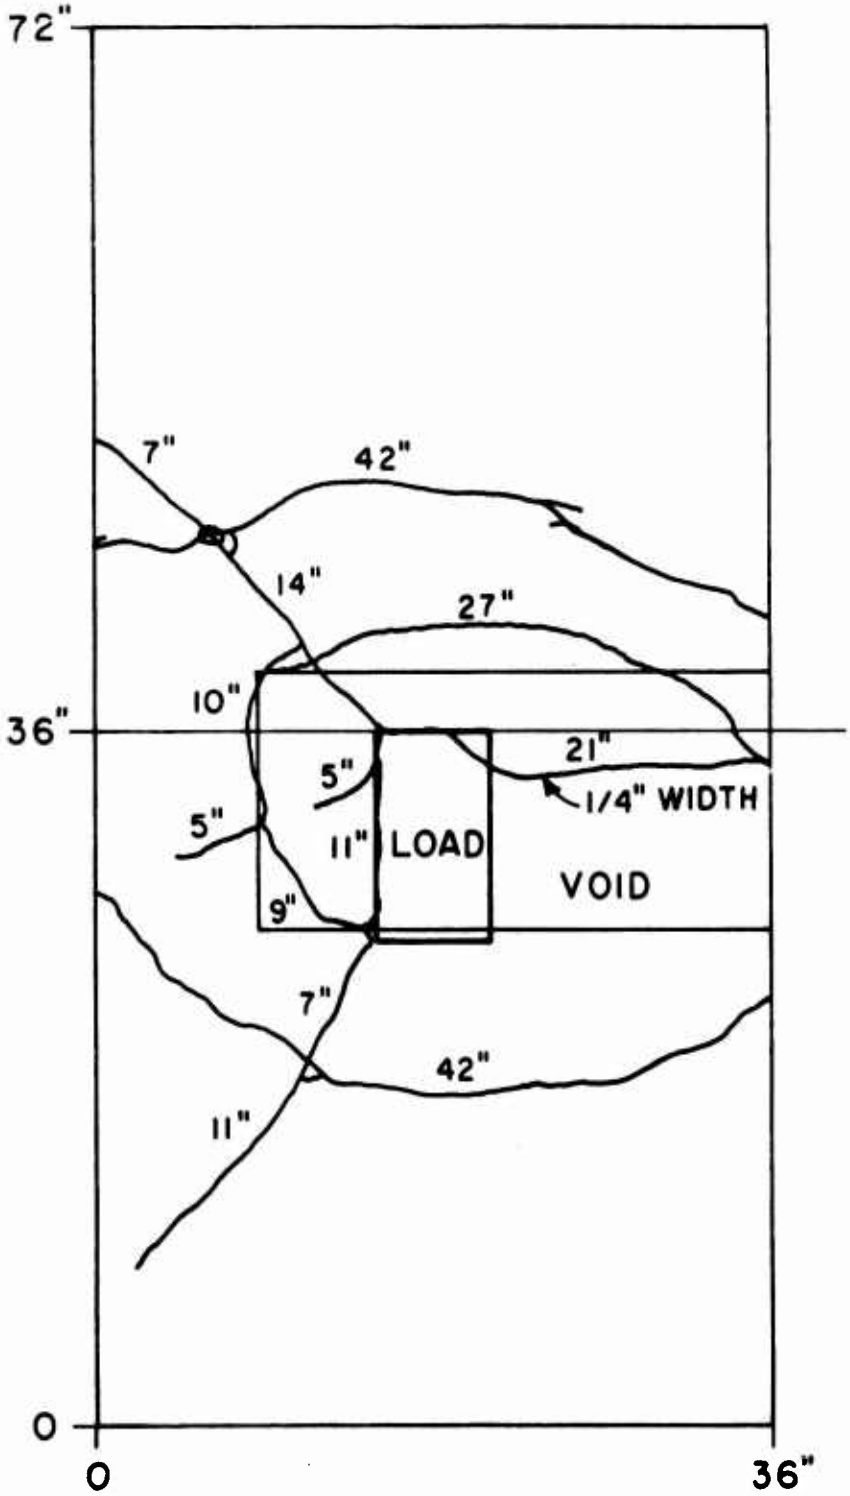
Figure 37. Crack Development on the Top of Slab 2

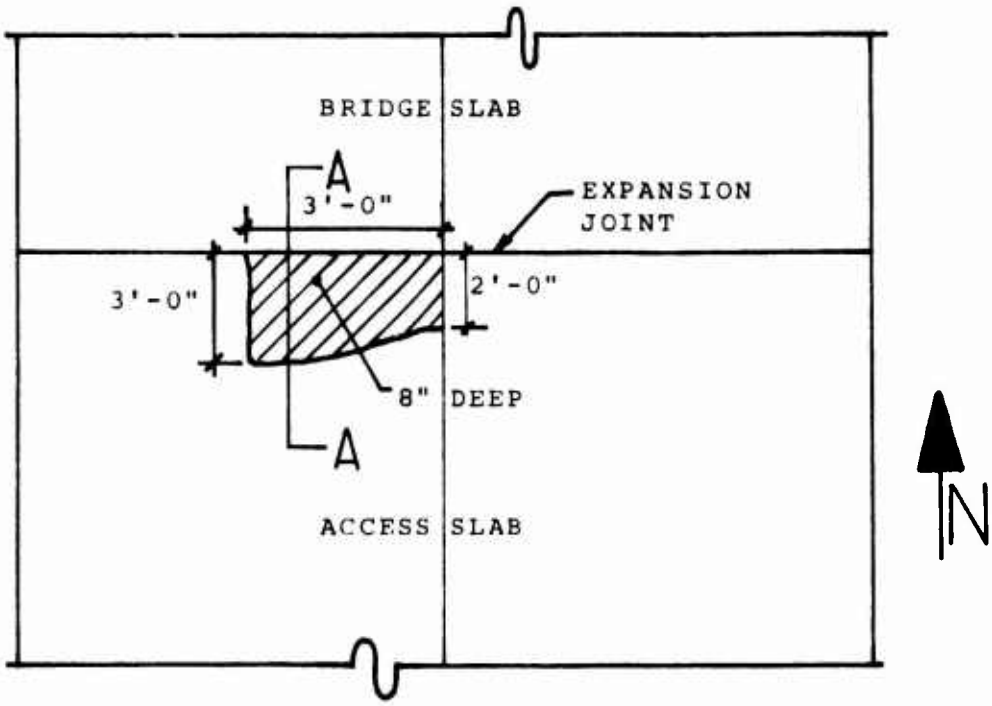
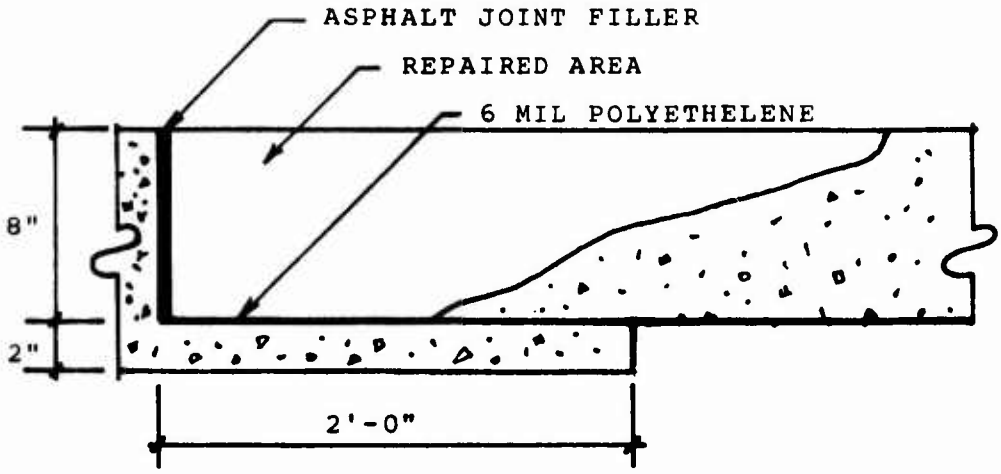
Figure 38. Repair Area 1 on Interstate Highway 35

Area 1. The repair measured 66 x 30 inches by 8 inches deep and was bounded by an expansion joint to the north side. Unsound concrete and asphalt joint filler were removed with an air hammer, and loose debris was cleaned out with compressed air (Figure 40). The concrete was then dried with a portable butane heater to remove possible moisture due to the rain which had fallen the previous day. The bottom of the repair was coated with polyester putty to preserve the expansion joint. Polyester putty was also applied to the vertical face of the adjoining slab, and a 1 x 8-inch board was placed vertically to maintain the expansion joint. A sand and gravel mixture of dried aggregate (40:60 ratio by weight) was placed in the void and screeded to grade. The aggregate was then saturated with the monomer system and finished with concrete trowels at 11:00 AM (Figure 41). There was some leakage at

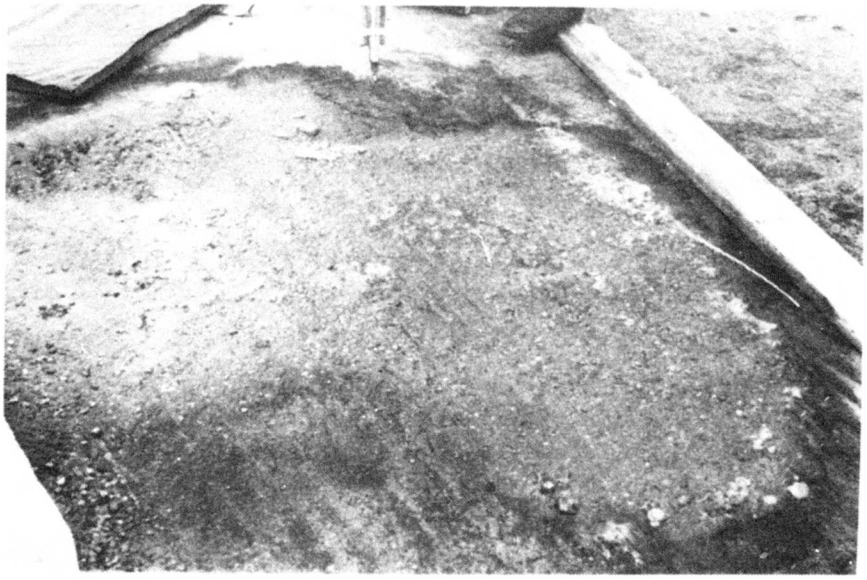
All repairs polyermized in less than 1 hour and were structurally sound. The surface of Repair Area 1 exhibited surface blisters which were theorized to be caused by expanding air from the exotherm reaction being trapped below the semi-hard surface of PC (Figure 50). The effect is only cosmetic and the "blistered" skin is quickly worn away by traffic. The reason for a preliminary surface hardening was the high ambient temperature and rapid cure time. The surface of Area 5 which was screeded rather than troweled contained less blistering of PC. The blistering was absent in Repair Areas 2, 3, and 4 which suggested that blistering was more of a problem in the deeper repairs (Figure 51). Both Areas 1 and 5 indicated a slight volumetric expansion resulting in the surface being 1/8 to 1/4 inch above concrete grade.

Figure 50. Blistering of Area 1

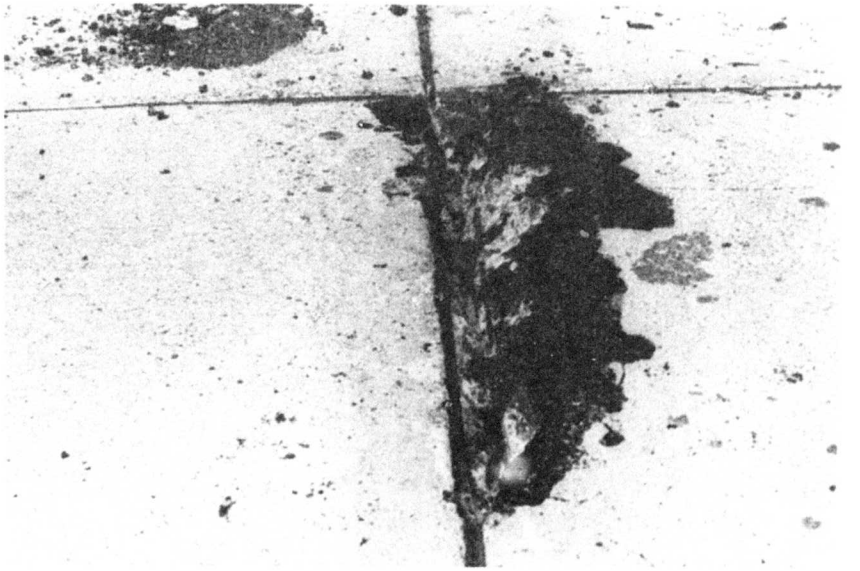
Area 1. The first repair was located at station 57 + 00 to 57 + 04, 12.5 feet south of the centerline (Figure 52). The repair measured 45 x 9 inches with depths varying up to 6 inches and was bounded by two expansion joints (Figure 53). A temporary asphalt repair was removed with an air hammer (Figure 54) and sandblasting (Figure 55). The repair was then cleaned of loose debris with compressed air. The removal of all asphalt was deemed necessary because asphalt tends to retard the curing of the monomer system. Wood strips were fitted along the two edges to maintain the expansion joints. An approximate 50:50 mixture by weight of oven-dried 3/8-inch topping rock and sandblasting was placed in the repair and leveled to grade. The monomer system (Table 17) was added until the aggregate was saturated (Figure 56). The repair was troweled with concrete trowels to produce a smooth finish (Figure 57). The total repair time of Area 1 was longer than normal because of several equipment breakdowns of the air hammer and sandblasting equipment. The monomer was not added until 12:00 noon, with final polymerization occurring by 1:10 PM (Figure 58). A total of 24,000 cc's of monomer was used to complete the repair, approximately twice the estimated amount because of severe leakage in the expansion joint.

Figure 54. Repair Area 1 After Removal of Asphalt

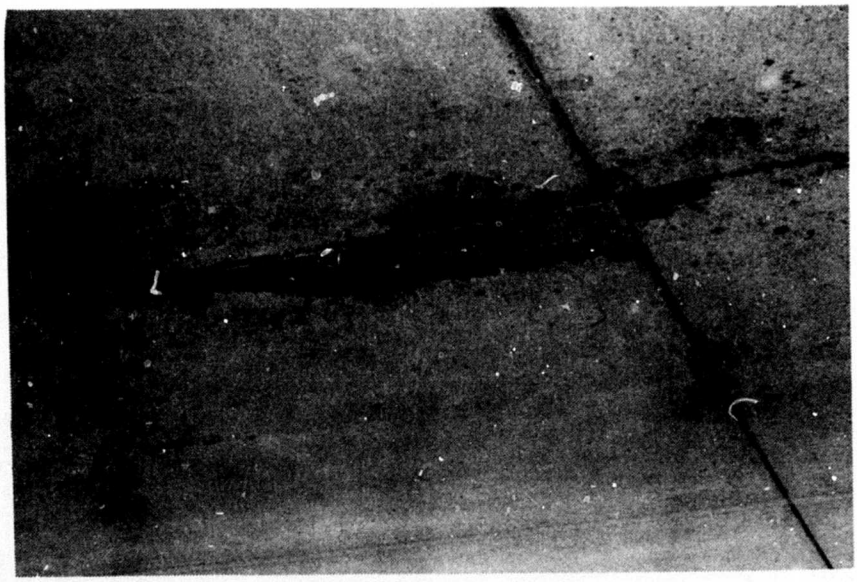
Figure 58. Completed Repair of Area 1

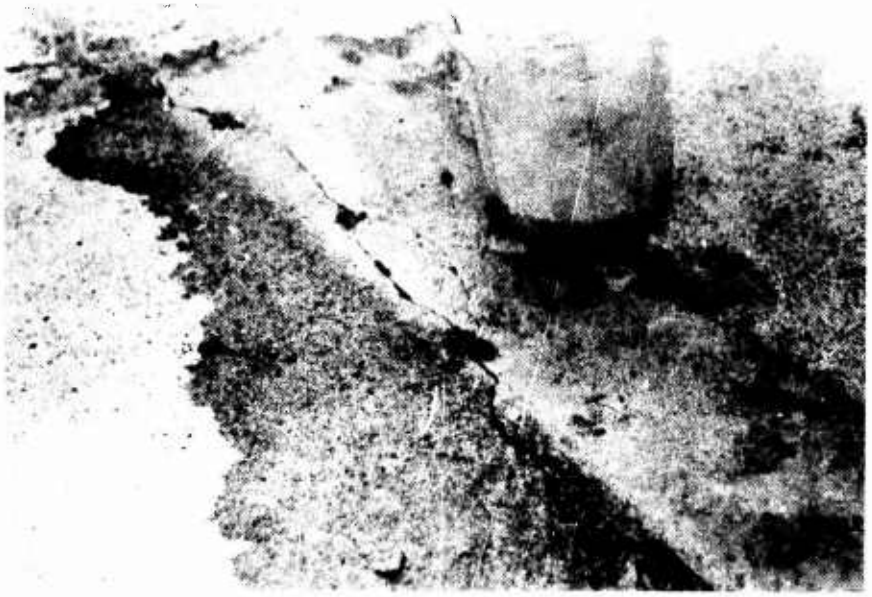
Area 4. It was noticed during the removal of loose concrete from Area 3 that monomer from Repair Area 2 flowed into the crack up to 3 feet away and had polmerized, bonding the concrete together on each side of the crack. This discovery led to experimenting with a new technique for repair in Area 4. It was decided, rather than air hammer out the crack concrete, to drill 1/2-inch diameter holes 6 inches deep along the crack at approximately 6-inch intervals (Figure 63). The holes were filled with sand and saturated with monomer (Figure 64). The monomer cured in approximately 1/2 hour and appeared to have good penetration into the crack.

Figure 64. Saturating Area 4 with Monomer
