Hot/Wet Environmental Degradation of Honeycomb Sandwich Structure Representative of F/A-18: Flatwise Tension Strength

DSTO-TR-0908

Airframes and Engines Division
Aeronautical and Maritime Research Laboratory

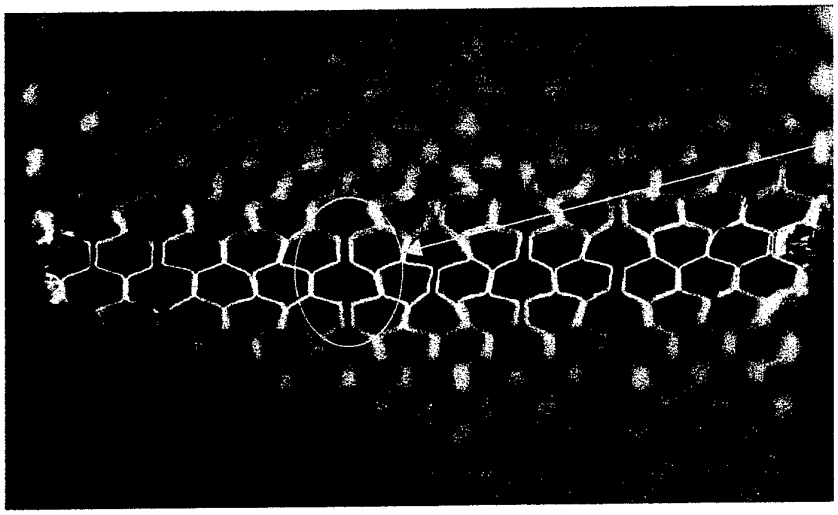
Figure 3 shows the degradation of adhesive node bonds in a honeycomb sandwich beam exposed to a tropical environment for a long time period. The beam illustrates both node and fillet bond degradation. There is no skin to core (fillet) adhesive left on the honeycomb core indicating an adhesive failure mechanism. The gaps between many of the honeycomb nodes are a consequence of extensive node bond degradation.

Node bond degradation along core ribbon direction.

Also note lack of any residual skin to core adhesive.

Figure 3 Degradation of node and fillet bonds in aluminium honeycomb core structure

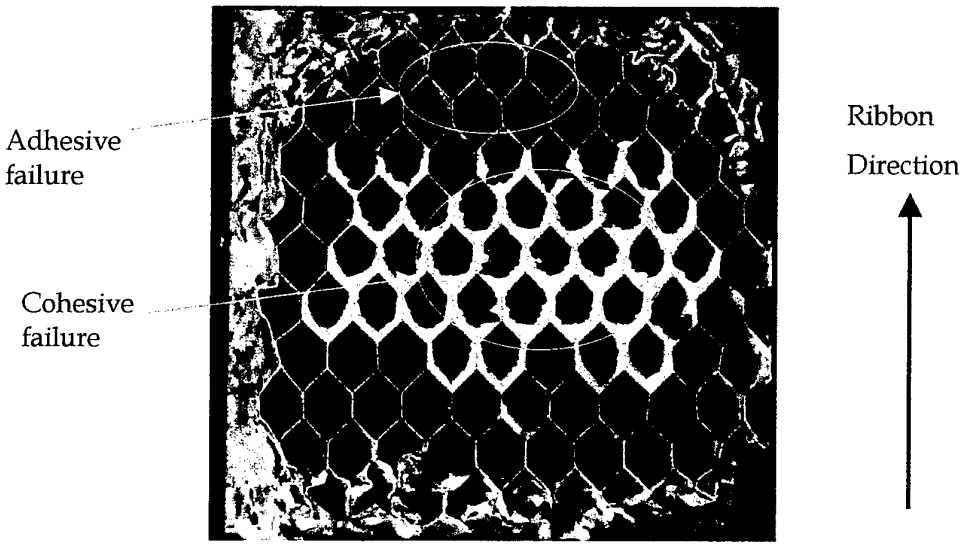
Figure 3 illustrates the way moisture diffuses preferentially along the ribbon direction of the core causing adhesive failure (ie: areas where no adhesive remains on the core). The region of adhesive failure is up to 3 cells from the sample edge in the ribbon direction while in the transverse direction only about one cell shows adhesive failure. This demonstrates the diffusion of moisture through the adhesive which joins the nodes along the "ribbons". Note that the sample also shows signs of corrosion along the perimeter cells.

Figure 3 Degradation of fillet bonds (effect of ribbon direction)

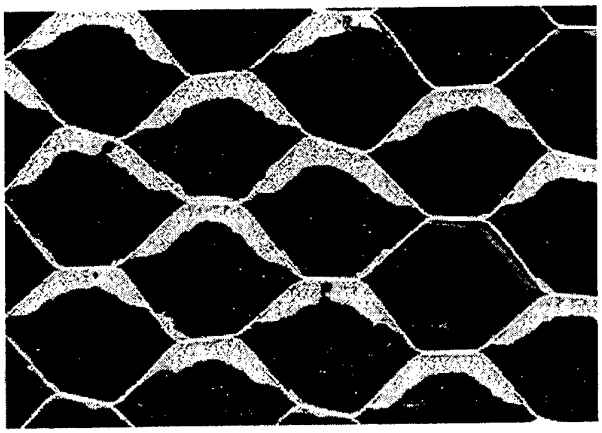
The skin to core fillet was biased in distribution around the perimeter of the core cells in some specimens as shown in Figure 13. Figure 14 shows the degradation of a direct ingress coupon; adhesive failure predominates. Figure 15 clearly shows cracking at a core node bond after being tested to failure in a FWT test. Figure 16 shows further levels of extreme degradation on exposure to liquid water for a period of 16 weeks.

Figure 13 Bias of the amount of adhesive remaining on the core of an environmentally degraded FWT coupon.

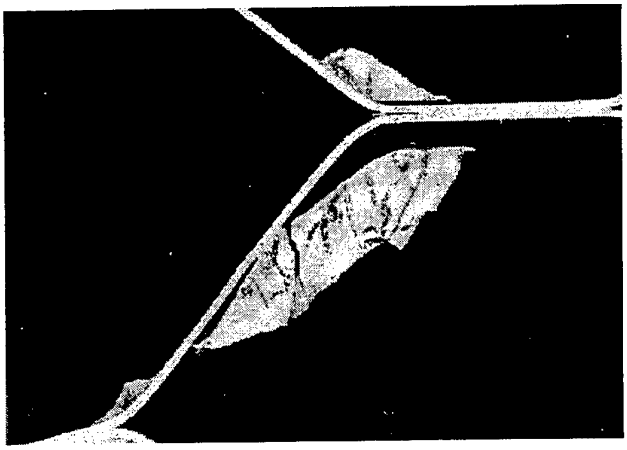
Figure 14. FWT direct ingress test coupon showing the fillet to core bond separation after 16 weeks of exposure (test conducted at room temperature).

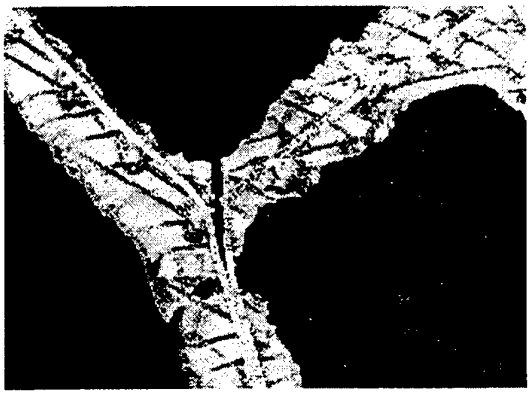
Figure 15. Cracking through the skin to core fillet and into the node bond in a direct moisture ingress sample after 16 weeks exposure.

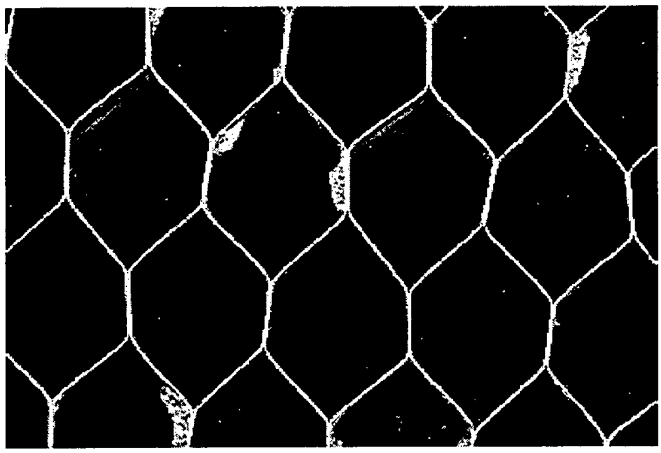
Figure 16. Core cells of a failed FWT test coupon exposed via direct moisture ingress for a period of 16 weeks. The failure surface is virtually purely adhesive.

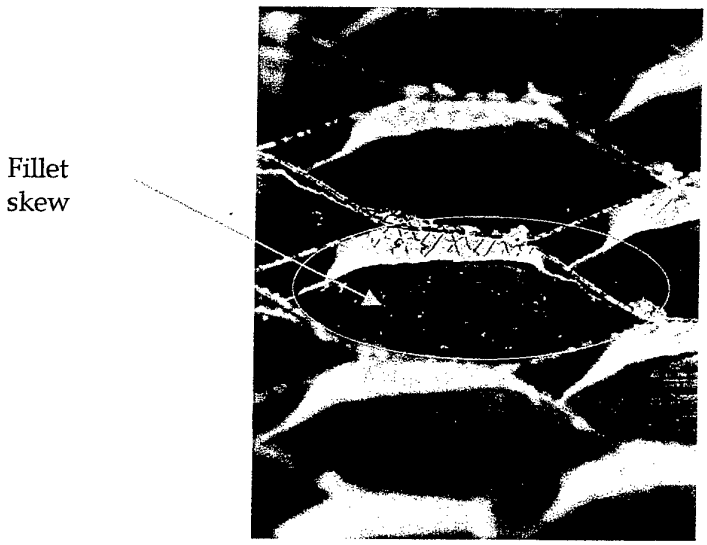
The fillet form was also skewed in some cases as seen in Figure 17. The ideal fillet form would be that of an 'equilateral' triangle, distributed equally around all edges of the cell. The fillet skew identified (Figure 17) shows an uneven distribution of adhesive depth and shape from the top of the cell to the fillet depth. The skew may be due to the cleaning procedure used to prepare the honeycomb material for bonding. Vapour degreasing of honeycomb material may cause impurities to collect on certain sides and to differing depths within the honeycomb cells. This effect has not yet been fully investigated and will receive attention in future testing trials.

Figure 17. Skew and bias in skin to core fillet adhesive.
