Audit Report

CORROSION PREVENTION FOR WHEELED VEHICLE SYSTEMS

Report No. 93-156 August 13, 1993

AUDIT REPORT ON CORROSION PREVENTION FOR WHEELED VEHICLE SYSTEMS

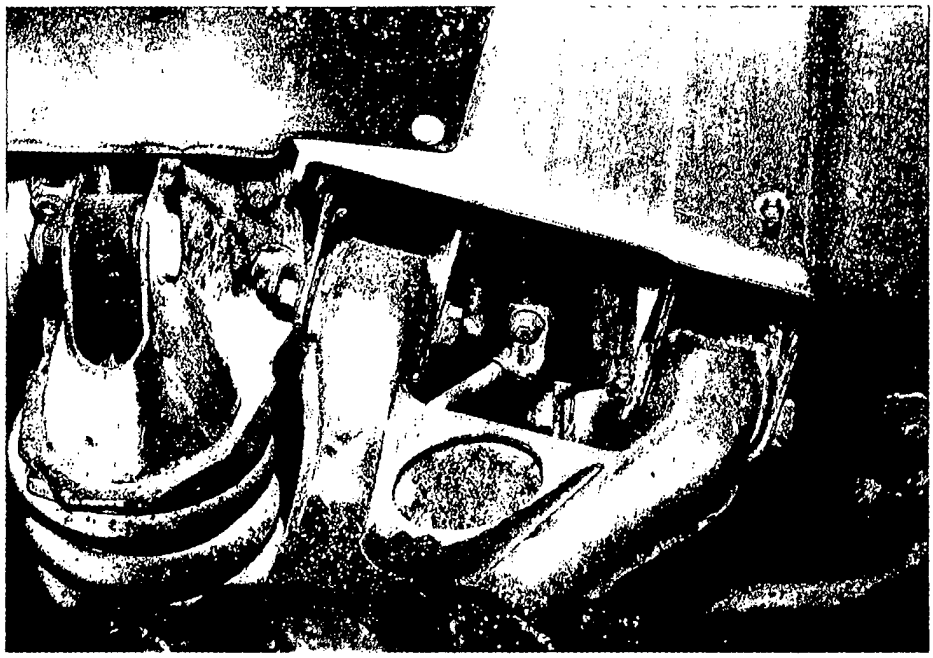
Photograph 1

Photograph 1. Corrosion of suspension and fasteners (Marine Corps HMMWV)

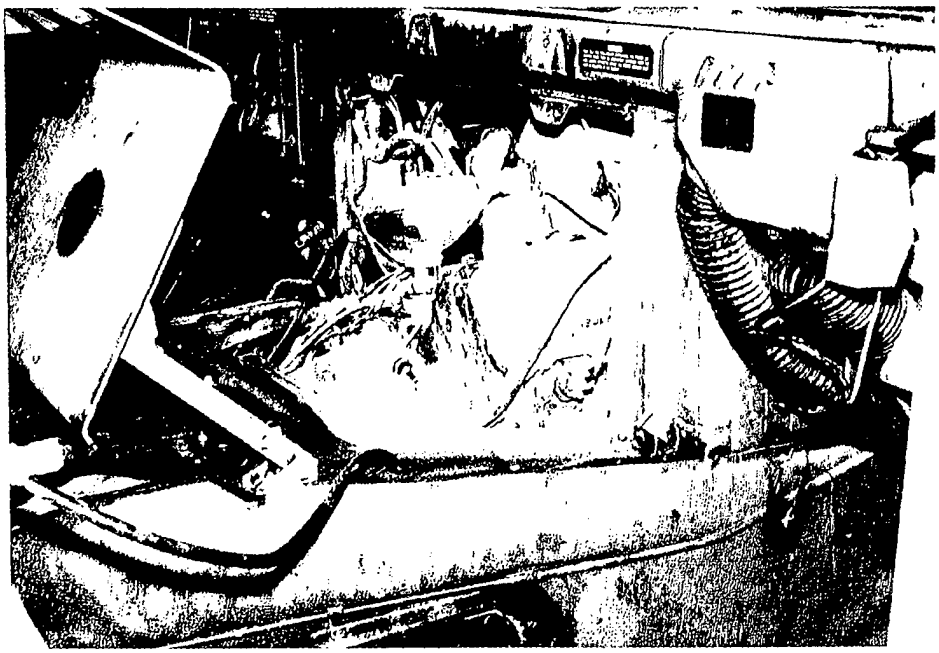
Photograph 2

Photograph 2. Corrosion of engine (Marine Corps HMMWV)

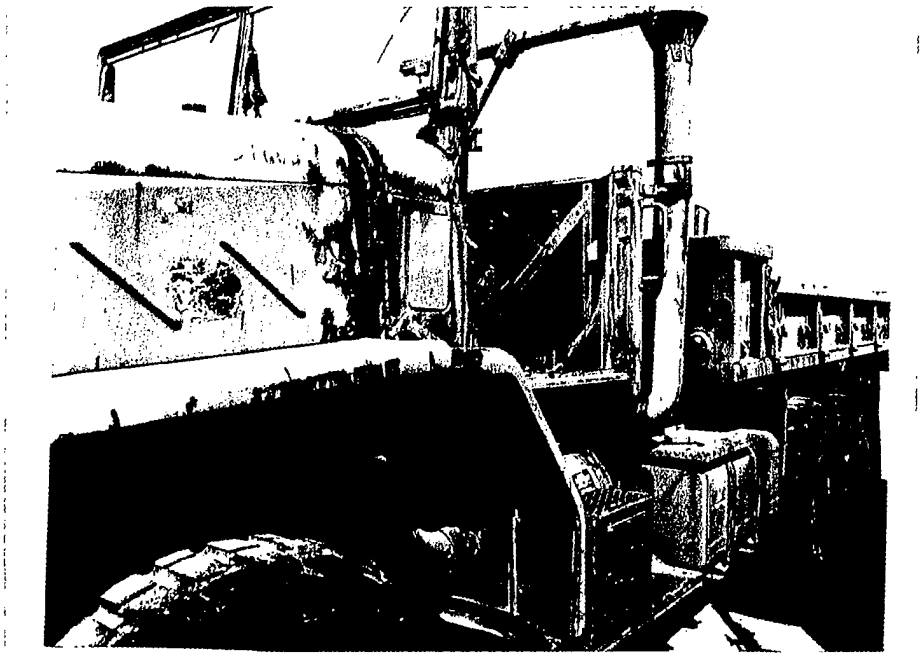
Photograph 3

Photograph 3. Corrosion (Marine Corps 5-ton Truck)
