Damage Assessment in TiB_2 Ceramic Armor Targets

Nevin L. Rupert, William H. Green, Joseph M. Wells, and
Kevin J. Doherty

Army Research Laboratory

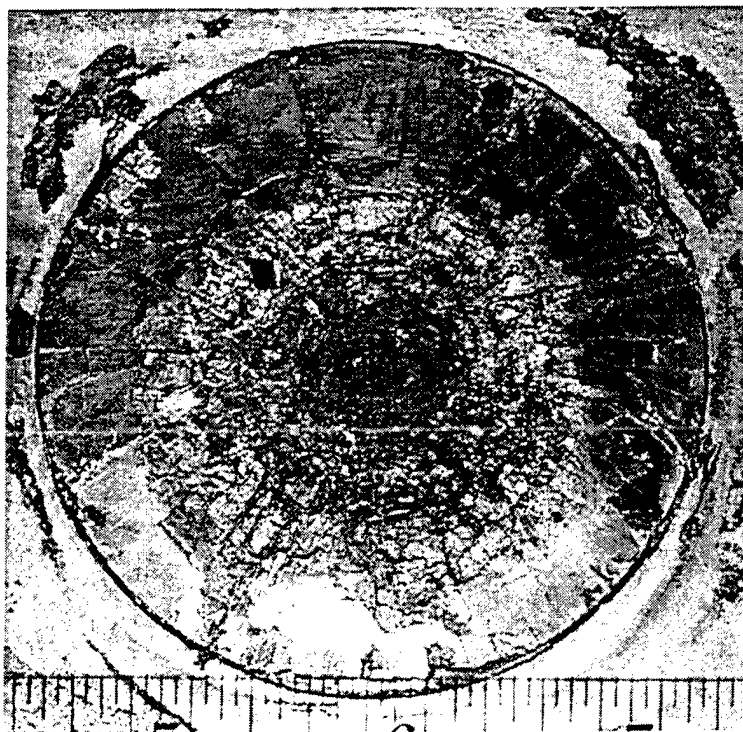
Macro photographs of the three ceramic disk targets after impact are shown in Figures 2, 3, and 4. Figure 2 shows a confined, but not prestressed, target disk. Figures 3 and 4 show prestressed disks using the 17-4PH steel rings for compression, with Figure 3 showing the result of one ballistic impact and Figure 4 showing the result of two sequential impacts. Figure 2 illustrates the typical appearance of a ceramic target when interface flow does not completely erode the penetrator. Initial inspection of the target after the cover plate was removed showed a mixture of residual penetrator material and powdered ceramic adhering to the cover plate. The mixture covered an area approximately 25 mm in diameter and was about 7 mm thick. The remaining ceramic, shown in Figure 2, has a hole perforating the center of the disk, a region of comminuted ceramic surrounding the hole, and extensive radial cracking reaching the outer edges of the disk. Contrast this with the appearance of the ceramic disk in Figure 3, where the penetrator was defeated, which shows very little radial cracking. The penetrator in this disk reached a depth of approximately 11 mm.

The first disk, which was not prestressed using the 17-4PH stainless steel constraining ring, was completely penetrated by the single impact. There was extensive ballistic damage within the disk, including comminuted ceramic damage and both internal and outer radial cracking. The internal cracking originated from areas of comminuted damage and the outer cracking originated from the edges (i.e., the circumference) of the disk. The outer radial cracking was unanticipated and is contrary to current damage models. The CT slices through the disk also showed the presence of complicated banded circumferential damage. The residual penetrator material was dispersed through the thickness of the disk with approximately uniform lateral extent (i.e., columnar).

Figure 2. TiB$_2$ disk without prestress; single impact.

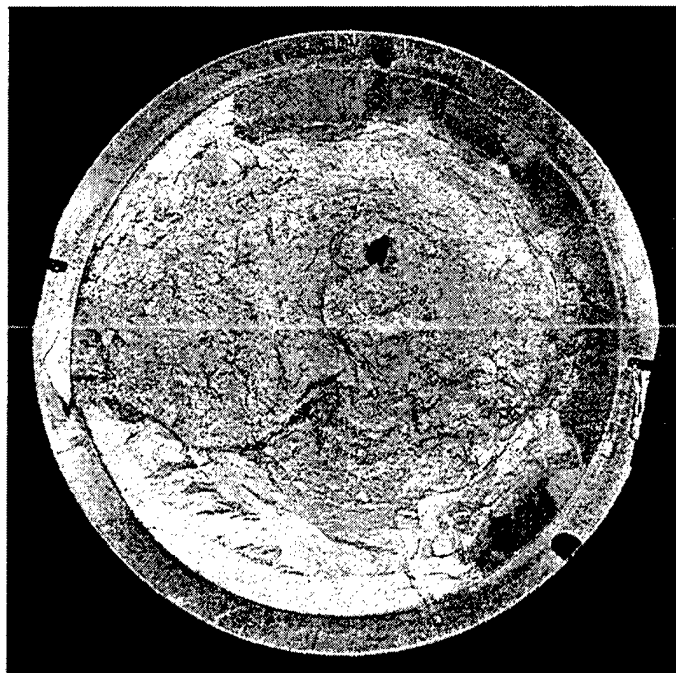
The second disk, which was prestressed, was impacted one time and exhibited extensive lateral flow of penetrator material. The penetrator reached a depth of approximately 11 mm and there was very little damage within the disk excluding the impact crater, including considerably reduced radial cracking. The differences in impact damage in this disk compared to the first disk (confined-only) can be attributed mainly to the compressive prestress resulting from the constraining ring.

Figure 3. TiB$_2$ disk with prestress; single impact.

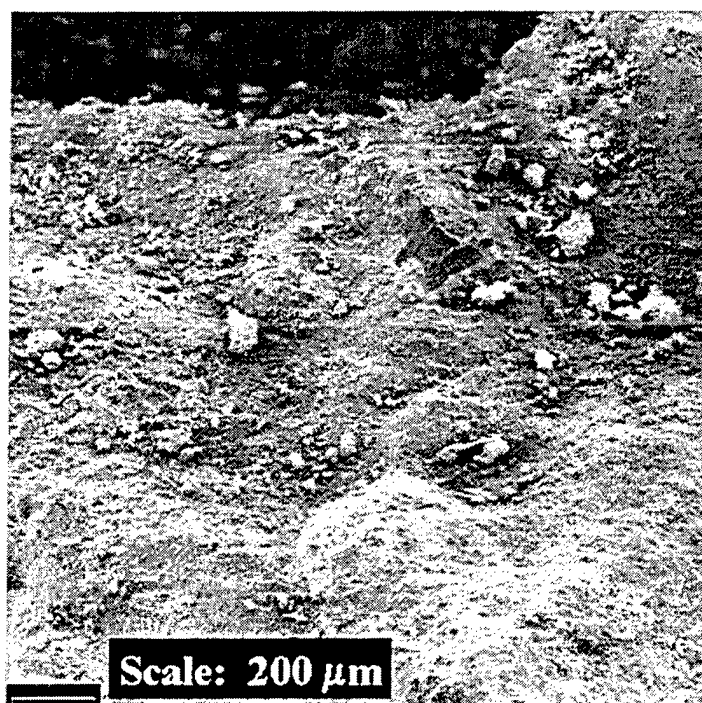
Figure 5. SEM image of single impacted disk.

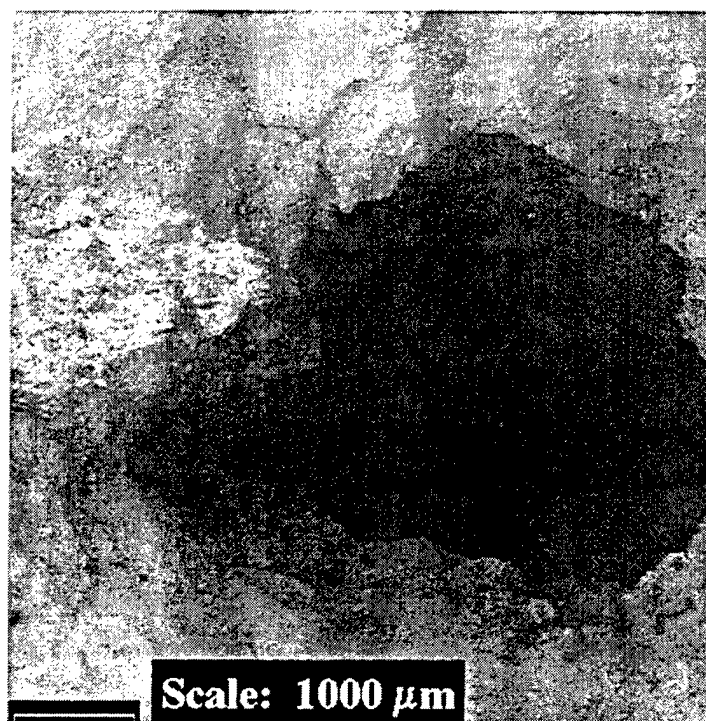
Figure 6. SEM image of dual impacted disk.

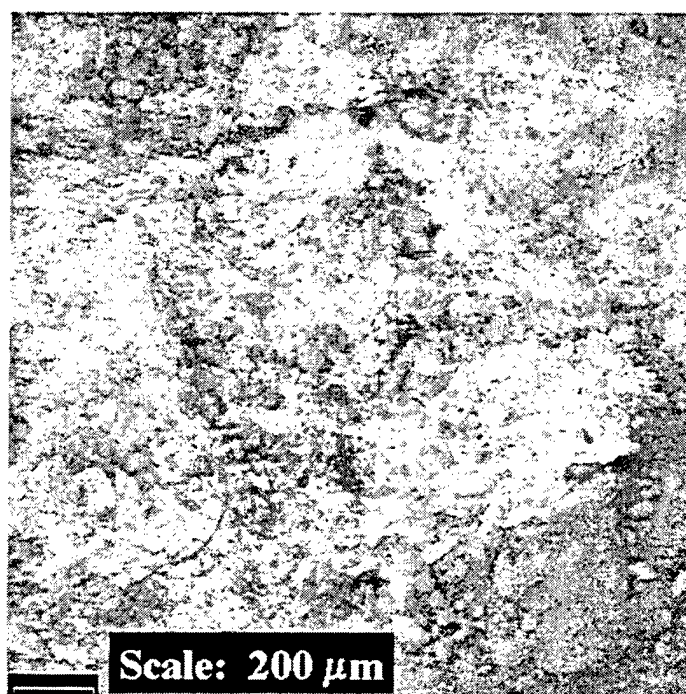
Figure 7. SEM image in area of crater from second impact on disk.

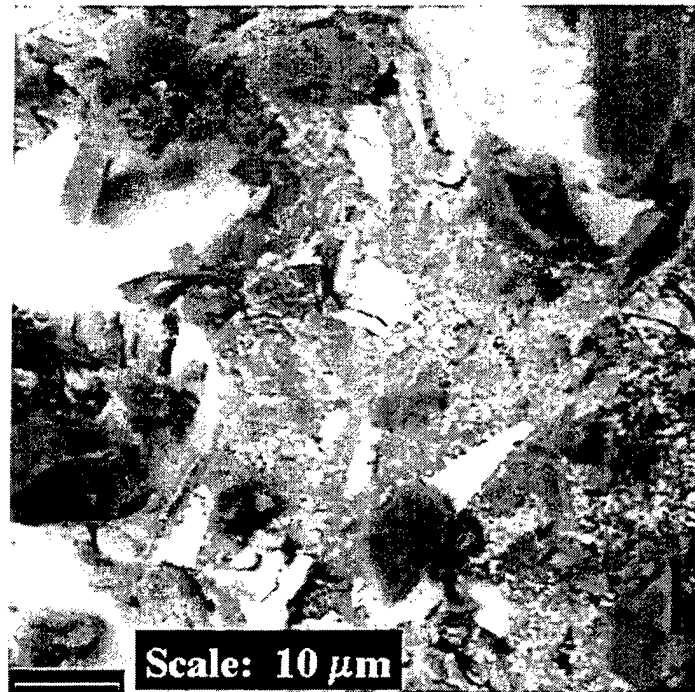
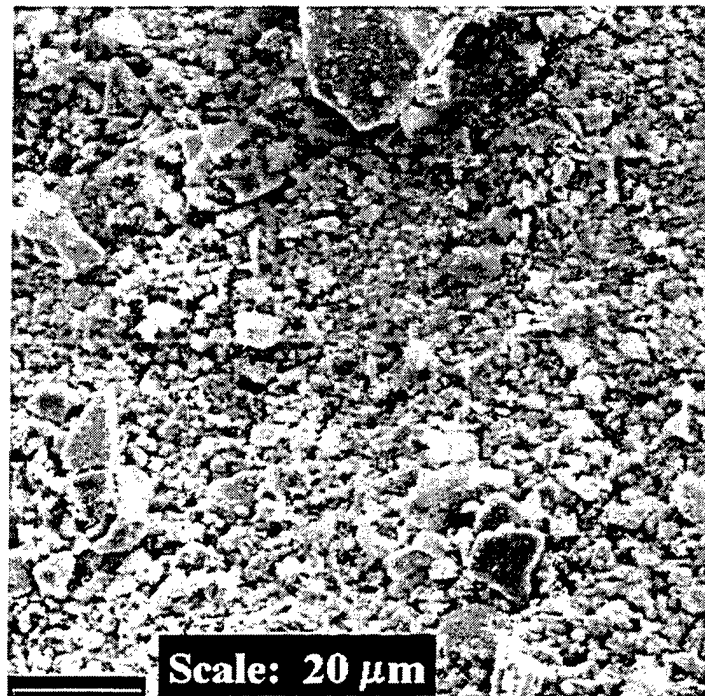
SEM images from the sequentially impacted disk also show a significant amount of comminuted ceramic adhered to the surface of the disk. Figure 10 was taken closer to the overall impact zone and shows a higher number of smaller pieces of comminuted ceramic. Figure 11, taken at increased distance from the impact zone, shows fewer smaller pieces as well as some relatively larger pieces of comminuted ceramic.

Figure 8. SEM image of tungsten region near penetration channel.

Figure 9. Higher magnification image of tungsten region.

Figure 10. SEM image 3 mm from penetration channel.

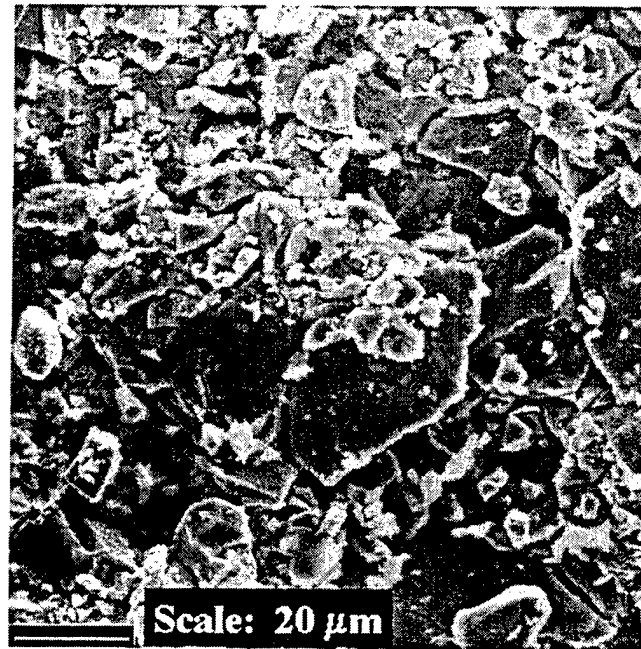
Figure 11. SEM image 13 mm from penetration channel.

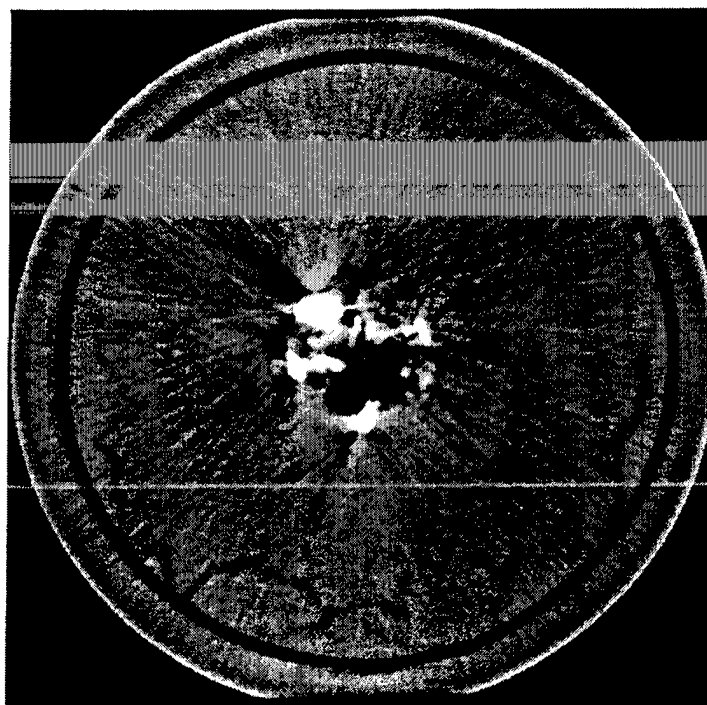
Figure 13 is a flash radiograph of a long rod penetrator as it is in the process of perforating a TiB$_2$ ceramic disk. This radiograph illustrates the presence of a limited initial lateral flow of the penetrator material on the ceramic surface prior to penetrating the disk. A CT scan 21.0 mm from the impact face is shown in Figure 14. The extent of the diameter of the disk is within the black ring. A flower petal-like pattern of dark band delimited ceramic damage is evident near the outside edges of the disk. Figure 14 also shows the presence of residual

Figure 14. CT slice 21.0 mm from impact face of TiB_2 disk in test no. R-7.

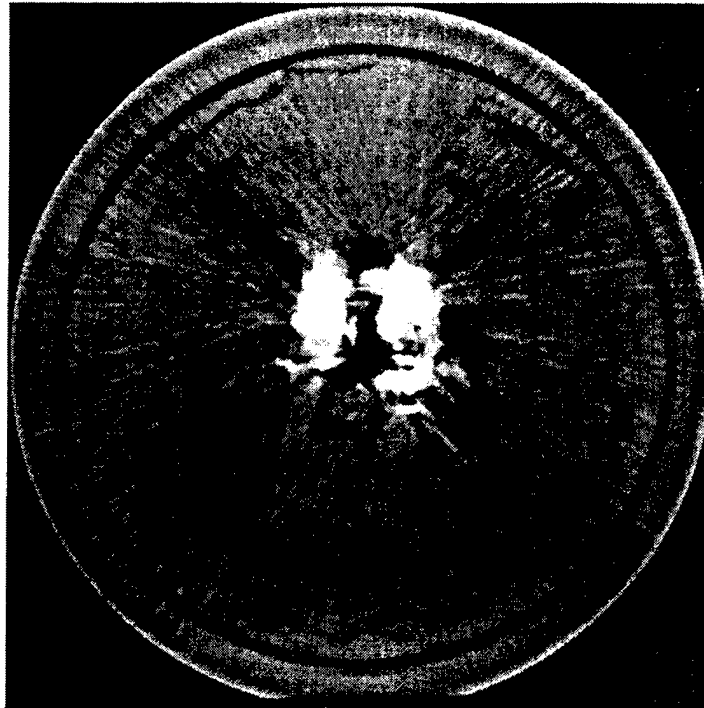
Figure 15. CT slice 4.5 mm from impact face of TiB$_2$ disk from test no. R-7.

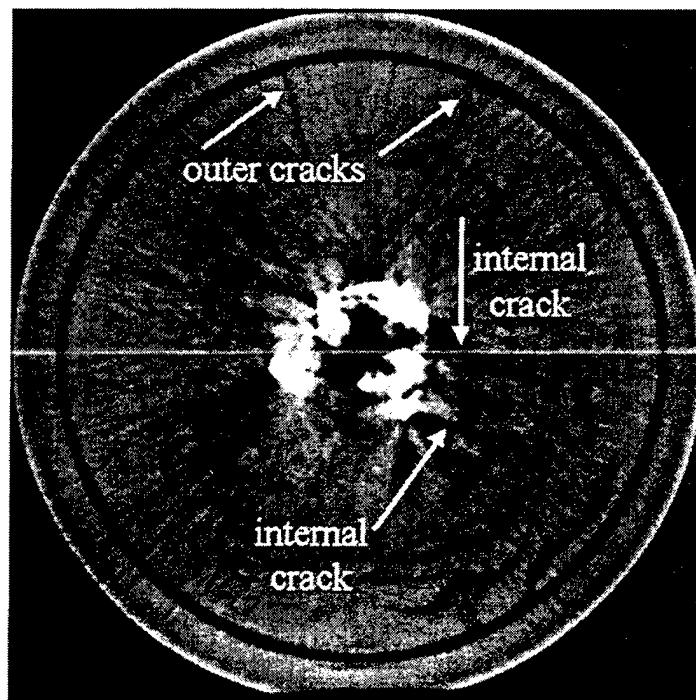
Figure 16. CT slice 3.0 mm from impact face showing two outer radial cracks in the TiB$_2$ disk from test no. R-7.

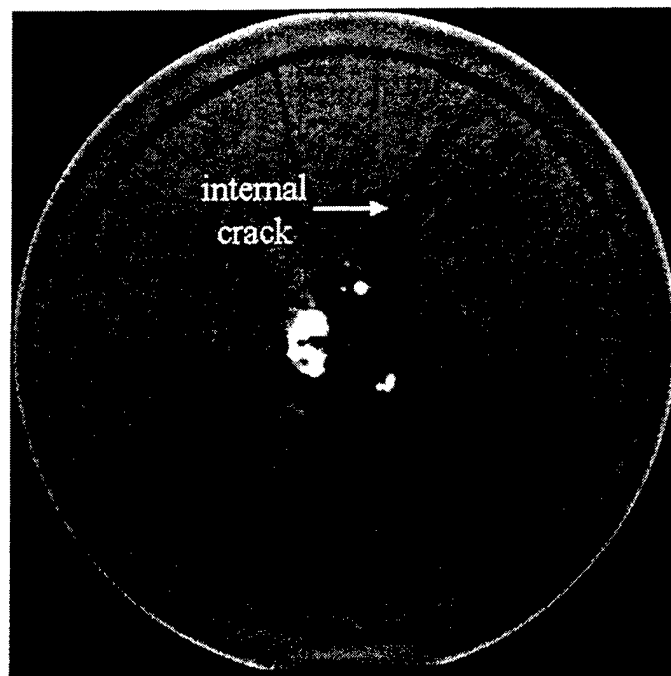
Figure 17. CT slice 1.0 mm from impact face of TiB_2 disk from test no. R-7.

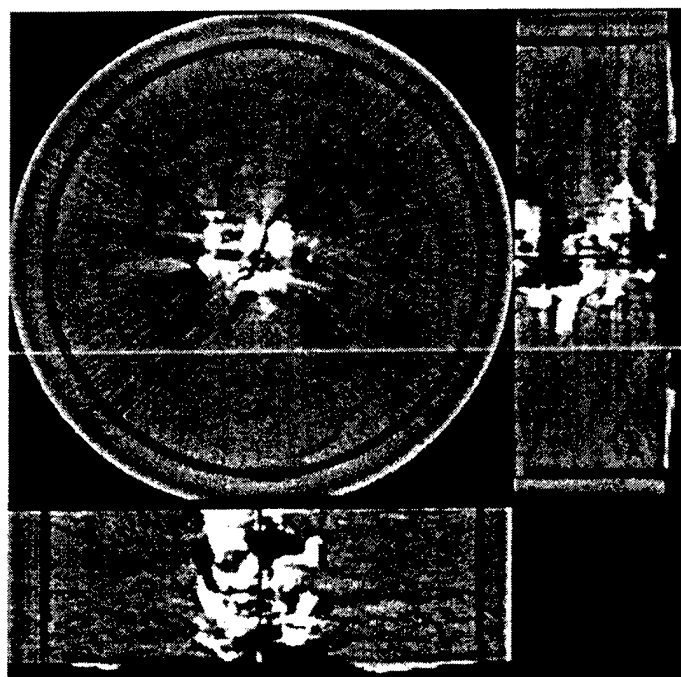
Figure 18 is an MPR image showing two perpendicular slices to the top slice view (top left), which is parallel to the CT scan plane. The top slice view passes through the midplane of the disk. The front slice (bottom) and side slice (top right) views are orthogonal 25-mm-thick slices in the through-thickness direction of the disk, which, in this case, pass through the approximate center of the disk. The MPR image shows the cracking and comminuted damage, as well as the non-uniform columnar placement of residual penetrator material, within the disk in these views. In general, the three different views can be arbitrarily located anywhere within the disk.

Figure 18. MPR image showing three perpendicular slice views for the TiB_2 disk from test no. R-7.

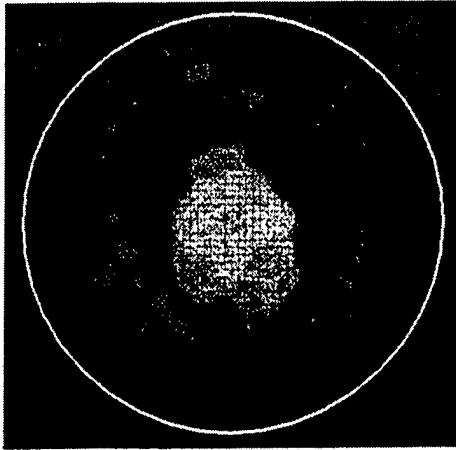
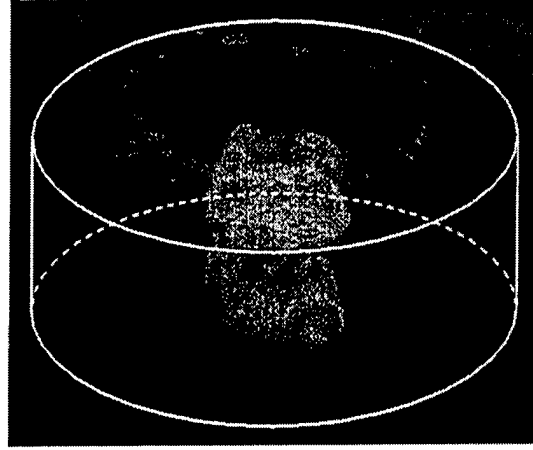
Figure 19(a) is a 3-D solid image of the entire disk with the impact face at the top of the image. Figure 19(b) is a 3-D solid image of the disk with approximately half of it "virtually" cut off perpendicular to the impact face (i.e., a semicircular section). This image shows damage and residual penetrator material in the virtual sectioned face. That is, if the disk were actually physically sectioned at the virtual location the revealed surface would have the damage and residual penetrator material as shown in Figure 19(b), assuming the sectioning process did not obscure or destroy it. Figure 19(c) is a further sectioned 3-D solid image showing only 1/4 of the entire disk.

Figure 19. 3-D solid images of the TiB$_2$ disk from test no. R-7.

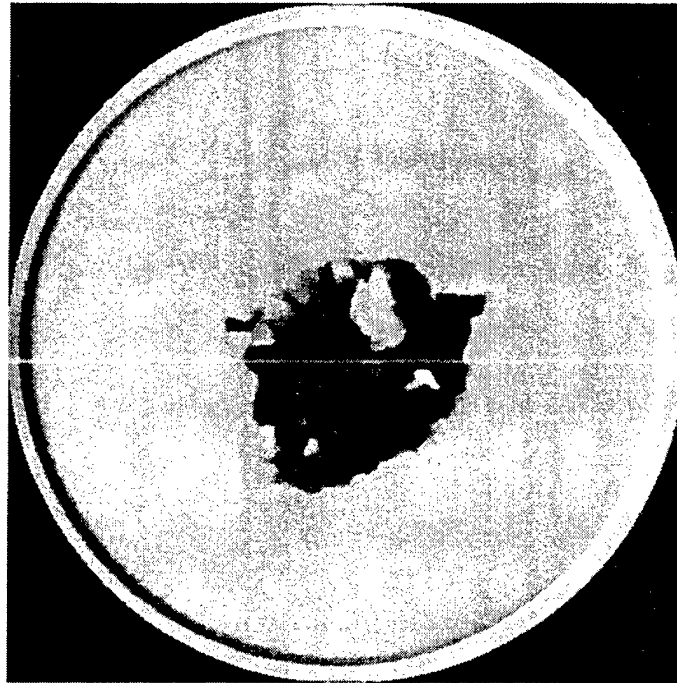
Figure 21 shows a static post-mortem flash radiograph of the residual penetrator material within the disk, in which the presence of extensive lateral flow of penetrator material is evident. A CT scan 22.5 mm from the impact face is shown in Figure 22. The extent of the diameter of the disk is within the black (on the left) and white (on the right) ring. Figure 22 shows that the disk has excellent physical integrity at this depth location, which is representative of the CT scans beneath the impact crater. Figure 23 is a CT scan 3.0 mm from the impact face

exhibiting no radial cracking, some fractured ceramic above the crater, and very little residual penetrator material within the crater. The disk material outside of the crater is largely intact, except for the relatively small band of fractured ceramic. Again, these characteristics are representative of the disk in the CT slices containing the crater.

Figure 23. CT slice 3.0 mm from impact face of the TiB$_2$ disk used in test no. 340.

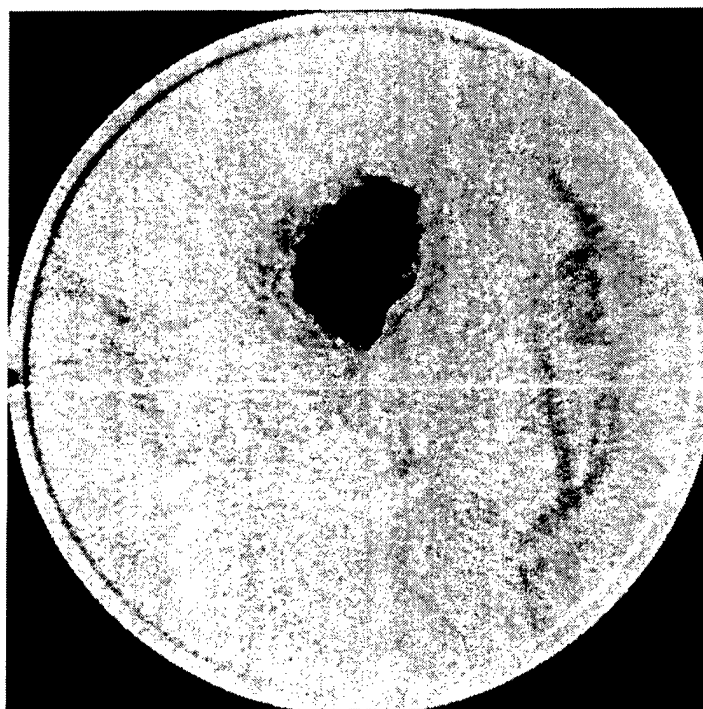
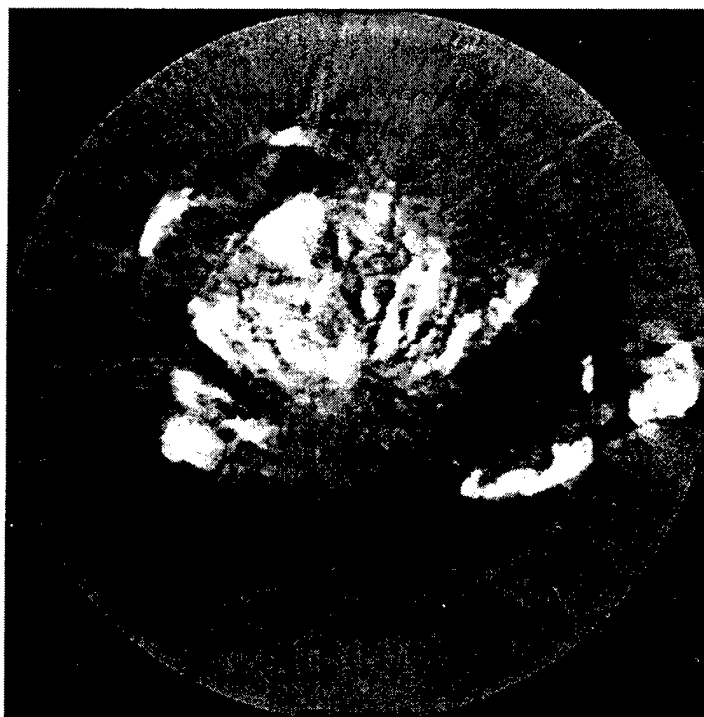
Figure 24 shows a static post-mortem flash radiograph of the second impact into the ceramic disk shown in Figure 22 (section 3.3.5). Additional lateral flow of the penetrator material is not evident when compared with Figure 21. A CT scan 23.5 mm from the impact face is shown in Figure 25. Figure 26 shows a CT scan 3.5 mm from the impact face with significantly more residual penetrator material, which has the effect of obscuring relatively small radial cracking, especially internal cracking, due to the streaking artifact. Figure 27(a) is a 3-D point cloud looking in the through-thickness direction of the combined residual penetrator material left in the disk after both impacts (it is upside down relative to Figure 25). In Figure 27(b), the orientation of the point cloud is the same as in Figure 20(b). The bimodal distribution of the combined residual penetrator material is evident in Figure 27(b) and the material is widely dispersed. The "partial cloud" more towards the center of the disk with greater depth is from the second impact, which perforated the rear face of the disk. Radial cracking is heavily masked in the CT scan in Figure 26 because of the residual penetrator material. Consequently, the disk was scanned perpendicular to the impact face as discussed in section 3.3.3 and MPR images were reconstructed from these scans. Figures 28(a)-(c) are such images, in which only the top slice view (top of image) parallel to the scan plane and front slice view (bottom of image) parallel to the impact face are shown. The front slice view passes through the top slice view perpendicular to the page. In Figure 28(a), the top slice is located near the top edge of the disk as it rested on its side on the (scanning) turntable and the front slice (FS) is 0.97 mm from the impact face, which is at the top of the top slice view. In Figures 28(b) and (c), the top slice is at the same location as in Figure 28(a), but the front slice is 2.15 mm and 3.32 mm from the impact face, respectively. The white material in Figures 28(a)-(c) is the steel constraining ring. At a depth of about 3 mm, the outer radial cracks are less visible and circumferential/laminar cracks appear. The radial cracks in the front slice views are not as long as those in the once-impacted confined-only disk (section 3.3.4). Secondly, these cracks change in size relatively little as a function of depth compared to those in the confined-only disk and they are relatively shallow, having a depth of only about 2 mm.

Figure 25. CT slice 23.5 mm from impact face of the TiB$_2$ disk used in test no. R-1 (2nd).

Figure 26. CT slice 3.5 mm from impact face of the TiB$_2$ disk used in test no. R-1 (2nd).

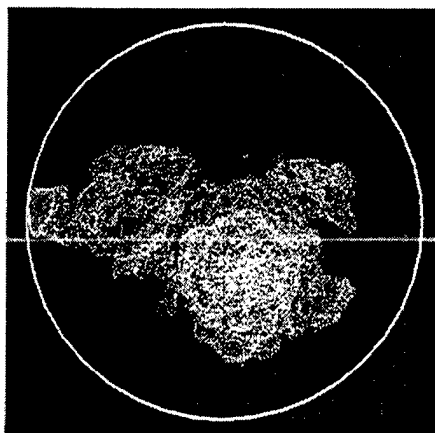
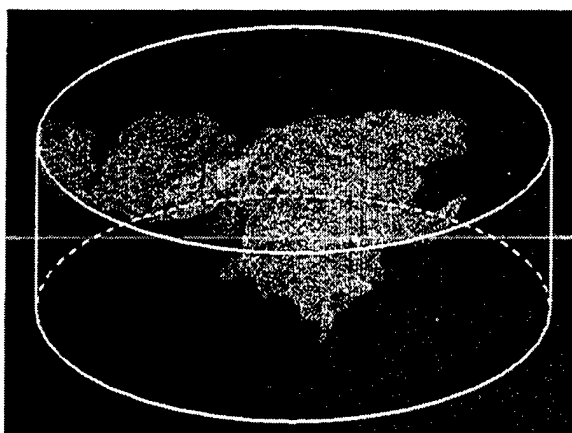
Figure 27.   Combined residual penetrator point cloud of the TiB$_2$ disk used in
test no. R-1 (2nd).
