September 1944 as
Restricted Bulletin E4I07

A POSITIVE-REPLICA TECHNIQUE FOR EXAMINING FINISHED METAL SURFACES AND ITS APPLICATION TO AIRCRAFT-ENGINE CYLINDERS

By Thomas P. Clark

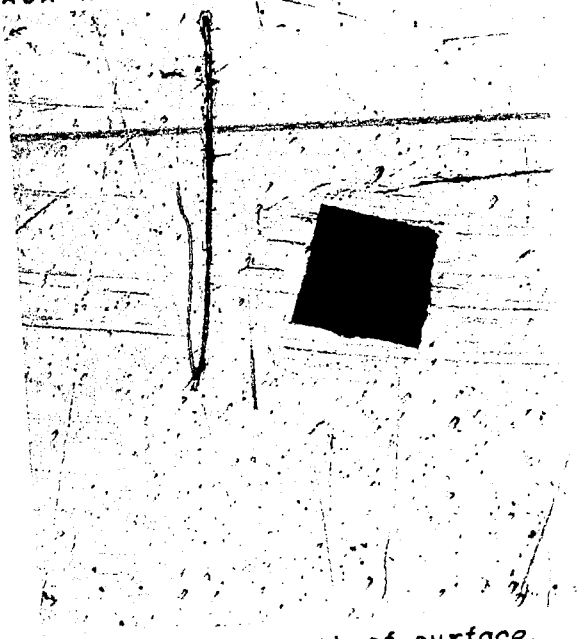
(a) Photomicrograph of surface.

Figure 1(a) is a photomicrograph of a metallographically polished steel surface; figure 1(b) is a photomicrograph of its

Figure 1. - A metallographically polished steel surface with a roughness of 1.5 microinches, rms. X100.

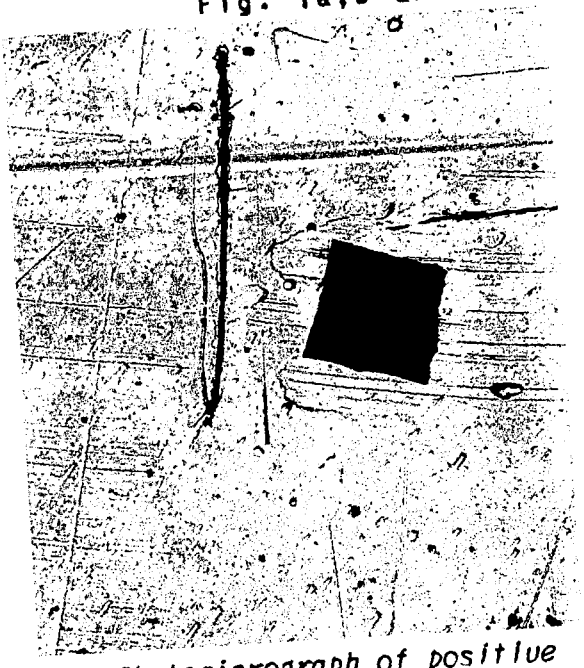
(b) Photomicrograph of positive replica of surface.

Figure 1. - A metallographically polished steel surface with a roughness of 1.5 microinches, rms. X100.

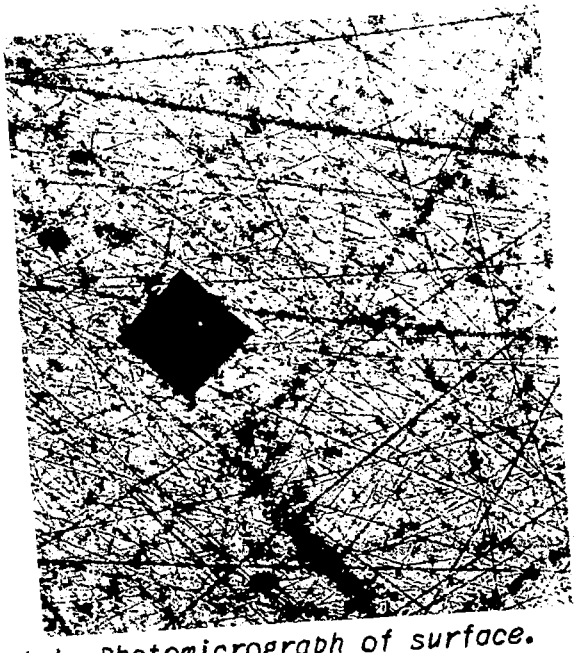
(a) Photomicrograph of surface.

positive replica. Figures 2(a) and 2(b) present a similar treatment of a lapped steel surface. The square holes that are visible in the photomicrographs were made with a Rockwell hardness tester. These figures show the degree of fidelity of reproduction possible with the positive replica. The specimen shown in figure 1(a) had a roughness of 1.5 microinches, rms, as determined by the Brush surface analyzer. Figure 1(b) illustrates the resolution possible with the positive replica at the small roughness value of 1.5 microinches, rms.

Figure 2. - A lapped steel surface with a roughness of 8.0 microinches, rms. X100.

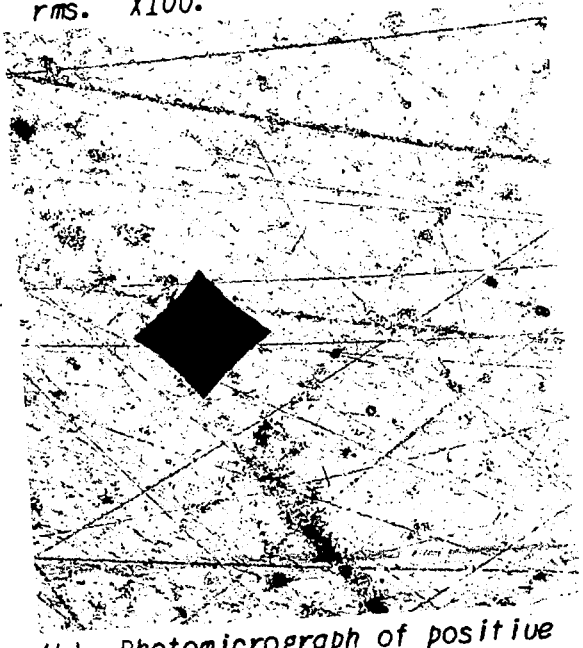
(b) Photomicrograph of positive replica of surface.

Figure 2. - A lapped steel surface with a roughness of 8.0 microinches, rms. X100.

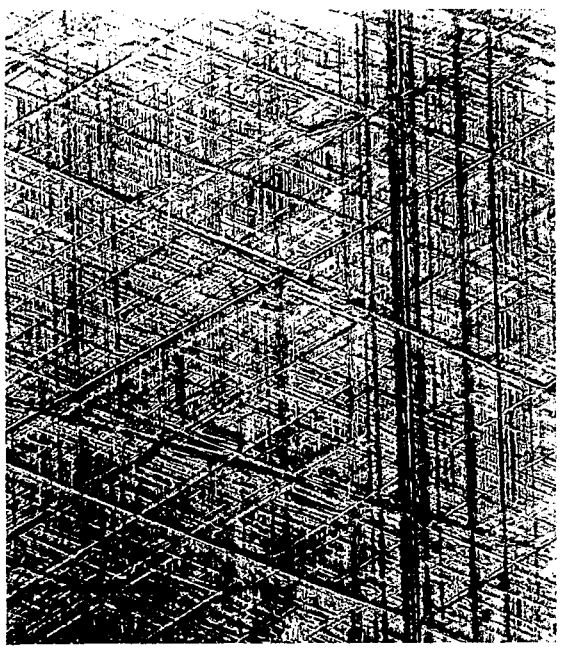
Figure 13 is a replica of the area containing the ring band at the bottom of ring travel in the barrel slightly worn after 33 hours. The ring bands have not yet begun to appear in this area. Figure 14 shows the top ring band at the bottom of ring travel in the worn barrel after 225 hours. In this area, the burnishing effect is not so noticeable as it is at the top of ring travel, but the fringe of smear metal is quite evident. At the top of ring travel the smear points downward whereas, at the bottom of ring travel the smear points upward. The edges of the smears shown in figures 10 and 14 start, in each case, at the forward edge of the ring as it leaves either the top or the bottom position of ring travel.

Figure 13. - A positive replica of the area at the bottom of ring travel of the top ring in an Allison V-1710 cylinder after 33 hours of test running. X112.

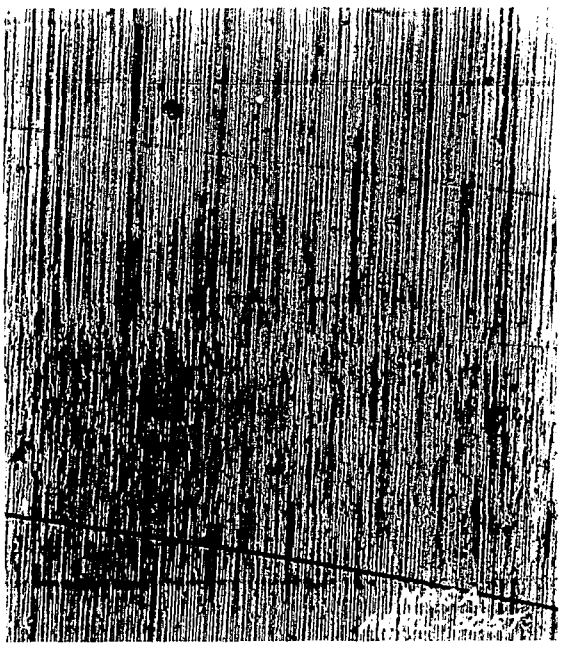
Figure 14. - A positive replica of the area at the bottom of ring travel of the top ring in an Allison V-1710 cylinder after 225 hours of test running. X112.
