Report 1783

DAVID TAYLOR MODEL BASIN
WASHINGTON 7 D.C.

SHOCK TESTING OF FT4A GAS TURBINE ENGINE GAS GENERATOR ON THE FLOATING SHOCK PLATFORM - PHASE I

August 1963 15 Report 1783

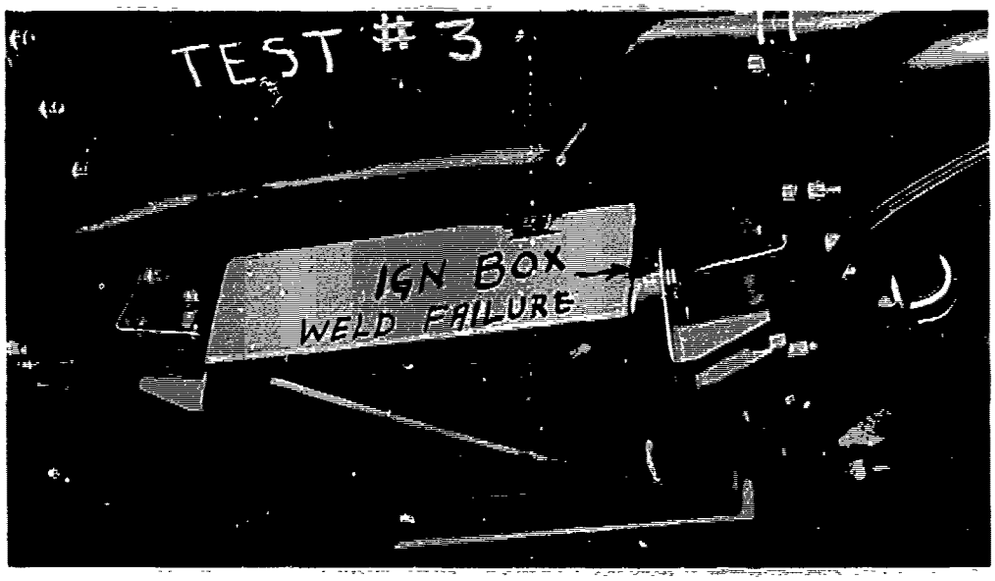
The engine was shut down immediately after the test; no rubbing or associated damage was detected during the rundown. The rotors were turned by hand prior to restarting and again no rubbing was evident. The engine was started and brought up to speed; no defects were observed. The breather lines were pressurized; no drop in pressure was noted (Table 4). Partial failures occurred in all weldments attaching the supporting studs of the ignition box (Figure 7).

Figure 7 - Ignition Box Weld Failure

The engine was started and brought up to speed; no rubbing or other damage was detected. The breather lines were pressurized and no leaks were found (Table 4). The igniter box stud-weld failures experienced on Test 3 increased. On the port side, the ignition lead fitting failed at its connection to the composite box. The top oil tank strap failed and the bottom strap was stretched.

The rear mount suspension bar port side was interchanged with the starboard bar and all bolts were replaced with bolts of same size and strength. An elastic shock cord was placed around the ignition boxes to retain them in position in the event the stud weld should fail completely.

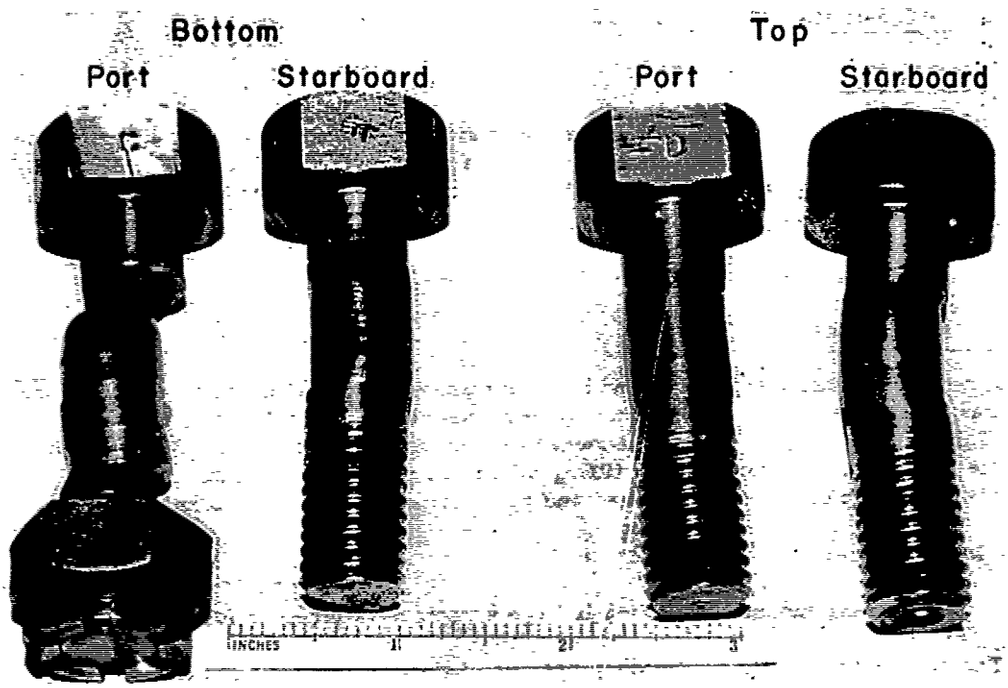
The bottom bolt on the port side suspension bar was sheared and the remaining bolts showed severe shear indentations. The sheared bolt failure is shown in Figures 10 and 11. The other damaged bolts are also shown in Figure 11.

Figure 11 - Damaged Suspension Bar Bolts

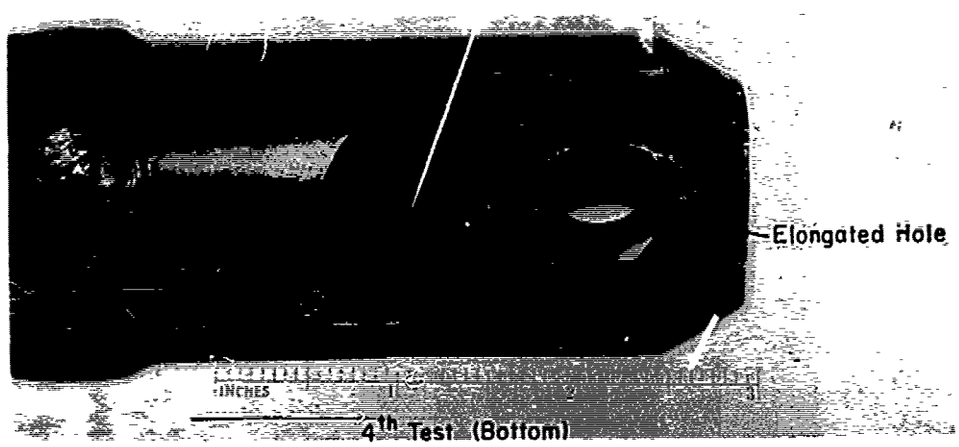
The suspension rod bottom bolt hole was elongated (Figure 12).

Figure 12 - Elongated Hole in Suspension Bar

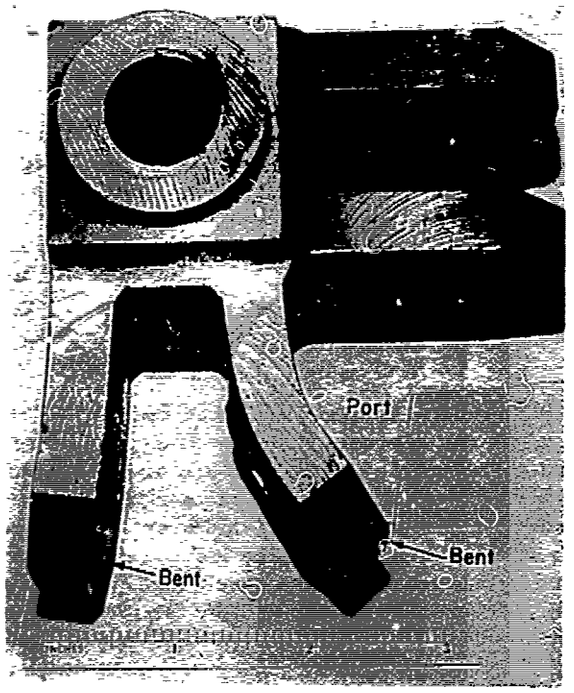
The 90° mount ring coupling port side sustained bending (Figure 13) and an elongation of the bolt hole (Figure 14). (Note indentation of bolt threads inside hole.) The forward mount sustained no visible damage; the linkage bolts were inspected but no shear or bending of the bolts was evident. The flange and holddown mount bolts were checked for torque; no change was noted.

Figure 13 - Damaged 90° Mount Ring Coupling

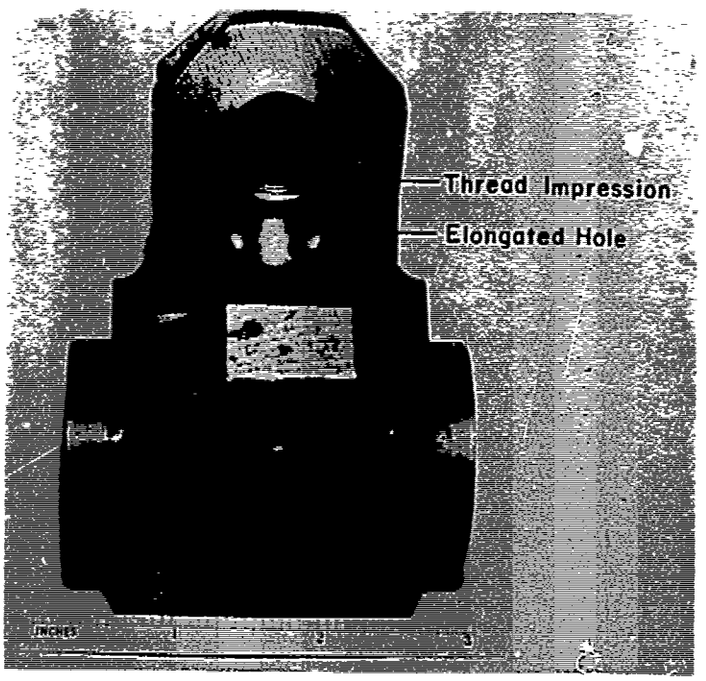
Figure 14 - Elongated Hole in 90° Mount Ring Coupling
