MEMORANDUM REPORT

NO. WAL 710/593

Metallurgical Examination of Face Hardened Armor Plate

DATE 29 February 1944

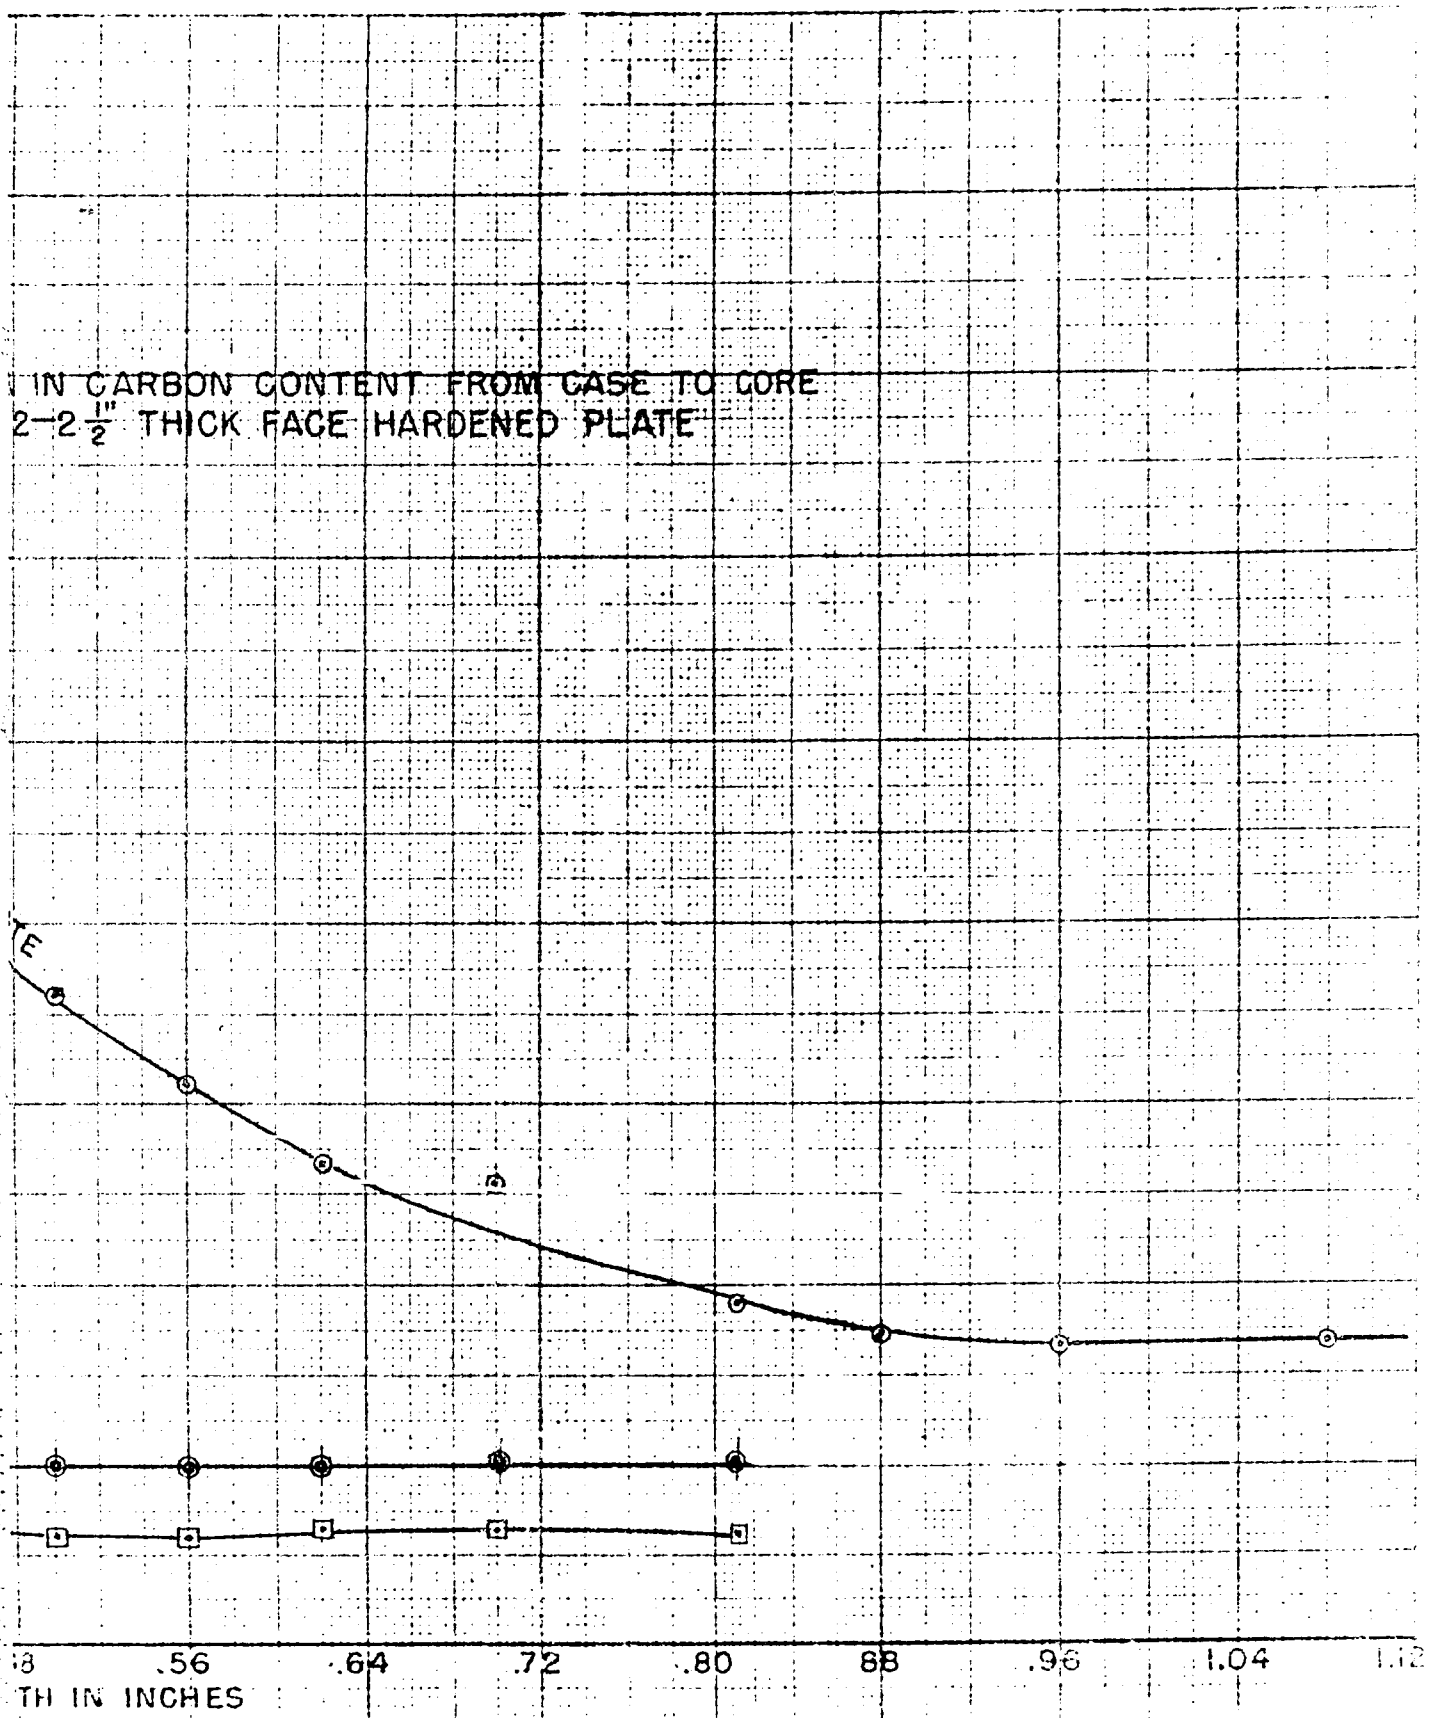
FIGURE 1

The variation in the carbon content from the outer carburized case to the core is presented in Table II and also is plotted in Figure 1.

A survey of the carbon distribution in the carburized cases of the Disston Plates Nos. 1, 2 and 3 indicates that depth of case in these plates varies from 1/4" to 5/16". These carburized cases are too shallow for plates of the thicknesses involved. The carbon content in the outer layers of these cases varied from 0.84-1.07% C.

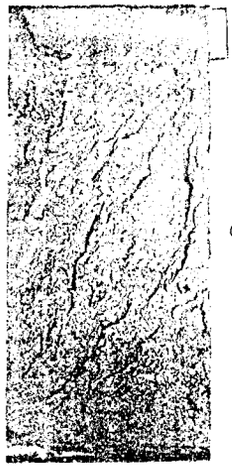
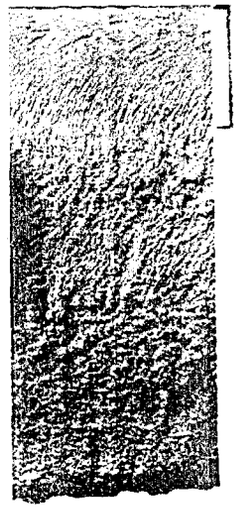
FIGURE 2

The results of the fibre test indicated that the base compositions of the Disston plates were not thoroughly quenched out resulting in crystalline fractures when given the fibre test. As noted in Table I, the alloy content of these Disston plates was not sufficient to promote adequate hardenability. The alloy content of the Carnegie-Illinois plate was sufficient with the medium percentage of carbon to result in adequate hardenability, thereby exhibiting a fibrous fracture when subjected to the fibre test. The fractures of the carburized cases of the Disston plates were fine and coarsely crystalline. The fracture of the carburized case of the Carnegie-Illinois plate was of a fine silky nature, especially in the outer layers. The total depth of the carburized case was readily revealed in the fibre fracture test, see the fracture of Disston Plate No. 2 in Figure 2. The light layer extending about 0.2" from the surface of the plate into the carburized case is really the effective part of the case, that is, the region containing tempered martensite and some carbides but no ferrite.

The results of these tests showed that the Carnegie-Illinois plate No. 4 had a "3" rating according to the standards given in Specification AXS-488 Revision 2, see Figure 2. Because of the fact that a crystalline fracture was obtained on the Disston plates, Nos. 2 and 3, it was impossible to determine the steel quality rating of these samples. The depth of case was readily detected in the fracture test for steel quality, see the fracture of the Carnegie-Illinois plate No. 4, Figure 2.

SAMPLE # 2
FIBRE TEST

SAMPLE # 4
STEEL QUALITY TEST

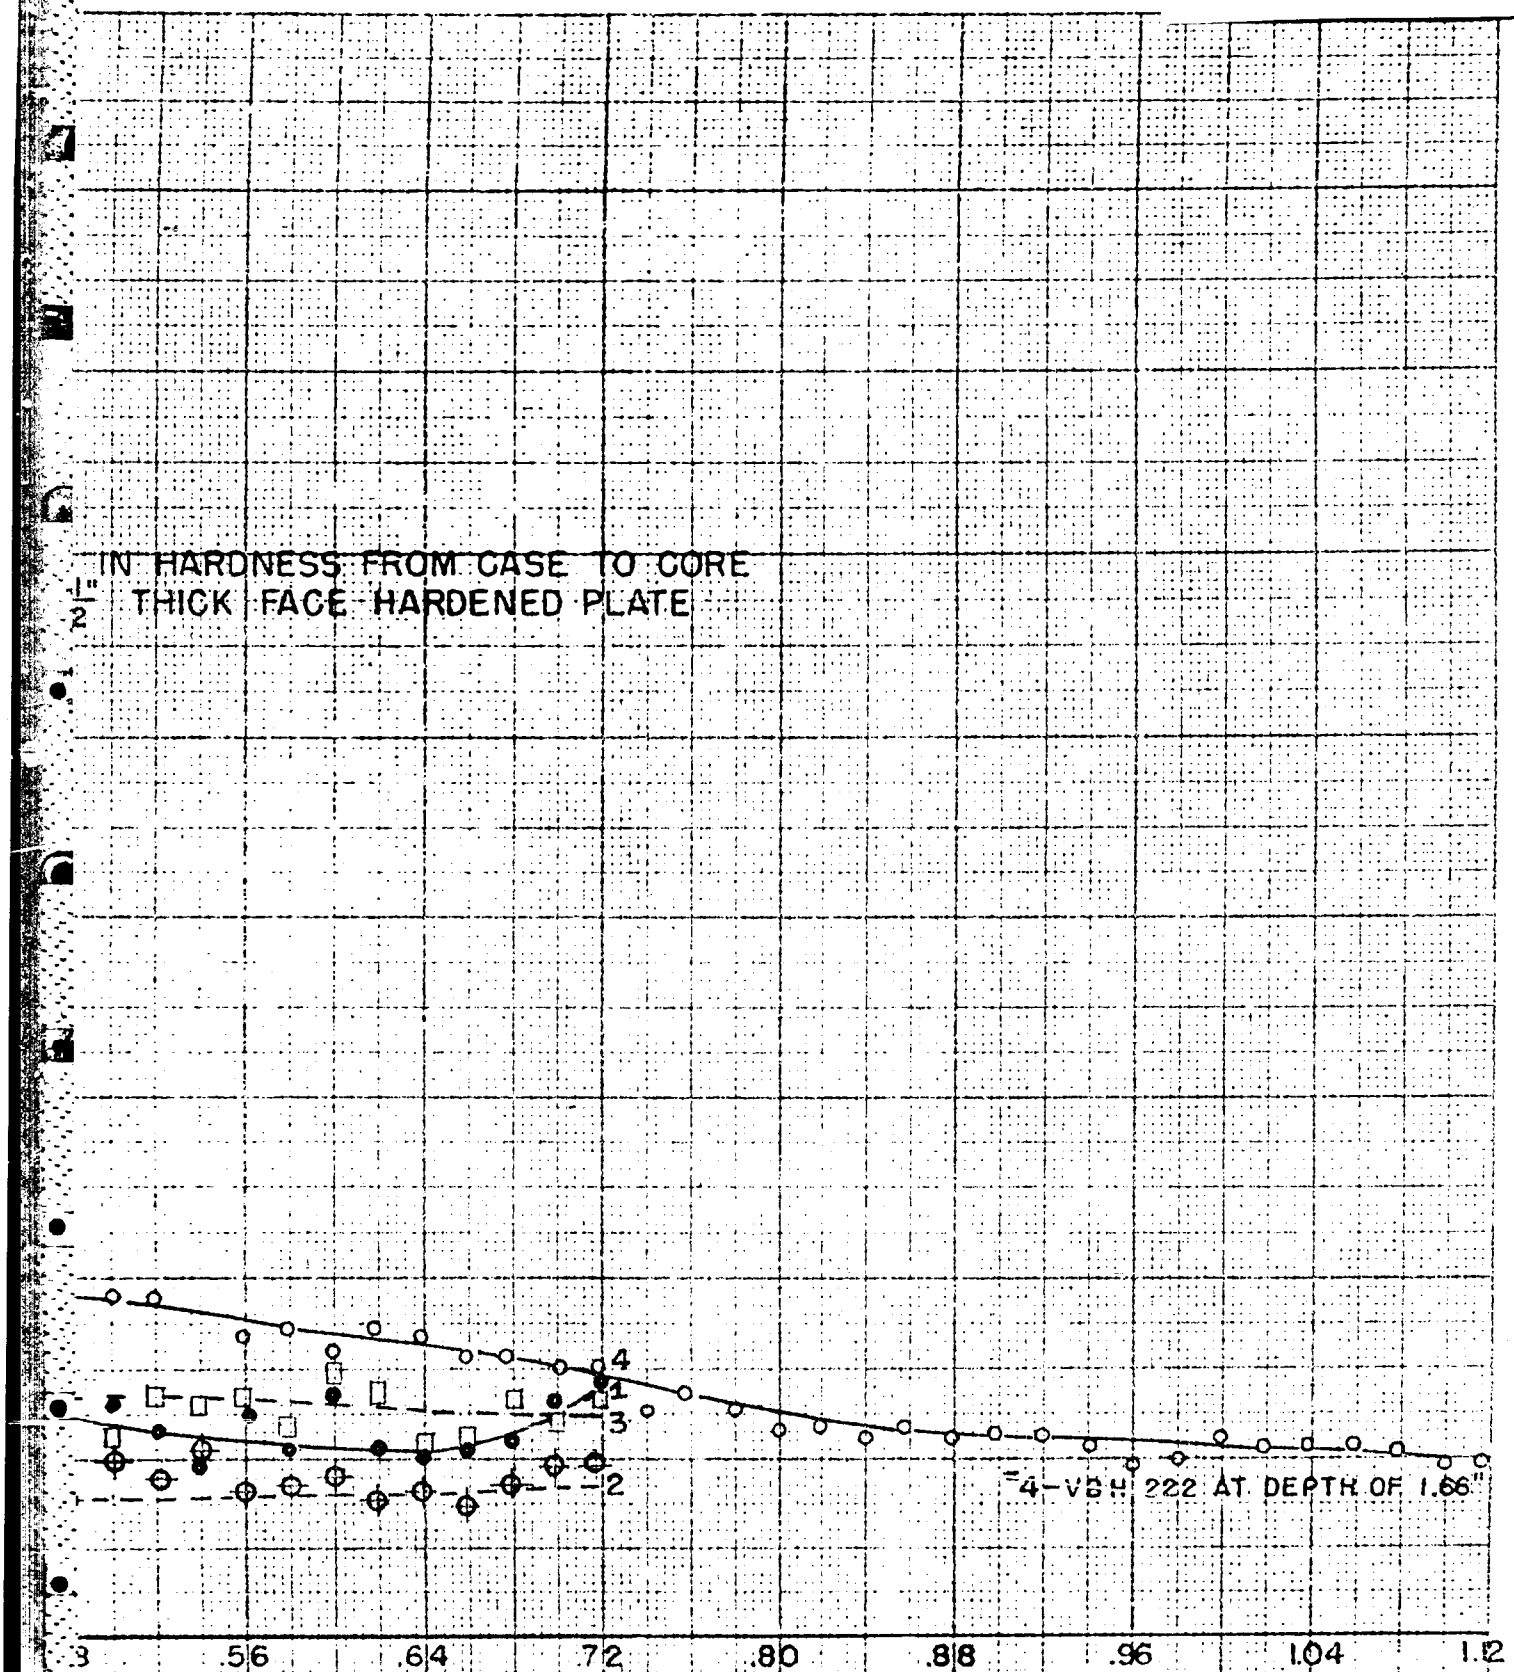
FIGURE 3

The results of the Vickers Brinell hardness surveys are shown in Figure 3. Vickers Brinell hardness determinations were made every .01" apart on the carburized cases and every .02" apart on the core. As noted in Table V, the depth of the effective case, namely at 400 Vickers Brinell hardness as recommended by some of the manufacturers of face hardened plate, is recorded.

The three Disston plates have shallow cases as determined by this hardness survey and also by studies of carbon distribution in the

case noted in Figure 1. The difference in hardness between the cases of the Disston plates and the Carnegie plate is also clearly indicated. A gradual decrease in hardness from the case to core is evident in the Carnegie plate. Furthermore, the hardness gradient in the core of the Carnegie plate, noted in Figure 1, is undoubtedly due to the method of quenching the face of the plate. The variations noted in the cores of the Disston plates were due to the presence of ferrite banding associated with tempered martensite.

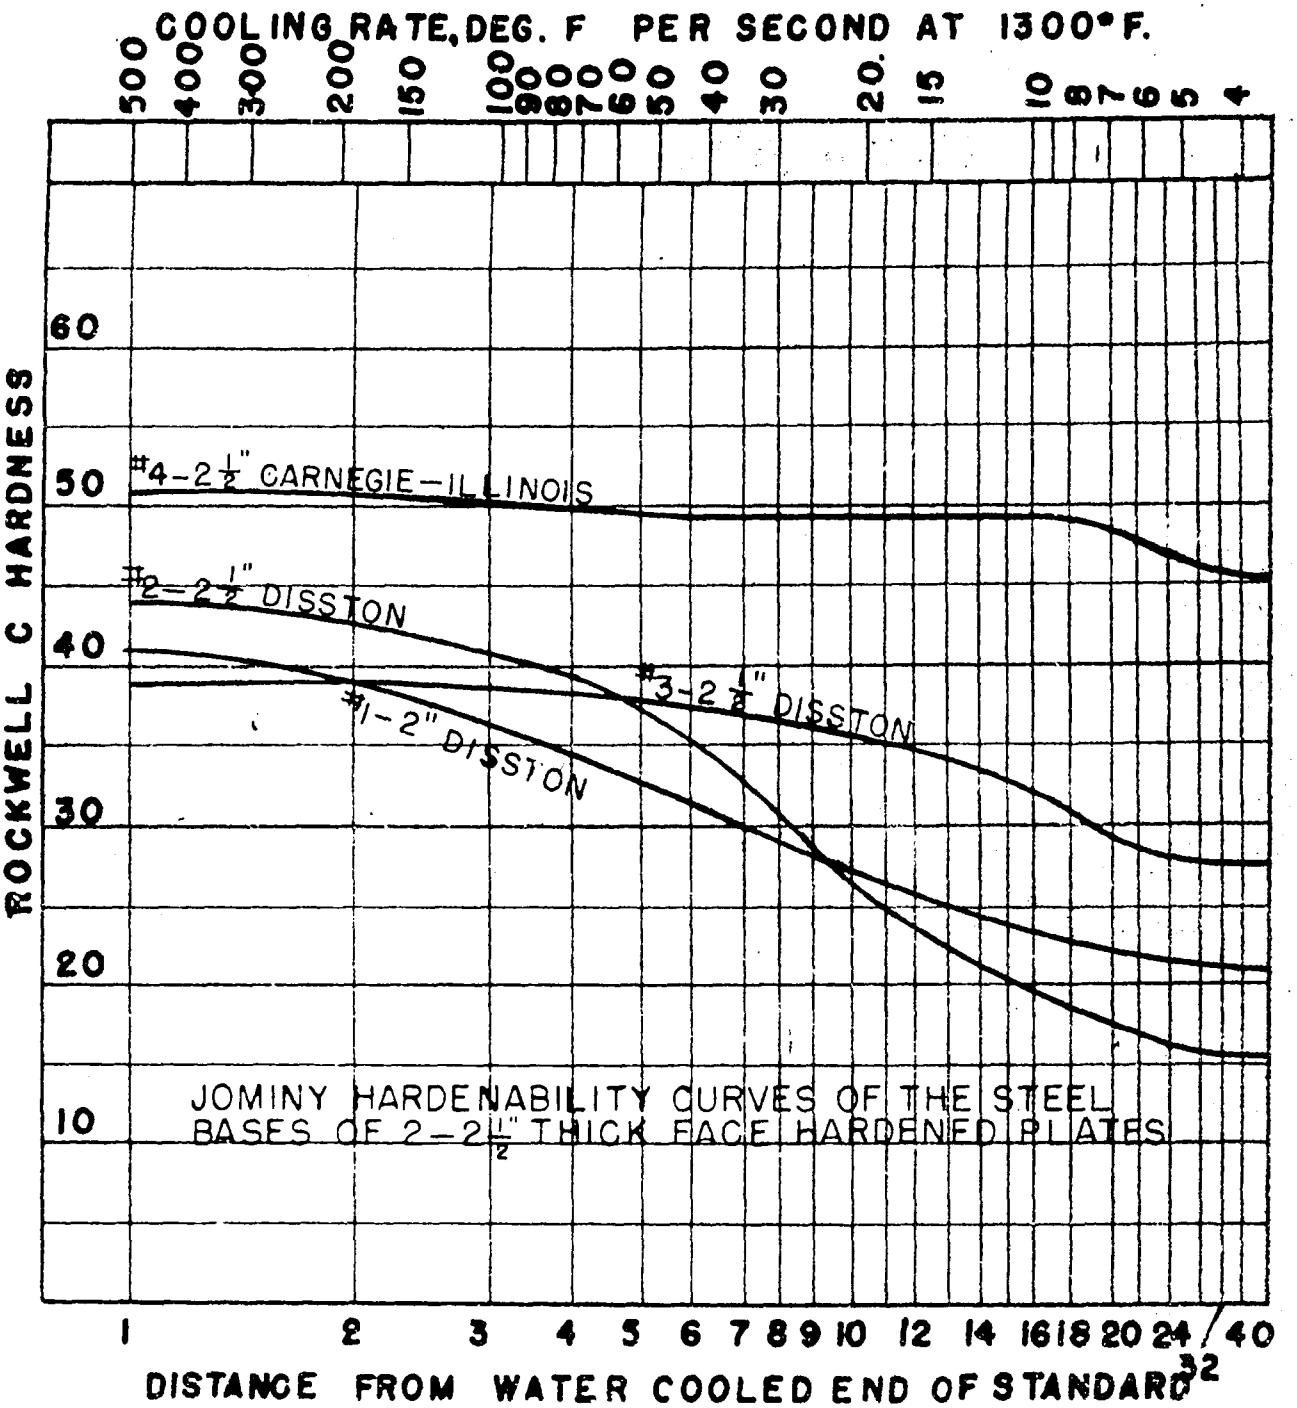
FIGURE 7

The results of the end quench hardenability tests made on Jominy bars machined from the cores of each plate are given in Figure 7. As mentioned previously, it is believed that the Carnegie-Illinois plate was double quenched, first by heating above the critical of the core and quenched, followed by heating above the critical of the case and differentially quenched. The hardenability of the core of this plate was sufficient to warrant proper quench hardening on the first quench. A survey of the Jominy curves of the three Disston plates shows that these steels contain too low alloy content for adequate quench hardening on the first quench of a similar double heat treatment.
