Report No. 710/431
Watertown Arsenal

July 24, 1942

ARMOR PLATE

Further Studies of the Mechanism of Penetration of Homogeneous Armor Plate

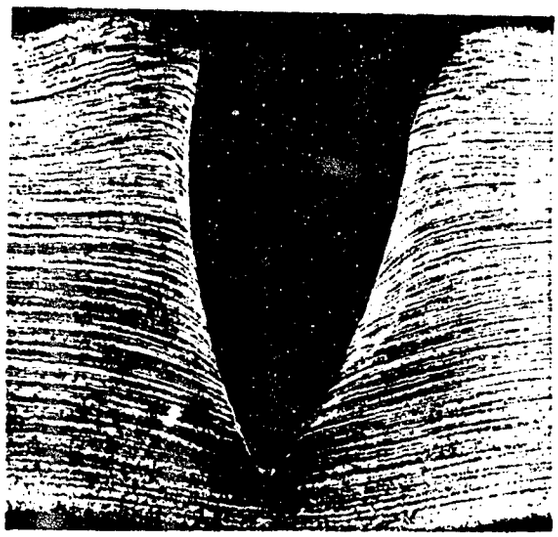
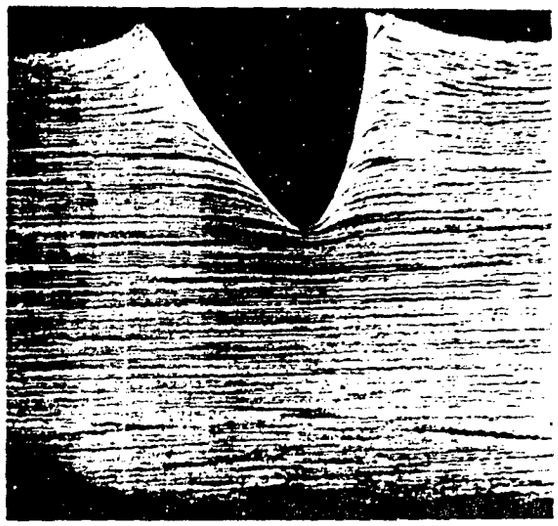
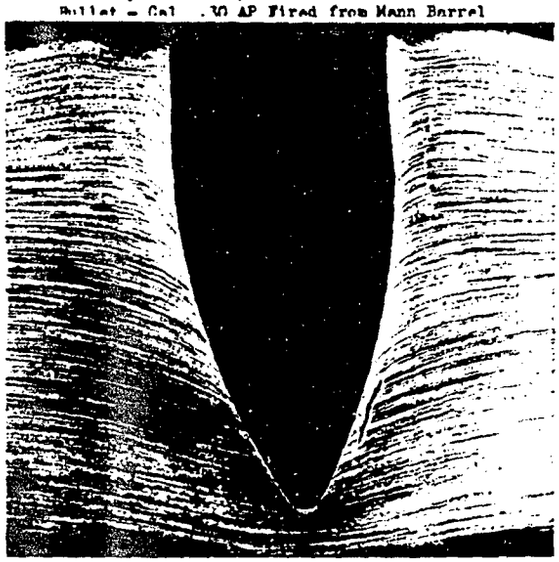
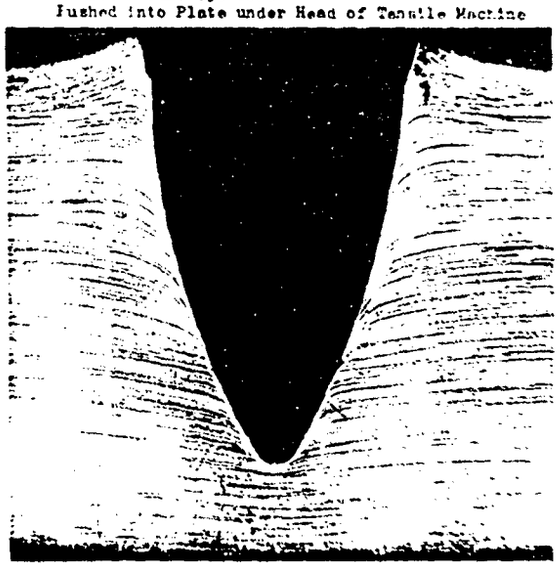
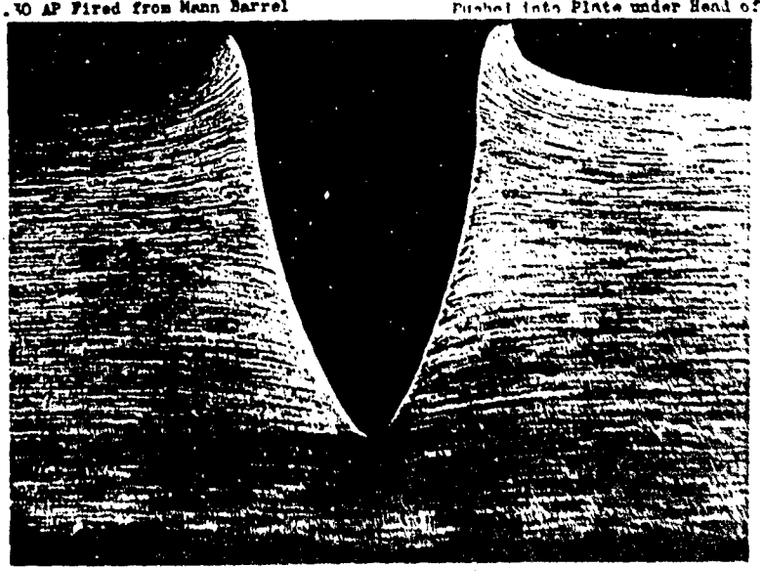
Figure 1

Examination of transverse sections of penetrations made by jacketed caliber .30 A.P. bullets and stripped caliber .30 A.P. cores shows the effect of the jacket on the ridge built up on the face of the plate during penetration. Figure 1B shows a cross-section of a penetration caused by a caliber .30 A.P. core fired from a smooth-bore gun. The metal at the face of the plate has piled up around the bullet similar to the ridge built up around a Brinell ball impression in soft metal. Figures 1A and 1C show the wave formation at the surface of the plate caused by the slight penetration of the jacket metal into the plate. In very soft armor plate, the jacket will penetrate to a considerable depth.

Figures 1B and 1D are transverse sections of static penetrations caused by pushing caliber .30 A.P. cores into the plate under the head of a tensile machine. The deformation of the banding is similar to that produced by dynamic impact with both rotating and non-rotating bullets.

A. Impact Penetration — No. SS31-2100
Velocity - 2100 Ft/sec.
Bullet - Cal. .30 AP Fired from Mann Barrel

B. Static Penetration — No. SS31-[illegible]
Bullet - Cal. .30 Core
Pushed into Plate under Head of Tensile Machine

C. Impact Penetration — No. SS31-2150
Velocity - 2150 Ft/sec.
Bullet - Cal. .30 AP Fired from Mann Barrel

D. Static Penetration — No. SS-[illegible]
Bullet - Cal. .30 Core
Pushed into Plate under Head of Tensile Machine

E. Impact Penetration — Velocity - [illegible] Ft/sec. — No. [illegible]
Bullet - Cal. .30 Core (Unplated) Fired from Smooth Bore Rifle

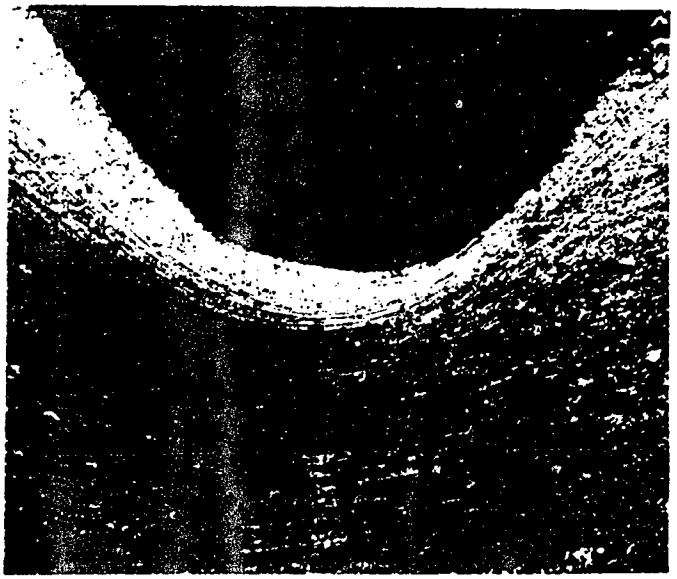
Figure 2

No "white layer" was observed in the transverse sections of the static penetrations examined. Figure 2A, a view of the bottom of penetration SS31-571, shows only pronounced displacement of the banding near the penetration. On the other hand, considerable "white layer" was observed in dynamic penetrations of both rotating and non-rotating bullets, (see Figure 2C, nital etch, of the transverse section of the bottom of penetration SS31-2100.) The formation of "white layer" seems to be, therefore, a function of the rate of deformation.

A. Penetration SS31-ST1
Static Penetration. Transverse Section through Bottom of Bullet Hole.

B. Penetration SS31-SL
Static Penetration. Section Parallel to and 0.246" Below Front Surface of Plate.

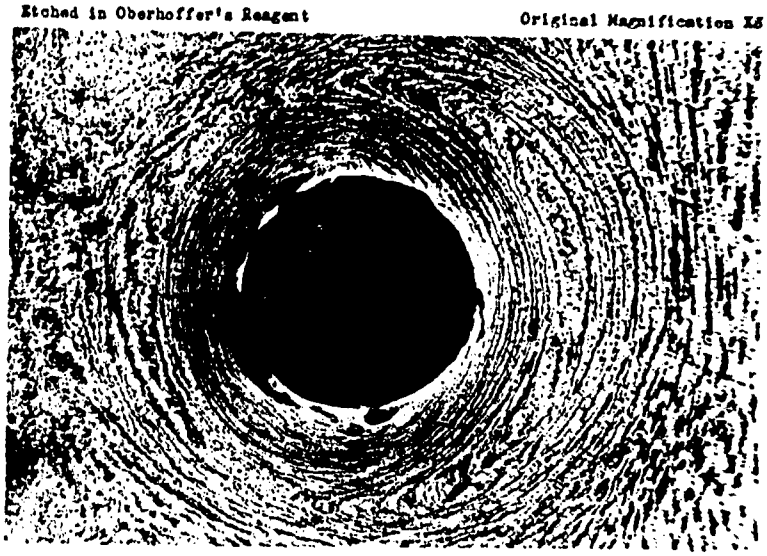
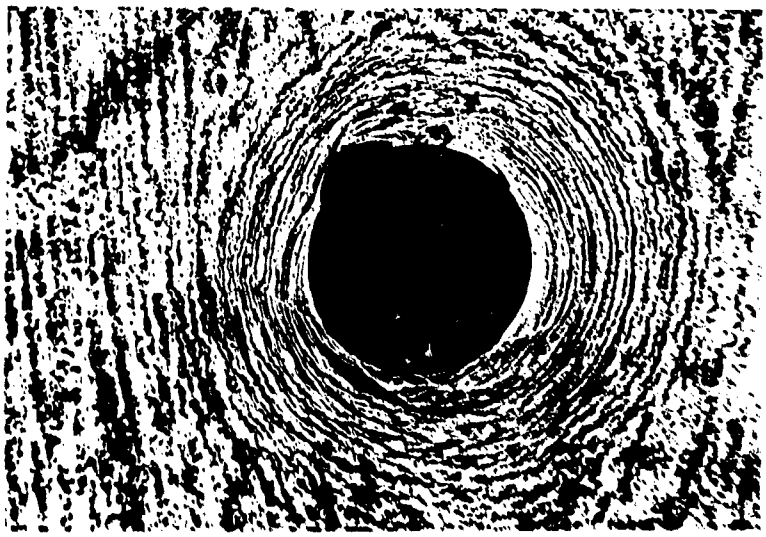
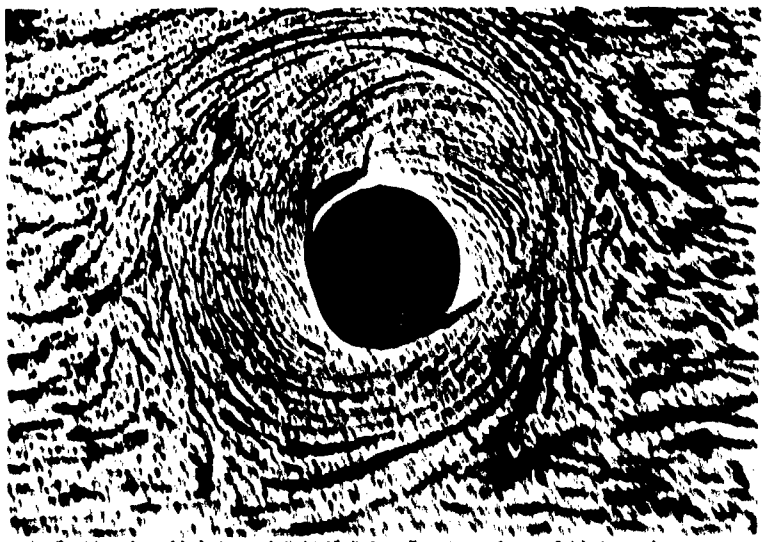
Figure 3

Views of planes parallel to the surface of the plate containing typical deformation produced by dynamic impact of caliber .30 bullets is shown in Figure 3, penetration No. SS31-2. A, B, and C are respectively sections cut near the top, middle and bottom of the penetration. The white material at the edge of the bullet hole in Figure 3A consists of portions of the copper jacket lining the penetration. Figure 3B shows considerable "white layer" branching off from the edge of the penetration at angles of roughly 45°. The displacement of the banding on either side of the "white layers" are evidence of the slip of the metal that caused the extremely localized heating that resulted in "white layer"

formation. Figure 3C shows a crack radiating from the bullet hole that contains several sections of "white layer".

A. Section Parallel to and 0.017" Below Front Surface of Plate.

B. Section Parallel to and 0.057" Below Front Surface of Plate.

C. Section Parallel to and 0.[illegible]" Below Front Surface of Plate and 0.001" Above Rear Surface of Plate.

Penetration No. 5371-2
Velocity - 2900 ft/sec.
Bullet - Cal. .30 A.P. Fired from Mann Barrel
Normal Impact

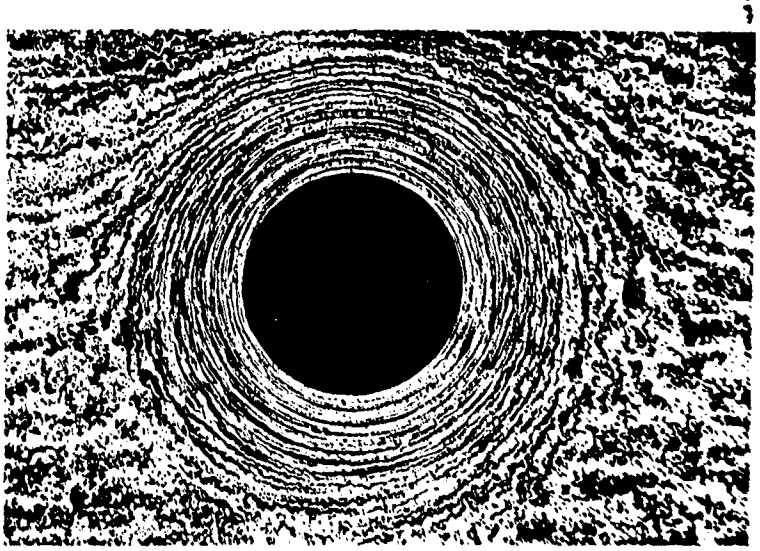
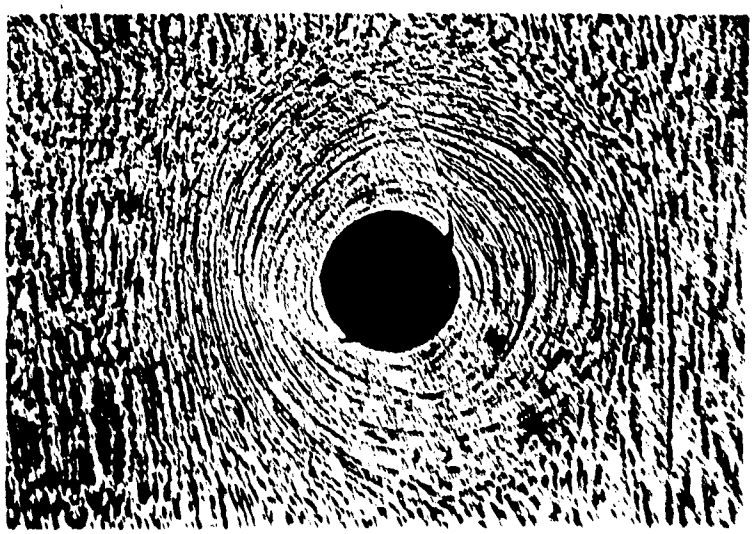
Figure 4

Views of planes parallel to the surface of the plate containing typical deformation produced by static penetration of caliber .30 A.P. cores are shown in Figure 4, penetration No. SS31-SL. A, B, and C again represent sections from the top, middle, and bottom of the penetration. Both penetrations No. SS31-2 and SS31-SL are complete to about the same degree, i.e. the nose of the bullet projecting through the back of the plate to about the same extent in each penetration. The thin concentric rings around the bullet hole of the static penetration are very similar to those around the dynamic penetration.

A. Section Parallel to and 0.026" Below Front Surface of Plate.

B. Section Parallel to and 0.246" Below Front Surface of Plate.

C. Section Parallel to and 0.[illegible]" Below Front Surface of Plate and 0.[illegible]

Penetration No. 831-EL
Velocity - Static Penetration Under Head of Tensile Machine
Bullet - Cal. .30 Core (Jacket Stripped off Prior to Penetration)
Normal Penetration

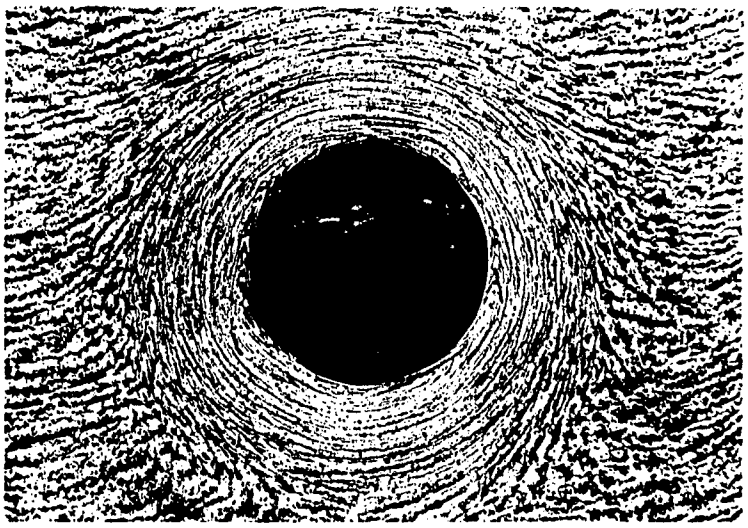
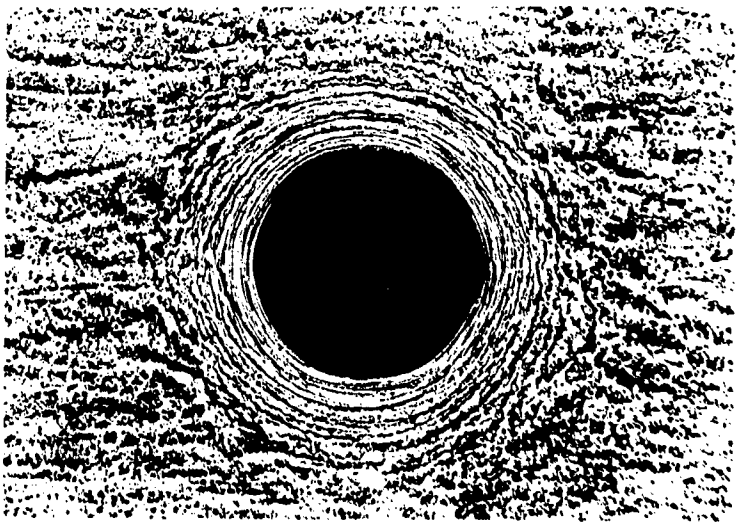
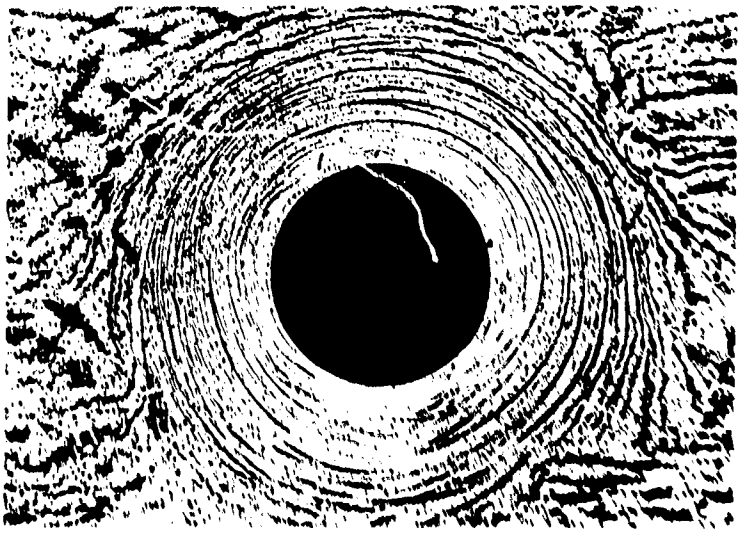
Figures 6A, B, C, are respectively views of sections parallel to the plate surface through the top, middle, and bottom of penetration No. 14 (2/26/42 D) in plate No. 620-2, produced by firing a copper-plated caliber .30 A.P. core from a caliber .257 Remington rifle. The

pitted white band around the edge of the bullet hole in Figure 6C is a portion of the copper plating. Some copper has also filled up a crack in the vicinity of the penetration.

Figure 6 illustrates a phenomenon that has been previously noted in W.A. Report No. 710/197; namely, the hour-glass shape of the volume of metal that is distorted during a complete penetration. Figure 6A, which is a view of a section 0.006" below the top of the plate shows distortion to an average distance of 0.13" away from the bullet hole. A section 0.228" below the impacted surface, Figure 6B, shows distortion to an average distance of but 0.10" from the bullet hole. A section 0.482" below the impacted surface, Figure 6C, shows distortion to an average distance of 0.18" away from the bullet hole. The metal in the middle of the cross-section of homogeneous plate undergoes severe lateral compression, but very little upward or downward displacement, while the metal near the extremities of the cross-section is displaced upward at the impacted surface and downward at the back surface of the plate to form the familiar bulges around penetrations. It is the upward and downward bending of the metallic fibers (segregation bands) near the plate surfaces that are responsible for the hour-glass shape that is revealed by metallographic means.

A. Section Parallel to and 0.006" Below Front Surface of Plate.

B. Section Parallel to and 0.228" Below Front Surface of Plate.

C. Section Parallel to and 0.483" Below Front Surface of Plate and 0.010" Above Back Surface of Plate.

Penetration No. 14(2/26/42D)
Velocity - 2306 ft/sec.
Bullet - Cal. .30 Core (Copper Plated) Fired from Cal. .257 Remington Rifle.
Normal Impact

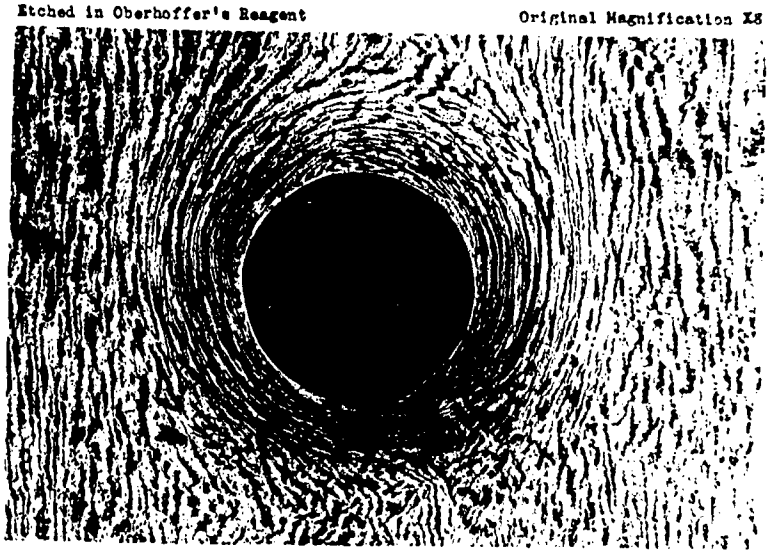
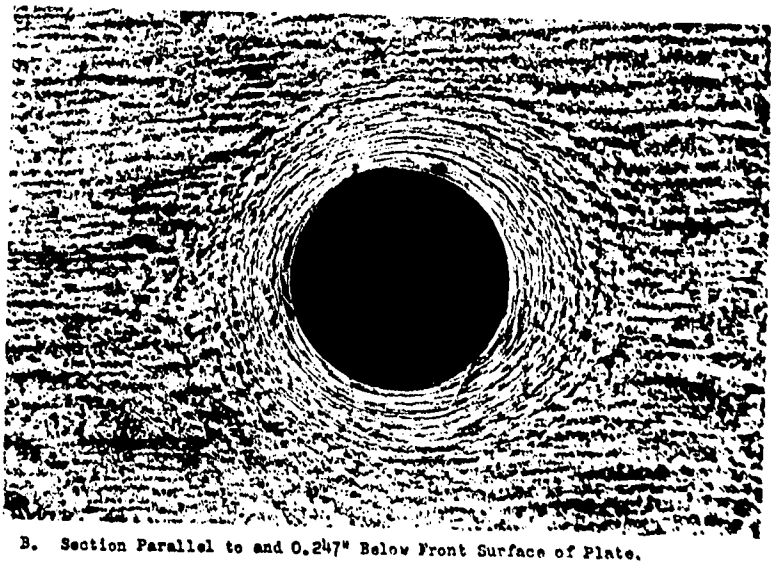
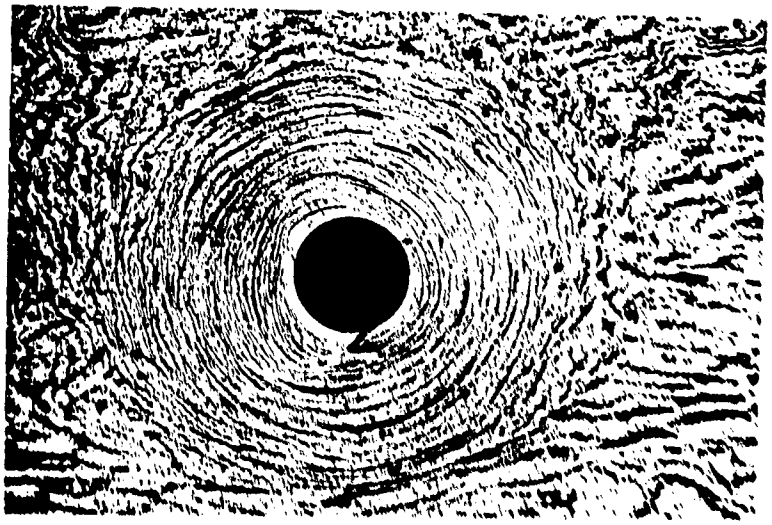
Figure 7

Views of sections cut parallel to the surface of the plate through a penetration made by a non-rotating caliber .30 armor piercing bullet core are shown in Figure 7. The formation of "white layer" and deformation consisting of concentric rings are identical with those produced by impact of a rotating armor piercing core, as in Figures 5 and 6.

A. Section Parallel to and 0.014" Below Front Surface of Plate.

B. Section Parallel to and 0.247" Below Front Surface of Plate.

Penetration No. 4(1/23/42A)
Velocity - 2475 ft/sec.
Bullet - Cal. .30 Core (Unplated) Fired from Smooth-Bore Rifle.
Normal Impact

C. Section Parallel to and 0.500" Below Front Surface of Plate and 0.012" Above Back Surface of Plate.

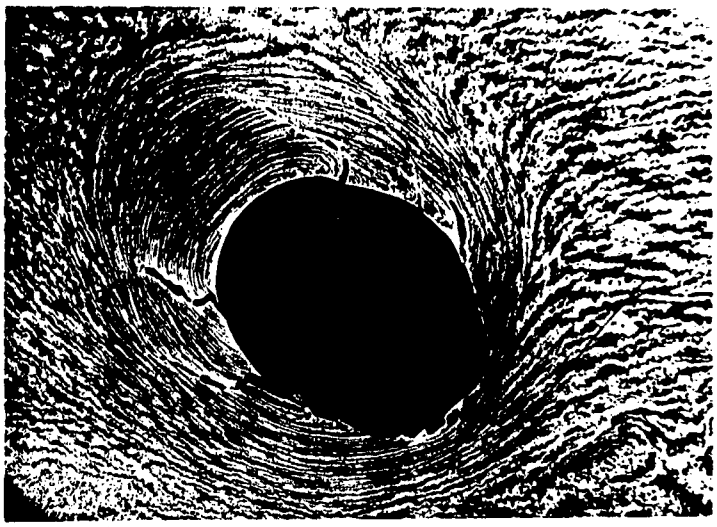
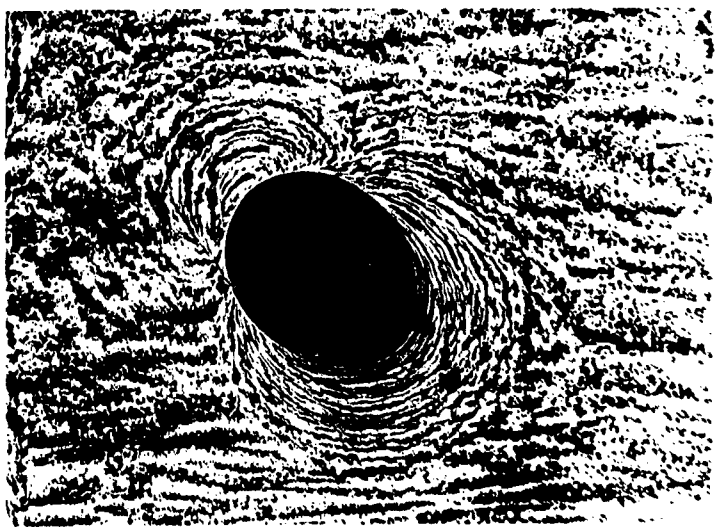
Figure 8

A yawed impact of a caliber .30 core against 1/2" homogeneous plate produced an interesting deformation pattern, as seen in Figure 8, which shows layers parallel to the plate surface through penetration No. 5 (1/3"/42 A). Figure 8A reveals a plane section 0.006" below the impacted surface. The bullet entered the plate from a direction that corresponds to the lower right hand region of the photograph.

The deformation is most severe in the upper left of the photograph, which is the portion of the metal that the bullet displaced upward as it entered the plate at an angle. On a layer 0.228" below the top surface of the plate, see Figure 8B, the deformation is most severe in the lower right of the photograph, which corresponds to the portion of the metal that is in compression beneath the armor piercing core, while the deformation in the upper left of the photograph represents the metal above the axis of the projectile which is deformed by a combination of compression and tension stresses. This variation in the distribution of the deformed metal with the depth of penetration suggests the reversal of stresses to which the body of the armor piercing core is subjected as it penetrates a piece of armor of this thickness.

Figure 8C shows a plane section 0.4[illegible]" below the impacted surface and 0.019" below the bottom of the bullet hole. The deformation in this region consists of the bending of the remnants of the dendritic axes, which had previously been deformed and aligned by hot working, into a circular pattern around the center of impact.

A. Section Parallel to and 0.006" Below Front Surface of Plate.

B. Section Parallel to and 0.228" Below Front Surface of Plate.

Penetration No. 5(1/30/42a)
Velocity - 2113 ft/sec.
Bullet - Cal. .30 Core (Copper Plated) Fired from Cal. .257 Remington Rifle.
Bullet Tested Prior to Impact.
