Watertown Arsenal Laboratory
Report Number WAL 710/414
Problem No. B-52

6 October 1943

Metallurgical Examination of Cast Turret No. 757 for M4 Tank, Manufactured by Union Steel Castings Co., Ballistically Tested at Subzero Temperatures at Camp Shilo, Canada.

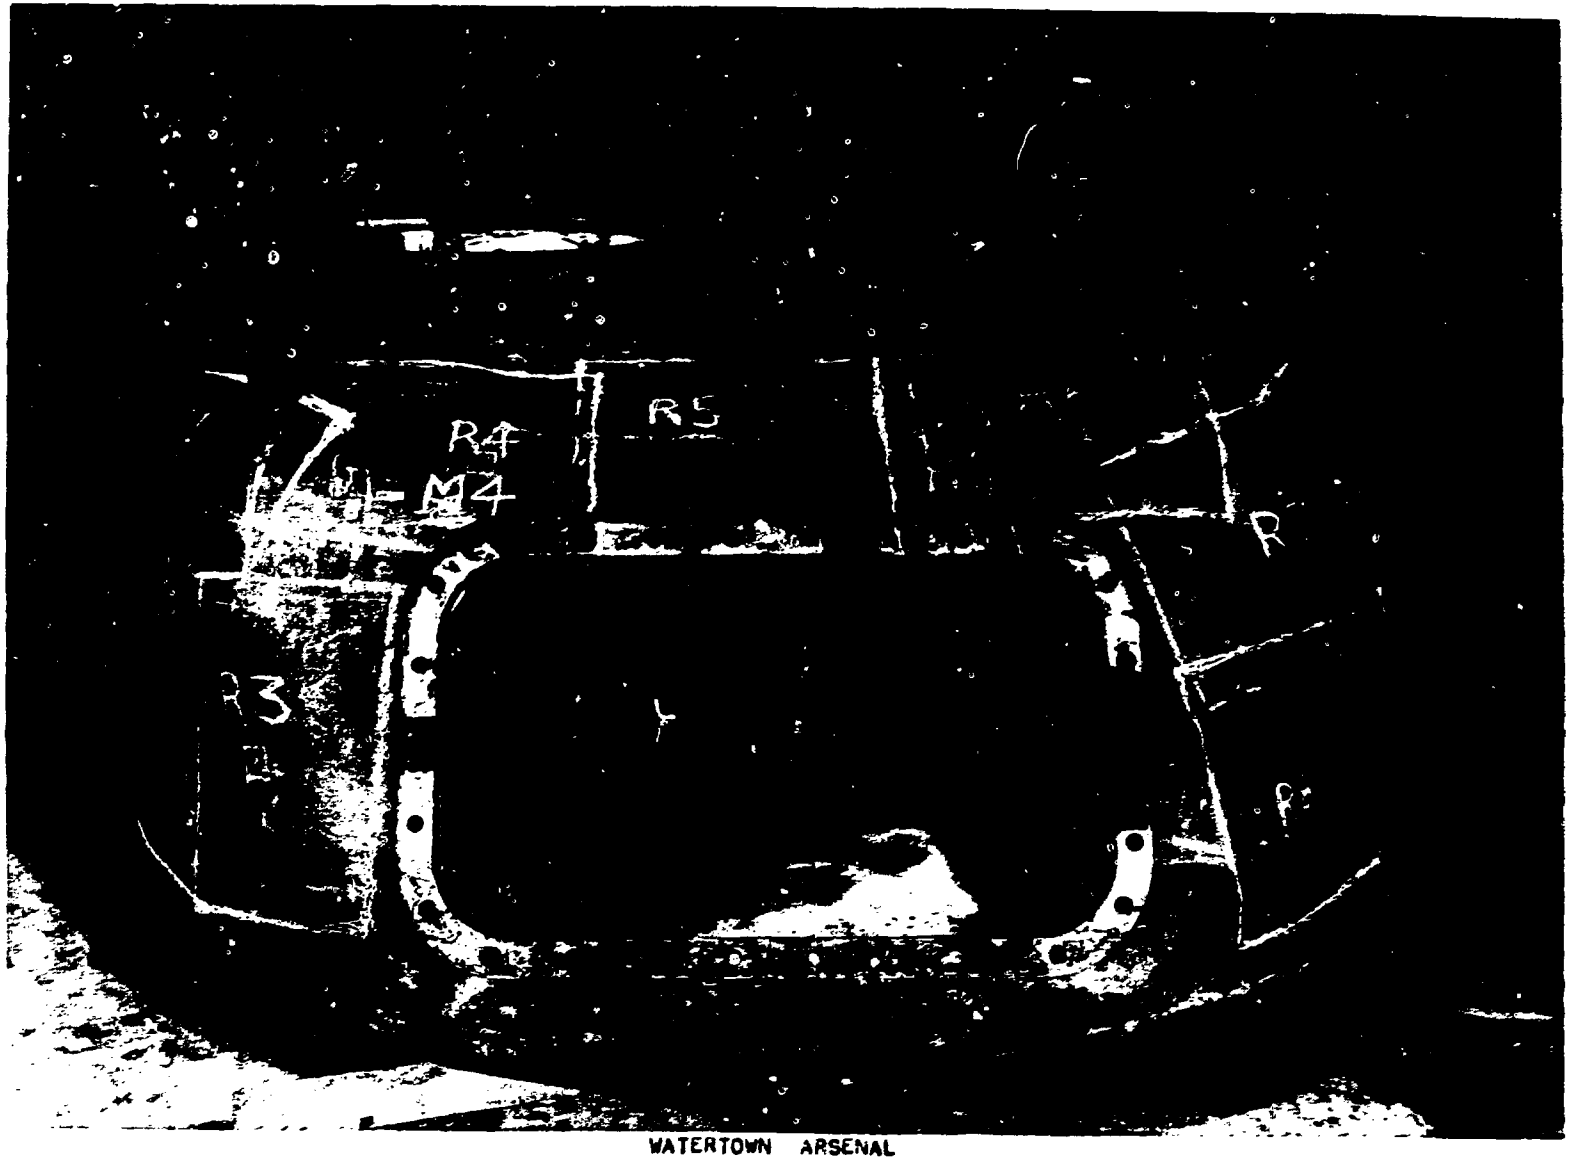
FIGURE 1

VIEW OF M4 TURRET MFG BY UNION STEEL CASTINGS CO. TESTED AT CAMP SHILO, CANADA, SHOWING AREAS RADIOGRAPHED AND SELECTED FOR METALLURGICAL EXAMINATION
WTN.710-2093

The projectile impacted the left front of the turret 13" from the bottom edge. Partial penetration with two 6" cracks originating at the impact. Punching started on inside of turret with 4", 3", 4" cracks. (Radiographic area R8, Figure 1).

The projectile struck the front of the turret 6" above the upper right edge of the casting and ricocheted, causing a 7" crack in the armor on the outside. On the inside of the turret there were cracks 9", 4", 4", 3" and 2" (star cracking). (Radiographic area R4, Figure 1).

The projectile struck the left front of the turret 4" above the top edge of the gun mount casting. The projectile hit the left lifting eye, displacing it and then ricocheted off the turret. Impact was 30" left of impact #5. Crack developed extending the entire distance between impacts #5 and #6. Further cracks 8" and 7" long developed on Round #5. On the inside of the turret 30" long crack developed between impacts #5 and #6. 3 cracks, 6", 5" and 3" (star cracking) on inside of impact #6. (Radiographic area R6, Figure 1).

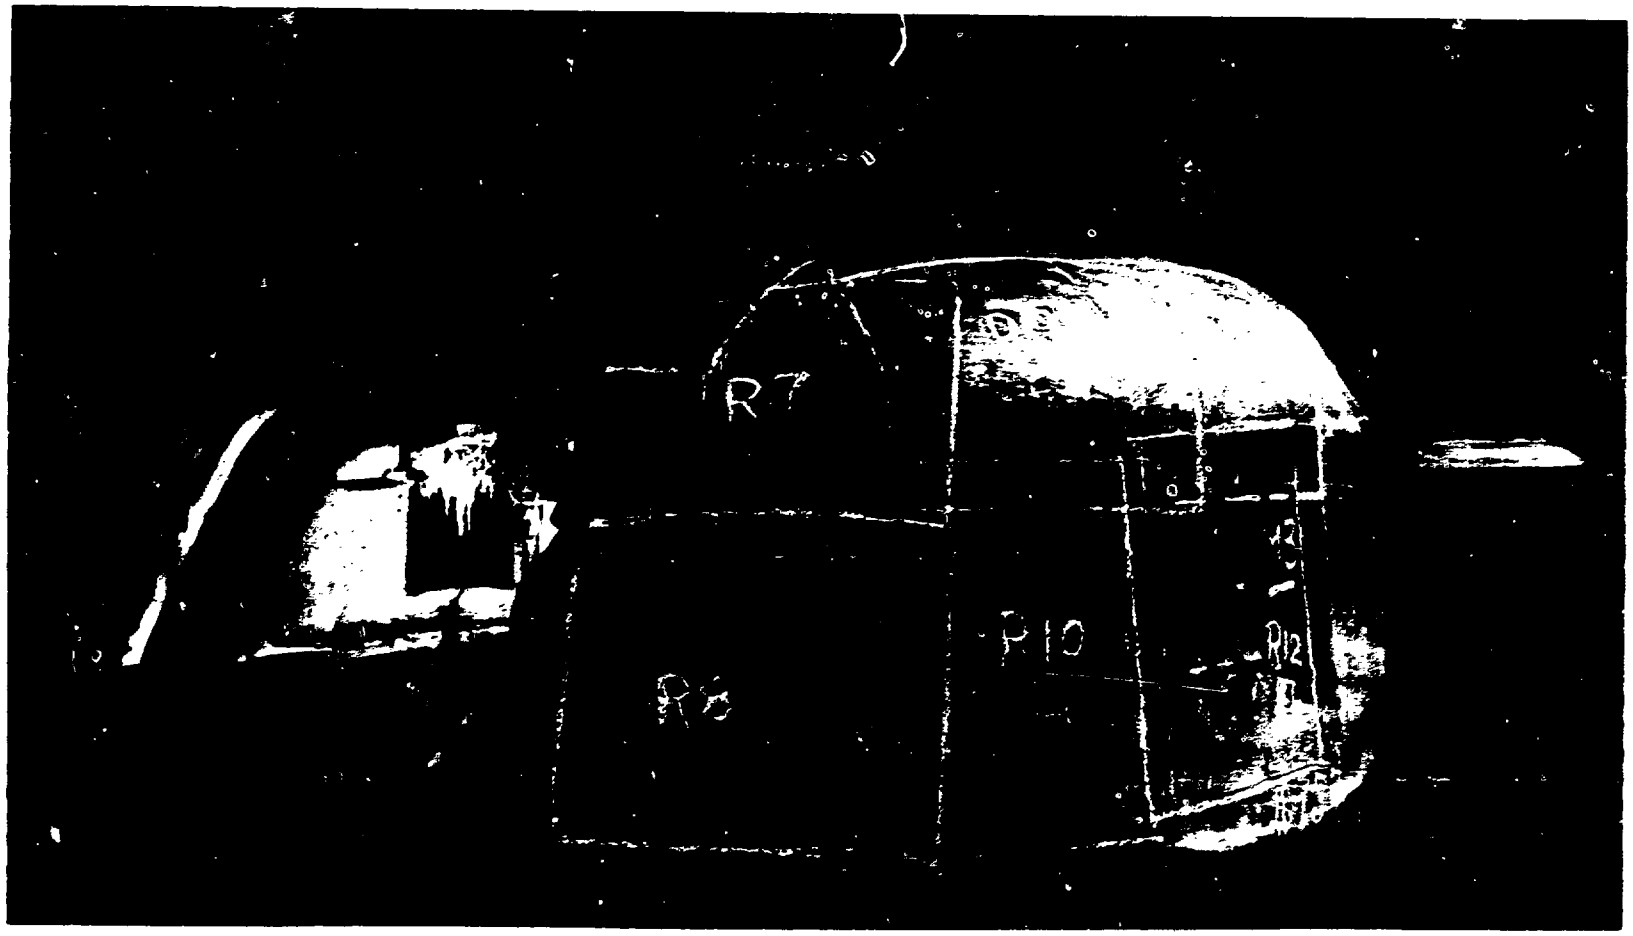
FIGURE 3

VIEW OF M4 TURRET MFG BY UNION STEEL CASTINGS CO. TESTED AT CAMP SHILO, CANADA, SHOWING AREAS RADIOGRAPHED AND SELECTED FOR METALLURGICAL EXAMINATION

The projectile struck the left side of the turret 12" above the bottom edge of the casting. Partial penetration. No cracks on the outside; on the inside there were cracks 4", 4", 4½" and 2" long, with incomplete backspall. (Radiographic area R12, Figure 3).

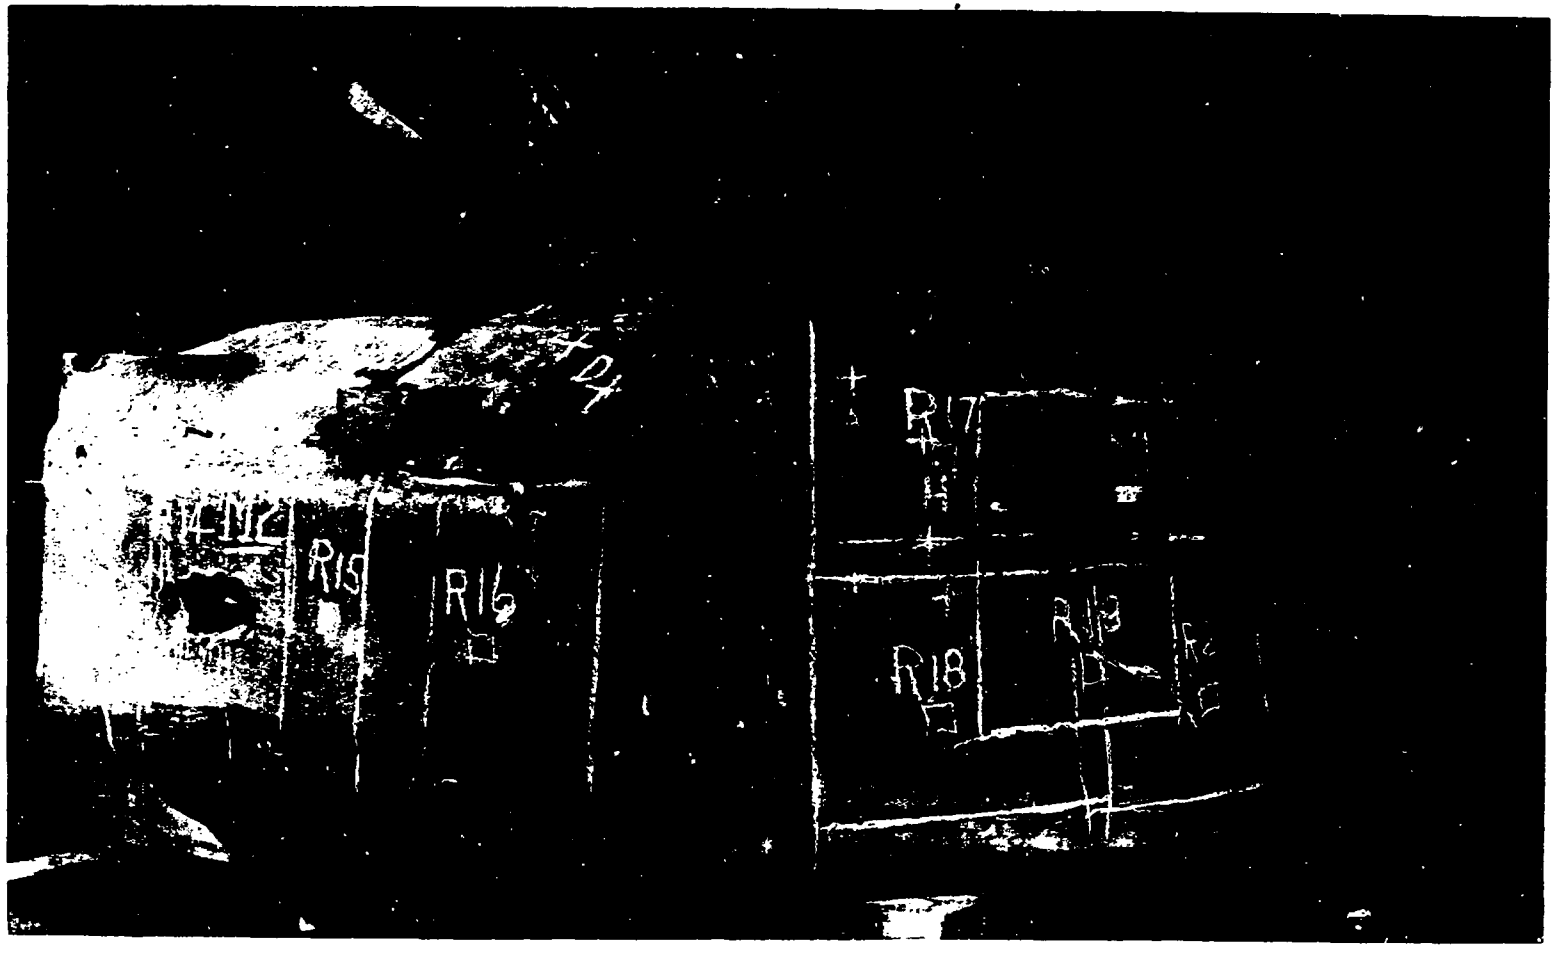
VIEW OF M4 TURRET MFG BY UNION STEEL CASTINGS CO. TESTED AT CAMP SHILO, CANADA, SHOWING AREAS RADIOGRAPHED AND SELECTED FOR METALLURGICAL EXAMINATION

The projectile impacted the right side of the turret 18" above the bottom edge. The casting cracked through the entire thickness of the armor, from the base to the top edge of the turret hatch opening, the crack being 37" long. An additional 10" crack developed through the impact and a 20" crack 10" from the impact. Star cracking developed on the inside of the turret and a punching started, no fragment being thrown into the interior of the turret. (Radiographic area R19, Figure 2).

The projectile struck the rear of the turret, 12" from the bottom edge of the casting. The projectile ricocheted but caused a punching in the armor 5" x 3" on the outside and 9" x 6" on the inside including back spall. 12" crack on outside of armor, 10" below point of impact. Fragment of armor thrown into the turret caused considerable damage to installations and dummy personnel. (Radiographic area R14, Figure 2).

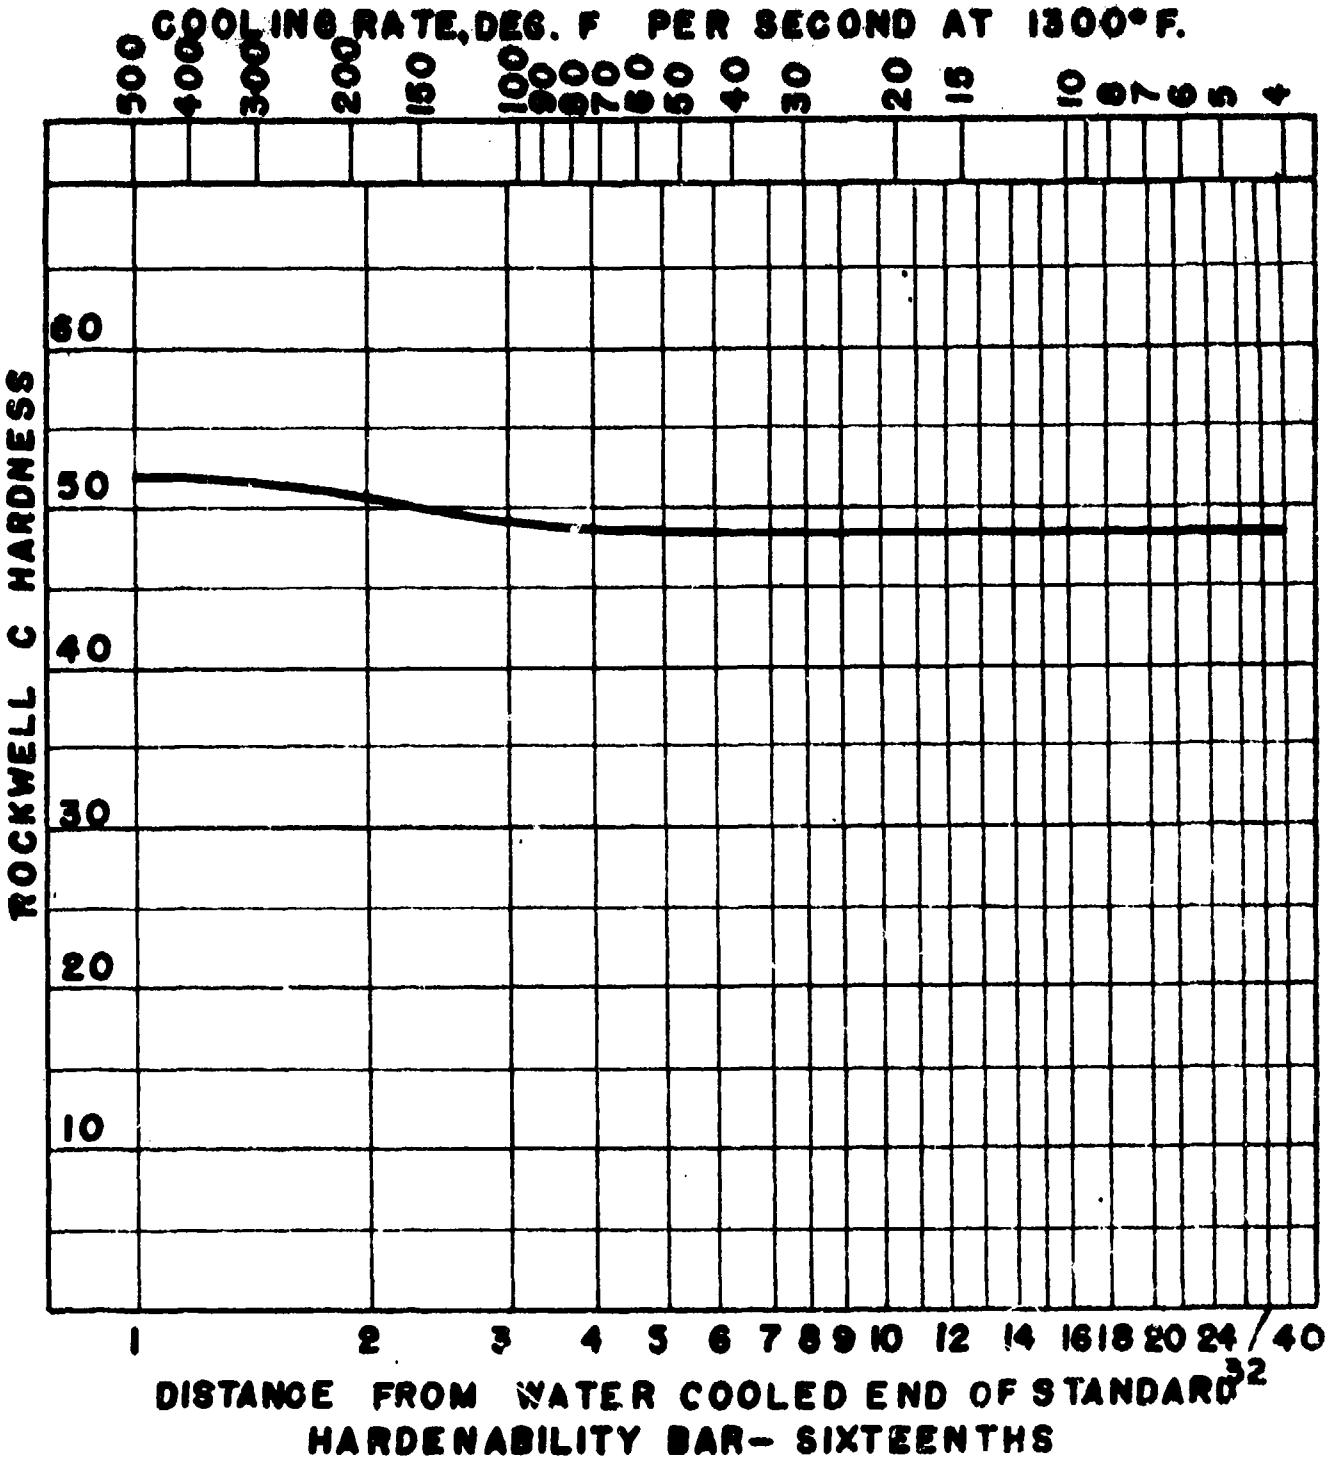
FIGURE 5

The hardenability was determined by end-quenching a standard Jominy bar according to the standard procedure after austenitizing for 2 hours at 1600°F. The hardenability curve shown in Figure 5 indicates that the steel possesses more than adequate hardenability to completely harden through upon quenching, since the maximum thickness of the casting is approximately 3" and the average thickness approximately 2".

JOMINY HARDENABILITY CURVE.

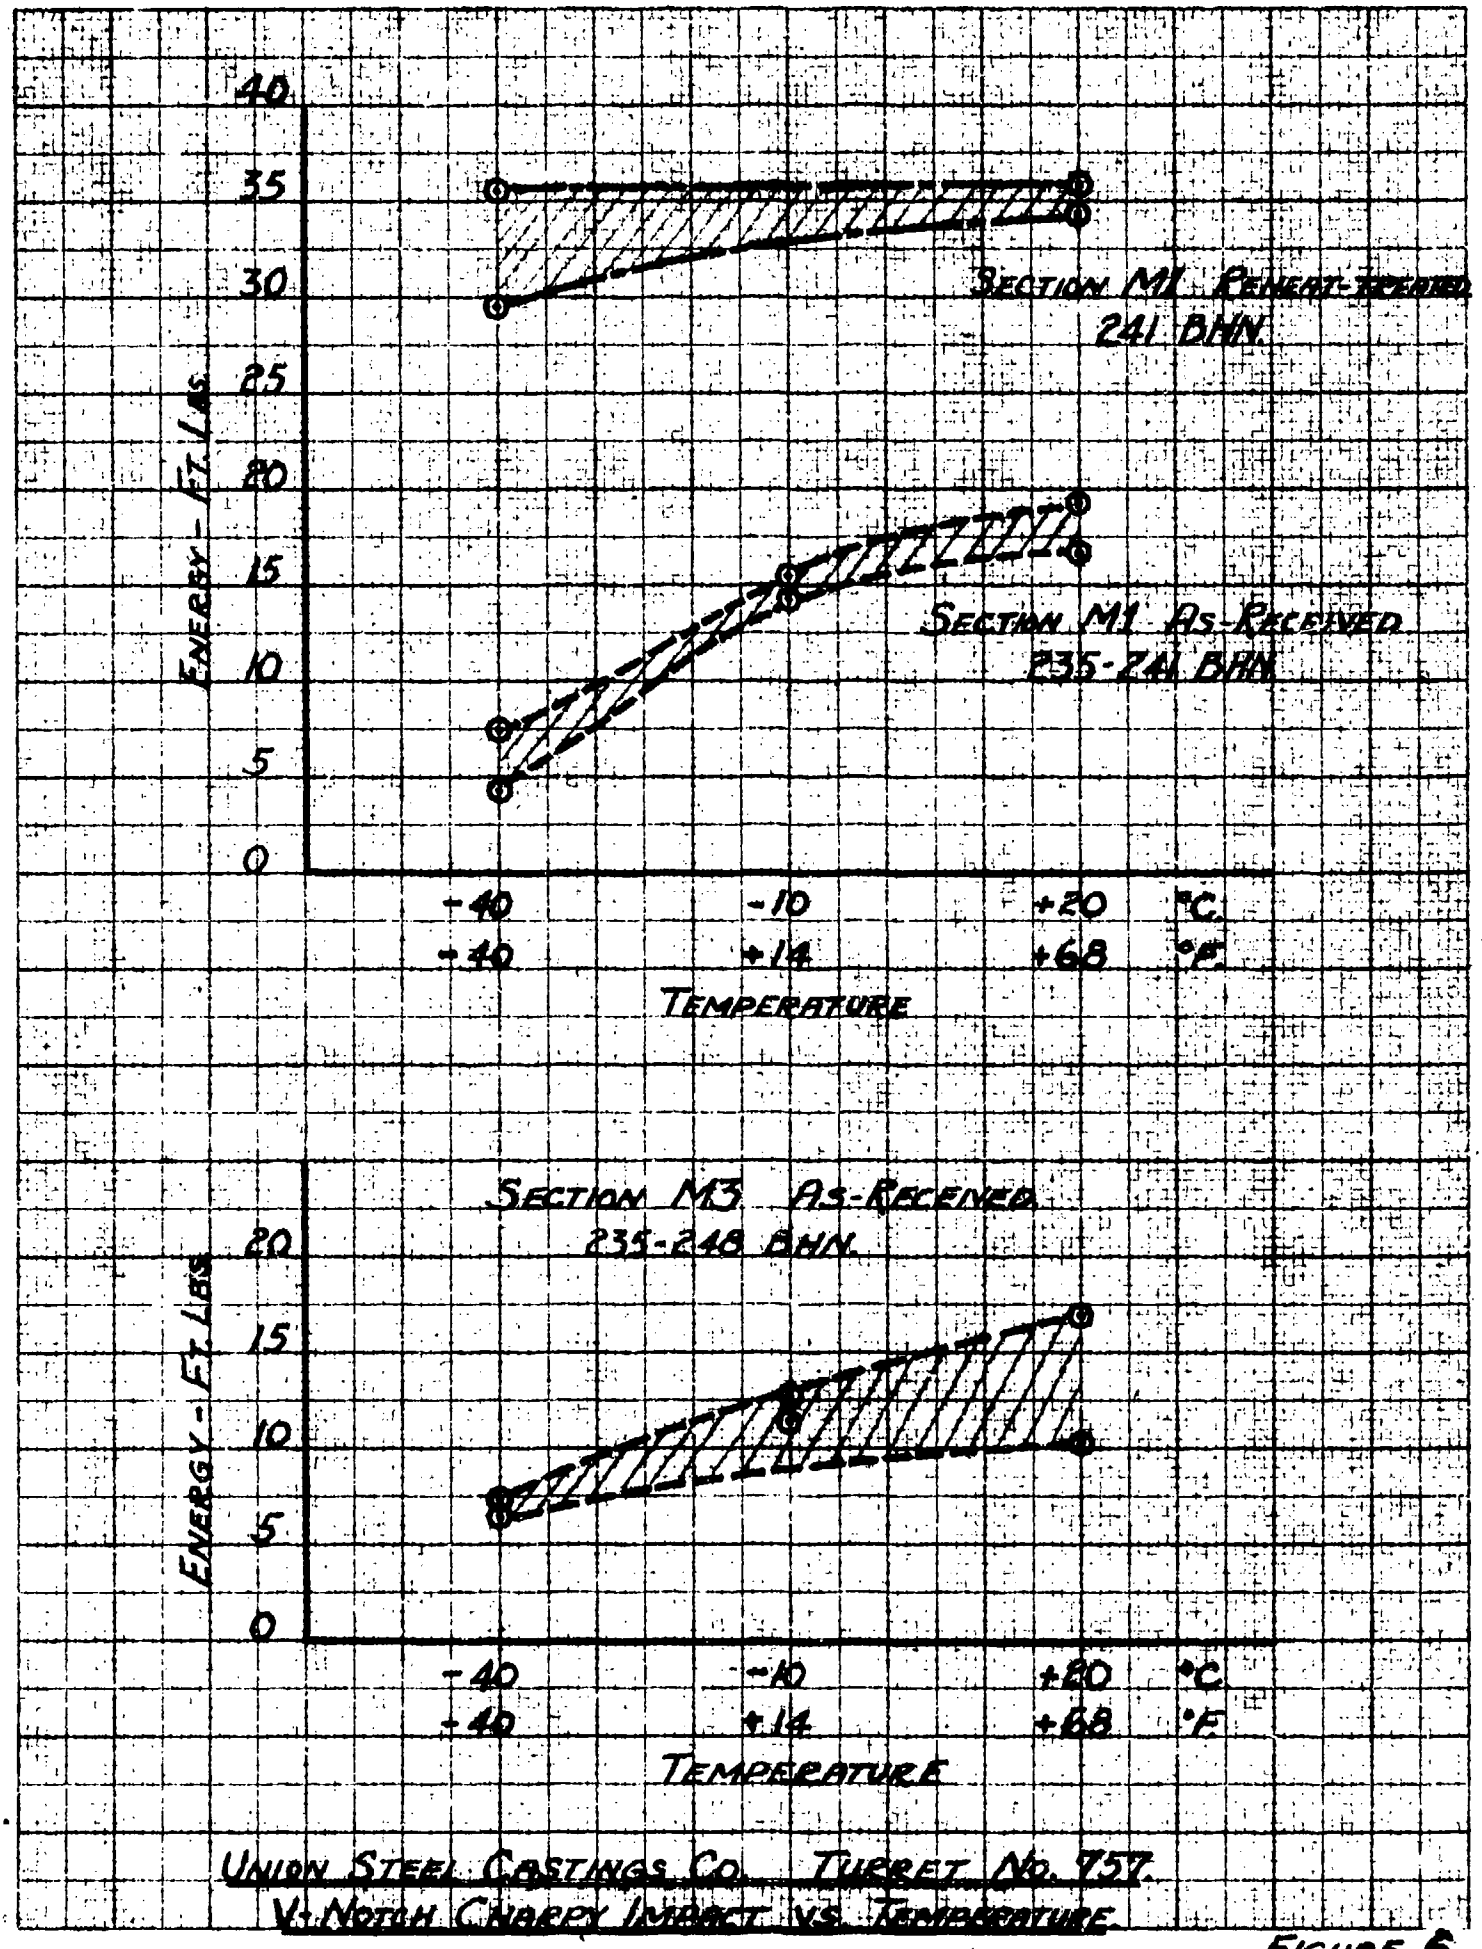
FIGURE 6

The results of the individual tests and a description of the resulting fractures are contained in Appendix C, and curves of impact strength vs. temperature are shown in Figure 6. The room temperature impact strength of the turret steel (10-20 ft.lbs.) is at least 40 ft. lbs lower than that usually possessed by sound, well heat-treated cast armor steels at a hardness of 240 Brinell. The impact strength at the temperature level at which the ballistic testing was conducted, namely -15° to -25°F (-25° to -30°C), is 7-10 ft.lbs. The poor resistance of the turret to shock at subzero temperatures is readily understandable

Poor impact properties and fractures such as possessed by the subject turret are indicative of poor heat treatment resulting in incomplete quench hardening and the formation of high temperature transformation products.[1]

Considerable improvement was however, effected in the impact strength, see Figure 6 and Appendix C. The room temperature V-notch Charpy impact strength was raised from 10-20 ft.lbs. to approximately 35 ft.lbs. at the same hardness. After reheat-treatment, the impact strength remains relatively constant down to a temperature of -40°C (-40°F).

UNION STEEL CASTINGS CO. TURRET NO. 757.
V-NOTCH CHARPY IMPACT VS. TEMPERATURE

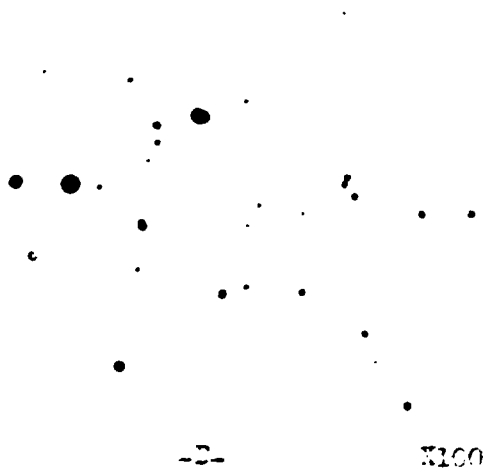
The reheat-treated piece of section M1 has a microstructure of tempered martensite free from high temperature transformation products, Figure 8E and F.

Section M1. As received. Globular inclusions occasionally [illegible] grain boundaries.

Section M1. Reheat-treated. Dendritic segregation. No rejected ferrite.

Section M1. Reheat-treated. Tempered martensite throughout section.
