Watertown Arsenal Laboratory
Report Number WAL 710/724
Problem Number R-4.28

10 February 1945

Metallurgical Examination of British Homogeneous and Face Hardened Armor

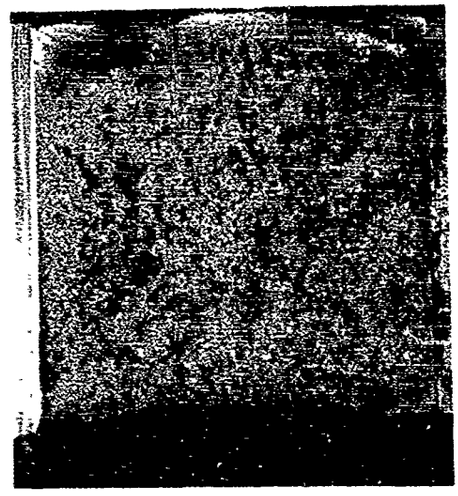
W.A. NO. 9

The fractures of Nos. 9 and 50 show that these plates possess good steel soundness. No soundness rating can be assigned to Plate 73 because of the almost wholly crystalline fracture, which would tend to suppress the appearance of any laminations that might be present.

Rated for their fibre characteristics, it is seen from Figure 1 that the fractures of Plates 9 and 73 exhibit crystallinity throughout most of the section. The crystallinity of No. 73 is coarse, whereas in the fracture of Plate 9 crystallinity occurs as small facets in a fibrous matrix. In Plate 50 a coarse crystallinity occurs only in the half of the fracture adjacent to Face B, the other half being fibrous. The presence of crystallinity in the fractures of all of the British homogeneous plates

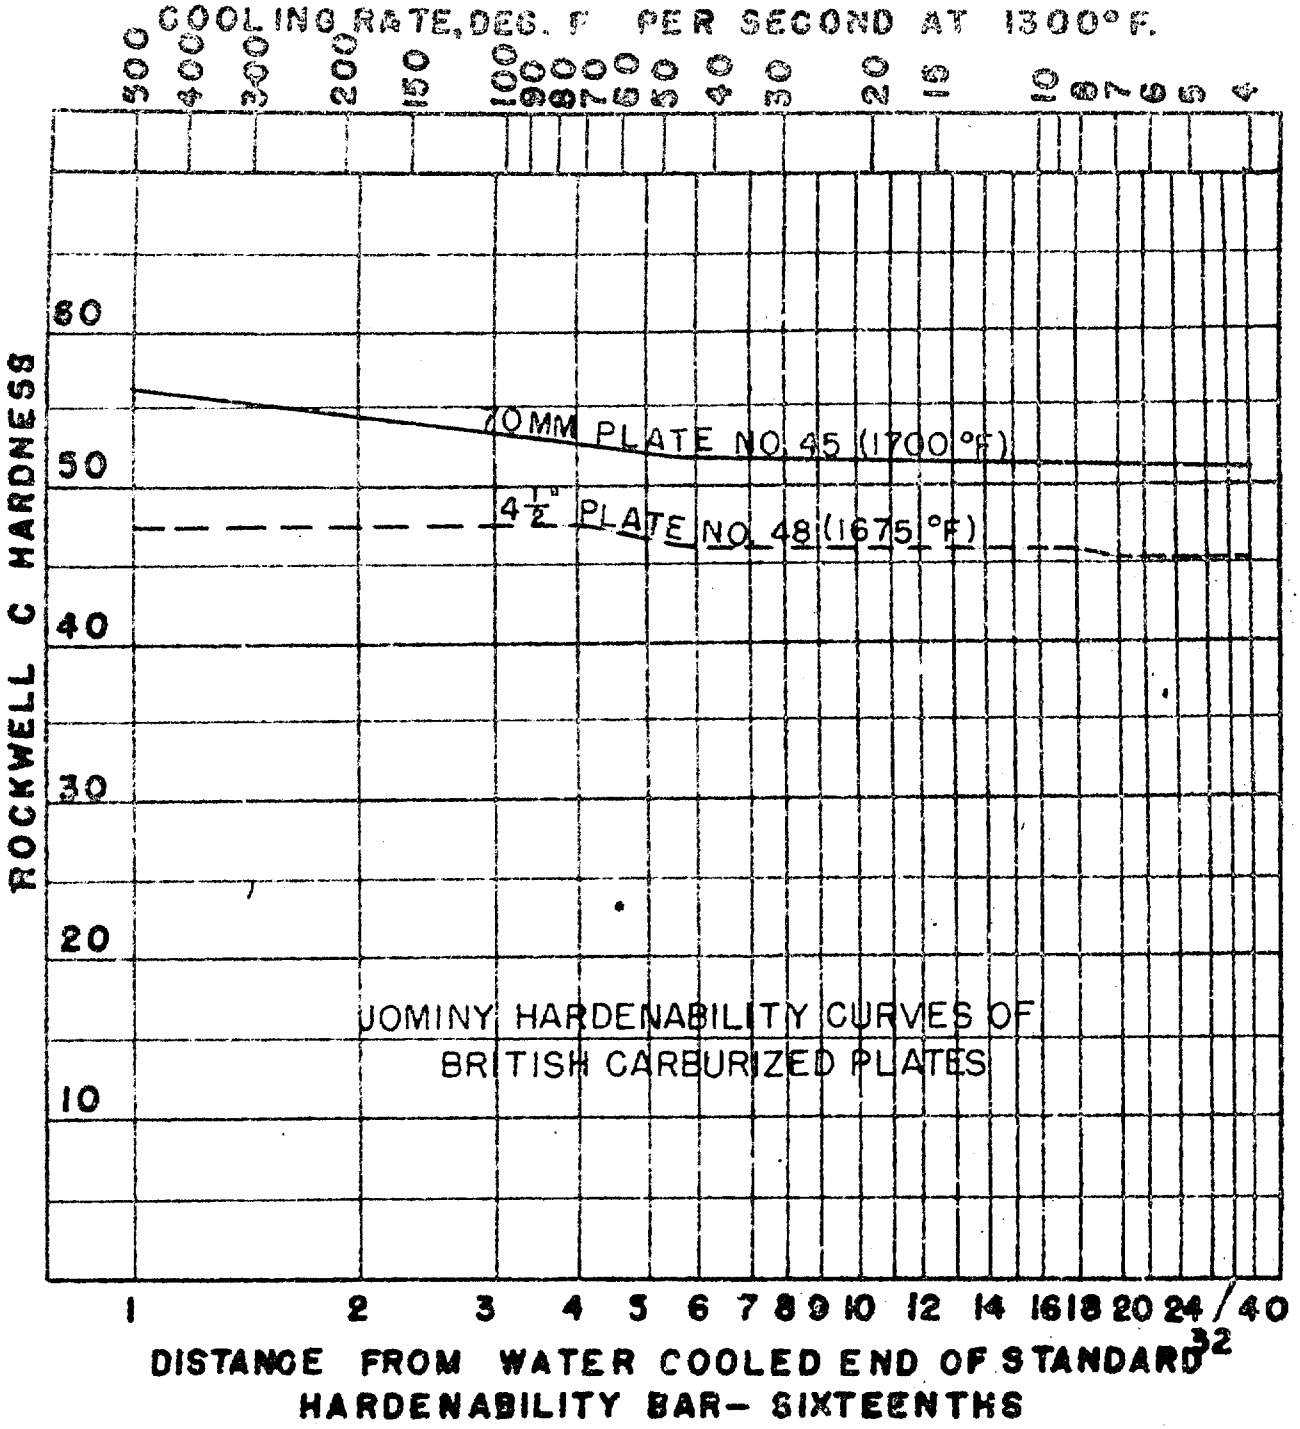
FIGURE 4

Results of the hardness surveys are tabulated in Table III and shown graphically by Figures 4 and 5. Results of the metallographic examination and other pertinent data are summarized in Table IV. A discussion of the hardenability data is given below:

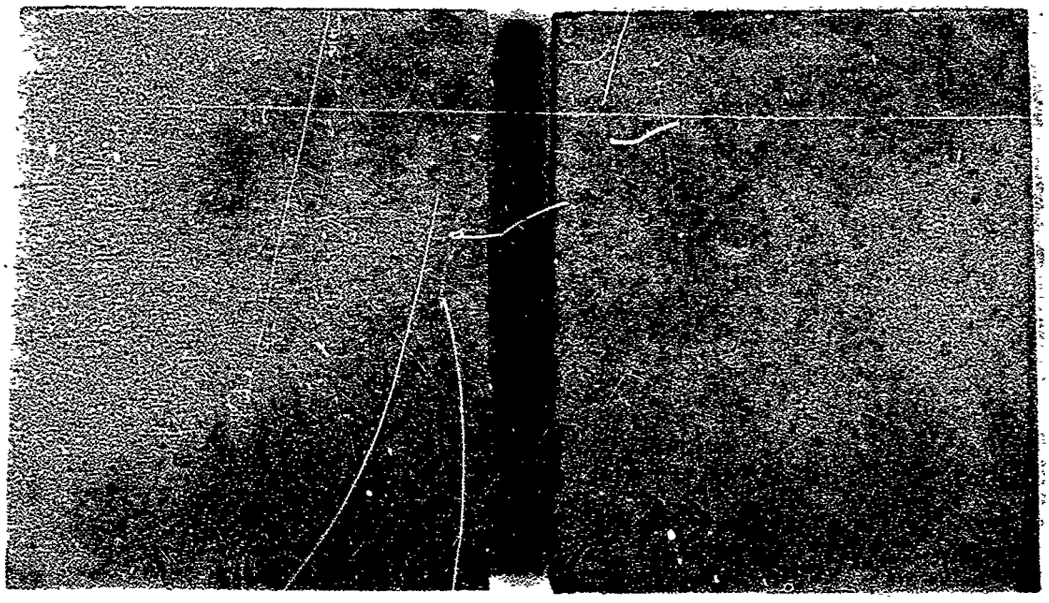
WTN.710-2317
FIGURE 8

The macroetched structures of the homogeneous plates are shown in Figure 8. All of the plates appear to have been cross rolled, with the rolling of Plates 9 and 50 having been done in one direction predominantly. No excessive non-metallic segregations that might cause planes of weakness have been revealed by the hot acid etch. Numerous short inclusion stringers are present in each plate, however.

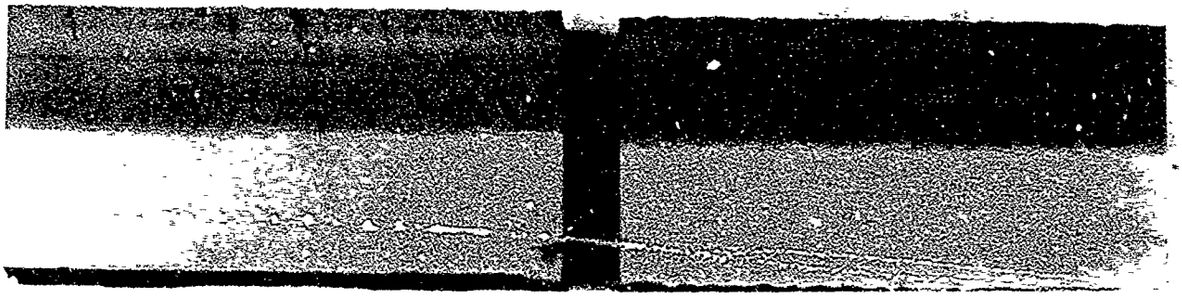
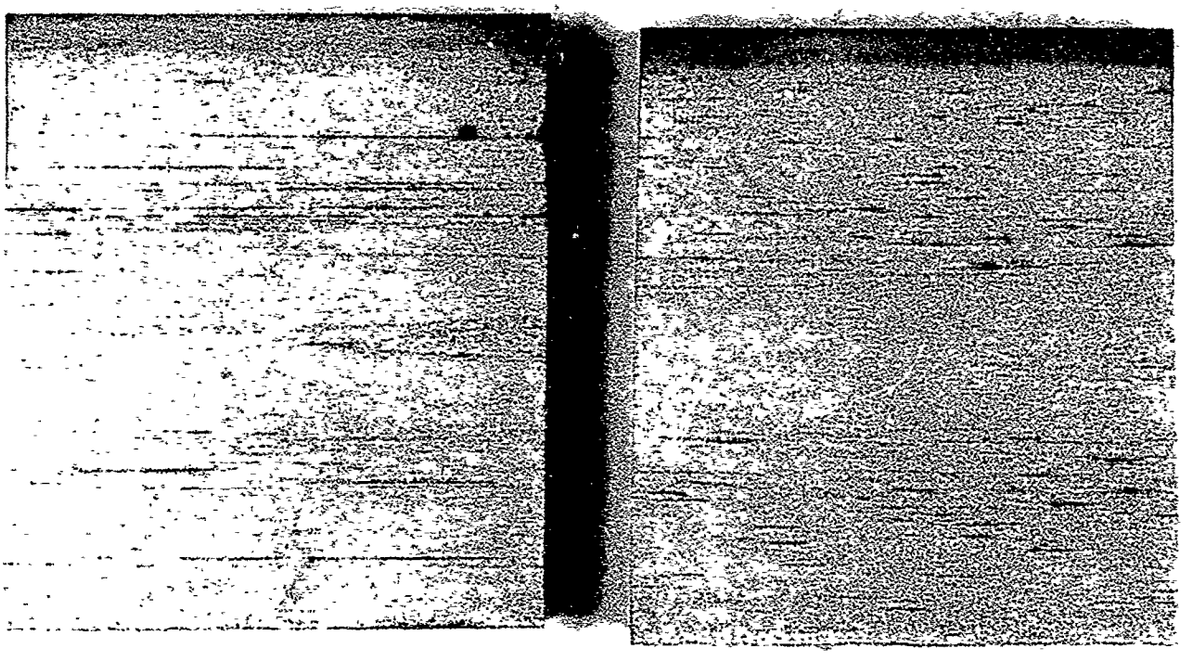
The hot etched structures of the carburized plates, shown in Figure 9, reveal that all had been cross rolled. From the pronounced "woodiness" of their fractures it was expected that the macrostructures of Plates 14 and 45 would contain more inclusion stringers and would evidence more indications that rolling had occurred in one direction mainly. Numerous long stringers exist throughout the section in the macrostructure of Plate 48, explaining the occurrence of deep ruptures in the fracture of this plate (see Section 1).

Short cracks are present in the cases of Plates 14 and 45. It is not unusual, however, for hard carburized cases to show cracks after macroetching.

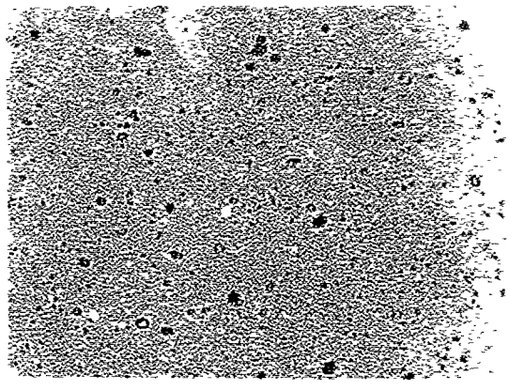
The inclusions which compose the short stringers revealed by all the macrostructures of these plates also resemble sulphides (Figures 10D and E). Plate 48 contains, in addition, numerous long stringers of oval light pink inclusions (Figure 10F). These inclusions are responsible for the poor steel soundness of the plate.

Plate 48 -F- X1000
Oval, light pink inclusions in long stringers throughout the section. Cause of poor steel soundness.

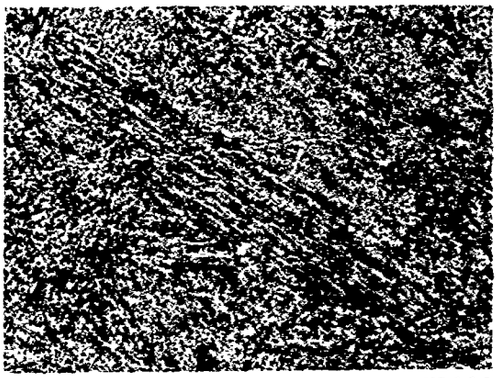
Plate 9 -A- X1000
Typical structure. Tempered martensite plus some tempered bainite. ASTM grain size No. 5.

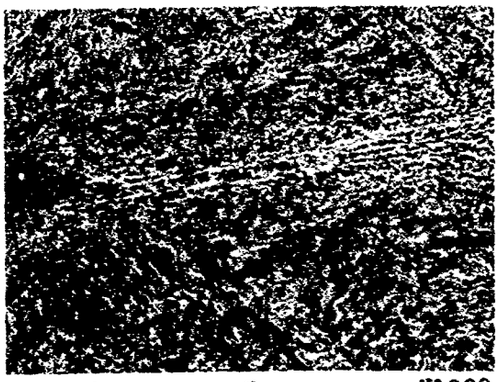
Plate 9 -B- X1000
Ferritic constituent found in small amounts chiefly at the center of the section.

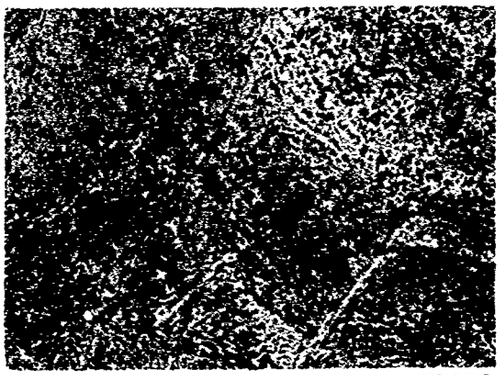
120mm. Plate No. 73 - A large amount of tempered ferritic and nonferritic, nonmartensitic, austenite decomposition products exists in the 120mm. plate, the amount increasing from the surface to the center (Figures 11C,D,E,F). From the hardenability data (see Table IV) the poor quench hardening of the plate is seen to have been caused primarily by inadequate hardenability. The quenching efficiency appears to have been poor also, as evidenced by the considerably larger amount of ferrite in the plate than exists at the air cooled end of the Jominy bar. Grain size of the plate is ASTM No. 5.

Plate 73 -E- X200
.35" from Face B. Slight banding. Same grain size as in -C-.

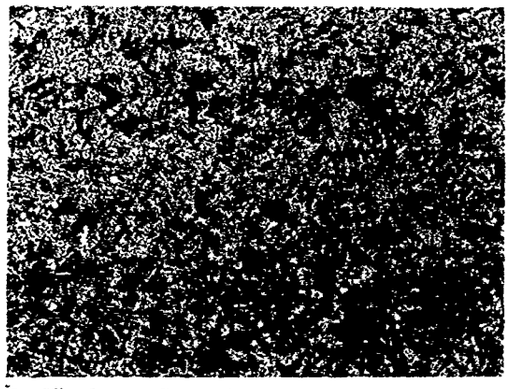
1.2" from Face B -A- X100
Bands and scattered needles of dark etching constituent in light etching matrix.

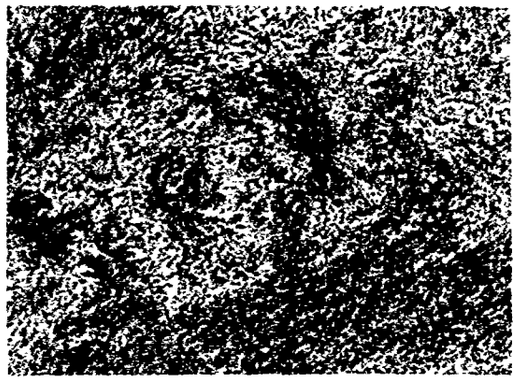
Same location as -A-. -B- X1000
Dark structure is tempered bainite. Light matrix is ferritic austenite decomposition product.

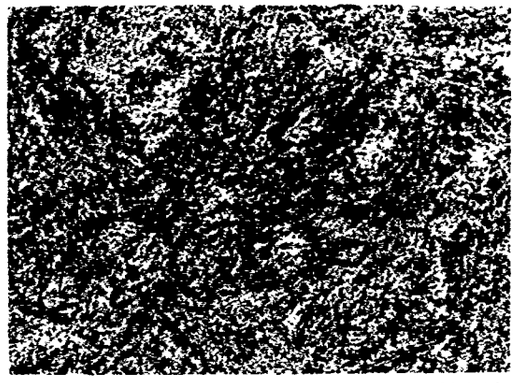
Same location as -C-. -D- X1000
Structure is chiefly tempered bainite. Remainder is the ferritic constituent.

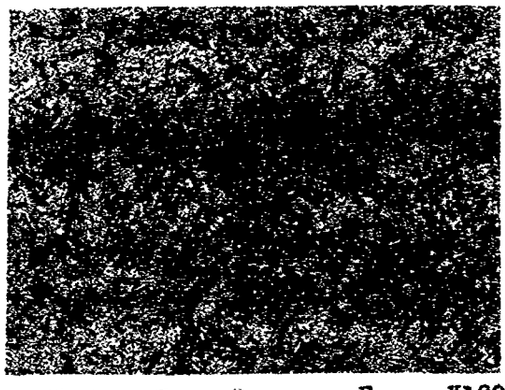
.35" from Face A. -E- X100
Slight banding. Acicular structure. Grain size in whole of section is ASTM No. 6-7.

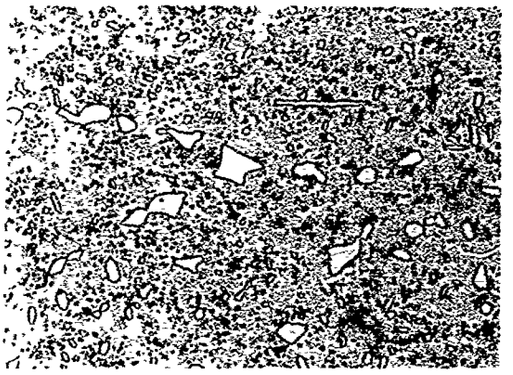
Case - .06" below surface. -A
Large carbides in light etching, structureless martensite.

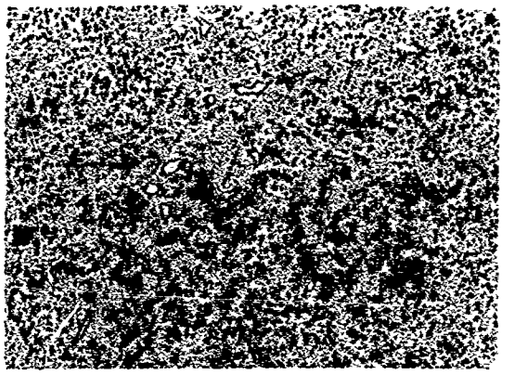
Case - .2" below surface. -B
Many smaller carbides in light etching, structureless martensite.

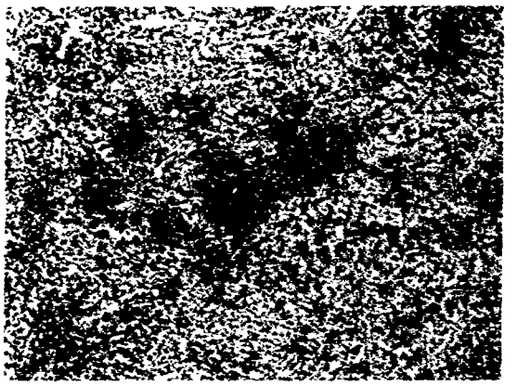
Transition zone - deep etch. -C
.6" below case surface. Martensite in highly tempered core structure.

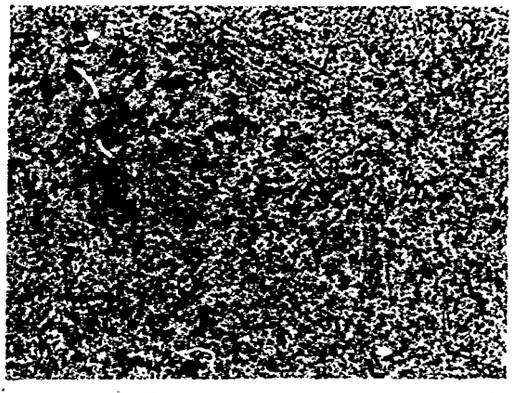
Core - .95" below case surface. -D
Predominant structure. Tempered martensite and/or tempered bainite.

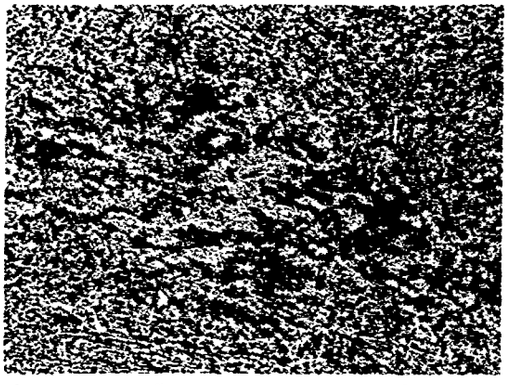
Core - .95" below case surface. -E
Peculiar structure detected throughout the core.

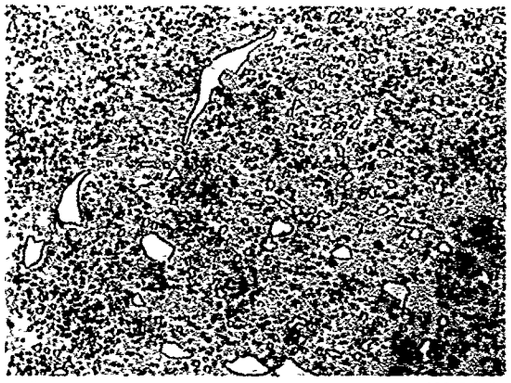
4% Picral Etch -A- X1000
Case - .06" below surface. Large carbides in light etching, structureless martensite.

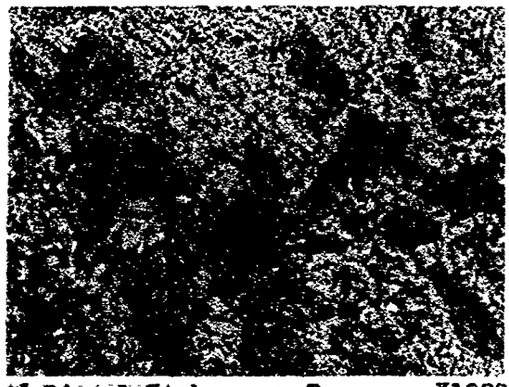
4% Picral Etch -B- X1000
Transition zone - .8" below case surface. Deep etch. Martensite in highly tempered core structure.

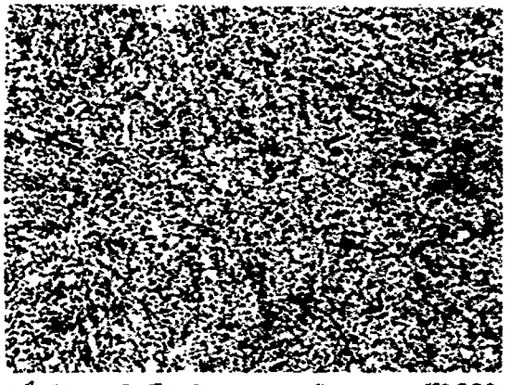
4% Picral Etch -C- X1000
Core - 1.3" below case face. Predominant structure. Tempered martensite and/or tempered bainite.

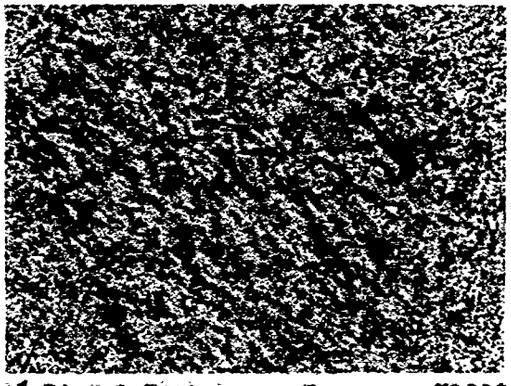
4% Picral Etch -D- X1000
Core - .5" from back surface of plate. Peculiar structure found throughout the core.

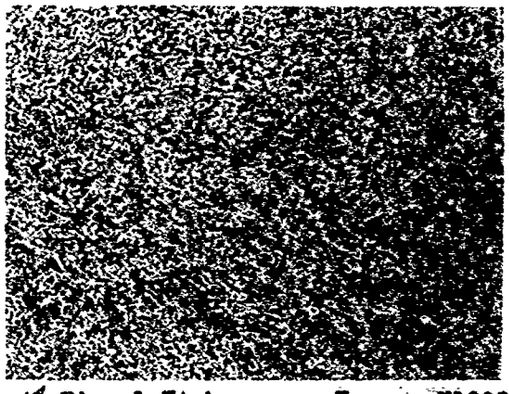
4% Picral Etch -E- X1000
Core - .5" from back of plate. Predominant structure. Tempered martensite and/or tempered bainite.

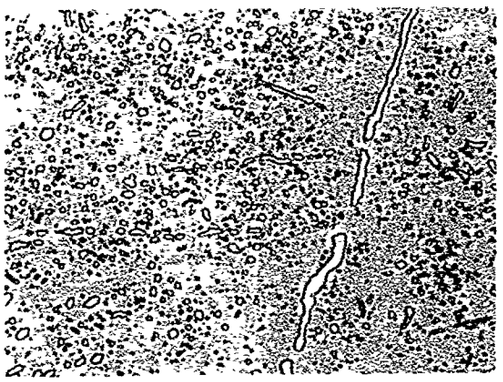
Case - .06" below surface. -A
Large carbides in light etching, structureless martensite.

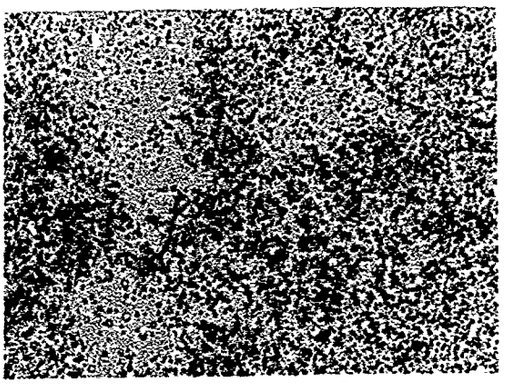
Case - .2" below surface. -B
Many smaller carbides in light etching, structureless martensite.

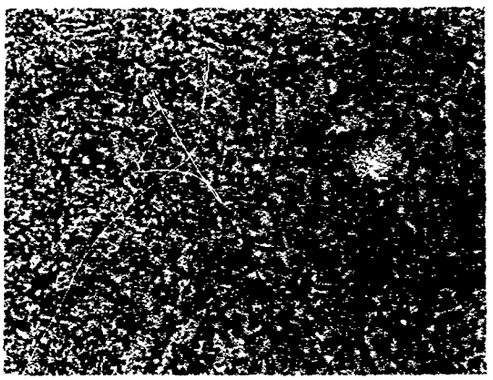
Transition zone - deep etch. -C
1.6" below case surface. Martensite in highly tempered core structure.

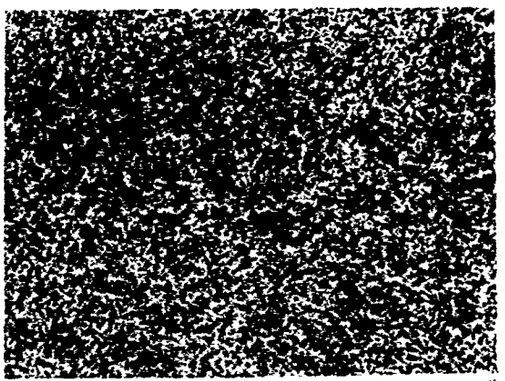
Core - 2.7" below case surface. -D
Structure of dark etching bands present here. Tempered martensite and/or tempered bainite.

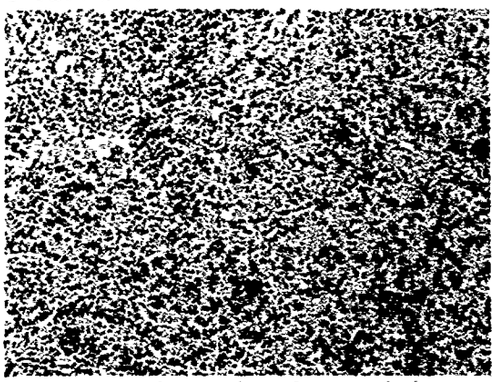
Core - 2.7" below case surface. -E
Structure in the light etching bands present here. Tempered high temperature austenite transformation products.

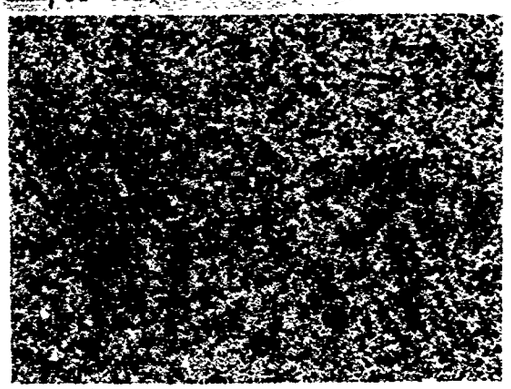
Core - .5" from back of plate. -F
No banding. Structure resembles both -D- and -E-. Grain size in the entire core is ASTM No. 6-7.
