TR 1468-TR (EX)

FIELD FORTIFICATIONS TEST EXERCISE DESERT ROCK VI

Project 8-12-75-001

2 November 1956

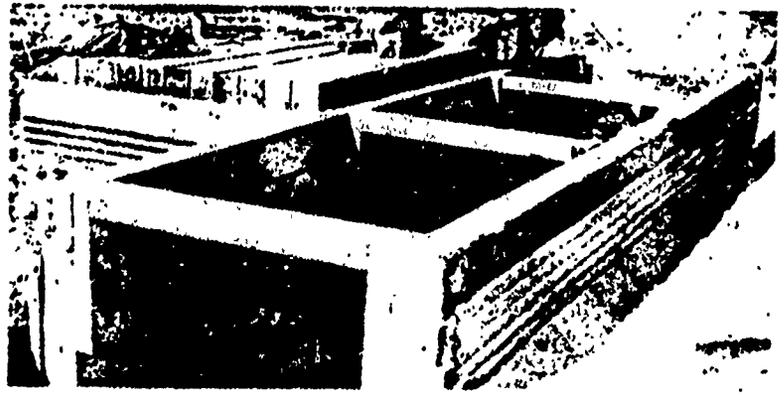
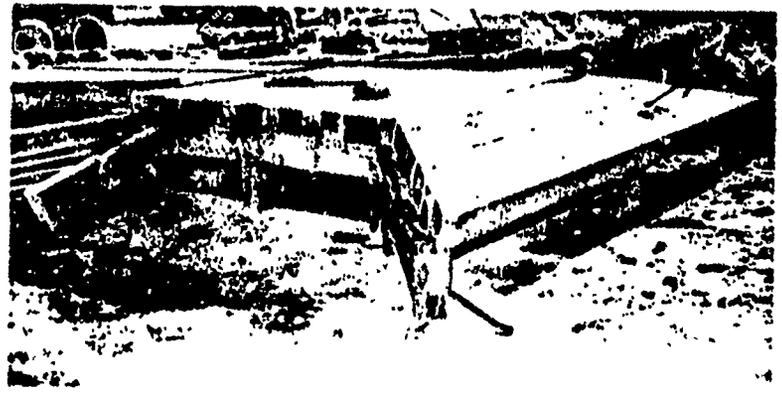
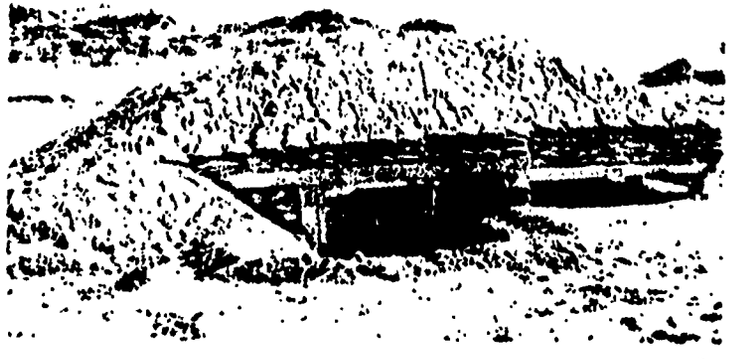
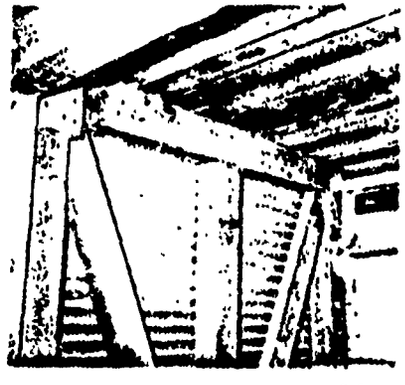
Fig. 10. Type A, various stages of construction.

TCS construction, right entrance

Looking toward front and side firing ports

Left to right through TCS

Left entrance, GZ to left

Wall opposite side firing port

Several points regarding worthwhile design changes were noted as a result of well-defined progressive failures obtained between ranges for both the A and E structures. Most notable of these is perhaps the spreader arrangement between the walls of the entrance trench. From Fig. 10 it can be seen that the spreaders were located between and at the top of the caps, and it is believed that many of the joint failures or separations can be traced to this arrangement. The lateral forces imparted to the ground zero side of

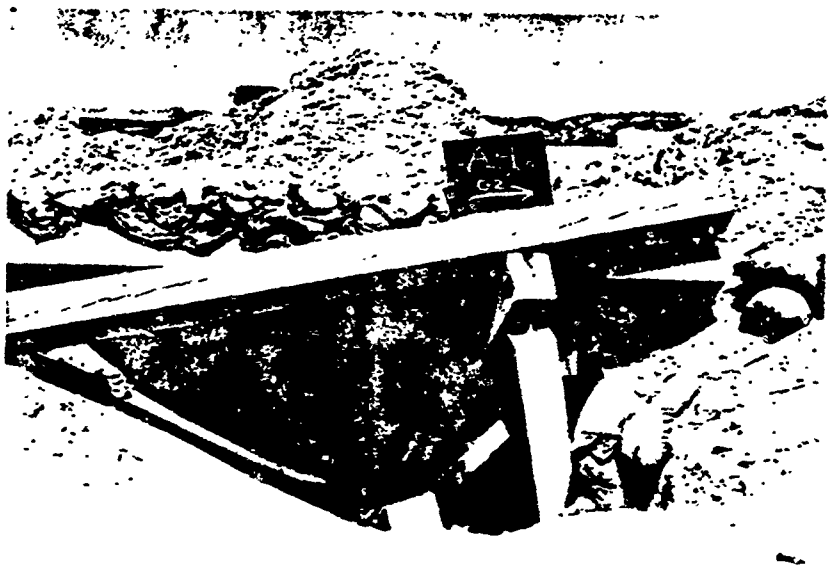
A13277

(a) 1000-Ft Range. Although access was possible through both entrances, this structure was severely damaged. Fig. 26 and 27 show damage to the right and left entrances, respectively. (Note: To understand such directions as right, left, and rearward, the reader should assume the observer was facing GZ.) The front and rear TCS caps (6-in. by 8-in. by 64-in. span) were broken in every span, and the cross bracing was pulled from the posts, and, in several instances, broken. Fig. 28, which is a photograph of the interior of the TCS looking from left to right, gives some idea of the extent of the damage. The caps failed in a surprising number of ways: (1) typical bending failure (Fig. 29); (2) bending failure caused by the horizontal component of the loading (upper left corner of the photograph in Fig. 28); (3) horizontal shear through the vertical dimension (end of the cap showing in the photograph in Fig. 26); and (4) a splitting or tension failure in the rear cap over an interior post which may have been started, initially, by horizontal shear. The splitting failure was a longitudinal separation of the cap along its vertical dimension and can be attributed to two opposing forces: (1) the rearward force transmitted to the cap by the roof stringer spikes; and (2) the restraining action of the drift pin which fastened the cap to the post.

Fig. 26. A-1 structure, right entrance.

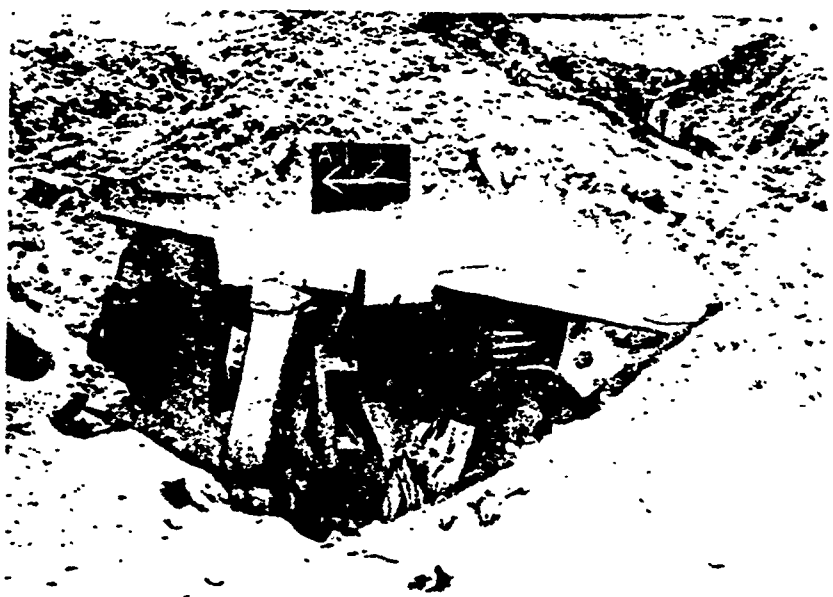
A13276

Fig. 27. A-1 structure, left entrance.

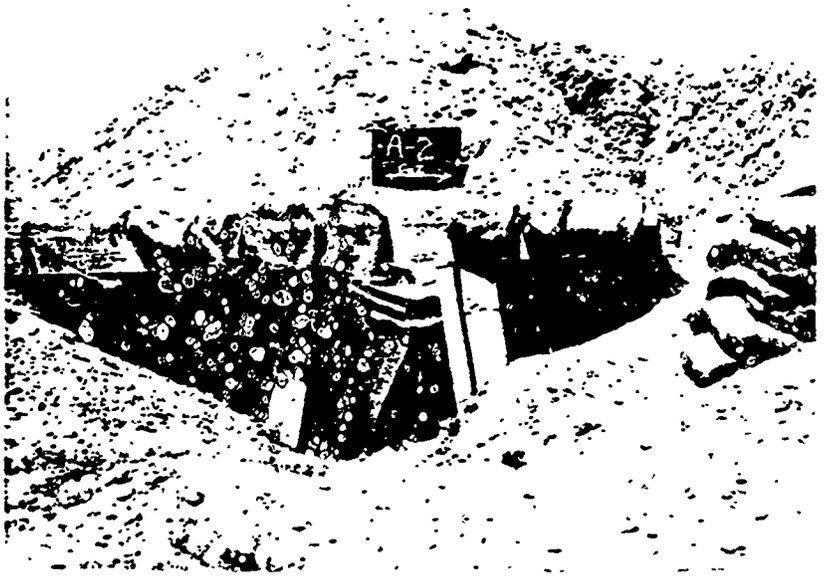
A13297

(b) 1150-Ft Range. Damage to the Type A structure at this range was similar to the damage at the 1000-ft range; however, severe damage was noticeably less and more localized. Figs. 31 and 32 show damage to the right and left entrances, respectively, and Fig. 33 is a view of the interior of the trench cover section looking toward the badly damaged right entrance which was approximately one-half filled with cover and backfill material. Only one cap failed in the entire structure. This was a bending failure of the right front span. The only post failure, apparently a bending failure, is shown in Fig. 34 which is a photograph of the left rear wall of the trench cover section.

Fig. 31. A-2 structure, right entrance.

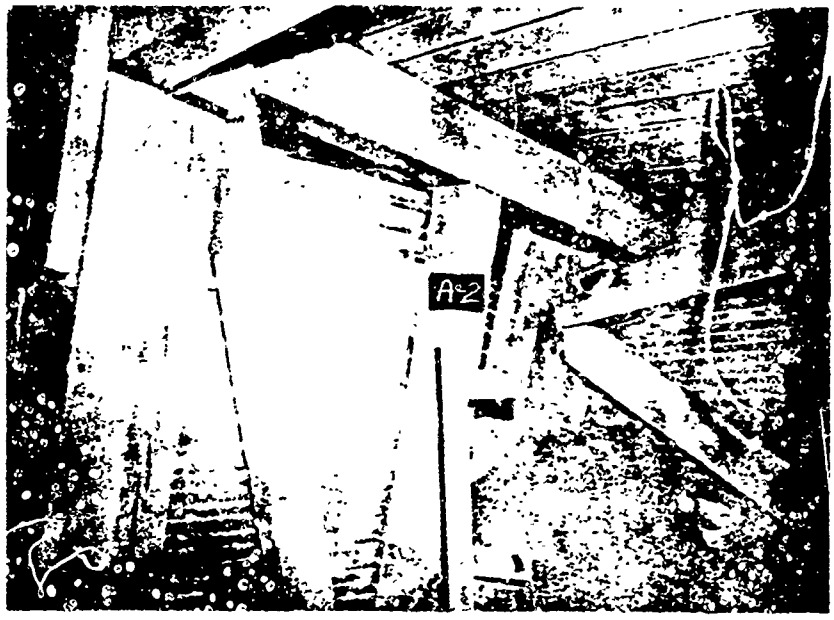
A13229

Damage to the emplacement proper is shown in Figs. 35 and 36. The caps and roof stringers were not moved to the extent they were at the 1000-ft range. Displacement was approximately 1 ft to the left rear. This displacement caused about 2 cu yd of earth cover to fall into the structure. Both firing ports and the aprons were destroyed. Fig. 37, a view of the structure looking

Fig. 35. A-2 structure, emplacement wall (GZ in direction of left foreground).

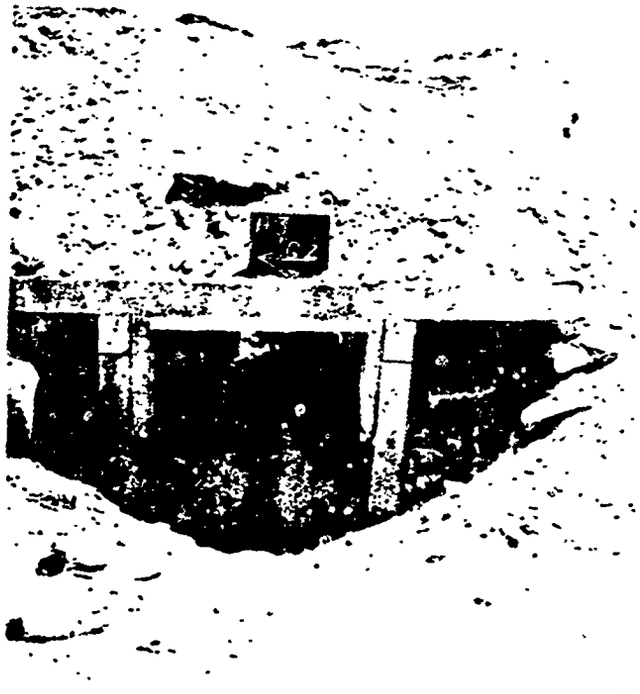
A13303

Fig. 39. A-3 structure, left entrance.

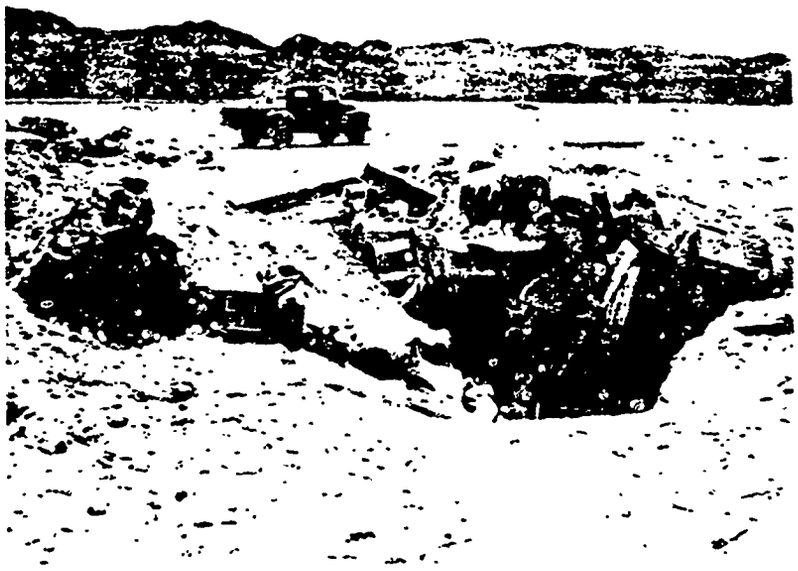
A13283

(a) 1000-Ft Range. The emplacement at this range was incapable of even partially withstanding the effects of the blast. Destruction was complete and in no way localized. Some idea of the extent of damage can be obtained from Fig. 61.

Fig. 61. Left side of E-1 structure.
