NATIONAL ADVISORY COMMITTEE FOR AERONAUTICS

TECHNICAL NOTE

No. 1399

PRELIMINARY INVESTIGATION OF A GAS TURBINE WITH SILLIMANITE CERAMIC ROTOR BLADES

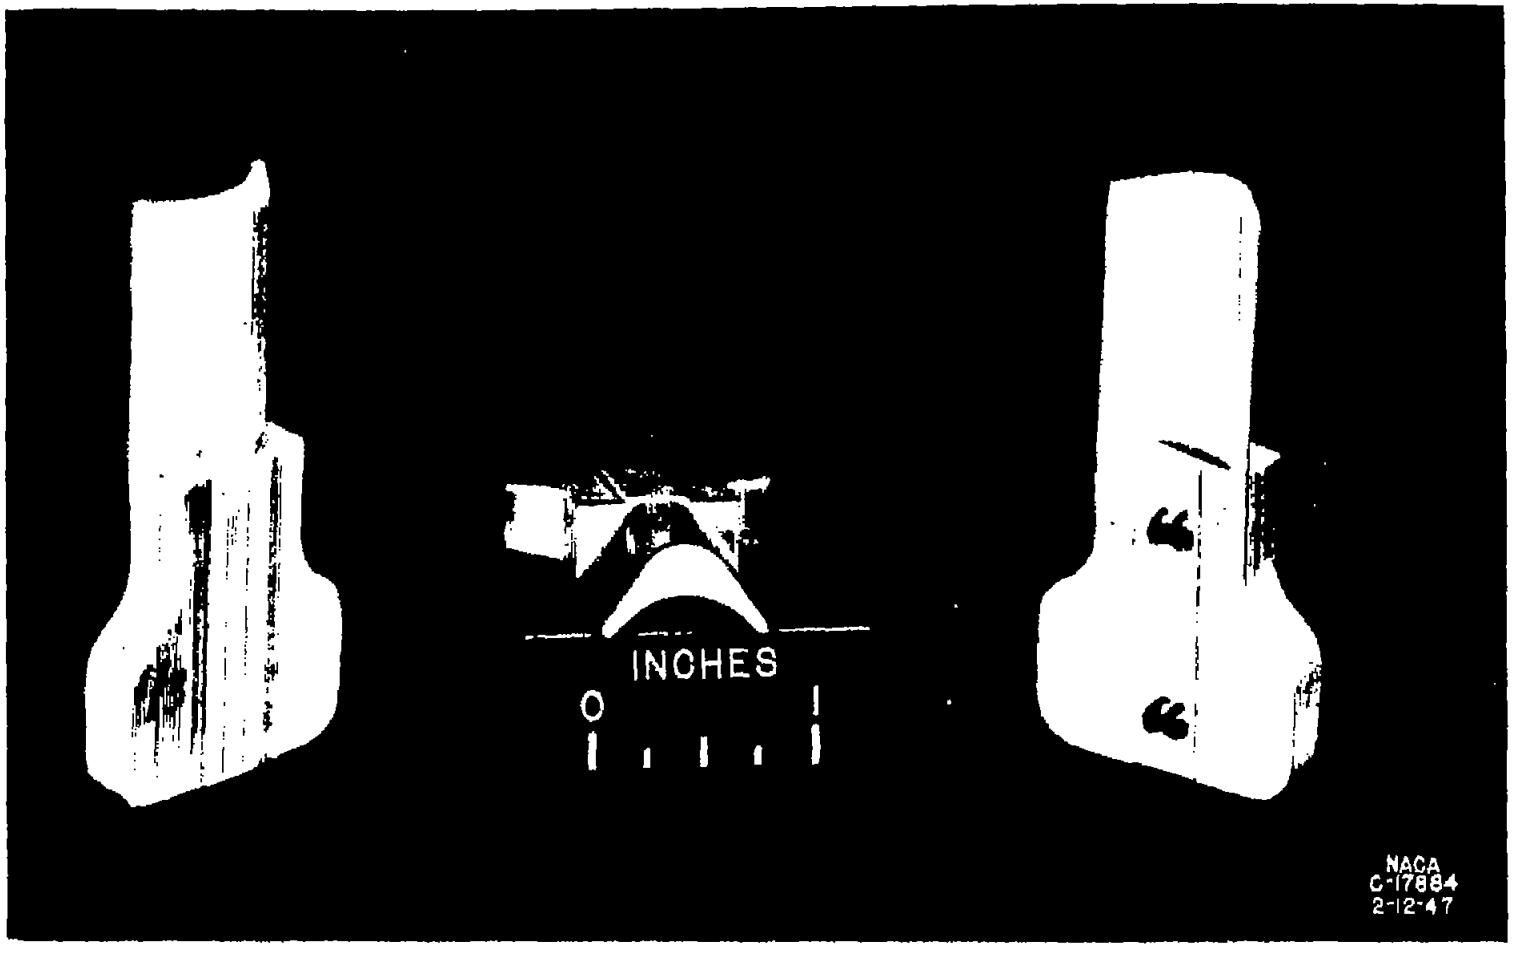
Figure 1. - First-design blades.

The second-design blades differed from the first because of the necessity for reducing stress concentrations in the blade. The blade base was increased in thickness perpendicular to the chord to eliminate the tongue and groove in the root section (figs. 1 and 7) and the radius of the fillets at the most critical section, that is, at the bottom of the blade section, was increased from 1/32 to 1/8 inch to reduce stress concentrations. The complete wheel had 58 blades. A gasket with a nominal thickness of 0.025 inch was used between the

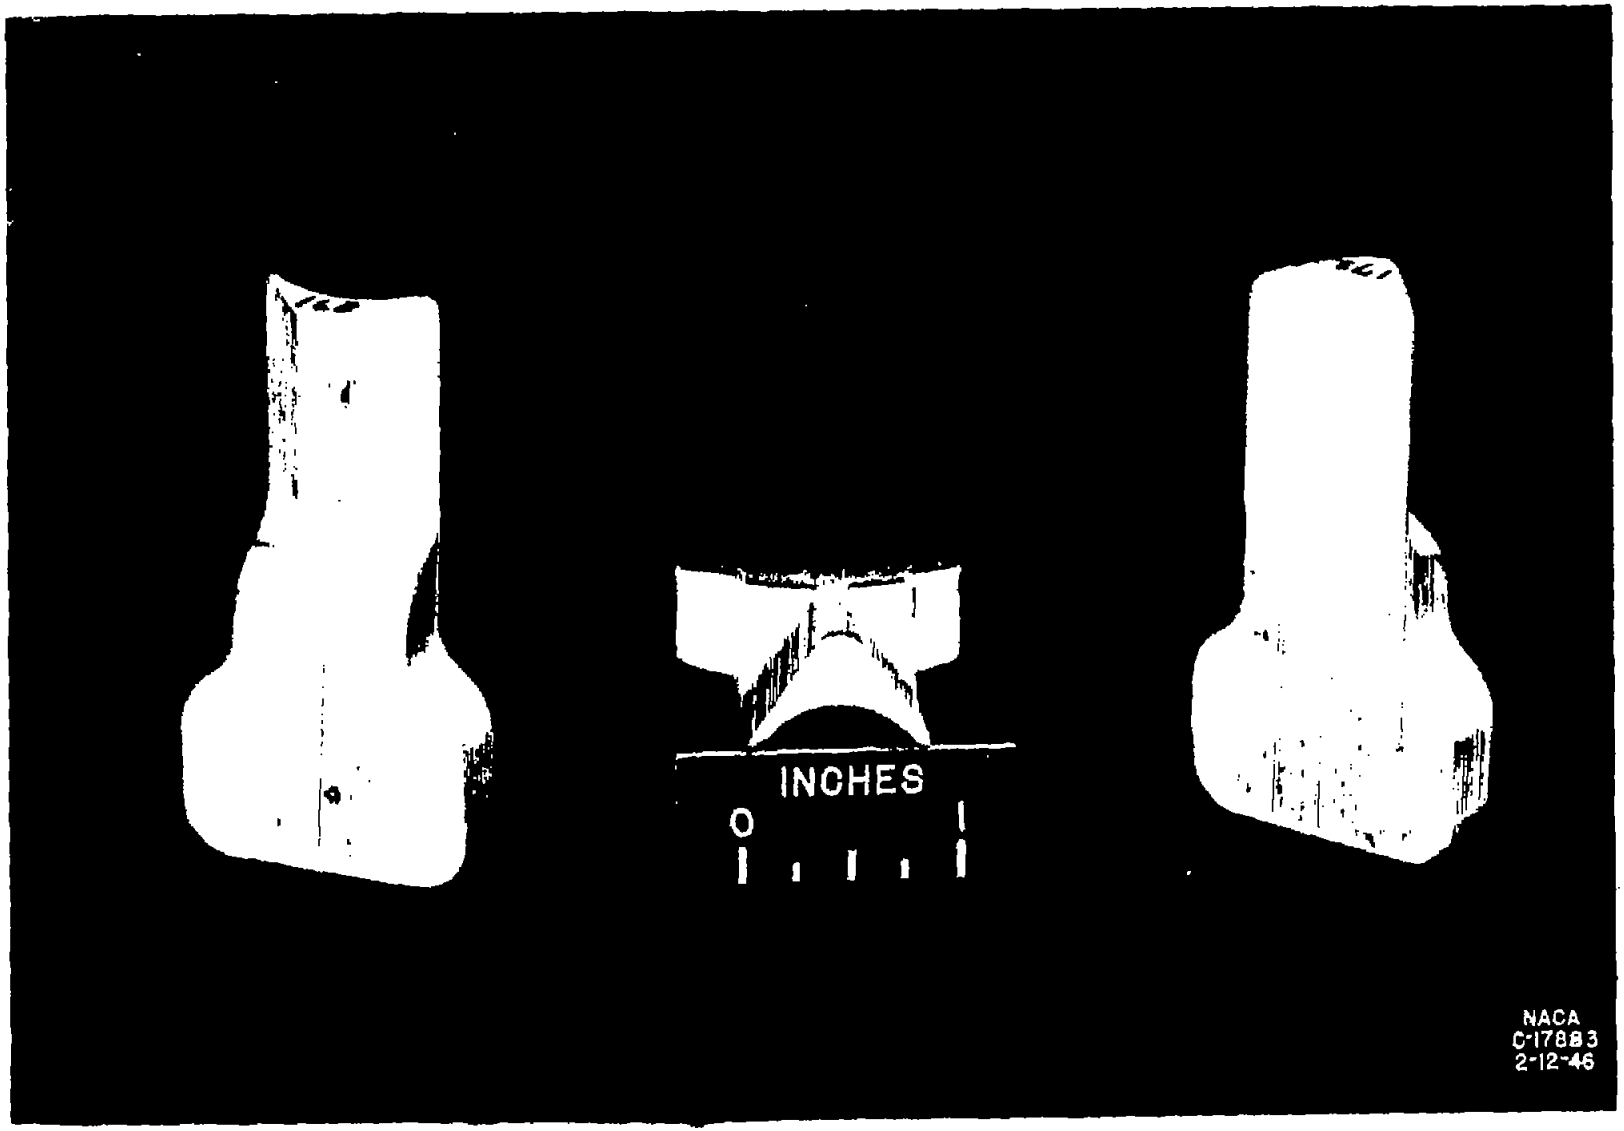
Figure 7. - Second-design blades.

Figure 8. - Second-design blades showing gasket used on alternate blades.

blades and the disks instead of the 0.062-inch gasket used with the first-design blades in order to reduce the amount of radial movement of the blades under the action of centrifugal force. In order that the same disks could be used, the blade size was increased by the amount the gasket thickness was reduced. The radial movement of the blades allowed by the compression of the supporting gasket increases the circumferential clearance between the blades. A 0.020-inch asbestos gasket preloaded to about 500 pounds per square inch was therefore placed between the blade bases to eliminate any further movement of the blades relative to each other. One strip of gasket material was run around the root section of alternate blades as shown in figure 8.

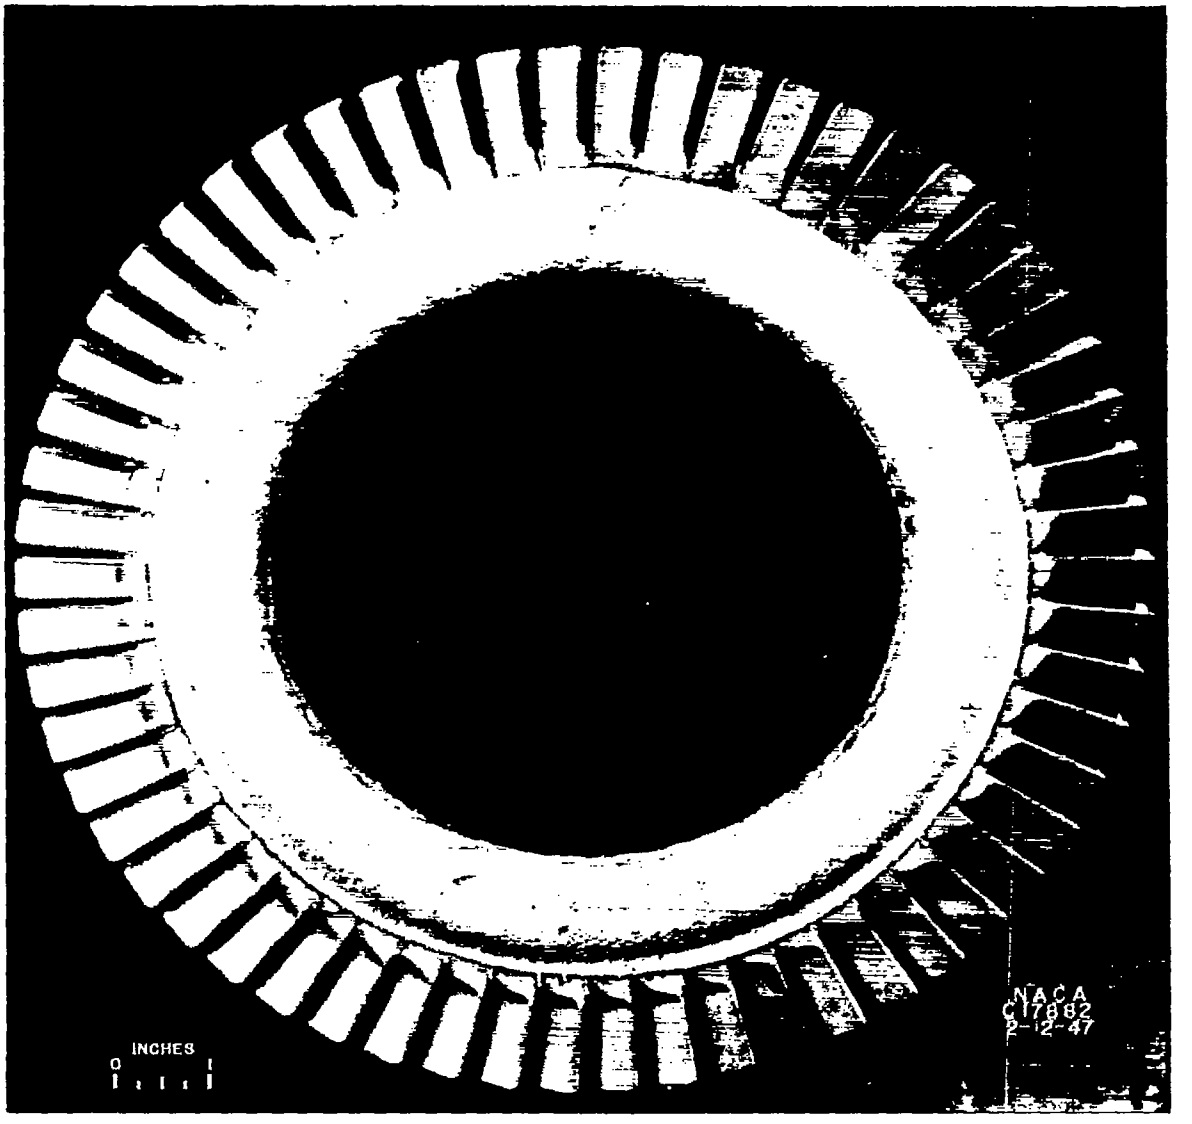
Figure 9. - Ceramic-blade ring with supporting gasket.

The blades were assembled into a ring (fig. 9) in a special wooden jig (fig. 2). The remainder of the assembly, balancing, and alinement procedure was the same as used for the blades of the first design and no changes were made in the setup. Figure 10 shows the rotor assembly.

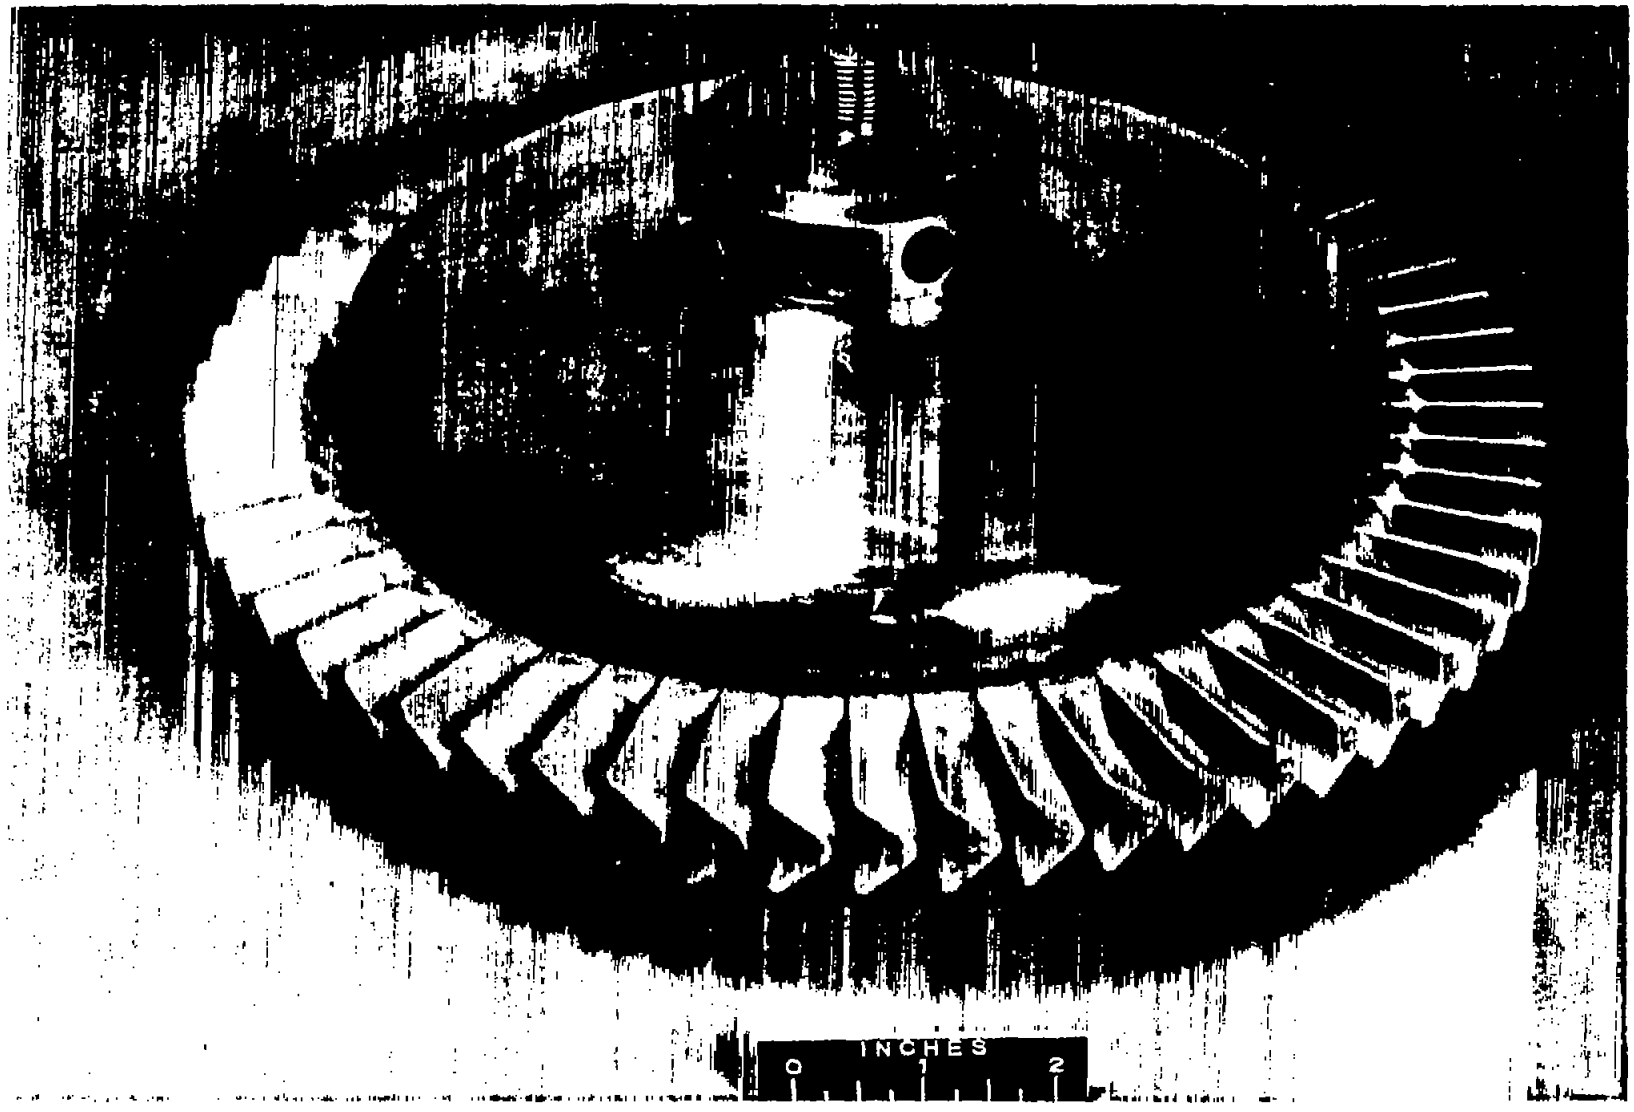
Figure 10. - Turbine-rotor assembly with second-design blades.
