NWC TP 4857

FLEXIBLE EXPLOSIVE LEAD, EX 22 MOD 0 DESIGN EVALUATION

ABSTRACT. A description of the design evaluation tests performed on the Ex 22 Mod 0 Flexible Explosive Lead is presented, together with the test results.

NAVAL WEAPONS CENTER
CHINA LAKE, CALIFORNIA • MARCH 1970

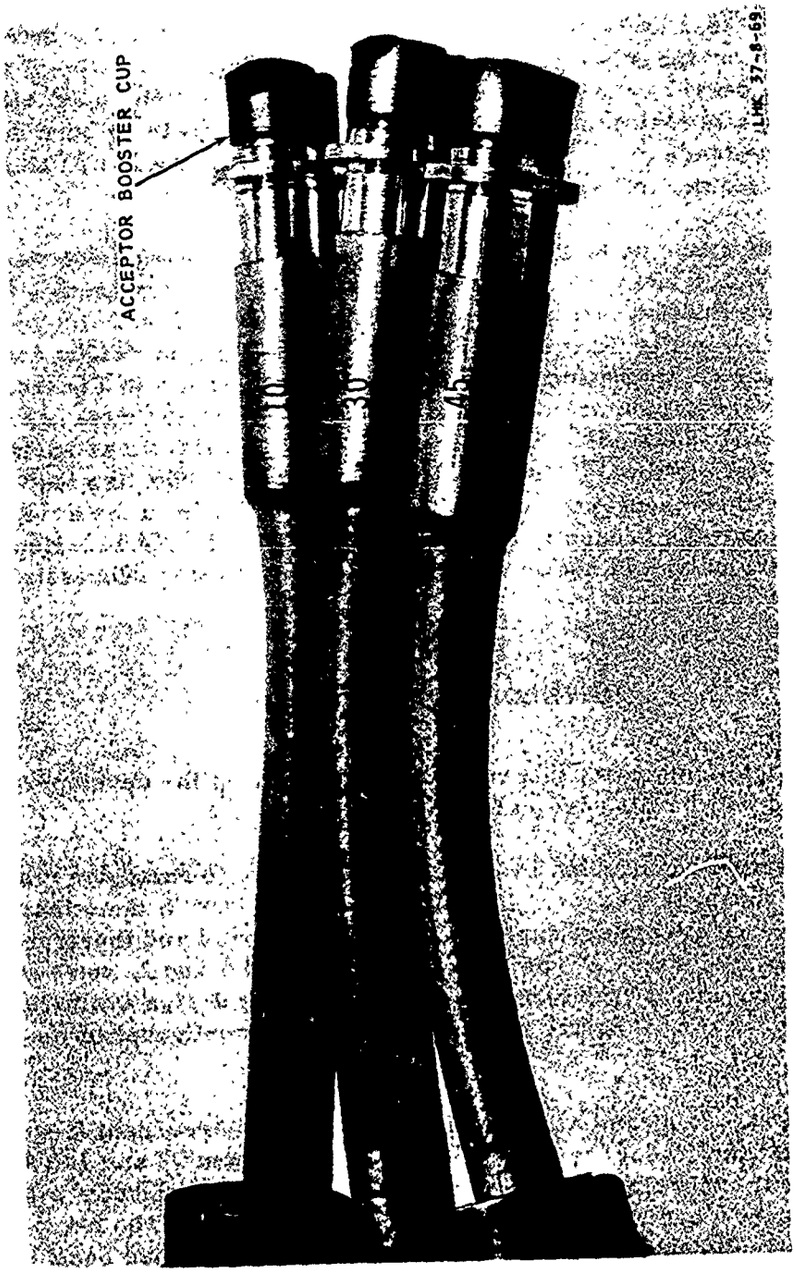
FIG. 8. Leads Following Jumble Test.

Three units from the group that had been given the Free Flight Test were subjected to the Jumble Test, as prescribed by MIL-STD-331, Test 102. These units sustained slight deformation of the acceptor booster cup during this test (see Fig. 8). These units were fired, and the dents obtained were of acceptable depth. Since the only criterion for passing this test was that the leads must not detonate or burn during the test, the leads exceeded this requirement by proving to be functional within acceptable limits as well.
