FLUID CONTAMINATION SURVEY OF 143 NAVAL AIRCRAFT HYDRAULIC SYSTEMS

13 March 1963

Final Report

DOUGLAS AIRCRAFT DIVISION • LONG BEACH, CALIFORNIA

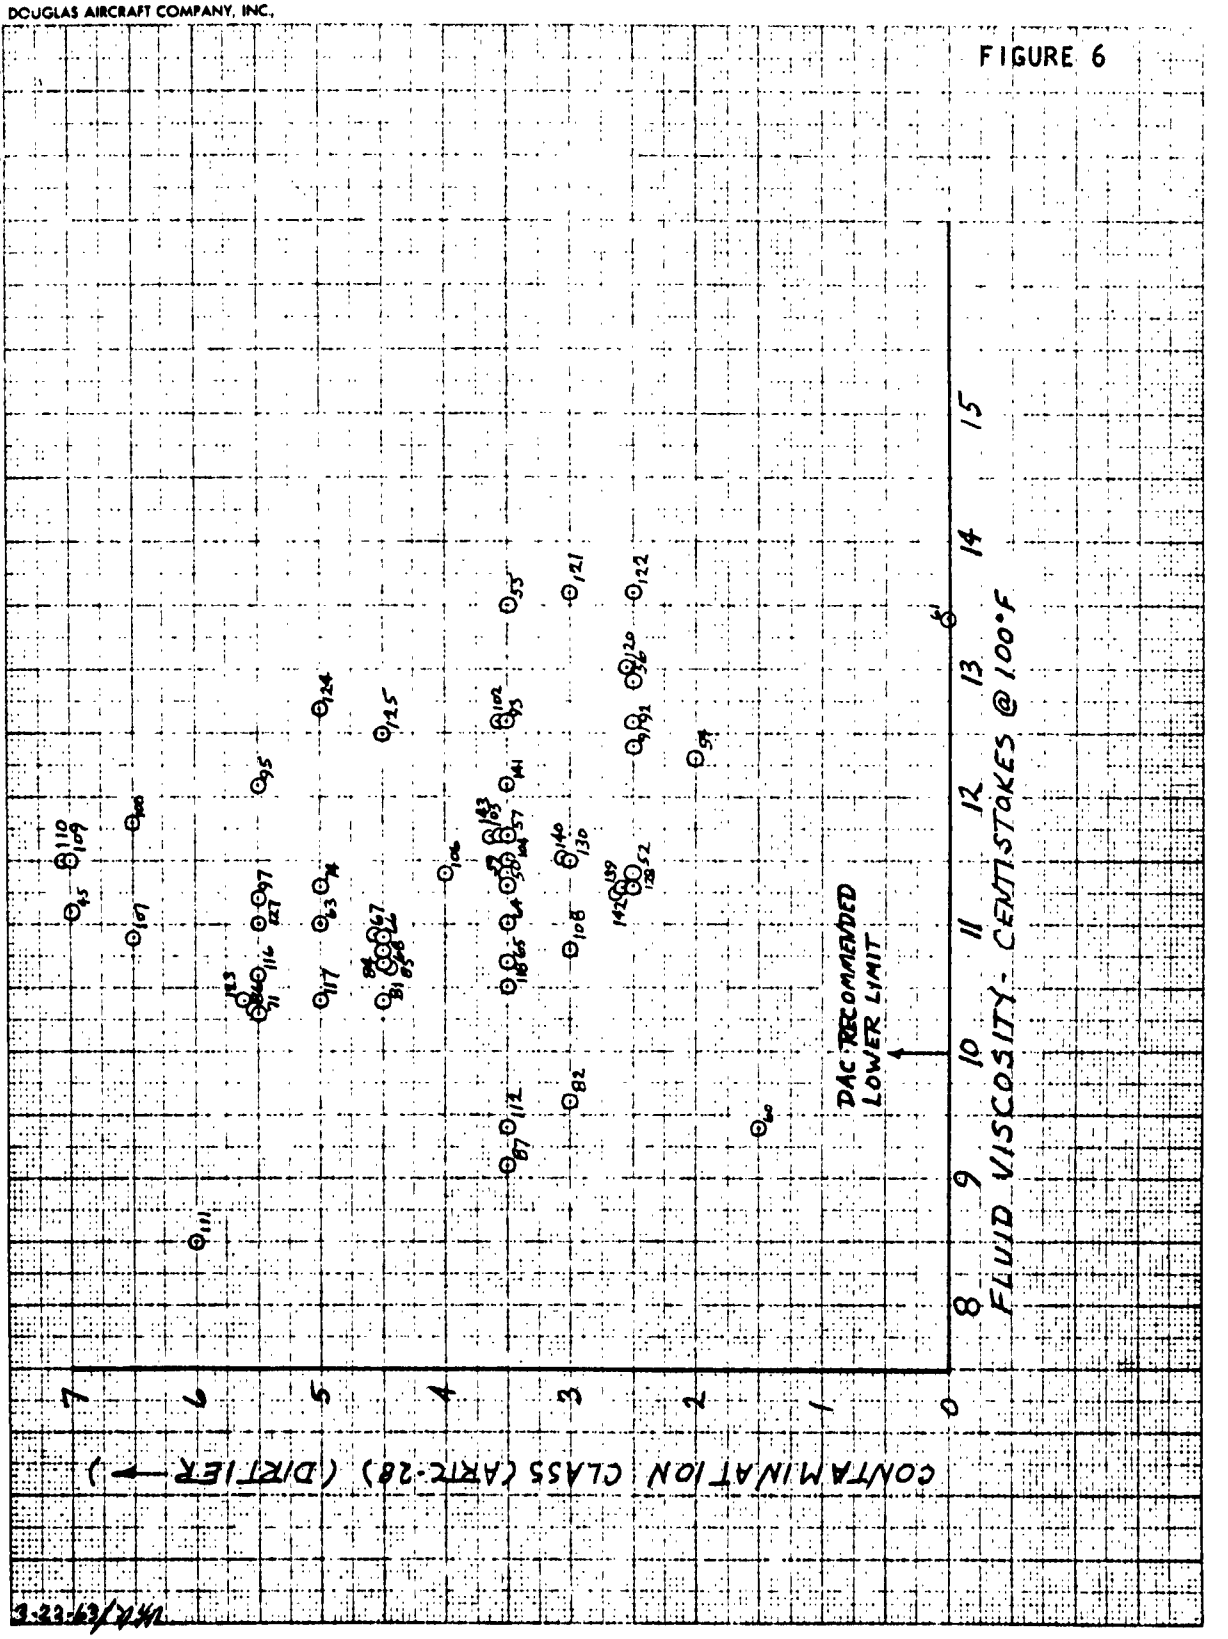
FIGURE 6

Figure 6 shows the contamination class vs viscosity of the fluid. There appears to be some relationship in thise case, but not sufficiently well defined to use viscosity as an index to contamination.

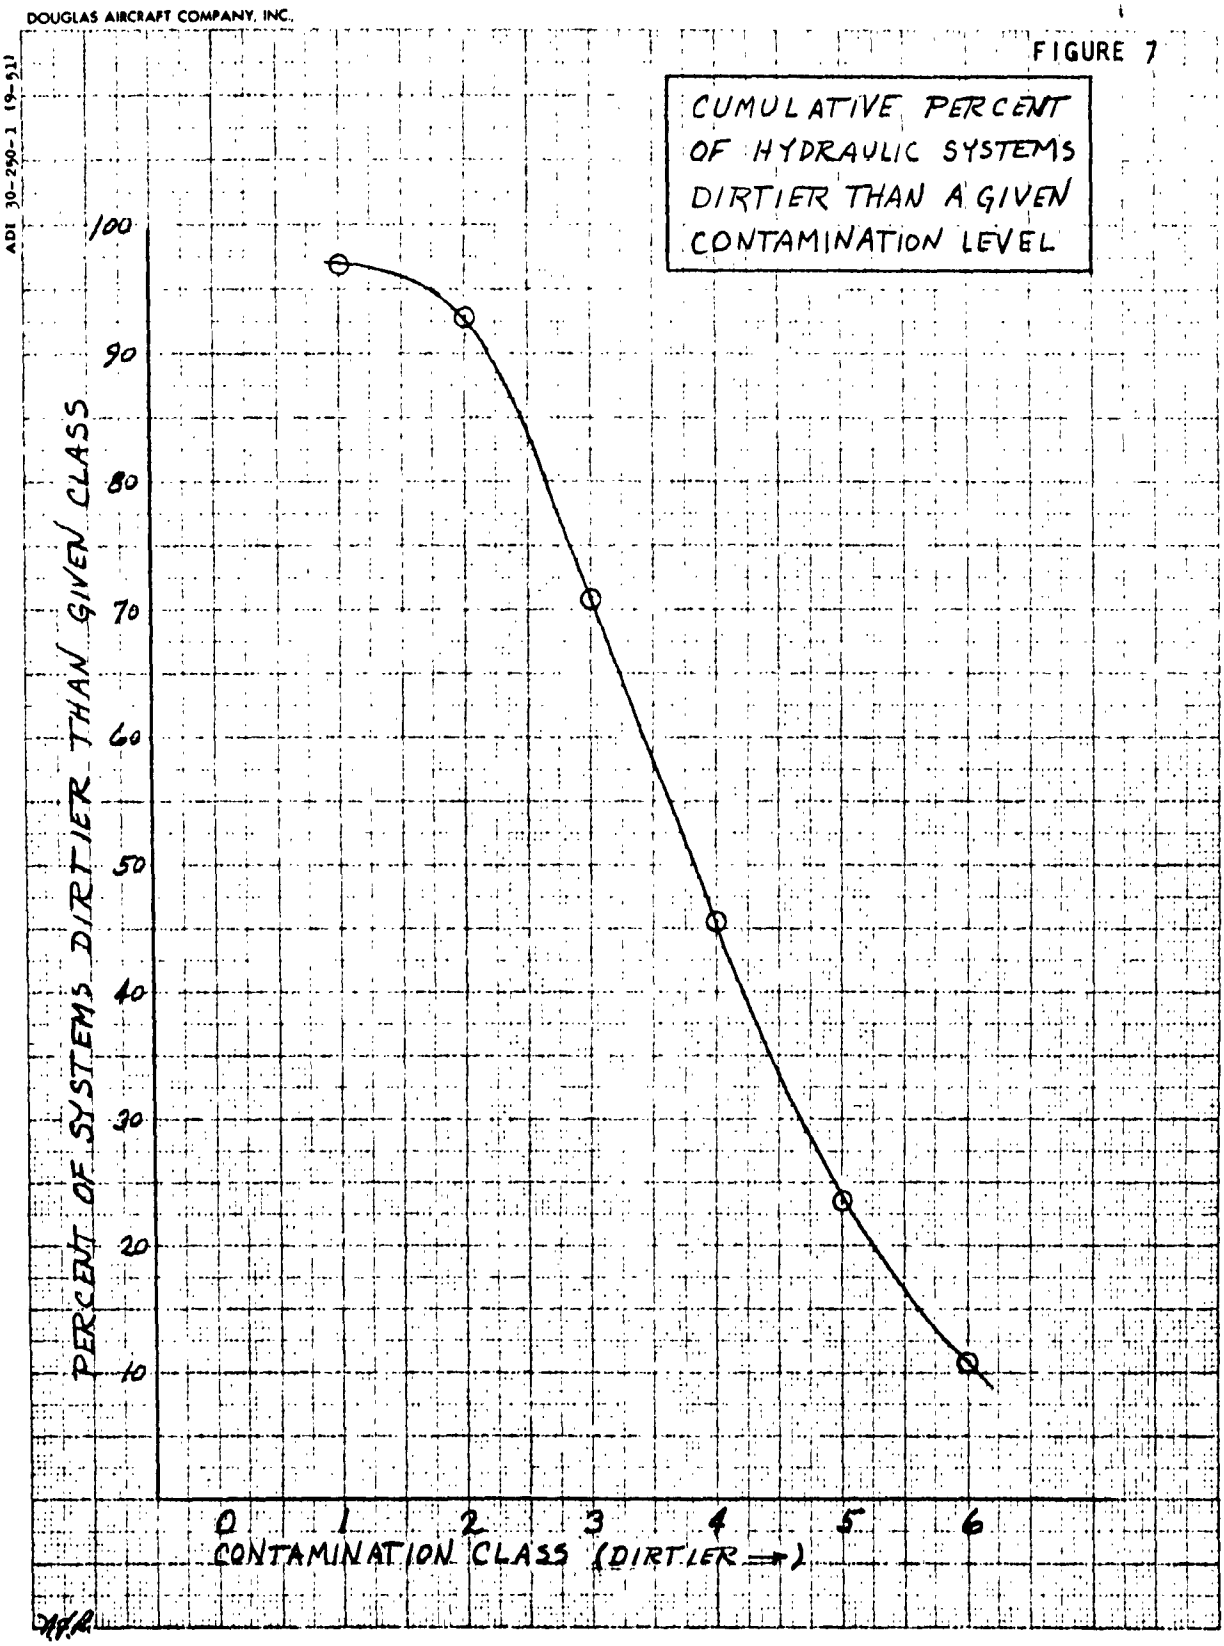
FIGURE 7

The curve, Figure 7, shows the contamination class (per Figure 2) vs the percentage of all systems which exceed that class. This curve indicates that while the mean contamination level for all systems is about Class 4, 23% are dirtier than Class 5, and 11% are dirtier than Class 6. Figure 9 shows this information in bar-graph form.

Figure 7 shows that in current Naval aircraft, more than half the hydraulic systems meet a contamination level of Class 4 or better. If all systems were that clean, there would be little trouble caused by contamination. However, about a quarter are dirtier than Class 5, the recommended limit, and more than 10 percent are dirtier than Class 6, which is 4 times as dirty as Class 4.

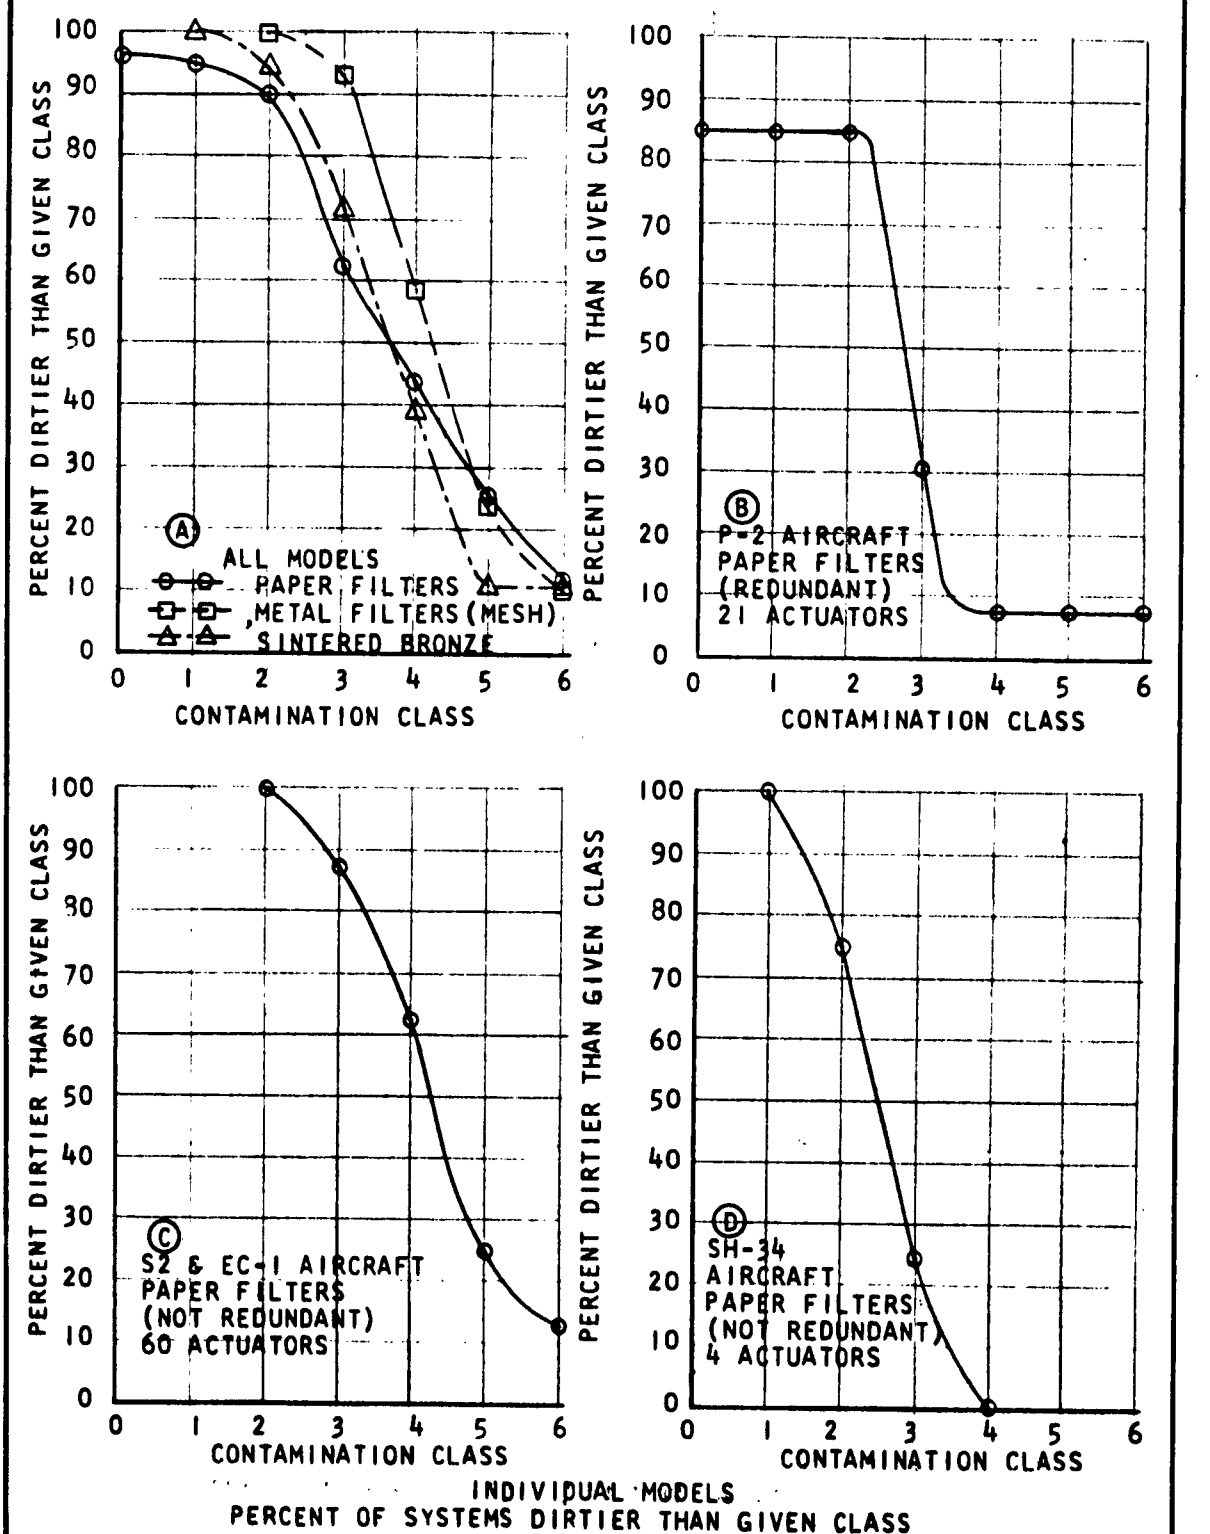
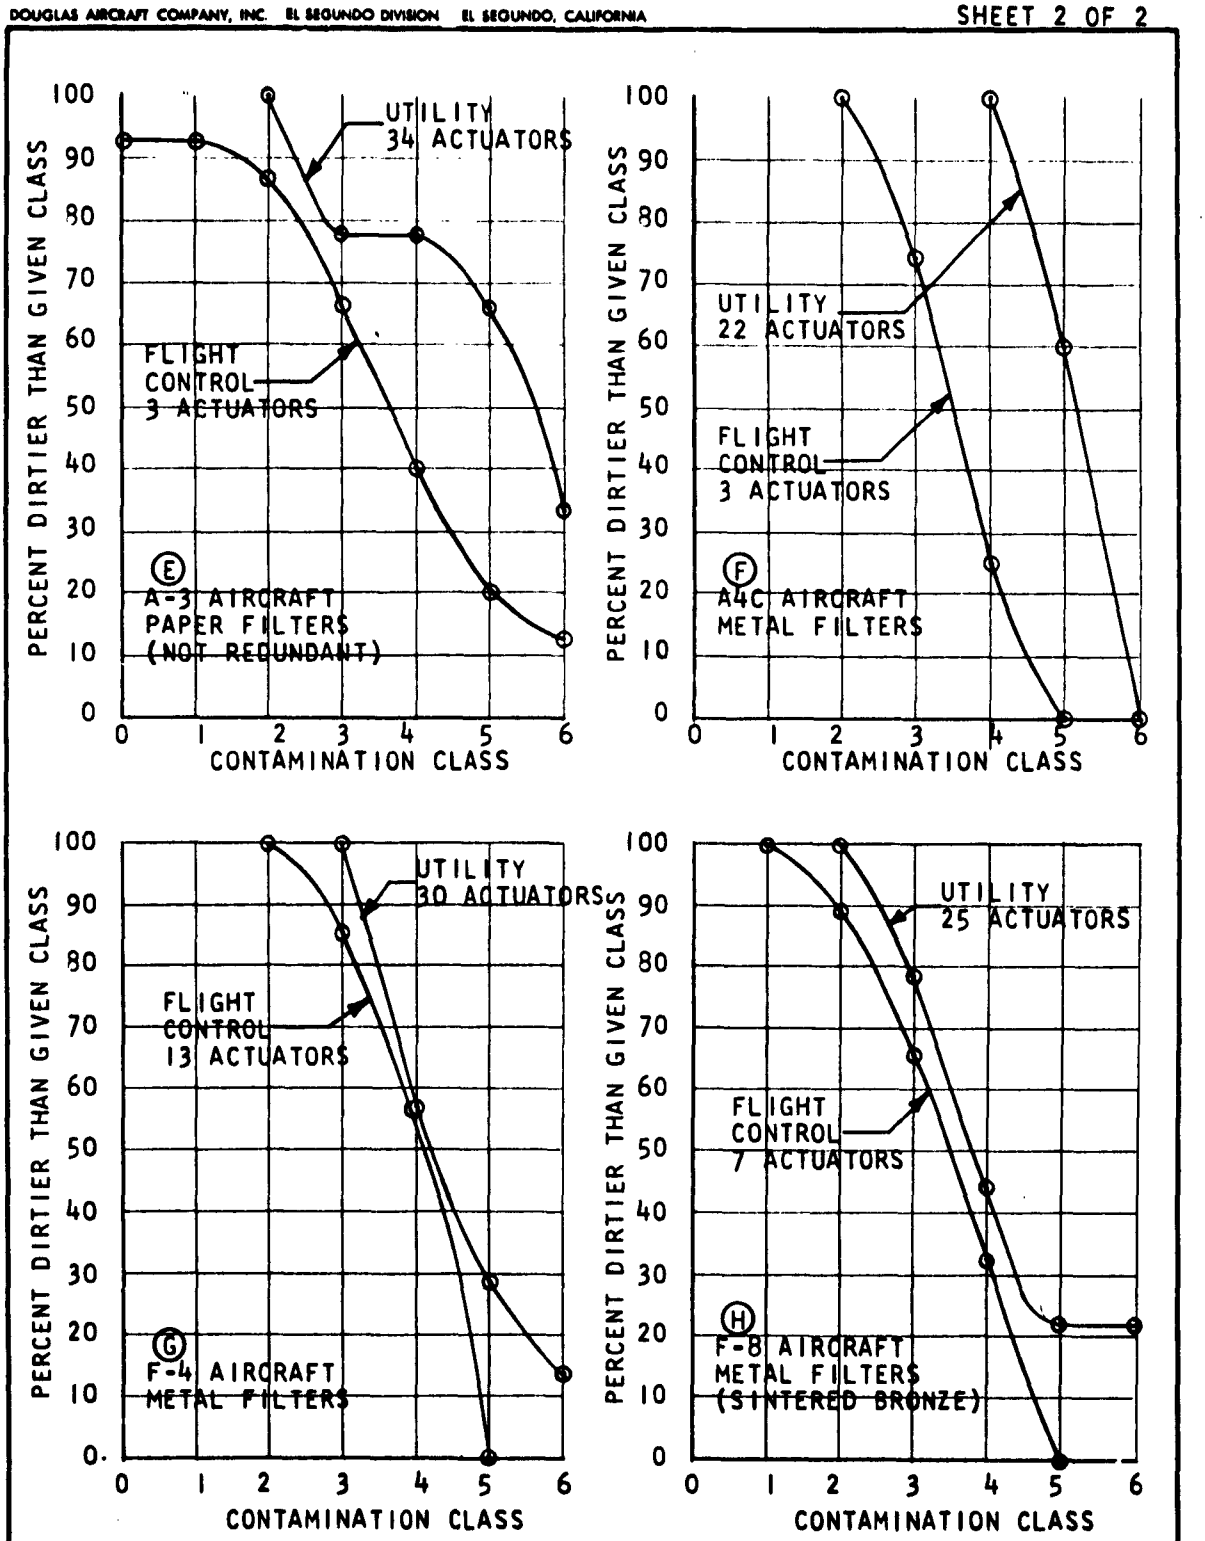
Figure 8 shows the cleanliness distribution by aircraft model, provided there are sufficient data to generate a curve. On several types of aircraft, three or less airplanes were tested. Figures 8E through 8H compare contamination levels of utility and flight control systems for four models. These curves show the flight control systems to be cleaner in each case, although the margins vary.

INDIVIDUAL MODELS
PERCENT OF SYSTEMS DIRTIER THAN GIVEN CLASS

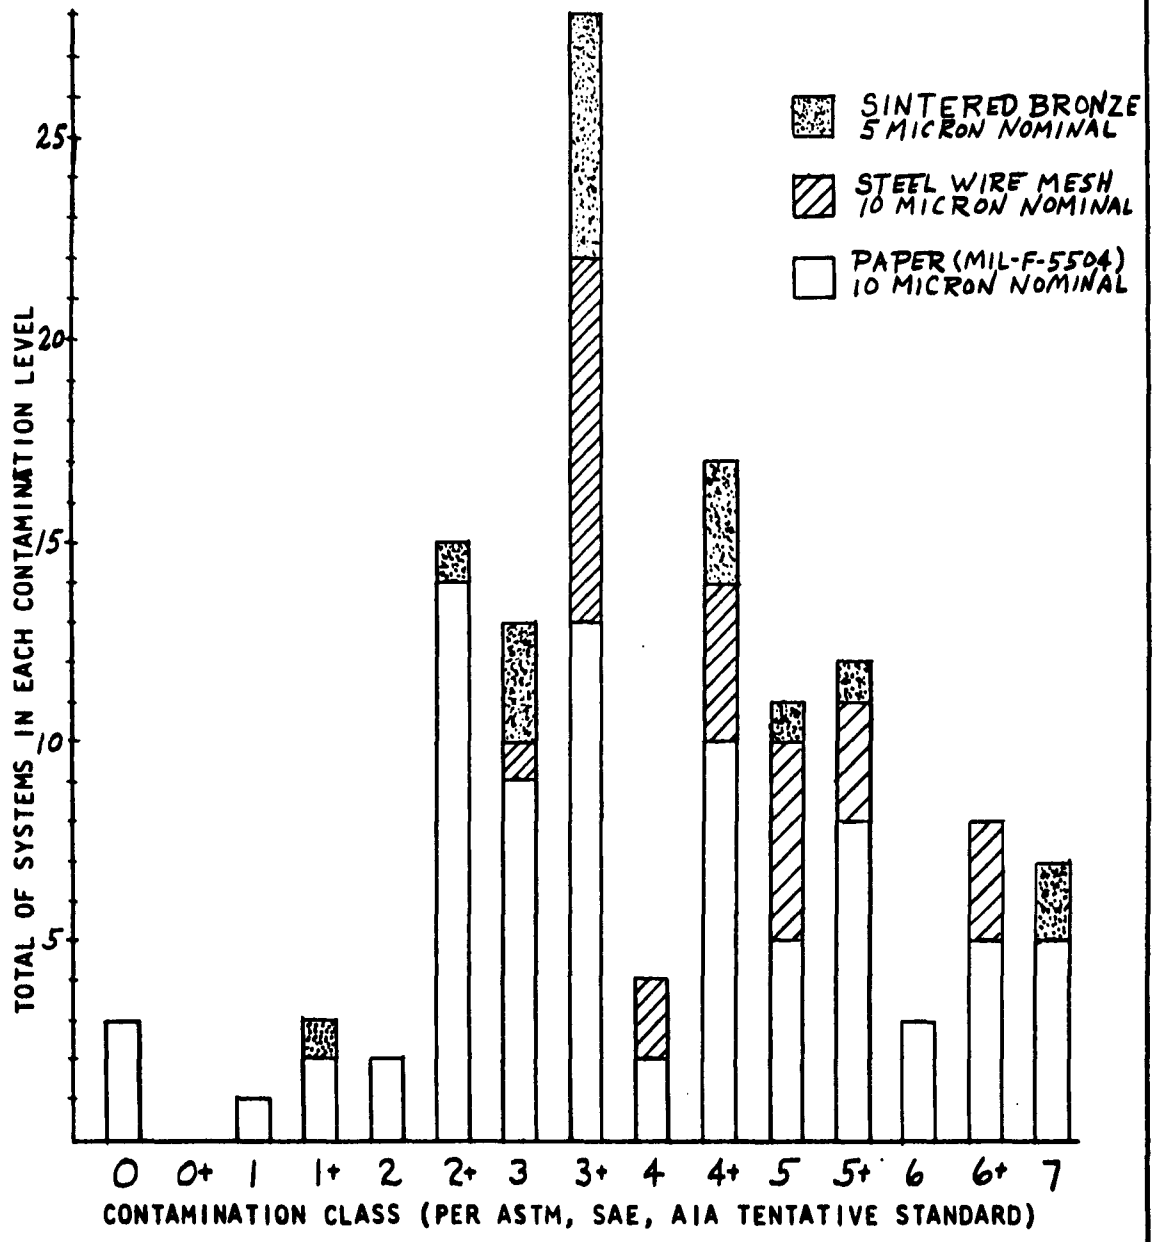
FIGURE 9

with paper filters were found in the "superclean" category-class 0 or 1, whereas no metal-filtered system was that clean. Some paper-filtered systems were also among the dirtiest tested. The metal filters give more consistent results, even though the average cleanliness level is not as good as with paper.

TOTAL SYSTEMS AND TYPES
OF FILTRATION IN EACH
CONTAMINATION CLASS

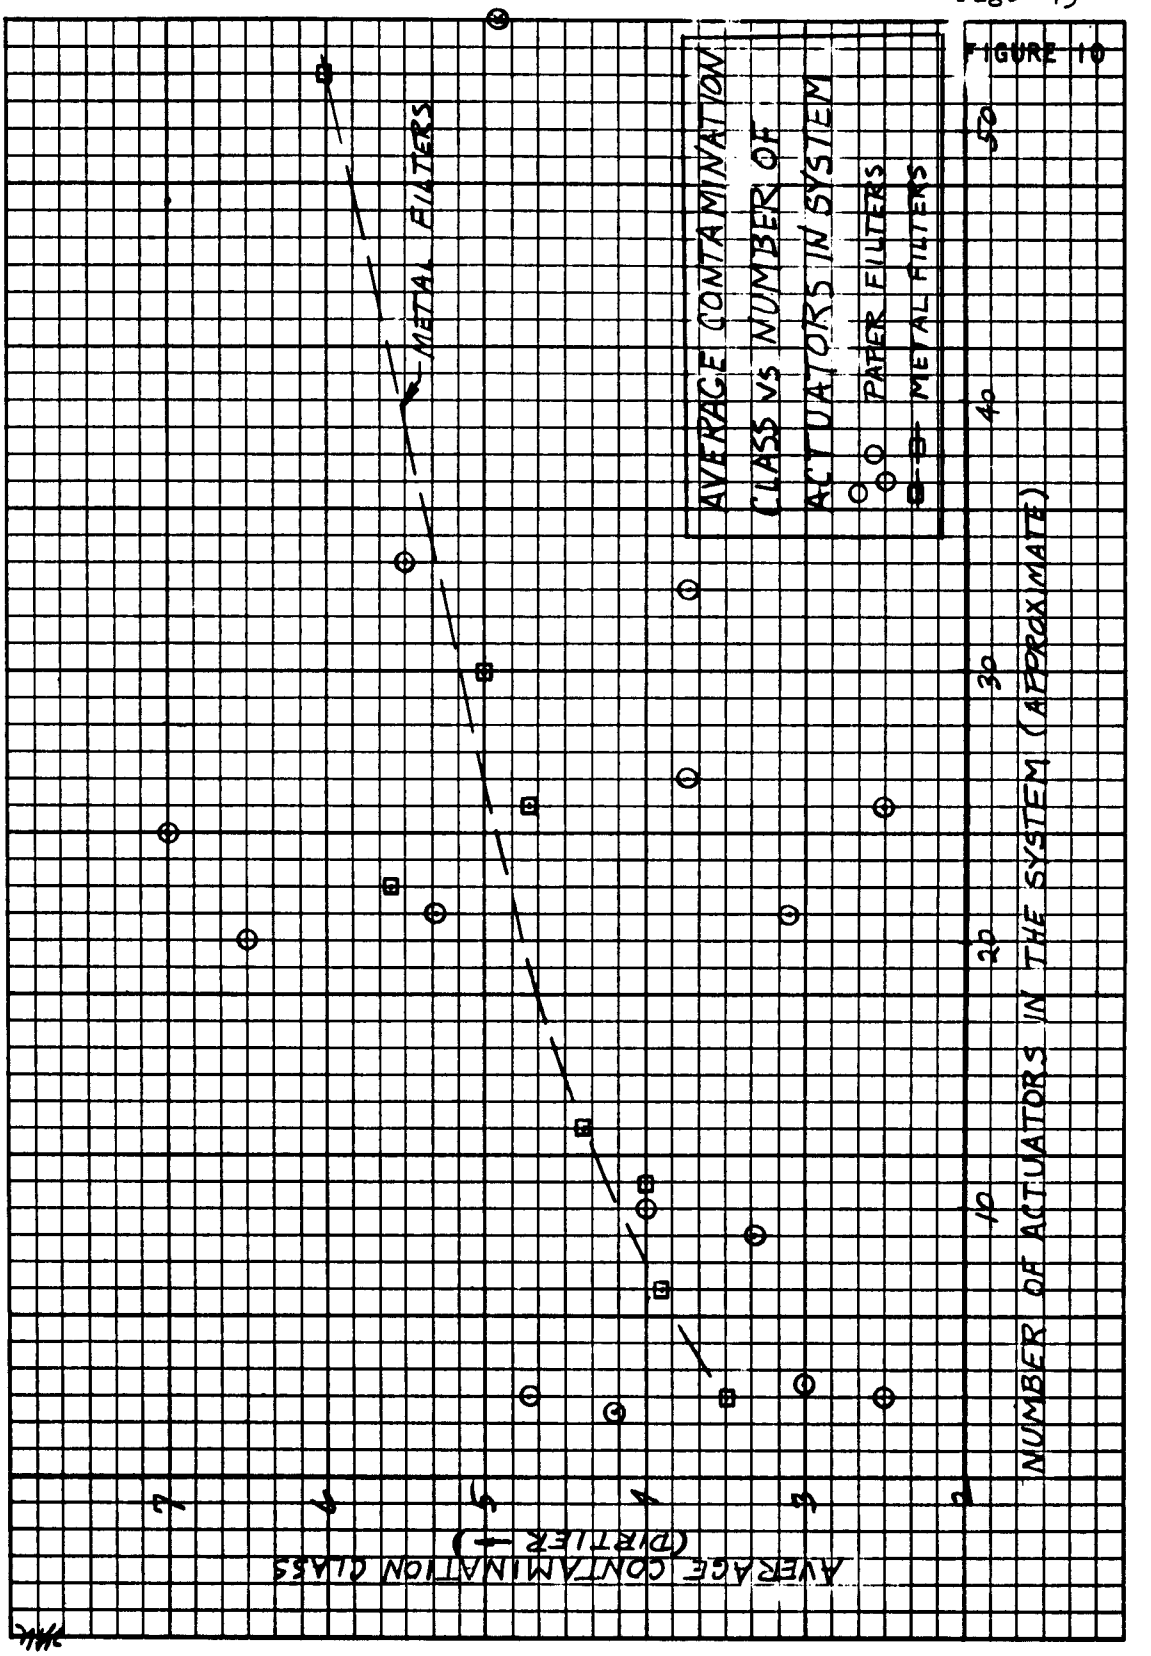
FIGURE 10

It does not necessarily follow that the actuators produce all, or even most of the contamination. More flow demand requires the hydraulic pump to operate under load more often, thus increasing its wear.

AVERAGE CONTAMINATION
CLASS VS NUMBER OF
ACTUATORS IN SYSTEM
PAPER FILTERS
METAL FILTERS
METAL FILTERS
AVERAGE CONTAMINATION CLASS
(DIRTIER →)
7
6
5
4
3
2
NUMBER OF ACTUATORS IN THE SYSTEM (APPROXIMATE)
10
20
30
40
50

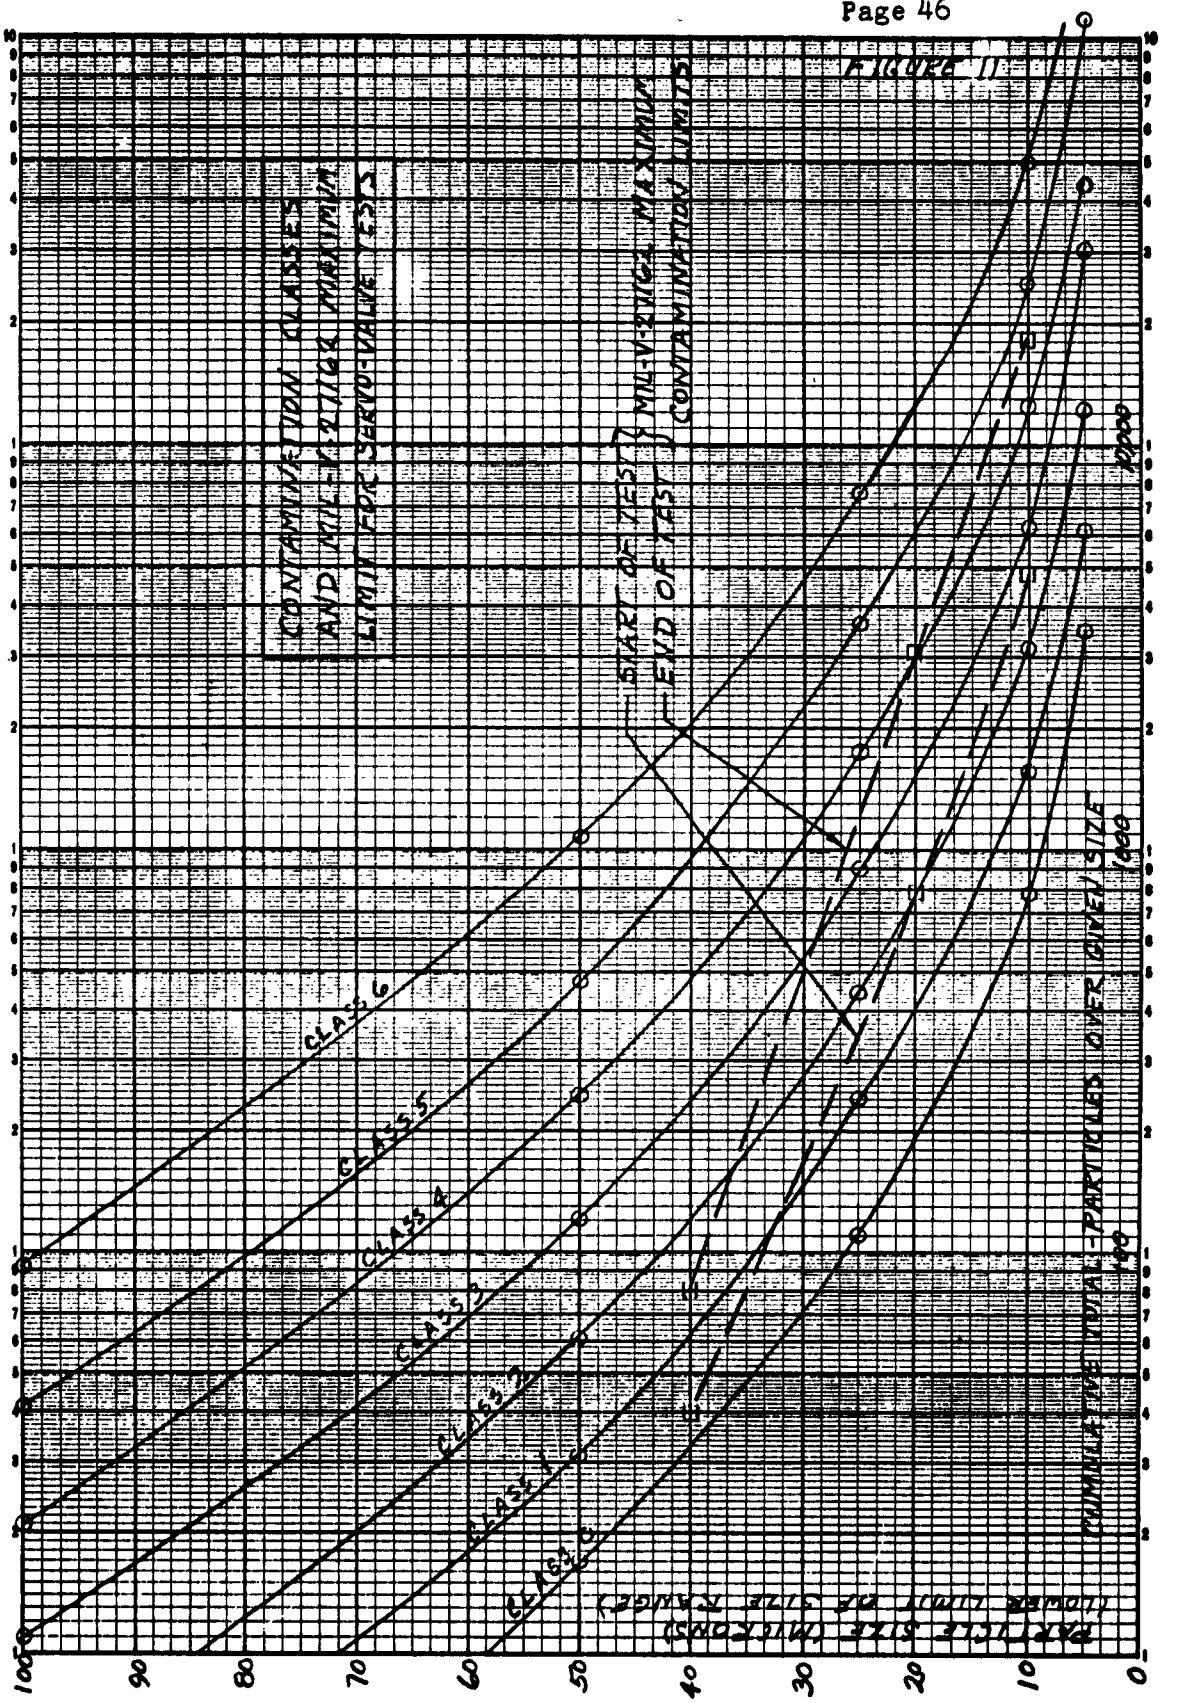
It was found that the electrical circuit could be adjusted to minimize the effect of servo valve degradation. Nevertheless, it seems clear that a Class 5 contamination level is marginal for this type of equipment, with Class 4 or better to be desired.

FIGURE 11
CONTAMINATION CLASSES
AND MIL-V-2162A MAXIMUM
LIMIT FOR SERVO-VALVE TESTS
START OF TEST
END OF TEST
MIL-V-2162A MAXIMUM
CONTAMINATION LIMITS
CLASS 6
CLASS 5
CLASS 4
CLASS 3
CLASS 2
CLASS 1
CLASS 0
PARTICLE SIZE (MICRONS)
(LOWER LIMIT OF SIZE RANGE)
CUMULATIVE TOTAL-PARTICLES OVER GIVEN SIZE
100
1000
10000
100
80
70
60
50
40
30
20
10
0
