AQA-TR-63-4
FINAL REPORT OF ENGINEERING TESTS
USATECOM PROJECT NO. 4-4-1142-01
TAKEOFF AND LANDING CAPABILITIES OF THE
CARIBOU CV-2B AIRCRAFT ON UNPREPARED
SURFACES

(Similar to Air Force Project Rough Road Alpha)
September 1963

HEADQUARTERS
U.S. ARMY AVIATION TEST ACTIVITY
EDWARDS AFB, CALIFORNIA

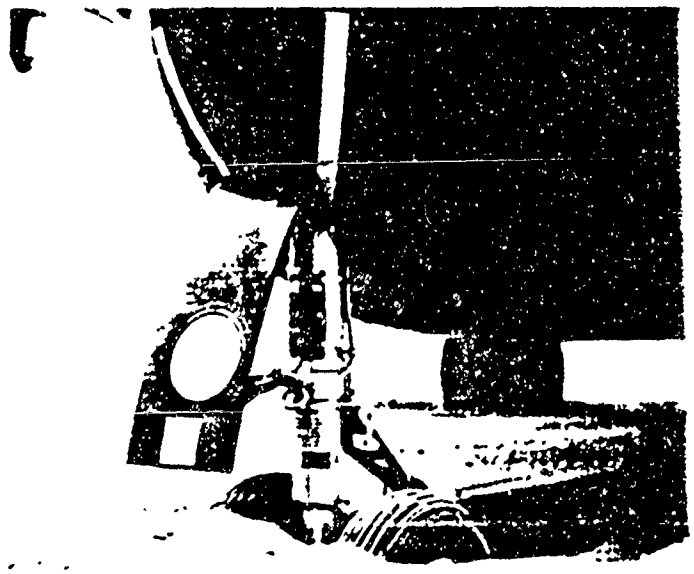
9. Aircraft Serial Number 62-4176 was operated on the sand subgrade for a total of seven cycles on 1 August 1963. The nose gear of this aircraft was equipped with the 8.50-10 tires. Maximum braking and reverse propellers were used during some of the landings. There were no difficulties encountered in operating the aircraft and no immobilization resulted. The average depth of rutting from braking was in the order of 5 to 6 inches. However, in some instances, deeper ruts were made as shown in photograph 6.

PHOTO 5
IMMOBILIZATION DUE TO RUTTING
AND SAND BUILDUP (SAND)
