FRETTING RESISTANT COATINGS
FOR TITANIUM ALLOYS

D.J. Padberg
McDonnell Aircraft Company

TECHNICAL REPORT AFML-TR-71-184

SEPTEMBER 1971

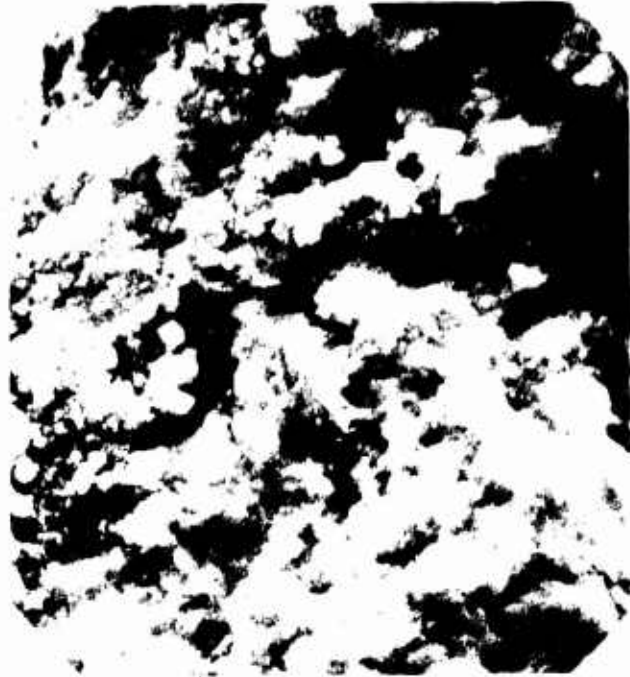
Those specimens with surface fretting damage as the failure origin were examined with the scanning electron microscope (SEM). Figures 12 and 13 show typical fretted surfaces at two magnifications. No detectable differences were observed between fretted surfaces resulting from different joint parameters. Figure 14 is a SEM photo of an unfretted surface.

Figure 12 Typical Fretted
Surface SEM Photo 300X

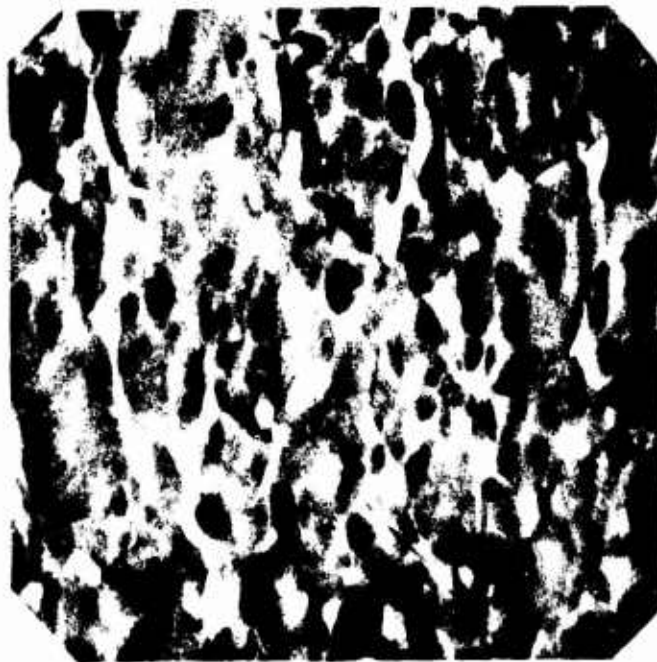
Figure 13 Typical Fretted
Surface SEM Photo 3000X

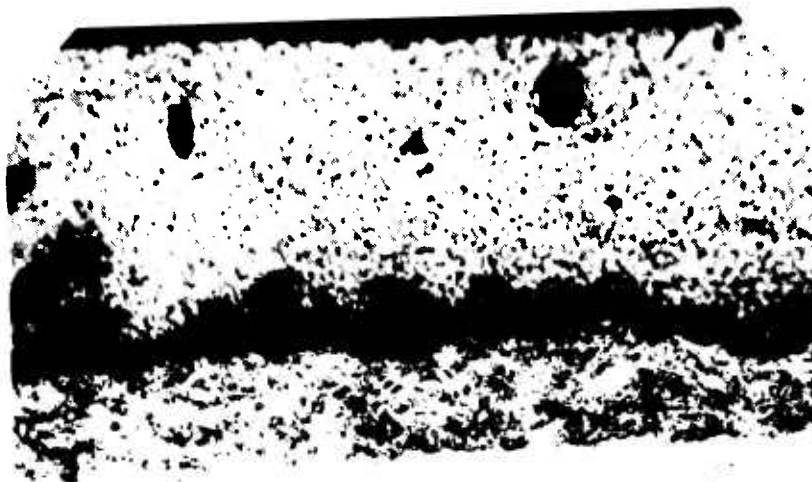
Figure 15   Detonation Gun Sprayed Tungsten Carbide, 250X

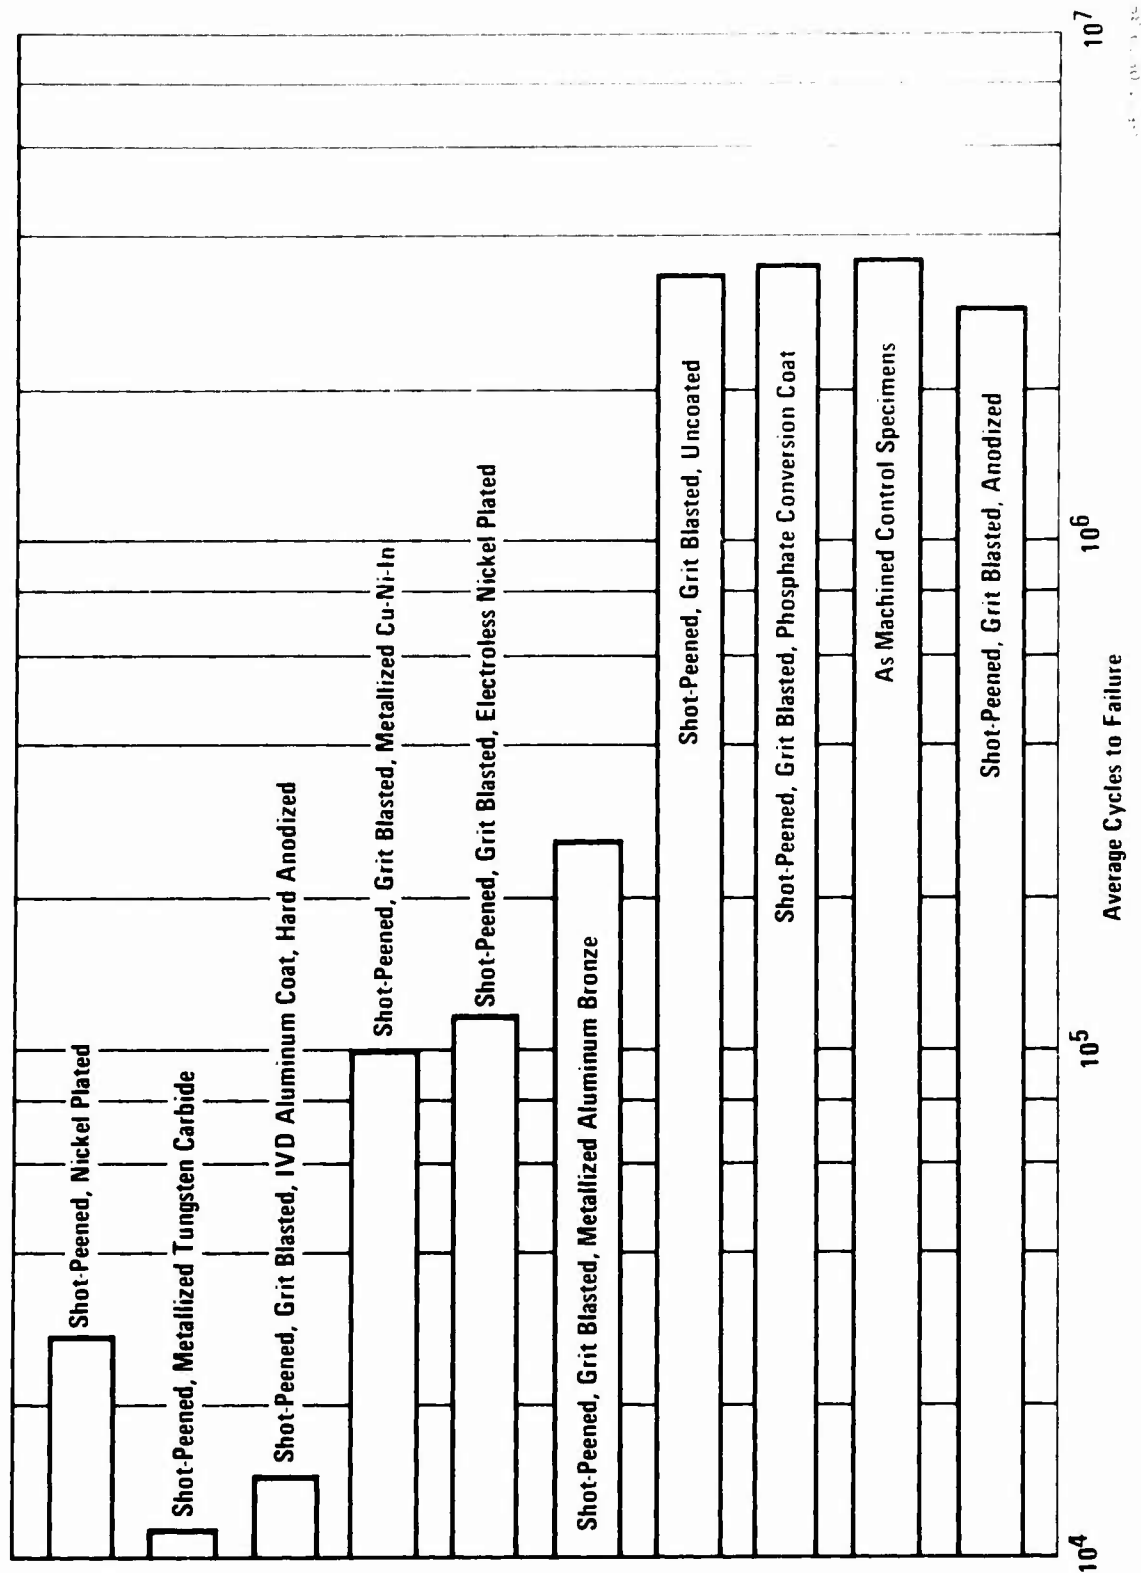
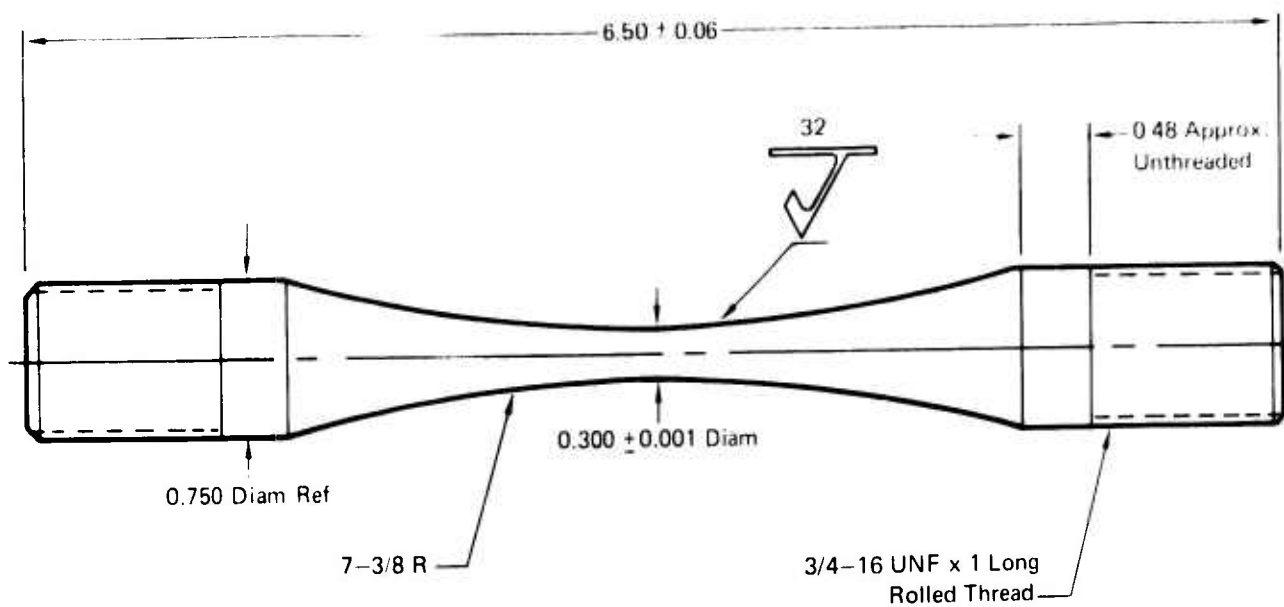
Figure 18 Task II Fatigue Testing

4.4 Fatigue Effect - The fatigue test results are shown in Figure 18. Fatigue specimens, to the design of Figure 19 were machined from the same material as the previous tensile bars (Harvey Aluminum Co. Heat No. A1-01). This material analyzed:

At 120,000 psi, only the fluoride-phosphate and the anodize (Tiodize II) coatings lasted nearly as long as the control specimen. These coatings were the only ones fatigue tested that did not initiate fracture. As seen in Figure 20, the failure originated internally. Figure 21 shows a fracture typical of the other coatings in which multiple origins can be seen in the coating itself.

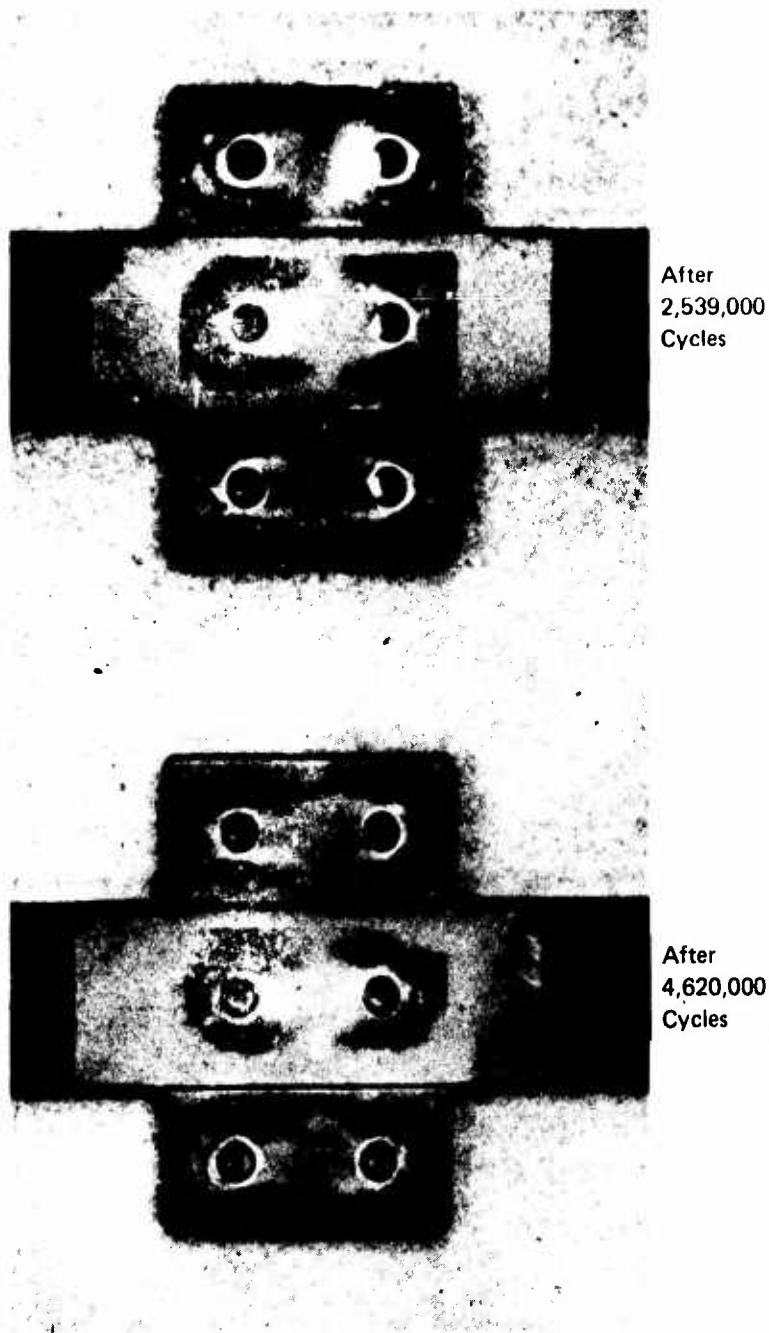
Figure 28   Gauge Section of Tiodize - Molykote 106 Coated Specimens,
Disassembled after Testing
