TECHNICAL REPORT ARBRL-TR-02283

A NASTRAN INVESTIGATION OF SIMULATED PROJECTILE DAMAGE EFFECTS ON A UH-1B TAIL BOOM MODEL

Arnold T. Futterer

January 1981

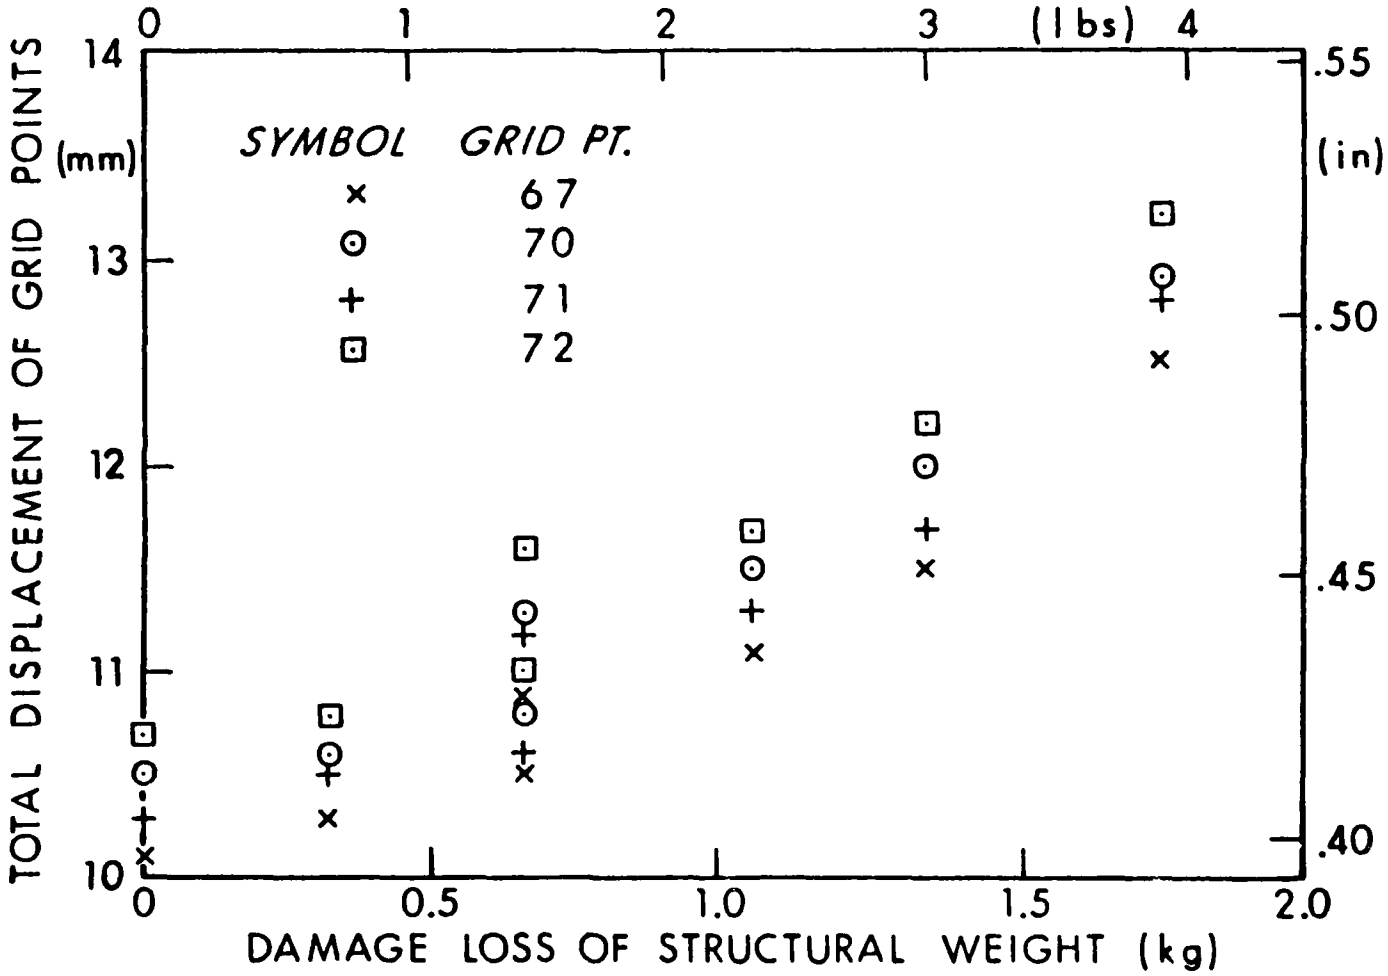
Figure 8. Displacements vs. Damage Weight Loss of Material on Right Side of Tail Boom Constructed of Aluminum Alloy

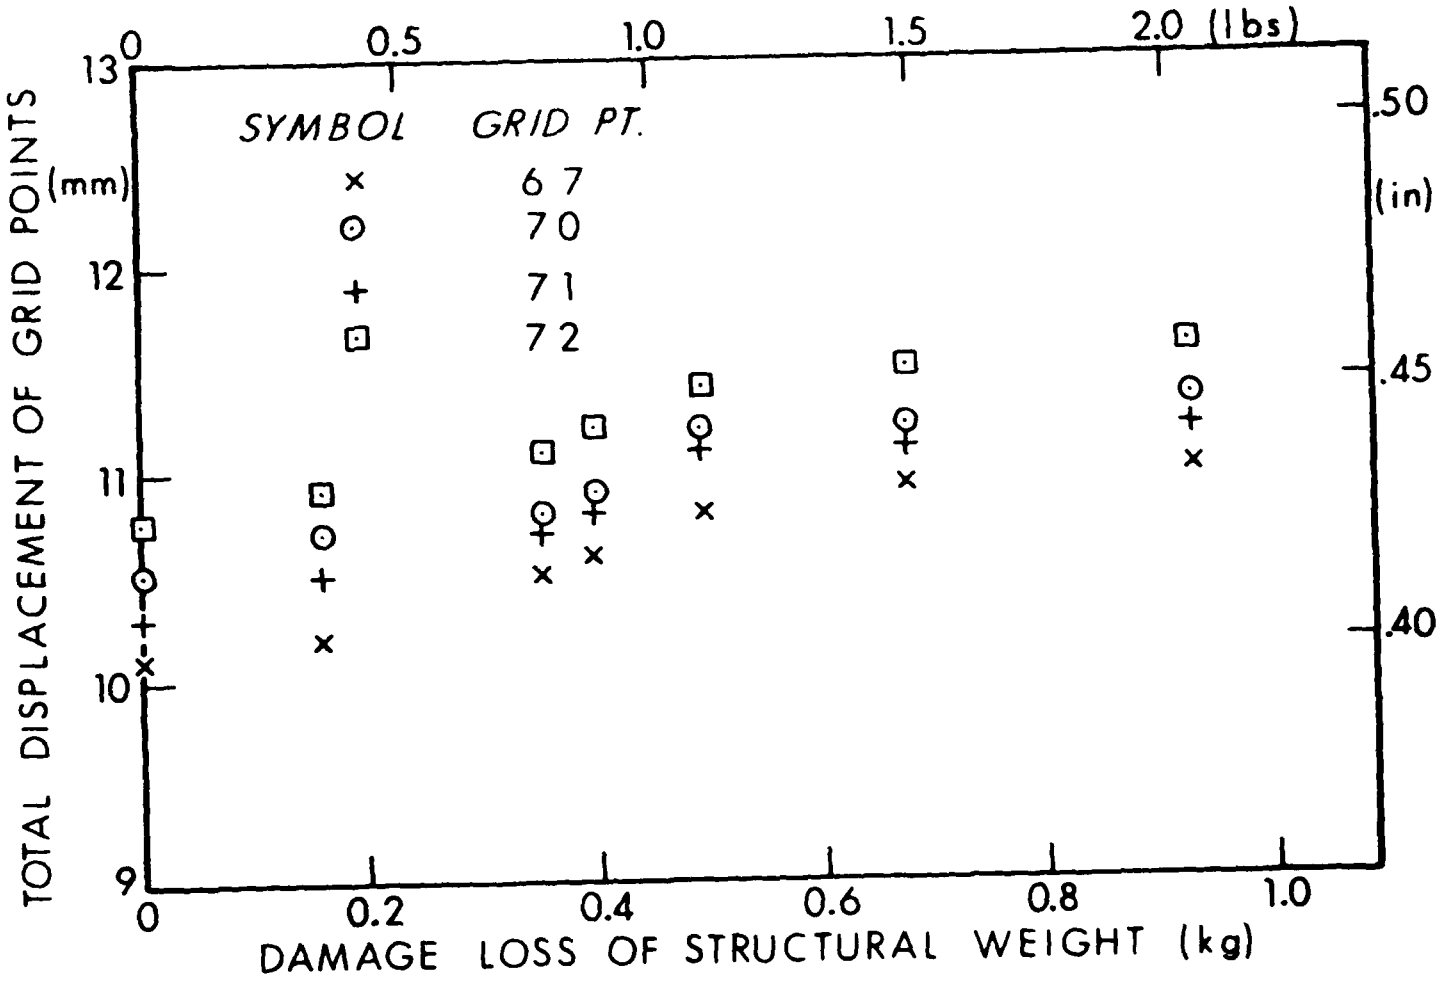
Figure 9. Displacements vs. Damage Weight Loss of Material on Left Side of Tail Boom Constructed of Aluminum Alloy

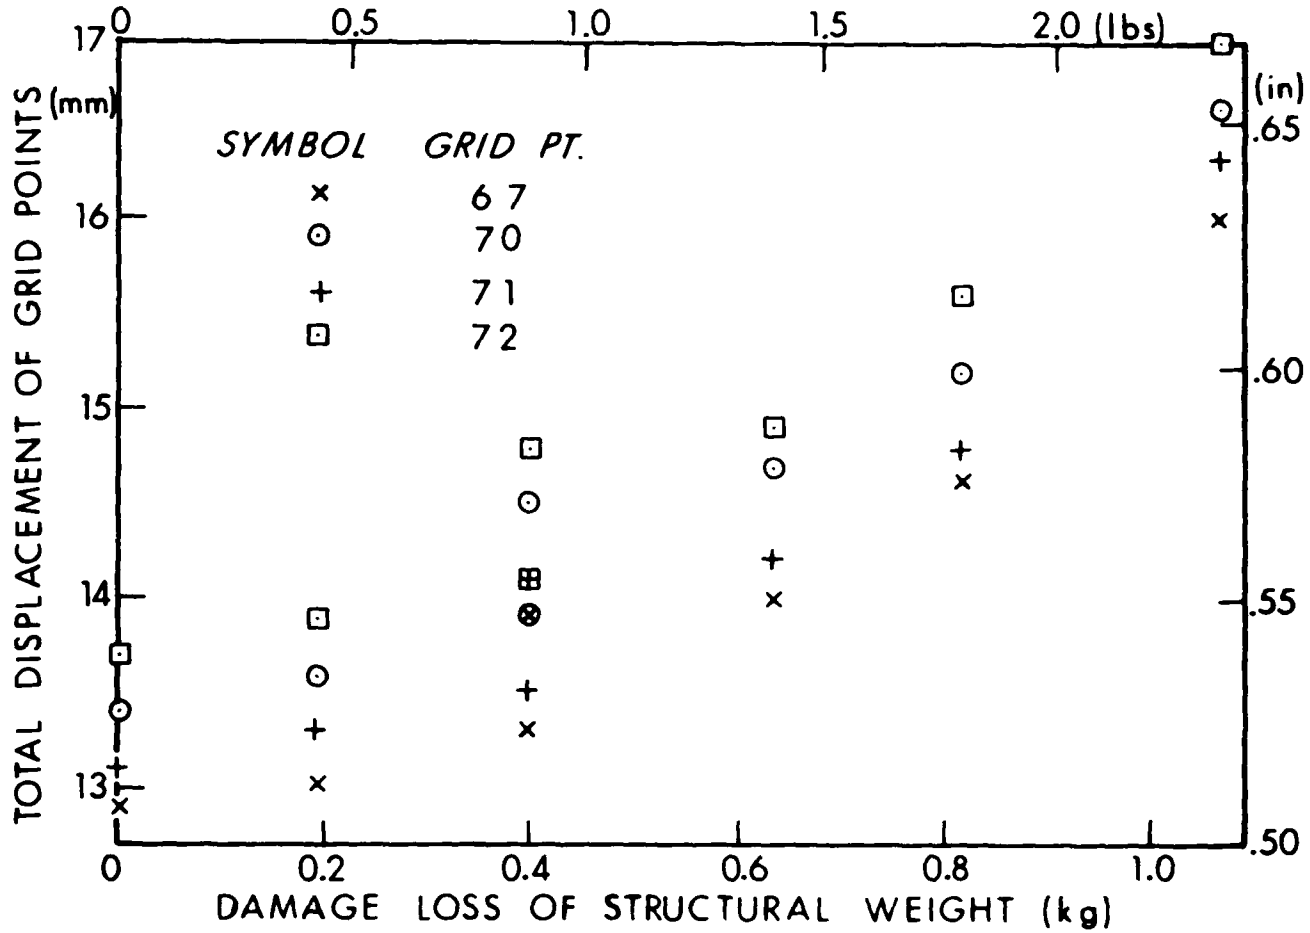
Figure 10. Displacements vs. Damage Weight Loss of Material on Right Side of Tail Boom Constructed of T300/5208 Graphite/Epoxy Composite

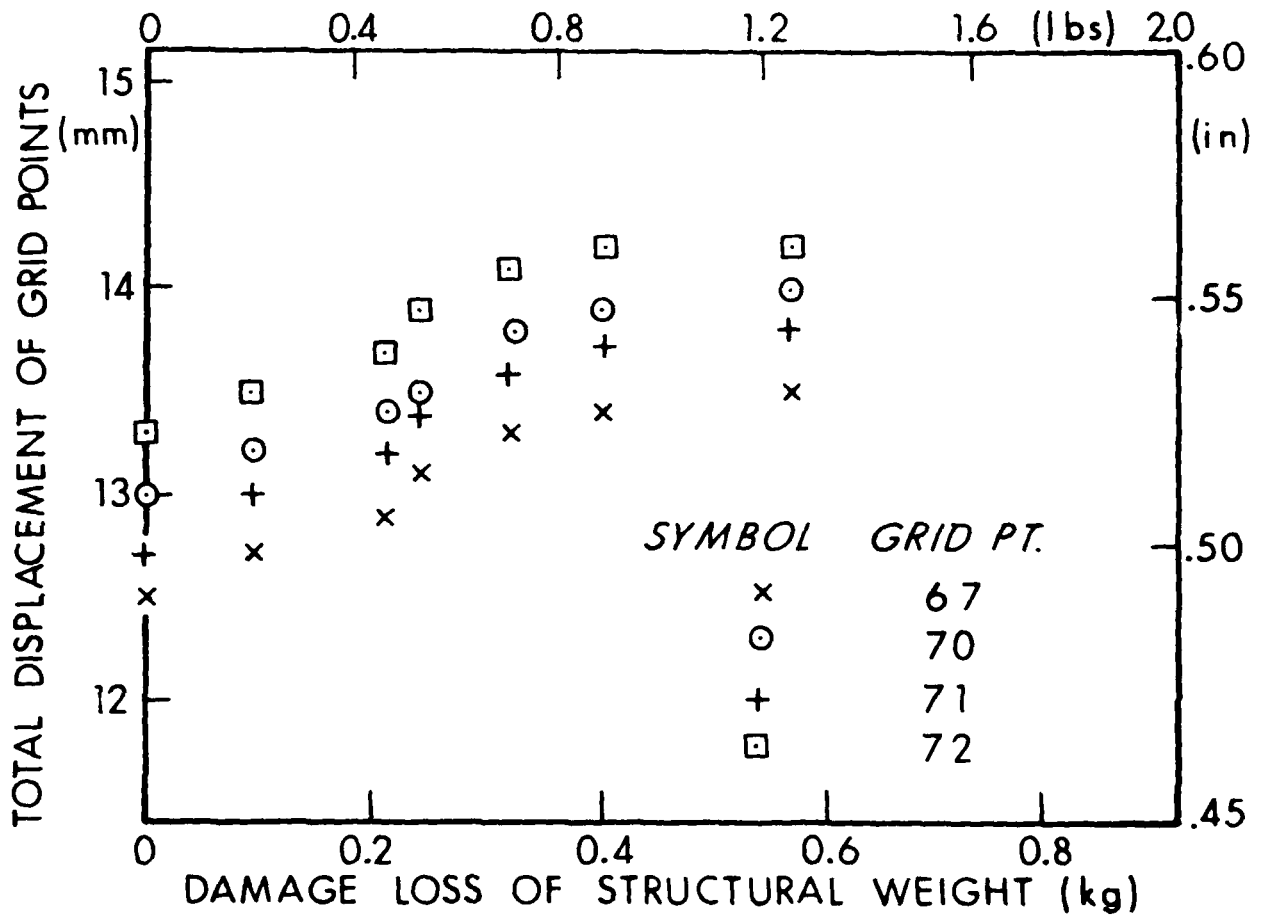
Figure 11 Displacements vs. Damage Weight Loss of Material on Left Side of Tail Boom Constructed of T300/5208 Graphite/Epoxy Composite
