MONROE LAKE DAM

NDI I.D. ~~NO.~~ PA-00633
PENNDER I.D. ~~NO.~~ 45-117

PHASE I INSPECTION REPORT,
NATIONAL DAM INSPECTION PROGRAM

JANUARY 1981

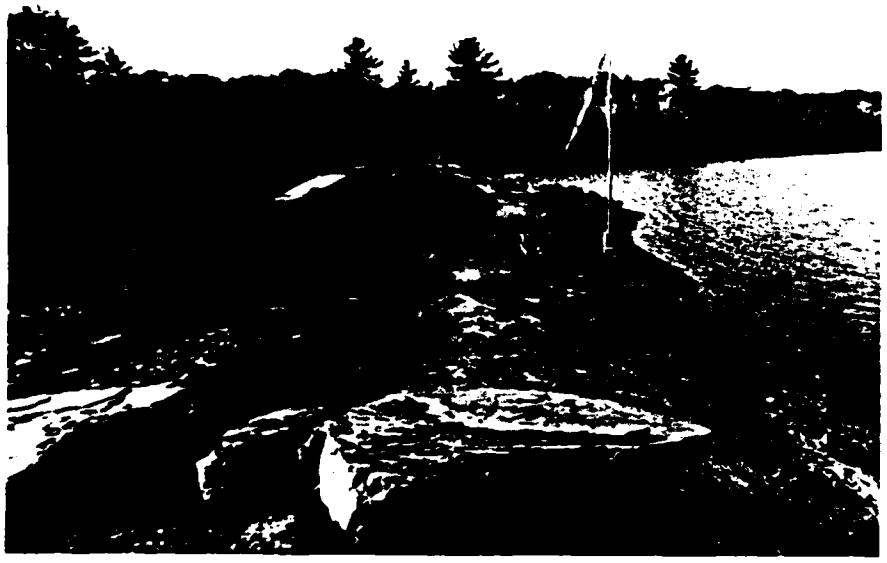
b. Embankment. Observations made during the visual inspection indicate the embankment is in fair condition. The structure is characterized as very irregular and poorly aligned both horizontally and vertically ~~(see Photographs 1, 2~~, 3, and 4). The downstream embankment toe is partially inundated by water that may be attributable to seepage through the embankment and/or leakage through or around the conduit ~~(see Photographs~~ 2, 3 and 7). The water is trapped in a trough area between the embankments of the dam and the downstream roadway. The condition may be exaggerated because the drainage culvert under the road appears to be partially obstructed ~~(see Photograph 8)~~. Minor erosion was observed along both the upstream and downstream dam faces. Although particularly evident along the upstream slope adjacent the outlet riser and along the steepest portions of the downstream slope, the erosion is not considered to be significant at this time ~~(see Photographs 2, 3 and 4)~~. Field measurements indicate low areas along the embankment crest between one-half and two feet below the elevation of the left spillway wingwall. The crest is covered with gravel and the slopes with weedlike vegetation.

Photograph 1 View across the embankment crest looking toward the right abutment.

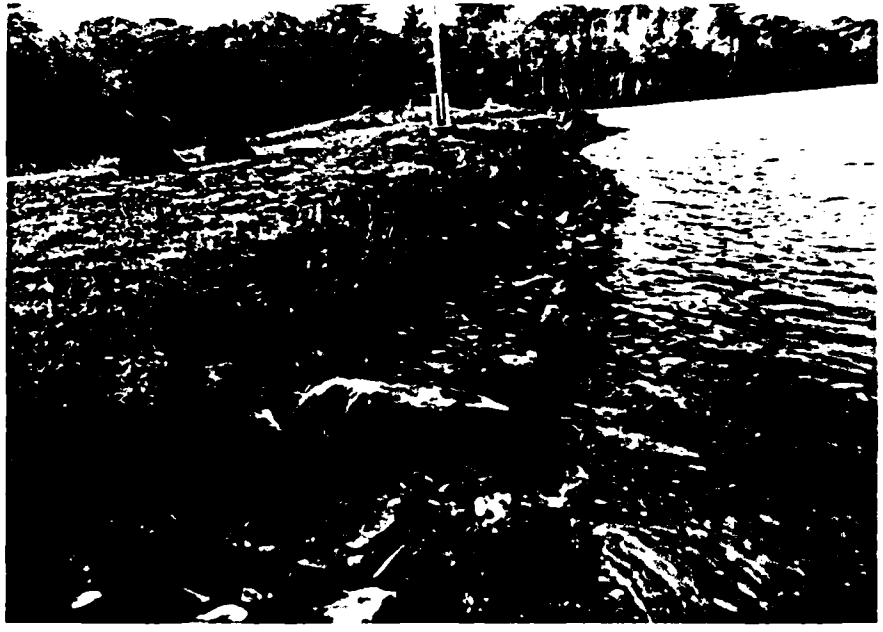
Photograph 4 Close-up view of the upstream embankment face near the left abutment.

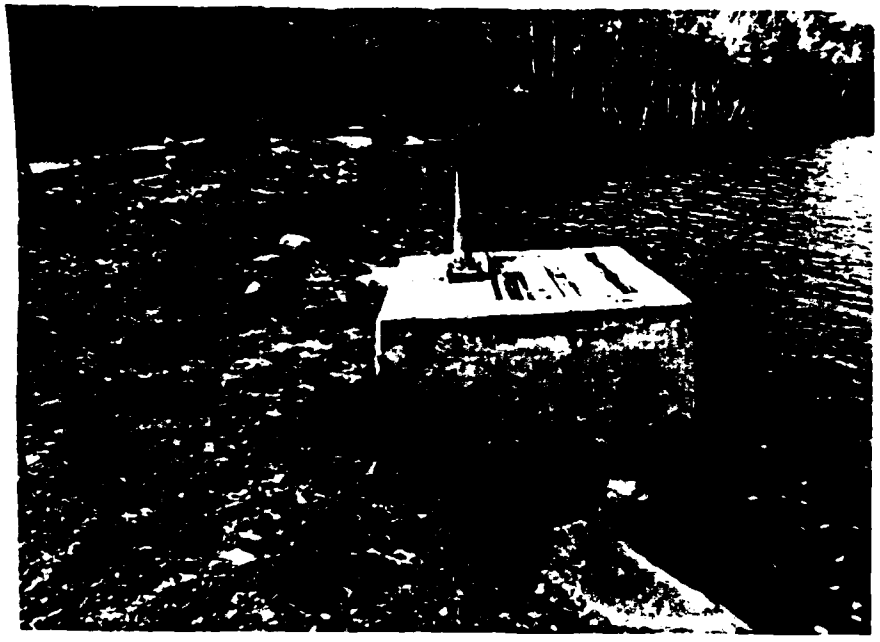
ITEM	OBSERVATIONS/REMARKS/RECOMMENDATIONS NDI# PA- 00633
INTAKE STRUCTURE	Vertical, concrete outlet riser located along the upstream embankment face. Concrete in good condition. Wooden hatch door atop riser needs to be replaced.
OUTLET CONDUIT (CRACKING AND SPALLING OF CONCRETE SURFACES)	Not visible. Downstream end is inundated.
OUTLET STRUCTURE	Only a small portion of the downstream face of the concrete outlet headwall is above water. This visible portion appears to be in good condition.
OUTLET CHANNEL	Discharges into roadway culvert. Culvert is presently clogged by muck and debris although a small amount of flow does manage to pass through it.
GATE(S) AND OPERATIONAL EQUIPMENT	18-inch diameter Rodney Hunt (Type S26 18A) sluice gate located at base of riser is functional and in good condition. Manually controlled from atop the riser. Operated in the presence of the inspection team.
OTHER	Stop log provision also located within outlet riser. A few of the logs appear rotted; however, the device is operable.

Photograph 5 View of the outlet conduit control mechanism atop the reinforced concrete riser located along the upstream embankment face.

d. Replace the deteriorated entry door and wooden stop logs associated with the outlet riser.

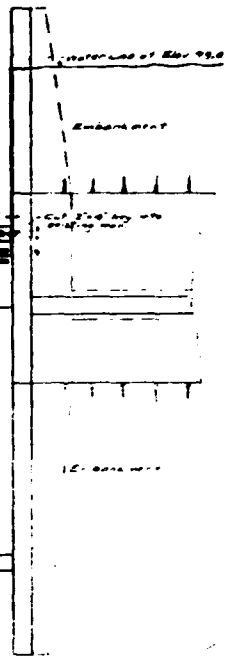
FIGURE 3

The Association has officially owned Monroe Lake Dam since 1968 and PennDER records indicate the group has always attempted to fully comply with state requests. To this end, modifications were made to the spillway to provide support for the cracked right spillway wingwall at the request of the state in early 1968 (see Figure 3). In the fall of 1969, however, seepage and piping were discovered along the downstream embankment toe, approximately

concrete culvert beneath the road embankment. The upstream portion of the spillway right wingwall, was buttressed by a concrete wall in 1968 as shown in Figure 3.
