CLINTON RESERVOIR DAM

INVENTORY No. NY 212

PHASE I INSPECTION REPORT

NATIONAL DAM SAFETY PROGRAM

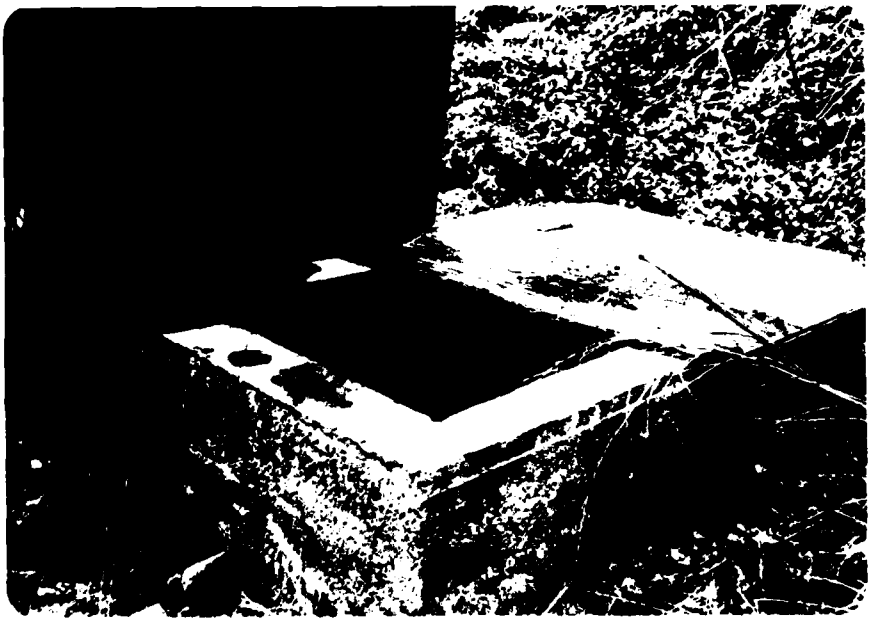
11. Outlet to reservoir drain located at toe of slope.
