TECHNICAL REPORT

# IMPROVED COATING SYSTEM FOR HIGH STRENGTH TORSION BARS

Final Report
23 April 1981

Avery J. Austin and
Nicholas F. Hayes
FMC Corporation
Ordnance Engineering Division
1105 Coleman Avenue
San Jose, California 95108

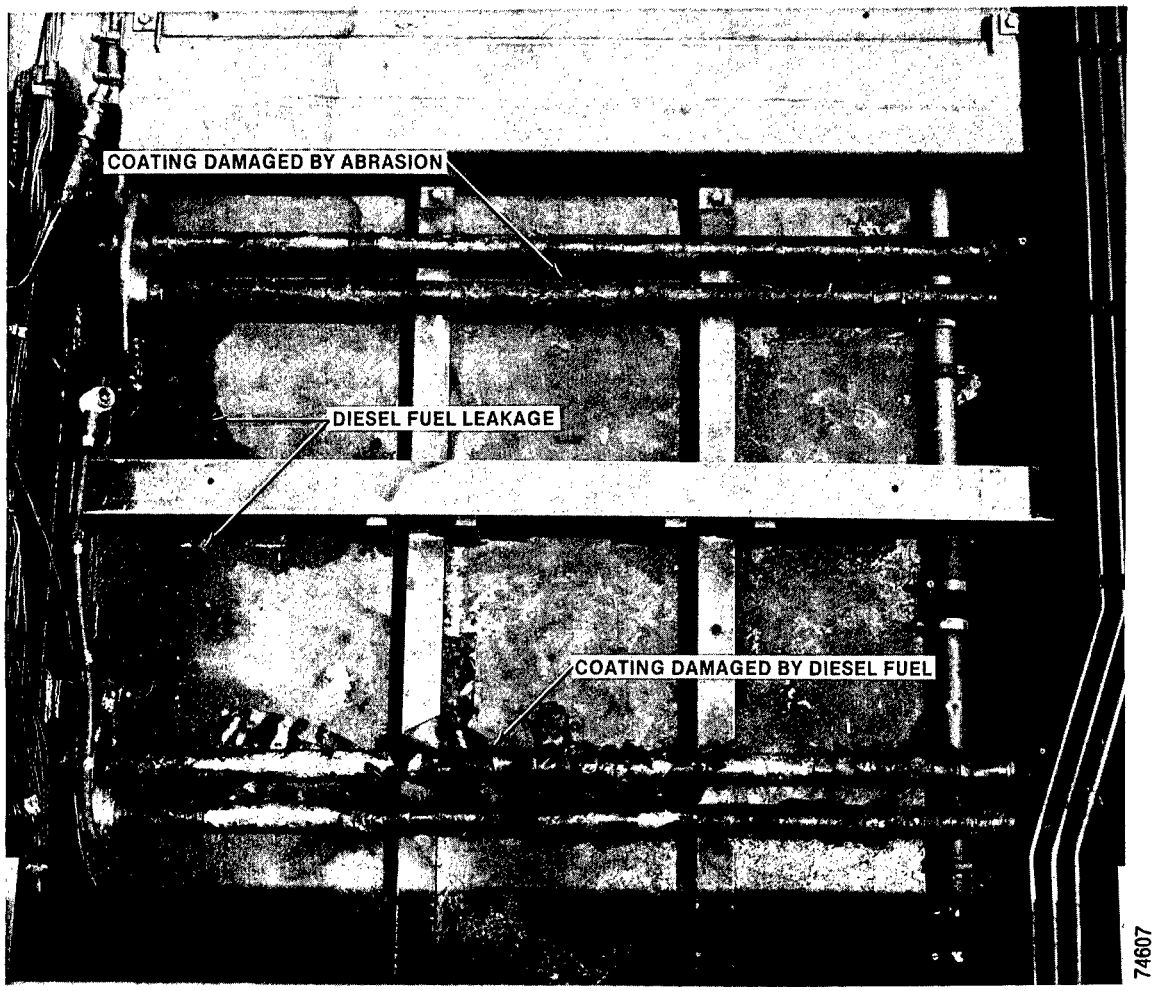
engine or crew compartment from vehicle swimming or cleaning operations run into the bilge where they come in contact with torsion bars. Diesel fuel (a hydrocarbon) has been found to attack tape adhesive, causing loss of tape integrity and exposing the primer paint to moisture and abrasive damage. Maintenance personnel sometimes walk on torsion bars or accidentally drop tools or vehicle parts onto them. Figure 1 shows an example of deterioration of the protective tape wrapping caused by diesel fuel that had leaked into the bilge and by abrasion from personnel walking on torsion bars.

Figure 1. Degradation of Torsion Bar Protective Tape Coating in M730 Vehicle (M113 Family) Bilge Resulting from Abrasion and Contact with Diesel Fuel.

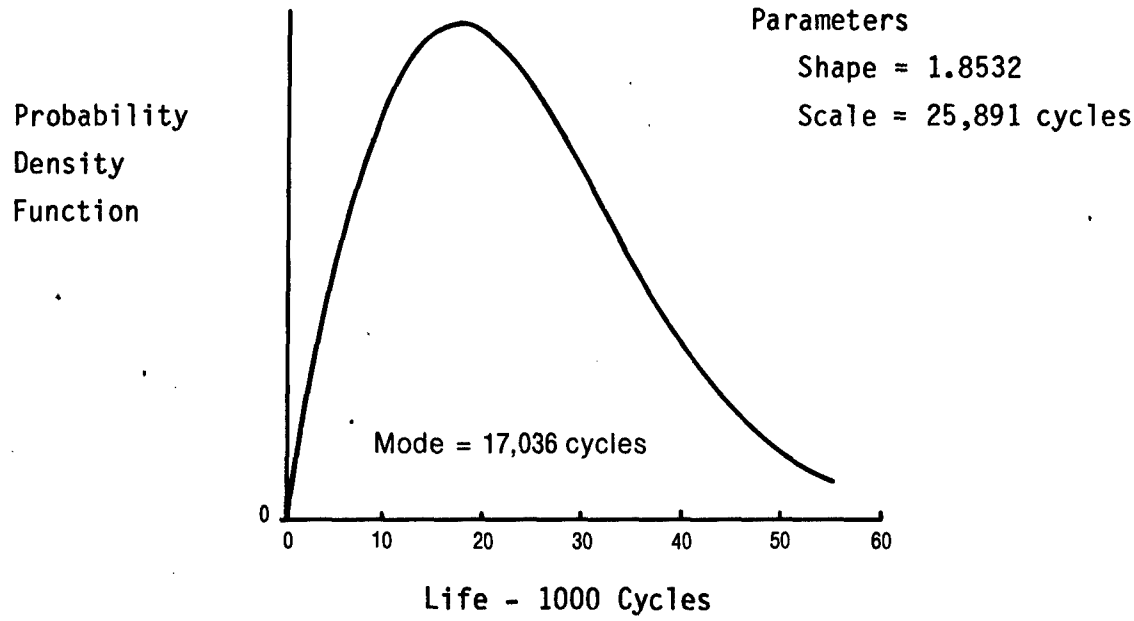
As discussed earlier, shape parameter determines the relative shape of the density function. The low shape parameter (1.8532) exhibited by tape/primer coated bars skews the failure distribution toward early life failure. Figure 9 is a computer generated representation of the probability density function (PDF) for this case. The mode parameter noted on Figure 9 is the most frequently occurring life for tape and primer coated bars.

Figure 9. Probability Density Function Curve for Tape and Primer Coated Production M113A2 Torsion Bar*

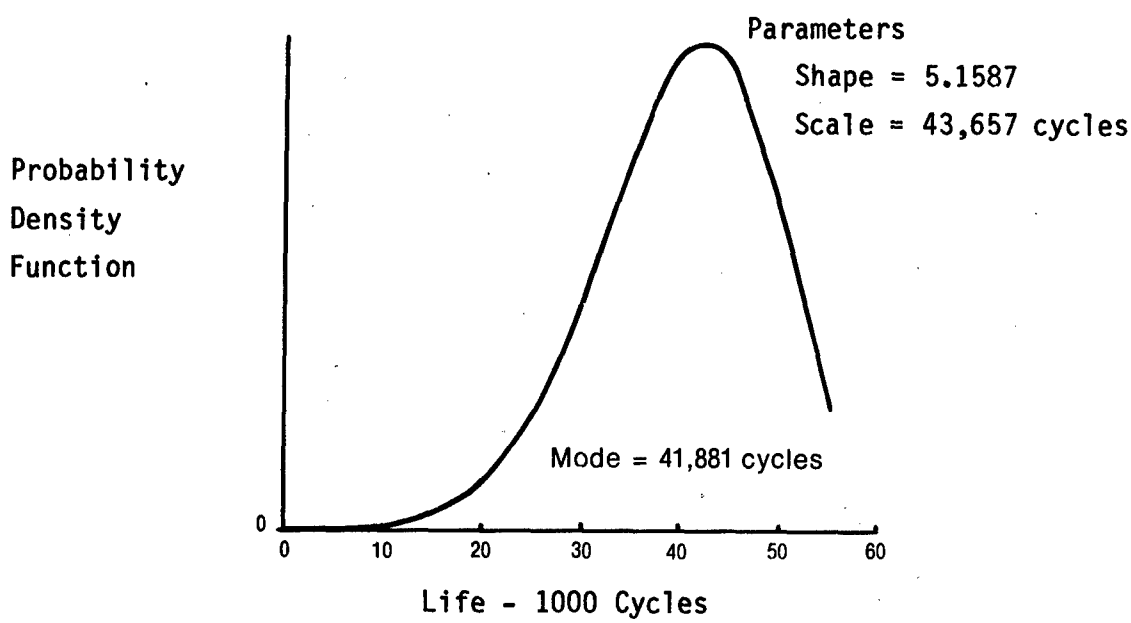
Figure 10 presents a similar representation of the PDF associated with the Plastisol coated bars. Comparison of curves in Figures 9 and 10 reveals a distinct difference in failure form. Tape and primer coated bars appear to have a short life (due to corrosion) as indicated by the low shape parameter (1.8532), whereas Plastisol protected bars with a much higher shape parameter (5.1587) have a longer life and tend to fail from fatigue. Note also that the mode parameter for Plastisol (41,881 cycles) is shifted away from the early failure that is exhibited by the tape/primer system (17,036 cycles). This shift represents a 146% increase in the most commonly expected life for Plastisol protected torsion bars. Further proof of increased life is provided by the fact that all Plastisol protected bars failed in the splines, indicating that corrosion did not penetrate the Plastisol, whereas all tape and primer coated bars failed at body damage/ corrosion sites.

Figure 10. Probability Density Function Curve for Plastisol Coated Production M113A2 Torsion Bar*

It is recommended that the Requirements Section of specification MIL-S-45387, Torsion Bar Spring Suspension, be revised to delete the use of tape and primer as a torsion bar coating system, and that Plastisol, Type I or II, Class 2, Specification MIL-P-20689, be applied in its place, per the method outlined in Appendix F.

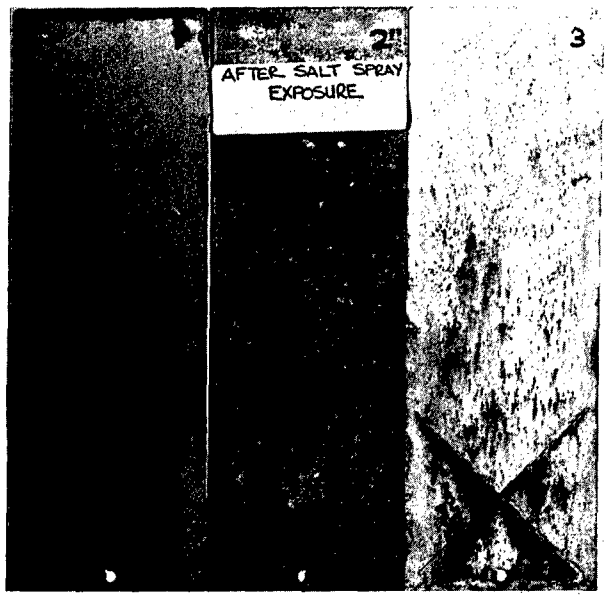
76781

SALT SPRAY RESISTANCE Alumazite Z coating exhibited least protection (336 hours) of all coatings tested.

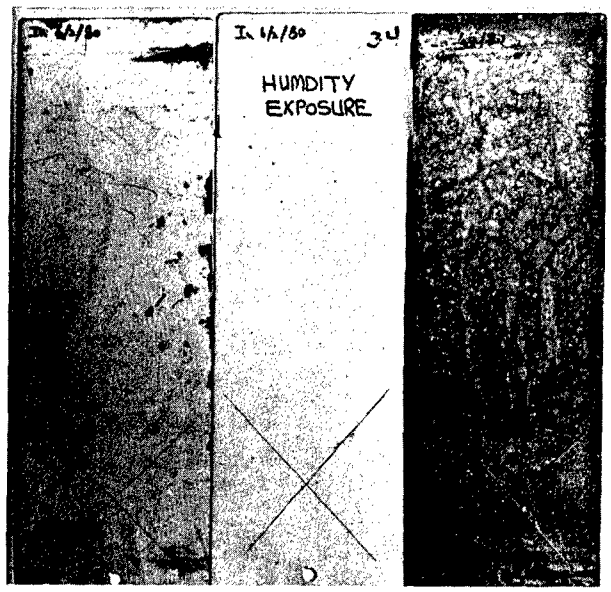
76780

HUMIDITY RESISTANCE Alumazite Z coating exhibited least protection (336 hours) of all coatings tested.

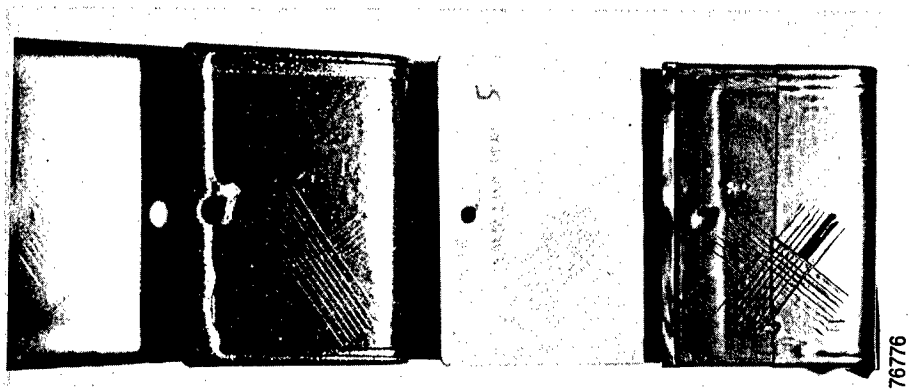
FLEXIBILITY & ADHESION Carbozinc SP81 coating failed both tests and was the only failure of all coatings tested.

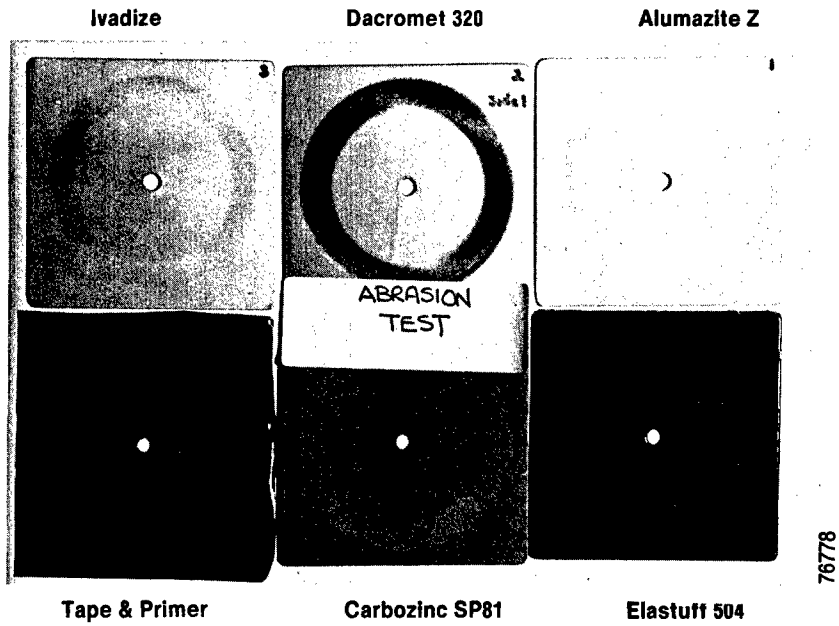
ABRASION RESISTANCE Dacromet 320 coating was penetrated, exposing steel panel.

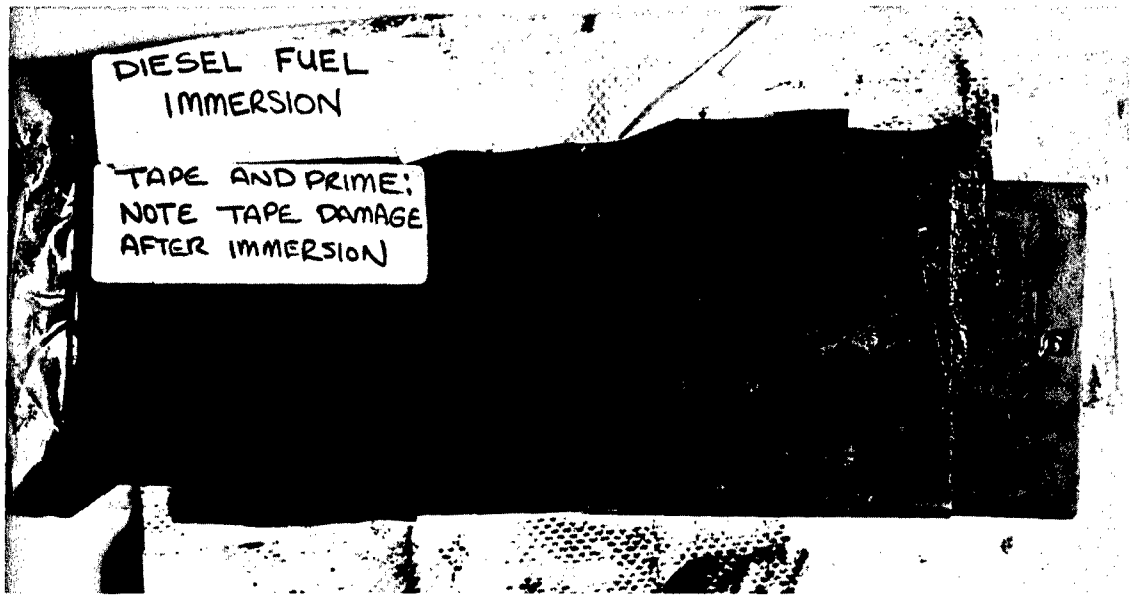
| COATING | CONDITION AFTER 7 DAYS |
|---|---|
| Tape & Primer | Affected<br>Tape peeled from edges.<br>Swelling and softening of adhesive observed. |

IMMERSION IN DIESEL FUEL Tape adhesive swelled and softened. Tape slid away from primed panel.

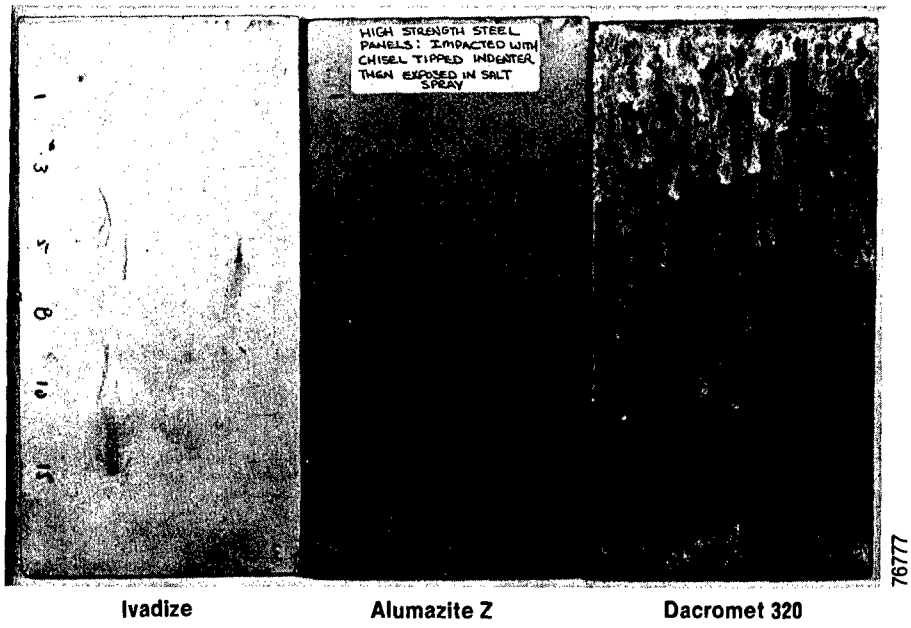
IMPACT RESISTANCE/SALT SPRAY CORROSION Numbers on hardened plates indicate impact energy level of chisel-edged tool. Three impacts were made on each plate at each energy level.
