INSTALLATION RESTORATION PROGRAM

PHASE I: RECORDS SEARCH

VANDENBERG AIR FORCE BASE, CALIFORNIA

JANUARY 1985

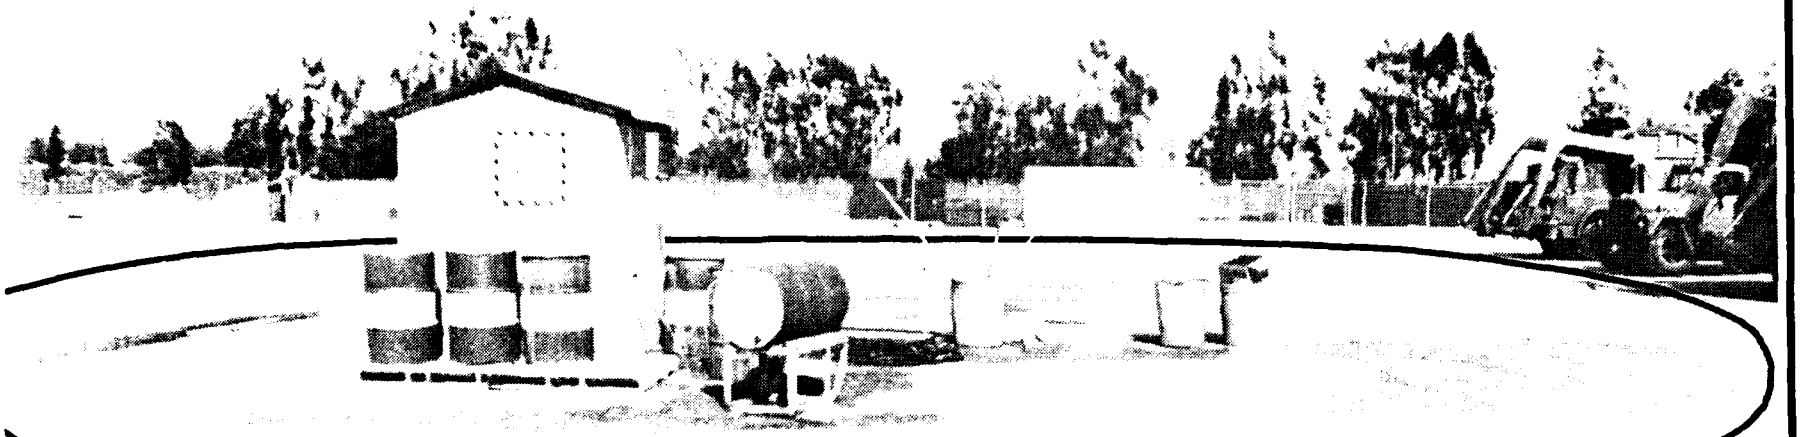
CS-1

FORMER PESTICIDE MIXING AND RINSEATE DISPOSAL AREA

the area should be conducted using an OVA to determine if any organic vapors are emanating from this area.
Chemical Disposal Site No. 1	It is recommended that soil samples be collected around the washrack area and analyzed for the pesticides included in the U.S. Environmental Protection Agency priority pollutant list. If contaminants are found, removal and disposal of the soil as a hazardous waste may be necessary.
Chemical Disposal Site No. 9	It is recommended that one upgradient and two downgradient monitor wells be installed at this area. Ground water samples should be collected and analyzed for the parameters in List A, Table 6.1-2.
Abandoned Underground Tank Area	It is recommended that a geophysical survey be performed to verify the existence of the underground tanks. Based on the results of this study, one upgradient and two downgradient wells should be installed at locations likely to intercept any underground leakage from the abandoned tanks. Ground water samples should be collected and analyzed for the parameters in List B, Table 6.1-2.
