Post Remedial Action Report Lansdowne Radioactive Residence Complex Dismantlement/Removal Project

June 1990

Department of the Army
Baltimore District, Corps of Engineers
P.O. Box 1715
Baltimore, Maryland 21203

The United States Environmental Protection Agency
Region II
841 Chestnut Building
Philadelphia, Pennsylvania 19107

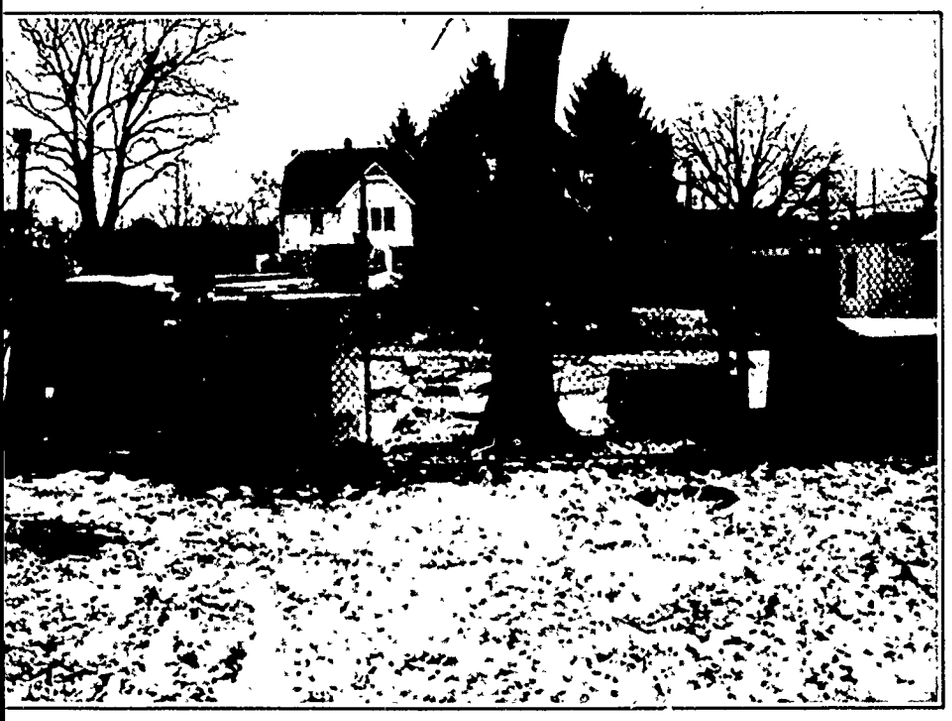
Fig. 6:1 - Jobsite Facing East from 99 E. Stratford Ave., Prior to Exterior Building Dismantlement.
August, 1988.

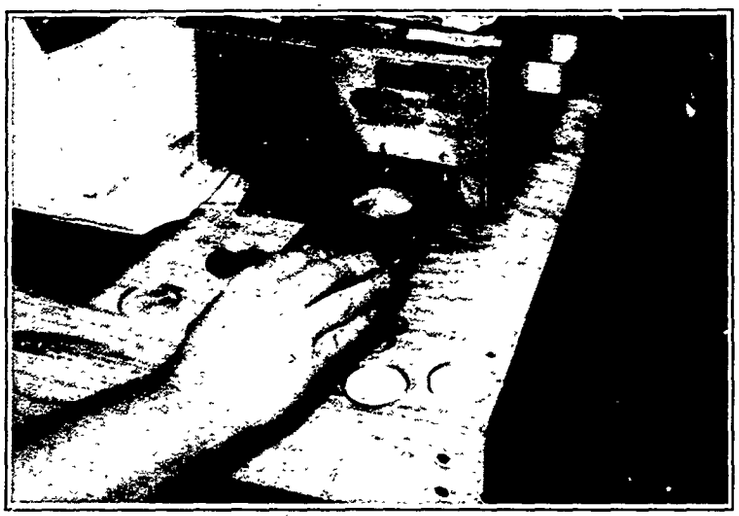
a. Filled rad-waste boxes were brought down to the OSF where they were wiped clean and smear samples were taken on all 6 sides to make sure that there was no loose contamination on the outside of the boxes before they were taken out of the radiation exclusion zone. Shown here are smear samples being counted for beta radiation.

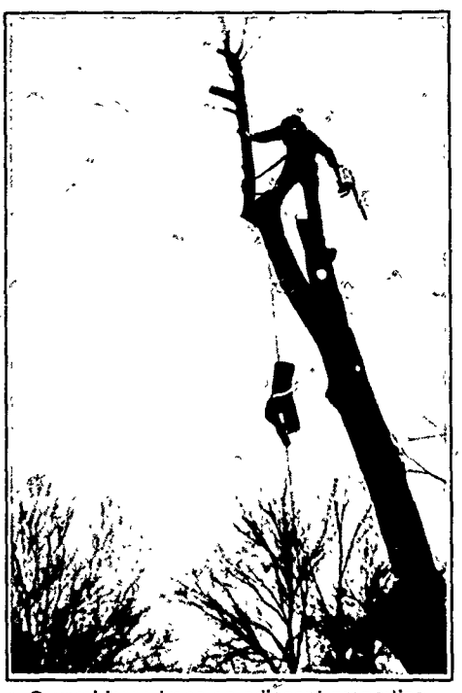
e. Several large trees on adjacent properties were enveloped by the expanding area of the soil excavation and had to be removed. Such trees were replaced for the owners during site restoration, however with nursery stock.

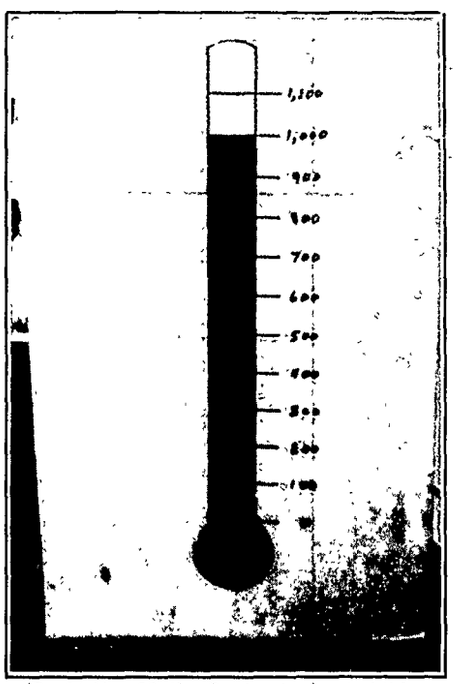
g. On 31 Nov 88, the Contractor posted this chart in the crew trailer to gage the rate of soil excavation. He told his workers that if the tons of soil excavated reached the green line by 22 Dec. they would not have to return from Christmas break until 2 Jan 89. The line was reached on 11 Dec. By 22 Dec., the excavated tonnage was off the chart.

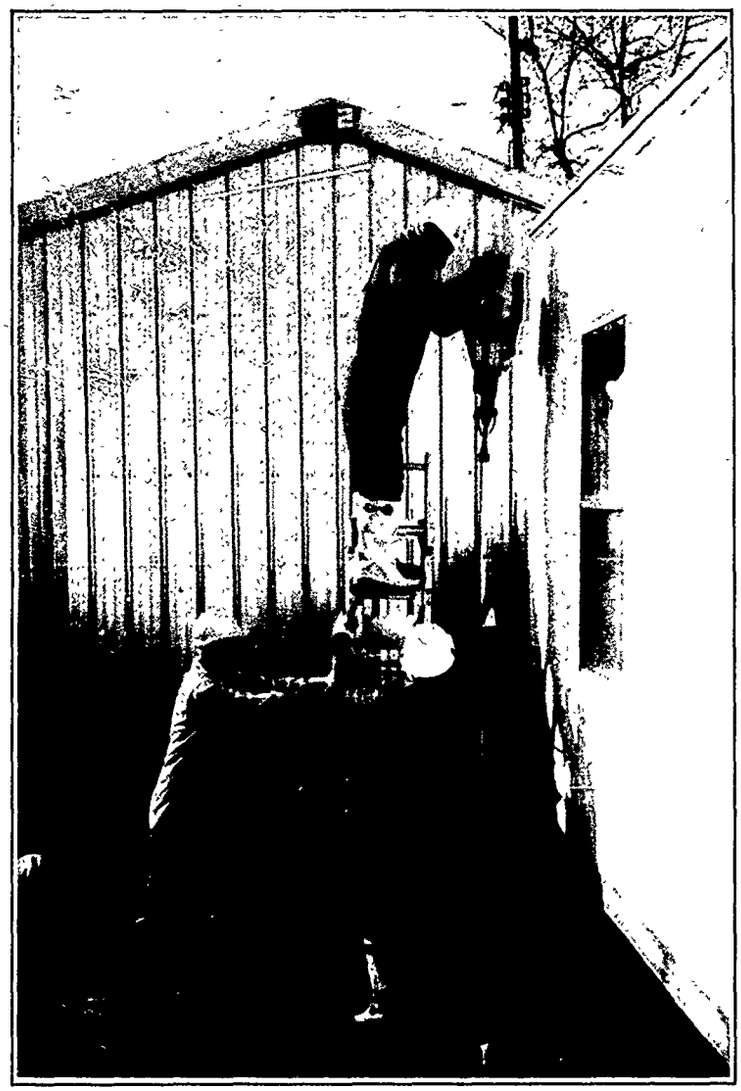
a. Workers driving aluminum conduit tubes in the jobsite administration area. The OSF is in the background; crew trailer is at right. A "Cobra" gasoline powered hammer, manufactured by Atlas-Copco was used to drive the pipe. A steel penetrometer point on the penetrating end of the pipe facilitated penetration and kept soil out of the inside of the pipe. The pipe in this photograph is being driven through the pavement of E. Stratford Avenue, in the vicinity of the sewer lateral from the 105 residence. Subsequent subsurface logging indicated that there had apparently been considerable exfiltration of radioactive contamination from the lateral. This was confirmed when the area was excavated.

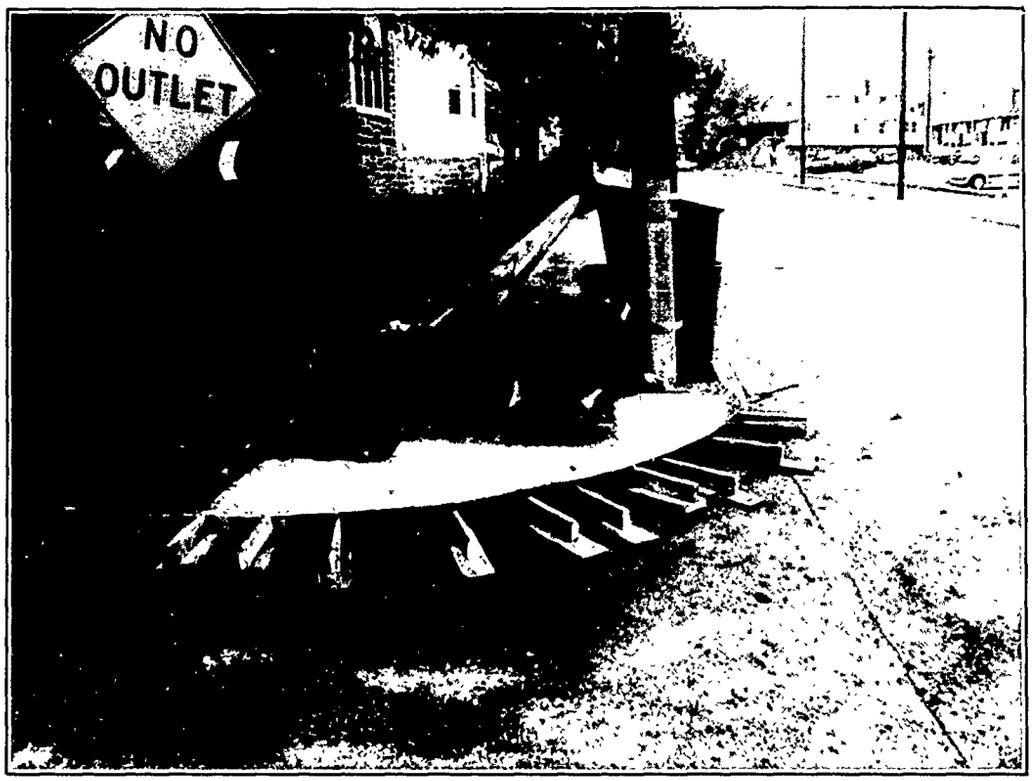
a. Repair to the curb at the corner of E. Stratford and Union Avenues. The curb was broken when it was rolled over by a truck hauling away rad-waste. This was held to be avoidable damage, so payment for the repairs was not made out of contract funds.
