WL-TR-93-2036

HIGH TEMPERATURE HYDRAULIC SEALS

K. R. Williams
McDonnell Douglas Aerospace
Transport Aircraft
3855 Lakewood Blvd
Long Beach, CA 90846-0001

Final Report for Period October 1987 - November 1992

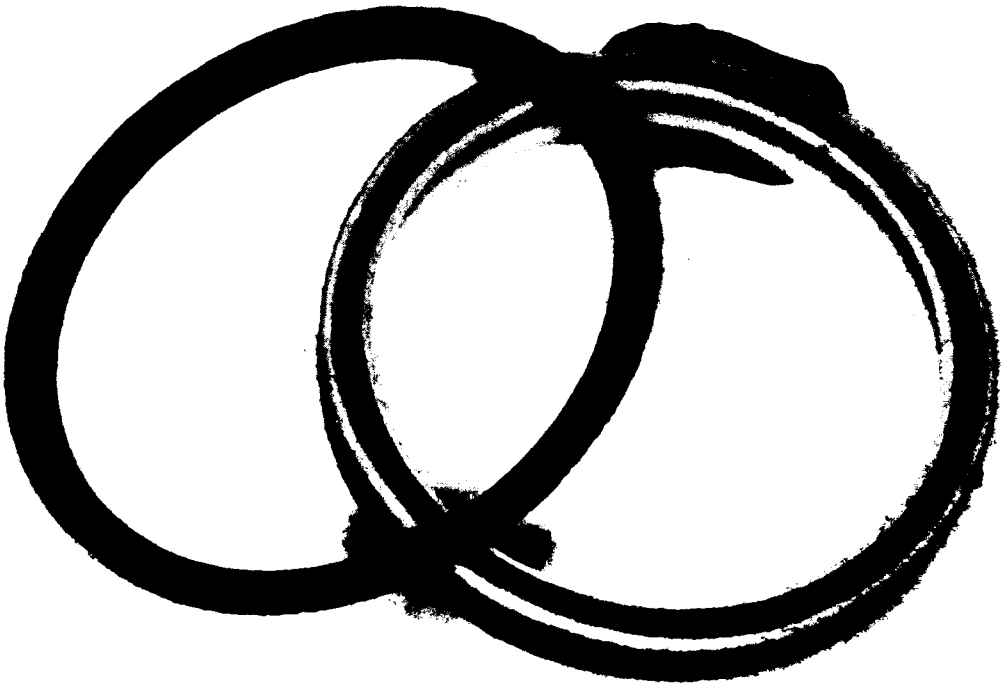
FIGURE 18-ADVANTEC SEAL FOLLOWING FIRST PRESCREEN TEST, SHOWING THE HIGH PRESSURE SIDE AND THE MATING PBI MATERIAL BACKUP RING.

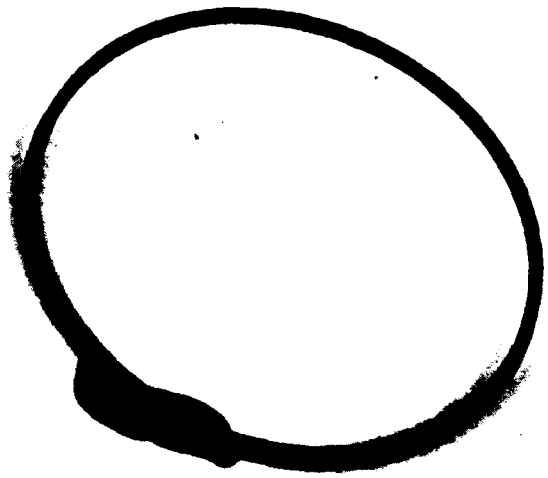
The Krueger Delta seal, Figure 19, was found to have the pressure balancing lands worn away and was reduced about 20 percent in cross section, but appeared to not be heavily damaged.

FIGURE 19- KRUEGER DELTA SEAL FOLLOWING FIRST PRESCREEN TEST.

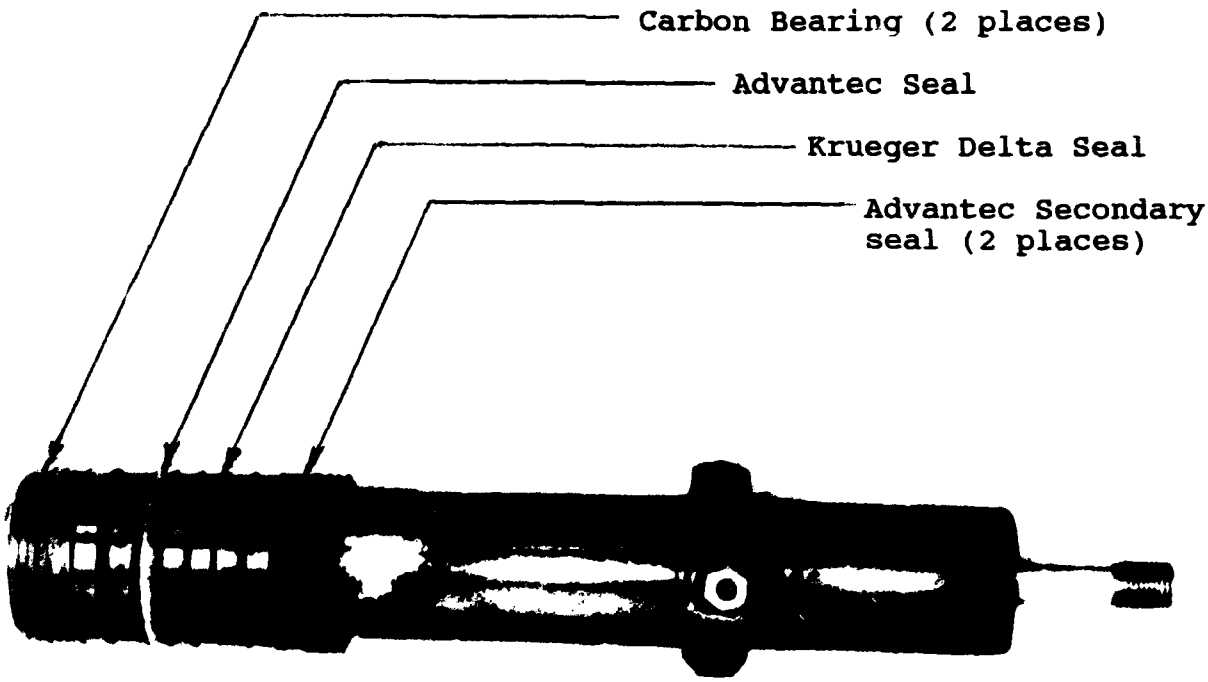
Less evidence of decomposed fluid was found within the sealing area, although the Advantec leak seals were again found to be coated with a black residue, and appeared to be quite worn. The carbon bearings at the extreme left and right ends of the seal area (referring to the figure) were quite clean and continued to exhibit the fluid distribution grooves machined in the O.D. These bearings were the same ones used in the first prescreen test and were reused for the two sequences of testing in the second prescreen test. Also, the Advantec primary test seal had less black deposit on the surface and some of the original white color of the jacket can be seen. The Krueger Delta seal can also be observed to protrude above the surface of the piston, indicating engagement with the test barrel.

FIGURE 22- PRESCREEN TEST MODULE PISTON SUBASSEMBLY FOLLOWING SECOND PRESCREEN TEST.

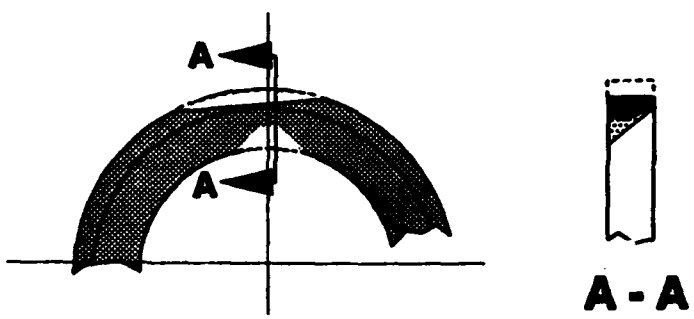
The Krueger Delta seal which had suddenly started leaking heavily was noted to be locally thinned at a location on the inside diameter. Because of the dark color of the seal ring, this feature could not be discerned in a photograph, so it is described in a sketch in Figure 23. This type of seal failure has been observed on other seals on previous occasions and may be described as an eroding away of the seal cross section under high pressure and flow, subsequent to a significant bypassing of fluid. In the case of the present test, significant flow was not available from the intensifier test arrangement so the damage was arrested quickly with the loss of pressure, following the start of the leak.

FIGURE 23 - LOCAL REDUCTION IN KRUEGER DELTA SEAL CROSS SECTION CAUSING HEAVY LEAKAGE

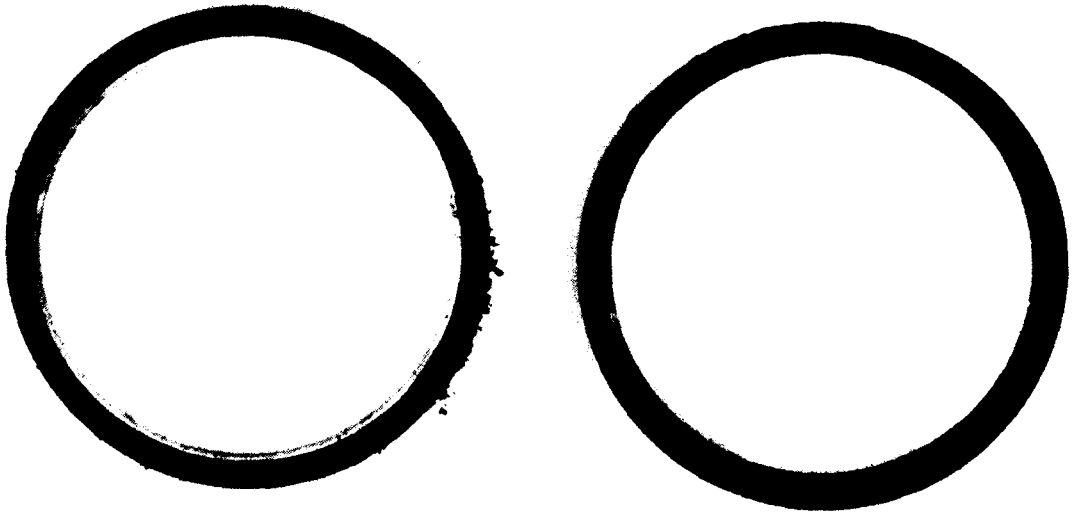
FIGURE 24 APPEARANCE OF ADVANTEC PRIMARY TEST SEAL UPON REMOVAL AFTER SECOND PRESCREEN TEST. THIS SEAL SURVIVED 50K CYCLES AT 600°F AND 5,000 PSI AND 50K CYCLES AT 600°F AND 6,000 PSI

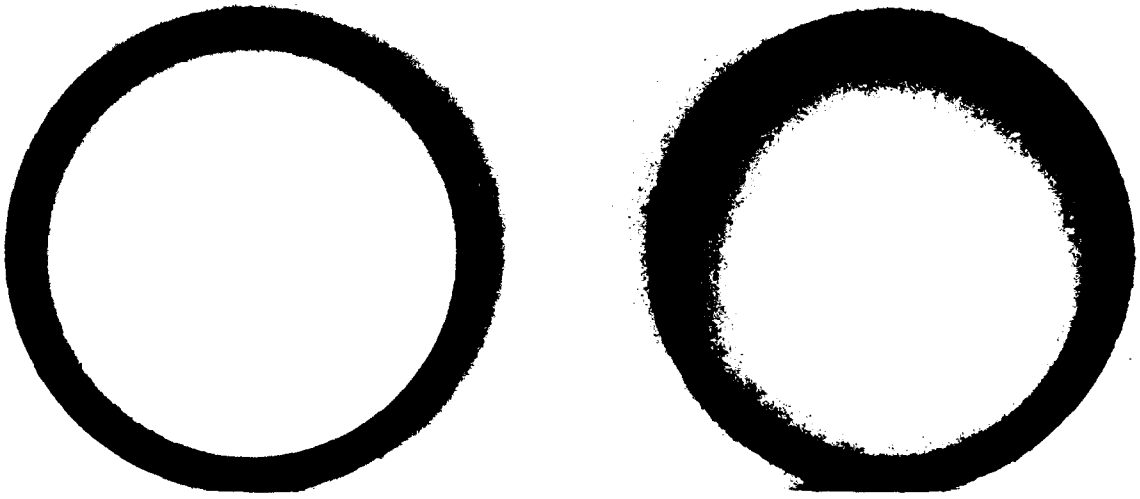
FIGURE 25 ADVANTEC SEAL USED IN THE SECONDARY POSITION DURING THE SECOND SEQUENCE OF THE SECOND PRESCREEN TEST.

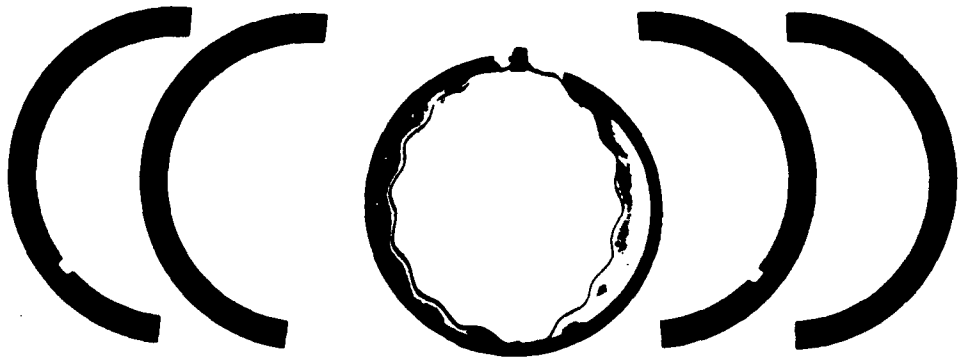
FIGURE 28-SHAMBAN S37905 PISTON RING ASSEMBLY

Early pressure-leak checks performed on these seals disclosed sufficiently severe leakage to prevent any pressurization of the test seals with the test equipment.

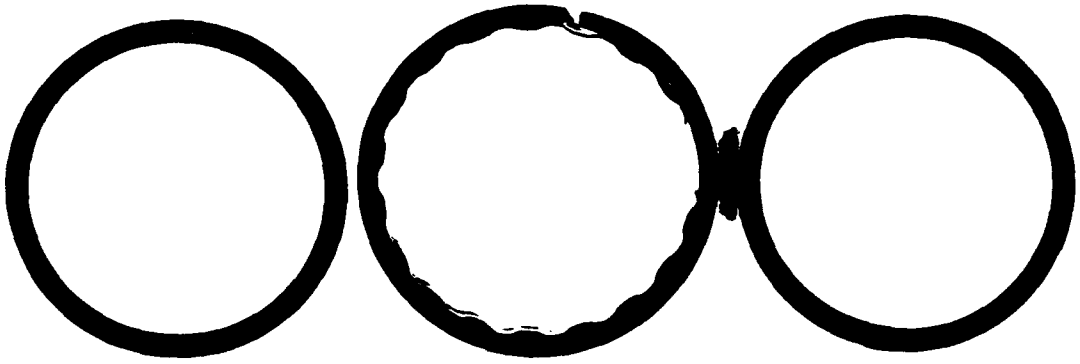
FIGURE 29 - FURON SPLIT PISTON RING ASSEMBLY
PART NO. 60706-01048

No change in the seals or hardware occurred during the evaluation.

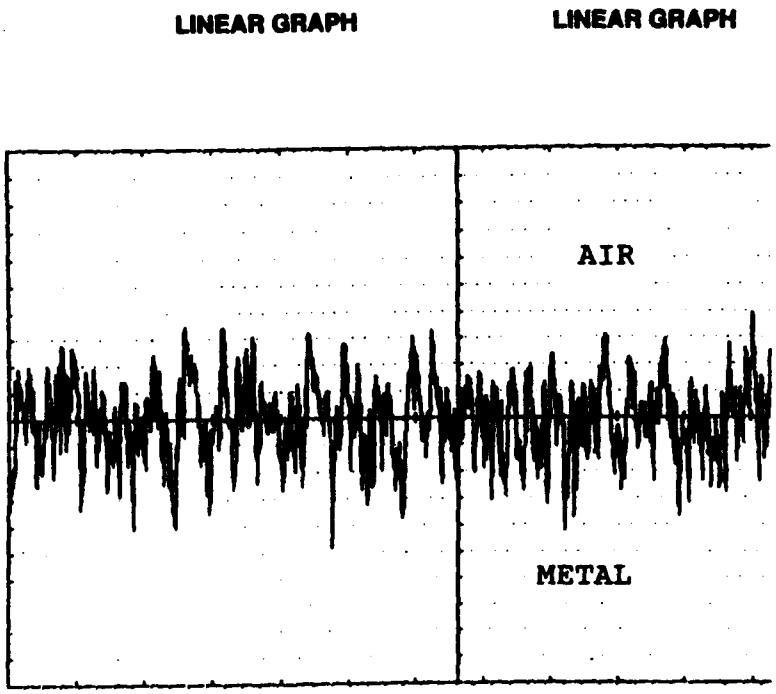
Notice, however, that the distribution of the peaks and valleys is not a homogeneous or uniform set that tend to be near the average of 11.5 microinches. Instead, there are within the measurement length more than 300 sets (Pc or peak count parameter near the bottom of the data column) which exceed 25 microinches, and 89 peaks that exceed 50 microinches. Even though this surface technically meets the specified requirements, it would cause early seal failure.

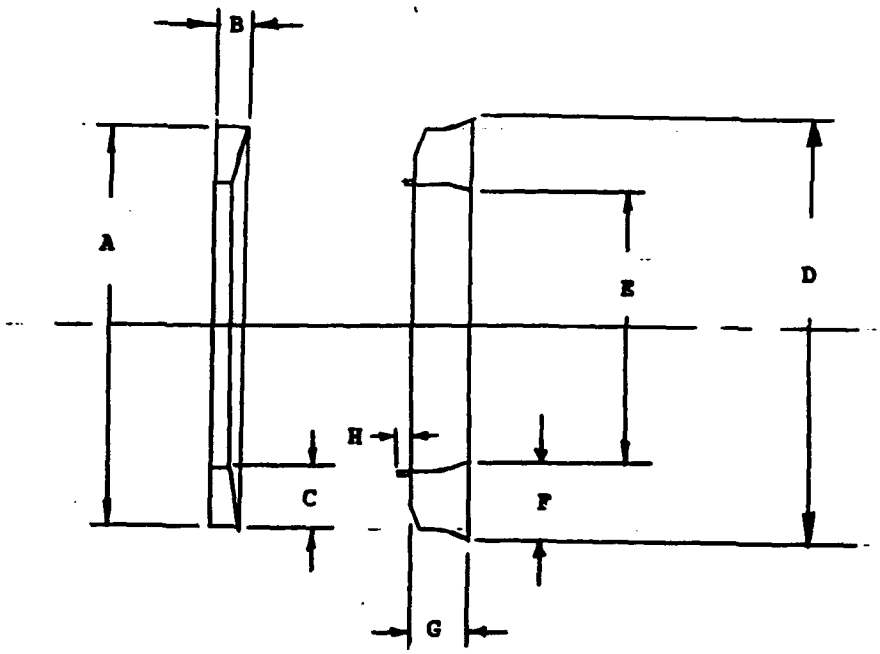
MEASUREMENT OF ADVANTEC MSE 20-500601 SEAL

DIM	BEFORE TEST	AFTER TEST
A	1.759 in.	NOT MEASURED
B	0.075 in.	0.076 /0.078 in.
C	0.123 in.	0.112 in.
D	1.7902/1.7904 in.	1.723 /1.725 in.*
E	1.474 in.**	1.475 in.
F	0.146 in.**	0.125 in.
G	(NOT MEASURED)	(NOT MEASURED)
H	(NO EXTRUSION)	0.025 in.

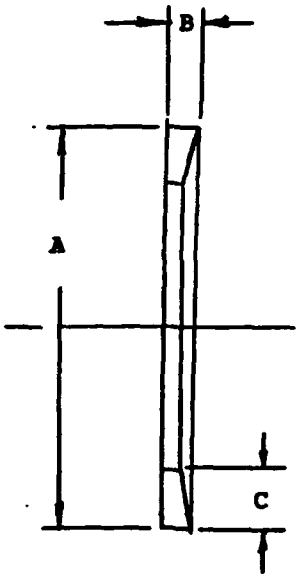
MEASUREMENT OF KRUEGER DELTA SEAL P/N 124520-1742

RESULT: Barrel 001
These seals were subjected to 50k 3-inch cycles combined with $1x\ 10^6$ dither cycles (one test block) at 600^oF and 5000 psi test pressure. At 36,180 3-inch cycles into this block the Krueger seal failed. Upon disassembly, it was found that the lead had melted from the K seal. The Krueger seal was replaced and the K seal was replaced with a gold plated K seal and the test was resumed with the same Advantec seal.
A second block of cycles was applied at 600^oF and 6000 psi; however, at 37.6k 3-inch cycles into this block, the Krueger seal was leaking beyond the failure criteria, so the test was stopped.

DIM	BEFORE TEST	AFTER TEST
A	1.743 in.	1.728 in.
B	0.060 in.	0.064/0.065 in.*
C	0.050 in.	0.040/.042 in.

* Includes 0.003/0.004 in. extrusion "feather"

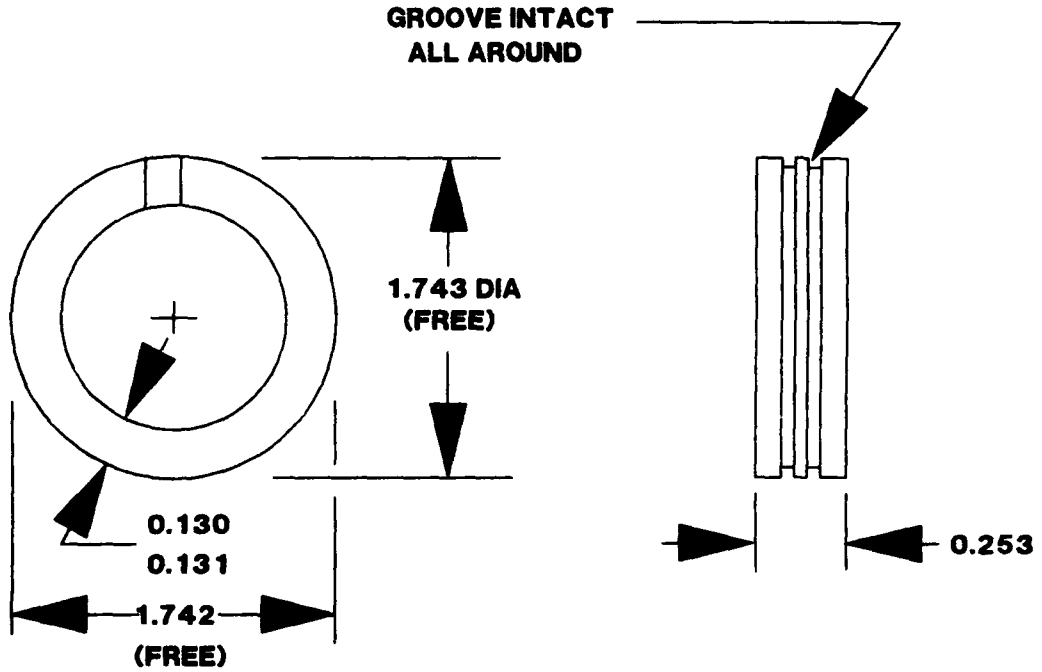
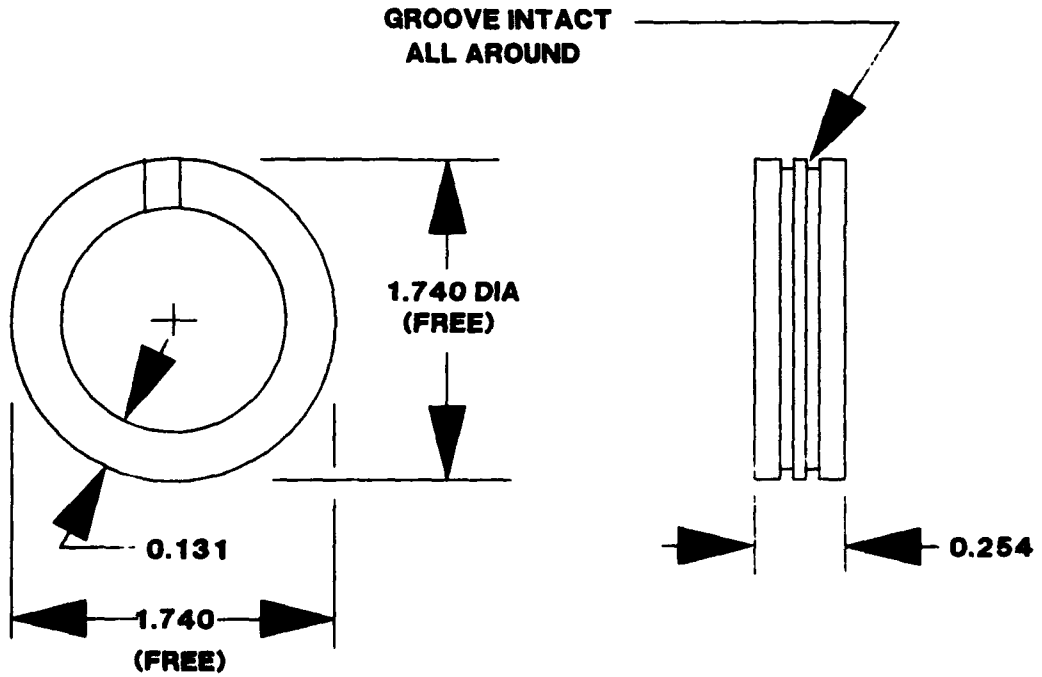
NUMBER 1 BEARING

RESULT: Barrel 002
These seals were first subjected to a -65°F cold test. Following the cold test, the seals were subjected to 600°F and 6,000 psi test conditions which they survived until 37,754 cycles, at which time total leakage volume exceeded limits.
Advantec seal was found in excellent condition and was retained for the following test. Krueger seal loading ring was found blocked by carbon particles from broken carbon bearing; otherwise, the Krueger seal was in good condition.

CONDITION OF CARBON SUPPORT BEARINGS FOLLOWING TEST

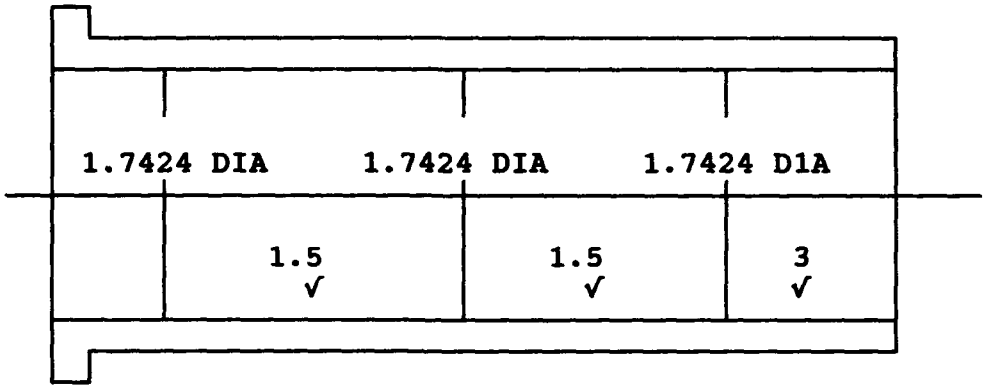
BARREL 001

BARREL DIMENSIONS AFTER TEST

NO MEASURABLE WEAR. SOME VISIBLE LONGITUDINAL SCRATCHES IN CENTER OF BARREL.

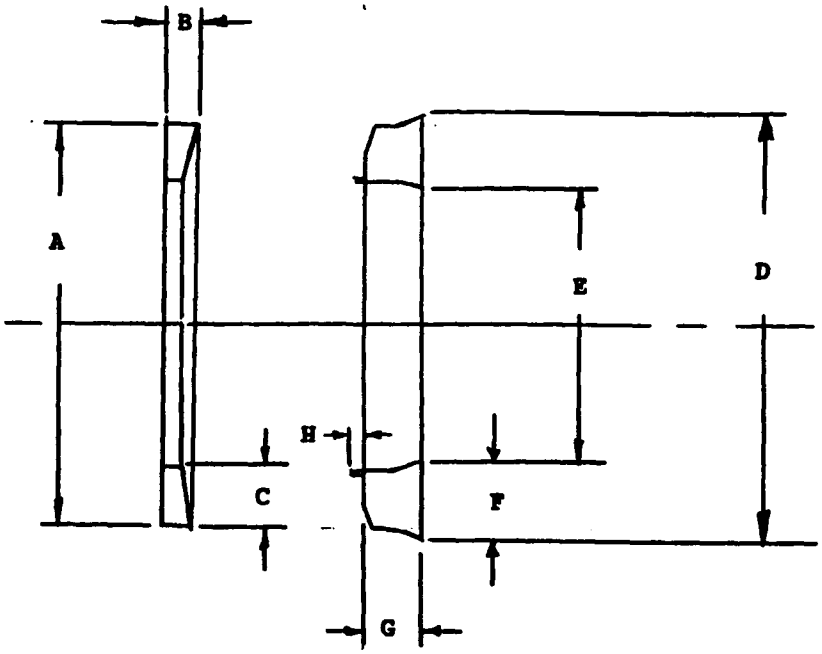
MEASUREMENT OF ADVANTEC MSE 20-500601 SEAL

DIM	BEFORE TEST	AFTER TEST
A	1.759 in.	**
B	0.074/0.075 in.	
C	0.122 in.	
D	1.768 in.*	
E	1.471 in.	
F	0.157 in.	
G	0.252/0.253 in.	
H	(NO EXTRUSION)	**

** Seal was worn thru to spring in a small area. It was not measured.
