ARMY RESEARCH LABORATORY

Fracture Analysis of an All-Ceramic Bearing System

ARL-TR-512

September 1994

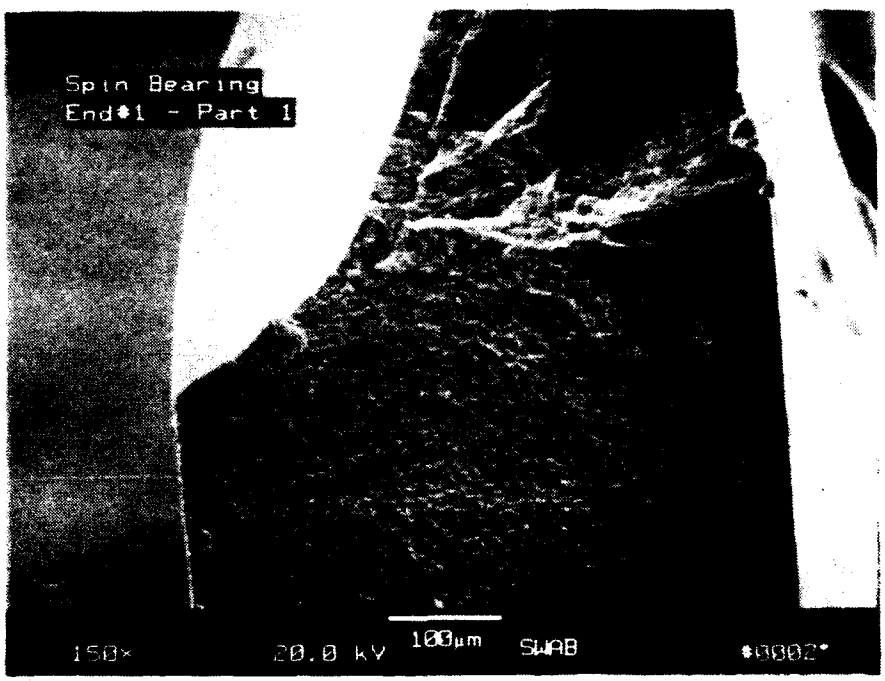
Three parts, labeled 1, 2 and 3 in Figure 6, of the End #1 inner race were examined. Figures 8 and 9 show the fracture surface of part 1. Both photographs reveal the presence of a series of machining related microcracks which are approximately 25-30 μm deep and connected to the raceway surface. An examination of this fracture surface at an angle, Figure 10, demonstrates that these microcracks have linked together in a step-wise fashion. Characterization of the fracture origin is as follows: Machining Damage, located at the surface with a depth of 25-30 μm, (MS^S, surface, 25-30 μm deep).

Figure 8. Photograph of the fracture surface of part 1 from End #1.

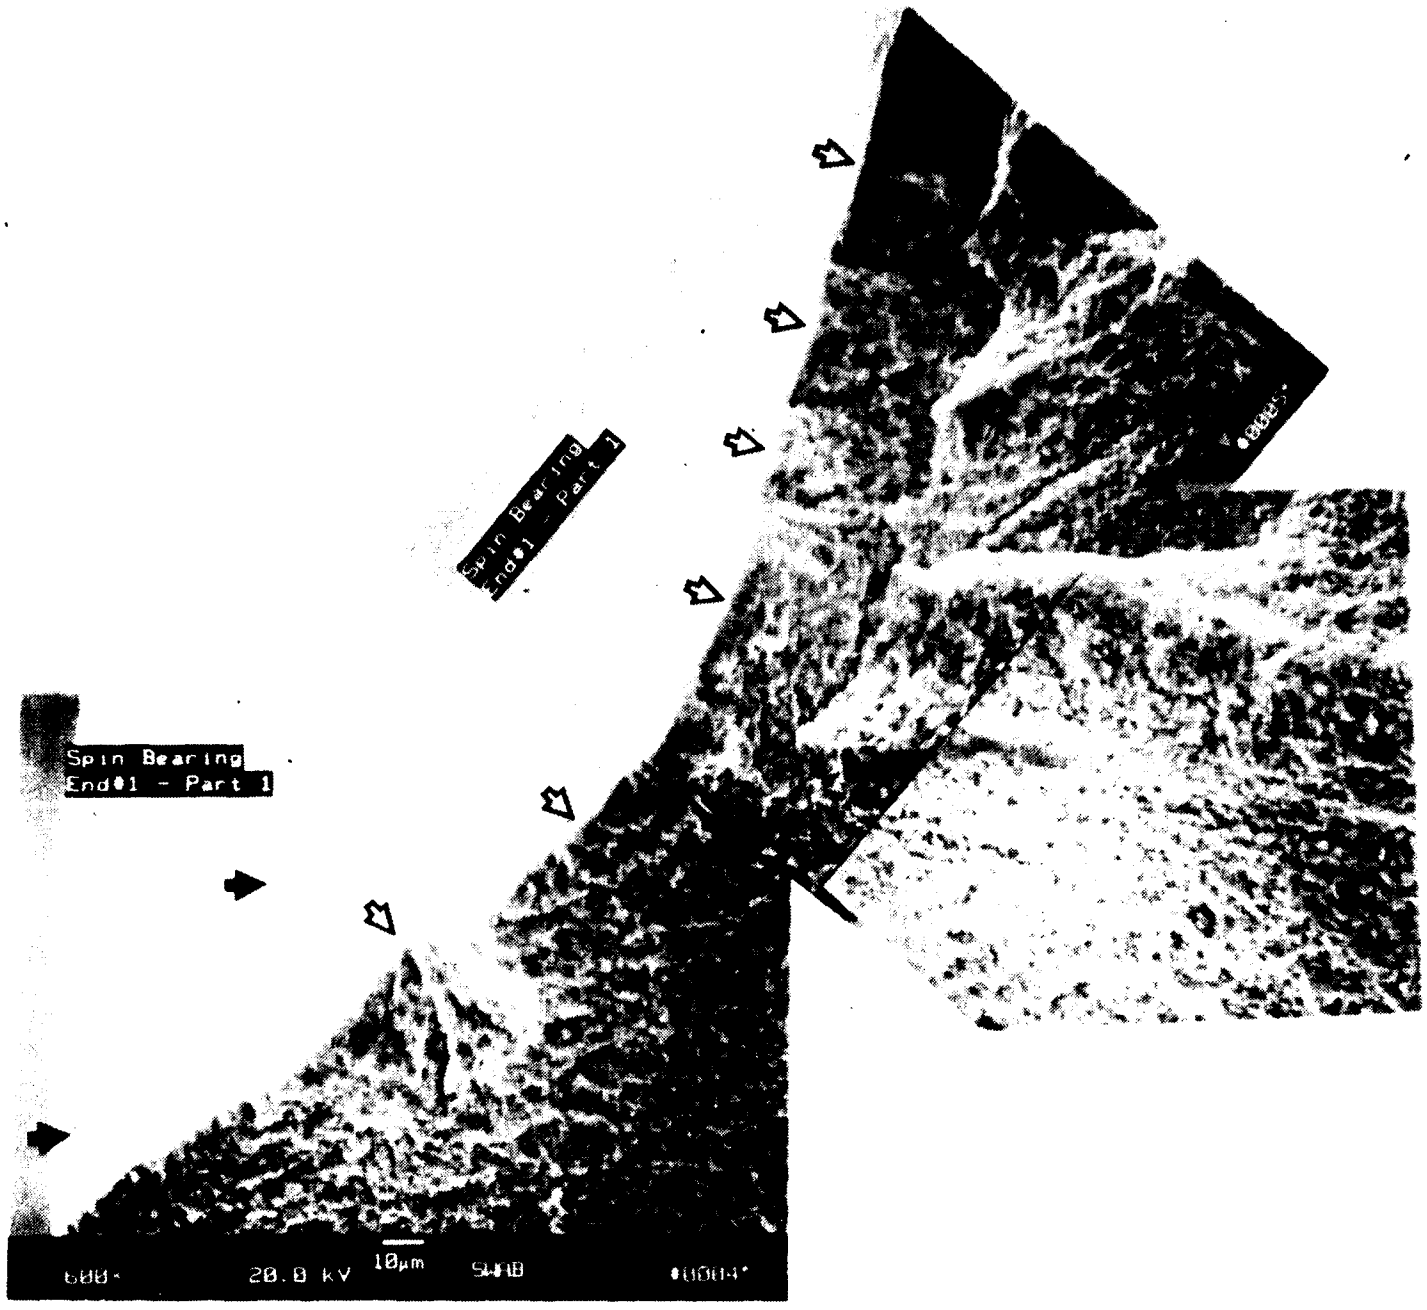
Figure 9. High magnification montage of the fracture surface of part 1 from End #1. Open arrows indicate the surface connected microcracks, (MS^S, surface, 25-30 μm deep). Solid arrows point out some of the machining striations in the raceway.

The first fractographic indication that the microcracks in this system were related to machining was the appearance (uniform shape and size) of the series of subsurface microcracks in Figure 9. Similar machining induced cracks have been shown to limit the strength of silicon nitride[18] and other ceramic materials.[19] Second was the step-wise propagation of the crack (see Figure 10) in part 1. Mecholsky et. al.[16] showed that grinding introduces two types of microcracks: one which is parallel to the grinding direction and one which is perpendicular to the grinding direction. The parallel microcracks are typically more severe. The grinding direction of the raceways is along the radial axis. Based on the stress state discussed previously the axial tensile stresses appear to be sufficient to grow the parallel (more severe) microcracks while the radial tensile stresses grow the perpendicular microcracks. These growing microcracks then link together, with the parallel microcracks becoming the steps and the perpendicular microcracks the risers, resulting in the step-wise propagation of the crack.

1) Develop a machining procedure specifically for the raceways.
2) Reduce the material removal rate during coarse grinding.
3) Eliminate grinding with coarse grit wheels.

suggestion would be to subject the NBD-200 material to a post-machining heat treatment. Previous work on NC-132[11,20] has shown that short duration exposures (< 10 hours) at temperatures approaching 1200°C result in an increase in the room temperature strength. This increase is due to the relaxation of the residual stresses created during machining and/or a change in the acuity of the cracks in the material.

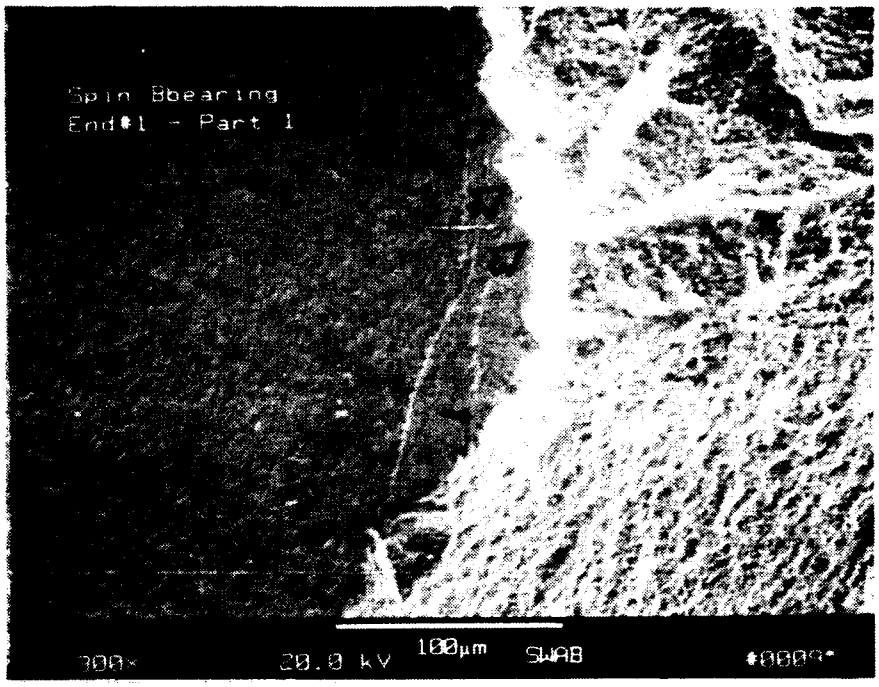
Figure 10. Photograph of the fracture surface of part 1 from End #1 when viewed at an angle. The open arrows show the "steps" of the crack propagation while the solid arrows indicate microcracks in the raceway.

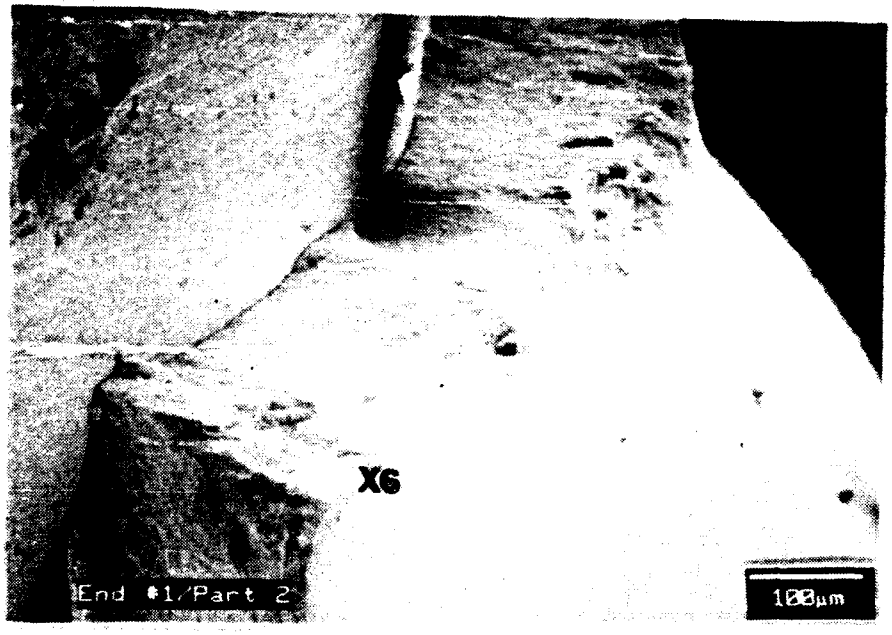
The SEM examination of parts 2 (Figure 11 and 12) and 3 (Figure 13) show that the texture of the fracture surface near the location of a ball is very rough but it becomes smoother as the crack proceeds away from this location. The texture will become rough again when the next ball is encountered. The outer edge (raceway) of the fracture surface also is very rough, but the surface texture becomes smoother as the crack proceeds through the raceway cross-section.

Figure 12. View of part 2 from an angle revealing the rough texture of the fracture surface just below the raceway surface and the smoother texture as the crack proceeds away from the surface. X indicates a ball location and the white arrow the direction of crack propagation.
