Detecting Gear Tooth Fracture in a High Contact Ratio Face Gear Mesh

DETECTING GEAR TOOTH FRACTURE IN A HIGH CONTACT RATIO FACE GEAR MESH

NASA TM-106822
ARL-TR-600

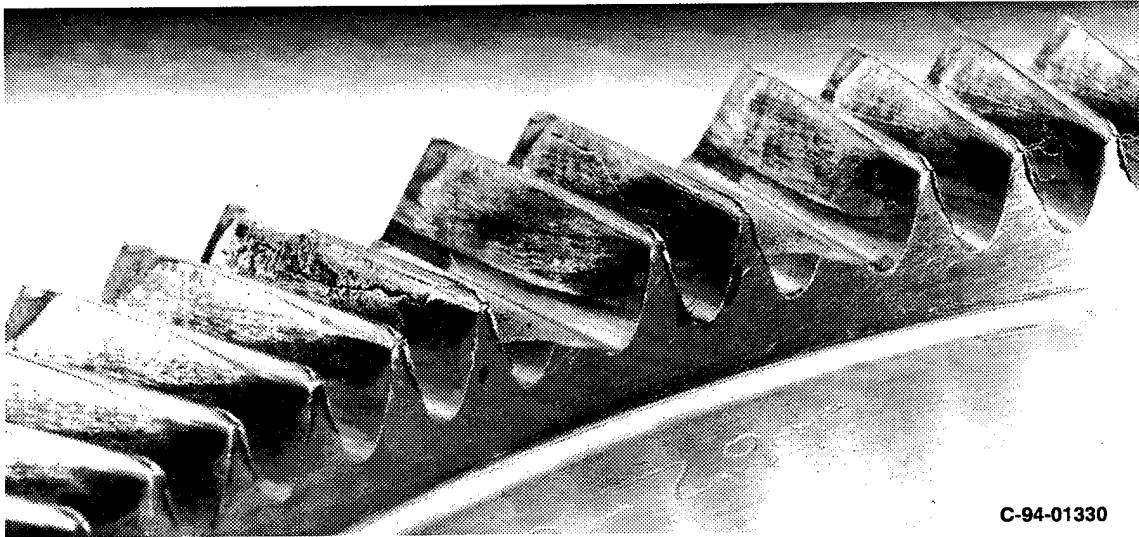
Figure 1 illustrates the tooth damage resulting from face gear run #1. During the last 7 hours of the test all of the teeth on the face gear experienced heavy wear damage, with some developing severe pitting and surface fatigue cracks as well. One tooth broke off at approximately 18 minutes before the end of the test, and the test was terminated when the second tooth broke off. Both were complete tooth fractures, as shown in the figure.

Figure 1.—Gear tooth damage at end of face gear run #1.

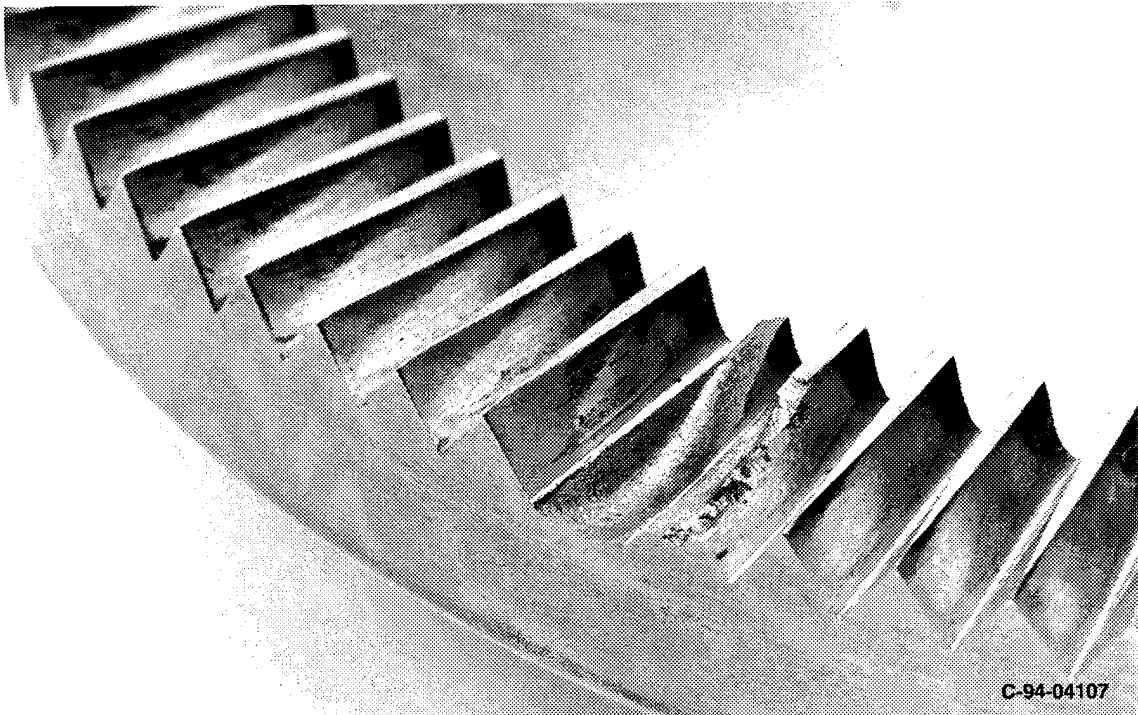
Figure 2 illustrates the damage resulting from face gear run #2. After about 25 hours into the run, the load was incrementally increased over a period of 5 hours to 200%. The test continued at 200% load until 3 teeth broke off. Almost one complete tooth broke off along with a majority of an adjacent tooth, as seen in this figure. The third tooth, positioned approximately 120 degrees from the two shown in figure 2, also experienced a partial tooth fracture of over 50% of the tooth.

Figure 2.—Gear tooth damage at end of face gear run #2.

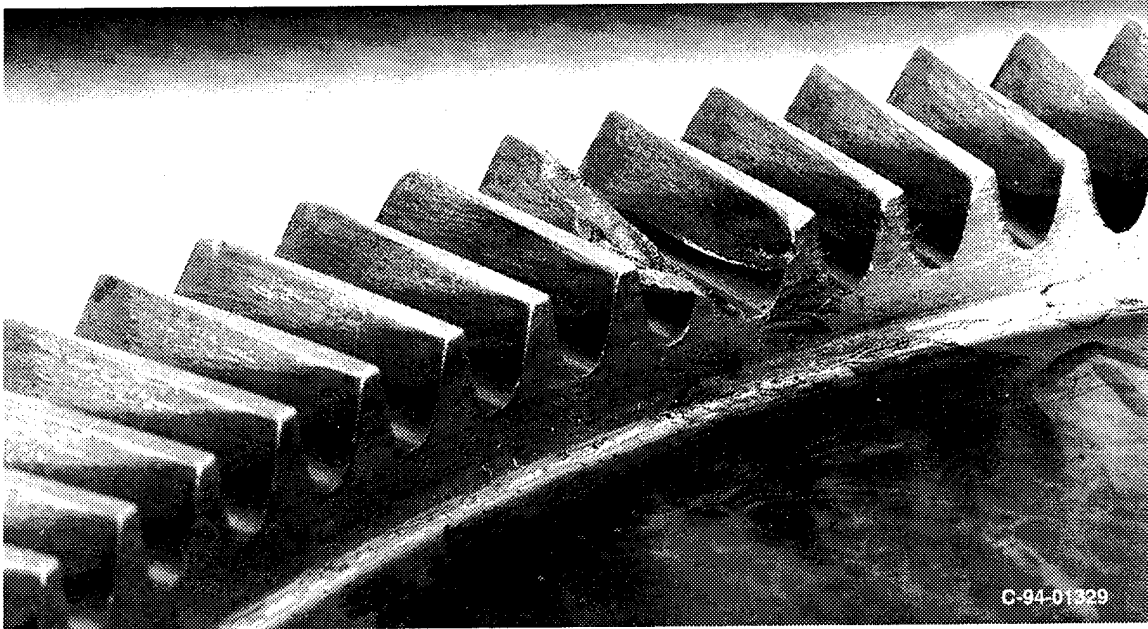
Figure 3 illustrates the tooth damage resulting from face gear run #3. During the last 3 hours of the run several teeth on the face gear experienced gradual pitting damage on the tooth surface. This resulted in the pitting-induced single tooth fracture at the end of the test. As seen in figure 3, nearly 75% of the tooth broke off. In addition, the tooth adjacent to the fractured tooth has extensive pitting damage, and a fatigue crack across most of the tooth width.

Figure 3.—Gear tooth damage at end of face gear run #3.

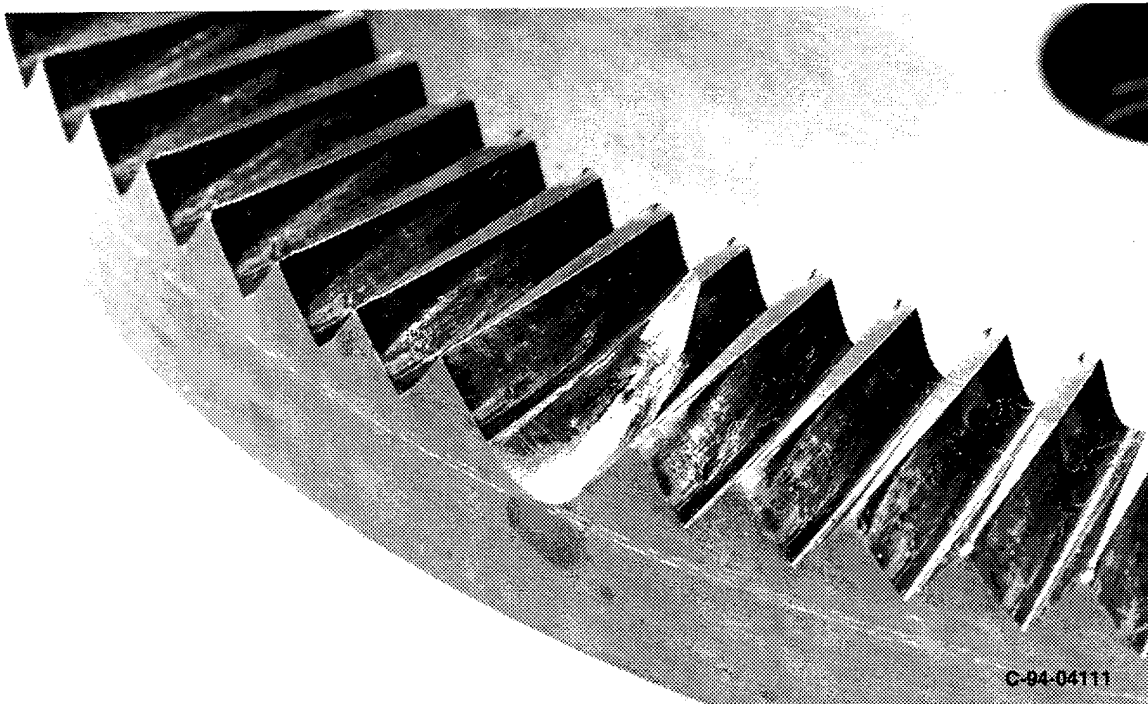
Figure 4 illustrates the damage resulting from face gear run #4. As seen in this figure, the damage was limited to a single tooth fracture. Approximately 75% of the tooth broke off during the test.

Figure 4.—Gear tooth damage at end of face gear run #4.

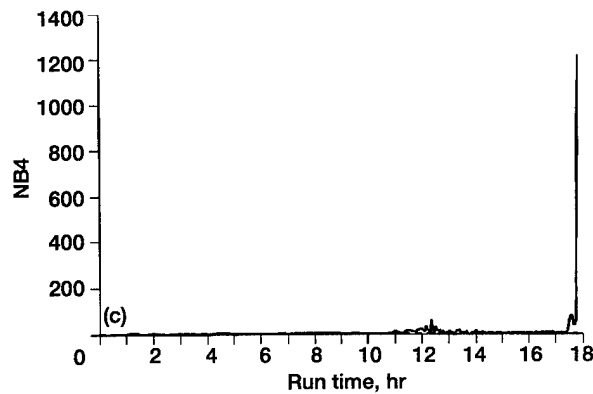
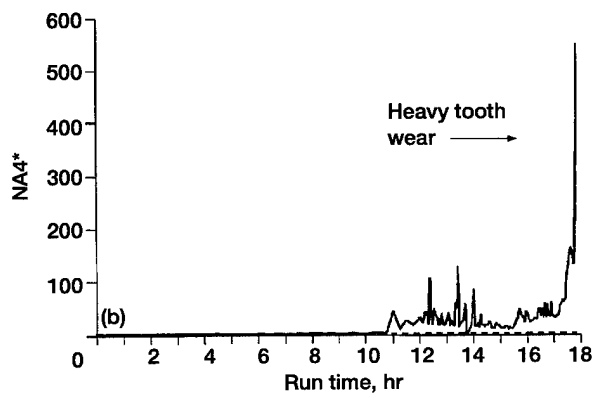
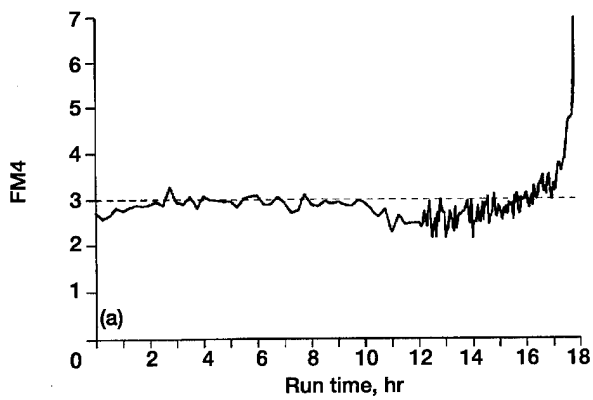
Based on the results, all of the gear diagnostic methods investigated reacted significantly to the multiple tooth fracture damage experienced in face gear runs #1 and 2. As seen in figure 5, all of the parameters clearly indicated the multiple tooth fracture damage at the end of run #1. One tooth, or a portion of a tooth, broke off at approximately 18 minutes before the end of the test, which may account for the "knee" seen in the resulting plots at approximately the same point in time. Table 1 lists the results of the methods for the last 30 minutes of run #1. From the graphs in figure 5, it appears that the indications from the methods are nearly instantaneous. However, as seen in table 1 there is a gradual increase in FM4, NA4*, and NB4 over the last 24 minutes. At the end of run #1, FM4 reaches a value of 7.0, NA4* reaches 549, and NB4 reaches 1213, all relative to the nominal value of 3.0. Similarly, as seen in figure 6, all of the parameters clearly reflect the multiple tooth fracture damage at the end of run #2. Table 2 lists the results of the methods for the last 24 minutes of run #2. Again, the damage indications from the methods are not instantaneous, but gradually increases over the last 21 minutes of the test. As seen in this table, at the end of run #2, FM4 reaches a value of 6.7, NA4* reaches a value of 142, and NB4 reaches a value of 369.

Method NA4* was able to detect more than just pitting and tooth fracture damage. As seen in figure 5b, only NA4* reacted significantly to the heavy wear damage experienced by the face gear during the last 7 hours of face gear run #1. As in previous tests [2,3], NA4* was shown to be capable of reacting to a number of different failure modes. In these series of face gear tests, NA4* was able to detect gear tooth pitting, heavy wear, and fracture damage. NA4* is however, sensitive to load and speed changes. For example, as the load was gradually changed from 100% to 200% of design load between the run time of 26 and 31 hours during run #2, NA4* gave a false indication of damage, as seen in figure 6b. These false reactions by NA4*, in this case, are much lower in magnitude than its reaction to the actual tooth fracture damage at the end of run #2.

Although method NB4 gave no reaction to the runs with single tooth damage, it did give the most robust reaction to the runs with multiple tooth fracture damage (runs #1 and 2). As seen in figure 5c and table 1, NB4 stays near the nominal value of 3.0 until near the end of run #1, where NB4 increases to over 400 times the nominal value. Similarly, as seen in figure 6 and table 2, NB4 stays relatively close to the nominal value until near the end of run #2, where NB4 increases to over 120 times the nominal value. In addition, NB4 does not appear to be as sensitive to load and speed changes as method NA4*.

Figure 5.—Face gear run #1 results. (a) FM4. (b) NA4*. (c) NB4.

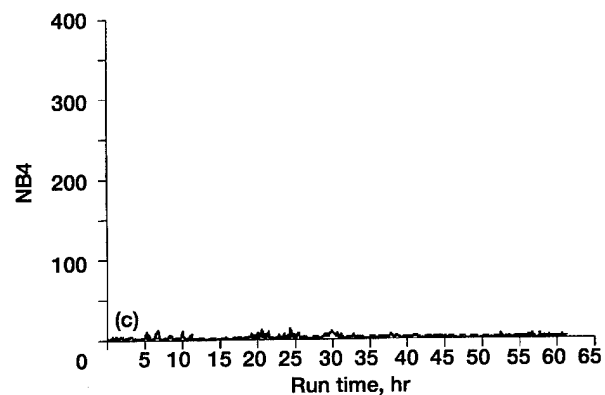
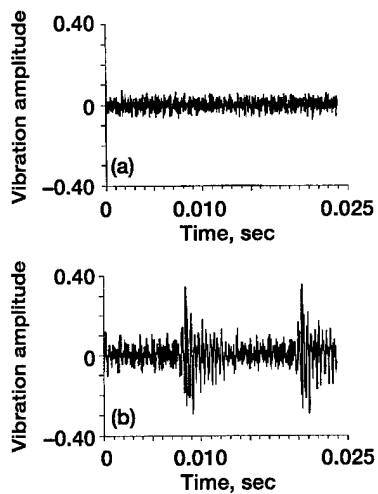
Figure 7.—Face gear run #3 results. (a) FM4. (b) NA4*. (c) NB4.

Single tooth damage, as experienced in face gear runs #3 and 4, was more difficult to detect using the methods investigated. As seen in figure 7, only FM4 and NA4* reacted to the gradual pitting damage and single tooth fracture experienced in run #3. The final values of these two parameters are much lower than that experienced in the runs with multiple tooth fracture damage. NB4 did not show any indications of the damage in this run. As seen in figure 8, none of the parameters give any indications of the single tooth fracture damage experienced in run #4. For both run #3 and run #4, the tooth fracture damage was similar, i.e. approximately 3/4 of one tooth broke off, however only run #3 had some damage detection success. This may be due to the fact that the tooth adjacent to the fractured tooth in face gear run #3 had extensive pitting damage and a large fatigue crack. Even though this adjacent tooth did not break off in run #3, it was damaged enough to act similarly as if it were partially fractured.

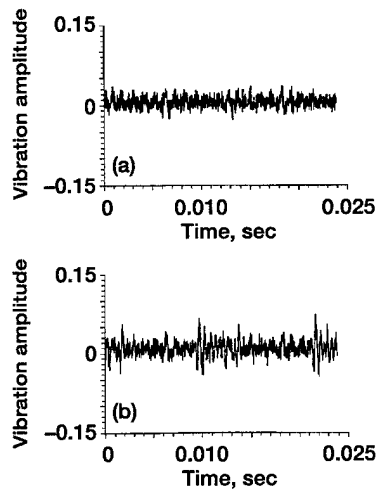
run #3 (figure 11), and no real change in the signal for the single tooth damage in run #4 (figure 12). It is apparent from these results that single tooth damage is difficult to detect in a high contact ratio gear mesh.

Figure 11.—Time averaged vibration
signal for face gear run #3.
(a) At start. (b) At end of test.

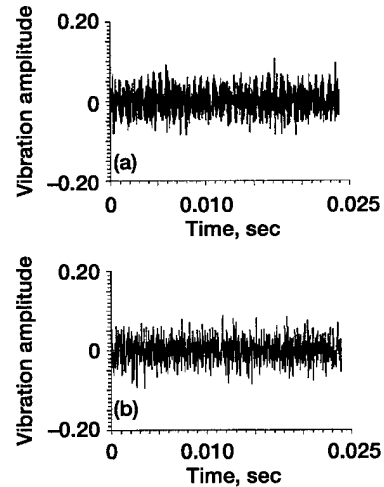
Figure 12.—Time averaged vibration
signal for face gear run #4.
(a) At start. (b) At end of test.
