ERDEC-TR-415

CLEANOUT AND DECONTAMINATION OF A MUSTARD AGENT TON CONTAINER

June 1997

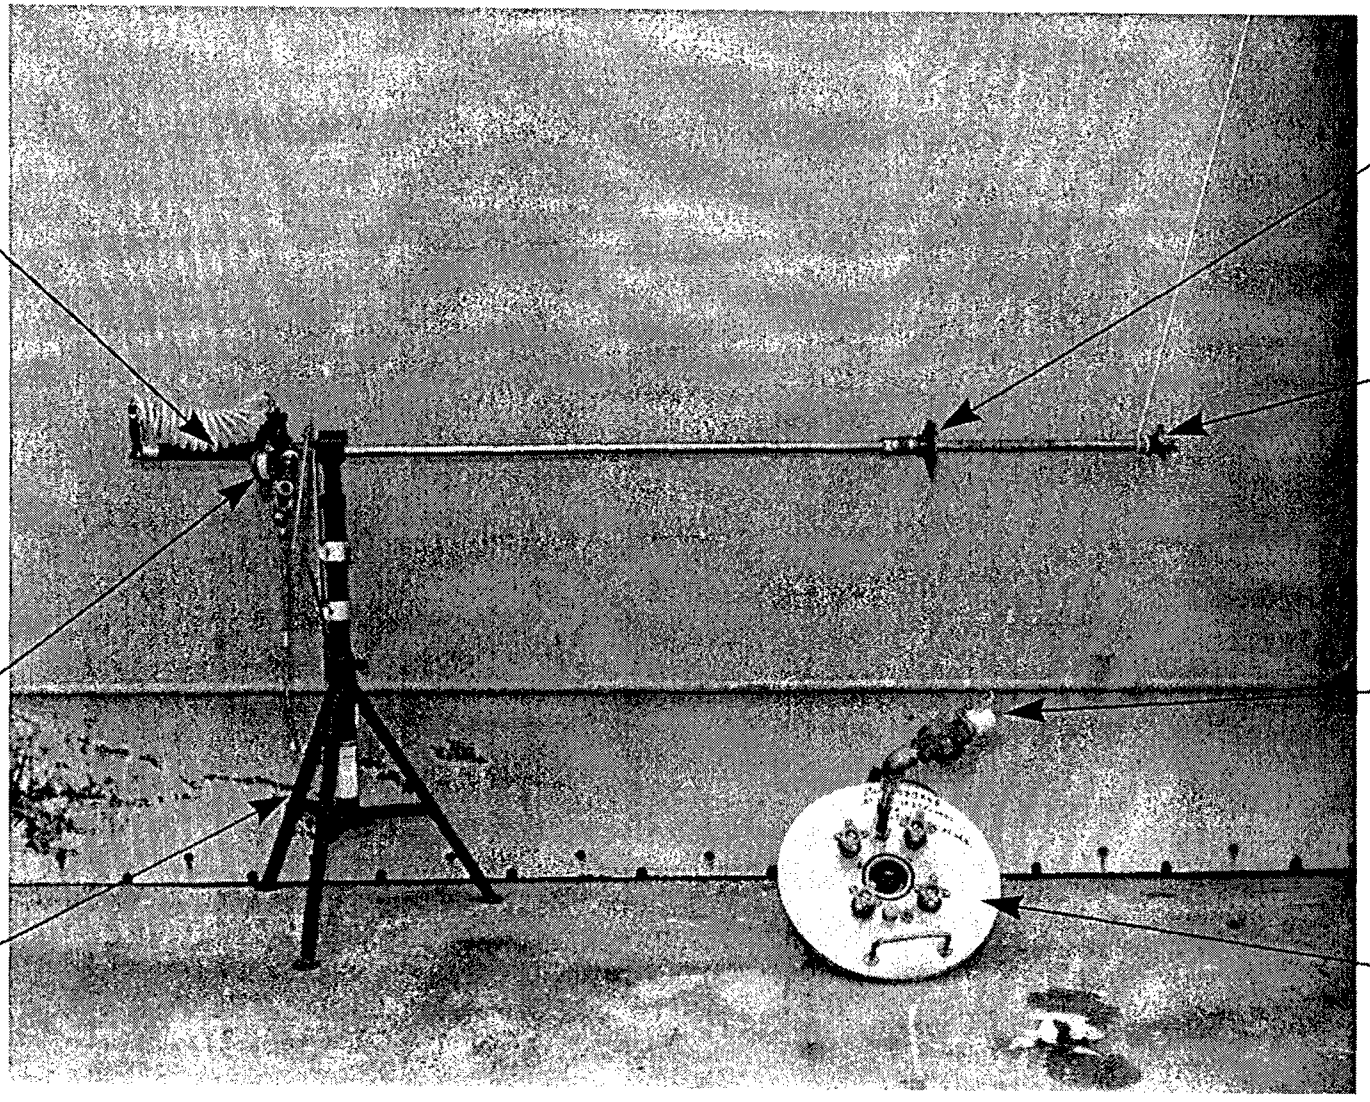
Figure 3-3. Lance and Nozzle Assembly & Interface Plate

After 15 minutes (13:38) of cleaning, the chamber operators attempted to move the lance and nozzle assembly from the 3/4 position to the 1/4 position; however, the wand would not budge. There were areas of rust over many parts of the wand and it was difficult to loosen. It was decided to continue and keep the nozzle at the 3/4 position for the entire first 30 minutes and to move it to the 1/4 position at the end of this stage of hot water spraying.

As stated earlier, there was a rusty film and corrosion over many areas of the wand which had prevented the operators from moving it during the cleaning process. The wand could not be moved while it was attached to the interface plate. The lance and nozzle assembly was removed from the interface plate and loosened using wrenches. The nozzle was moved to the one-quarter position (Figure 3-4).

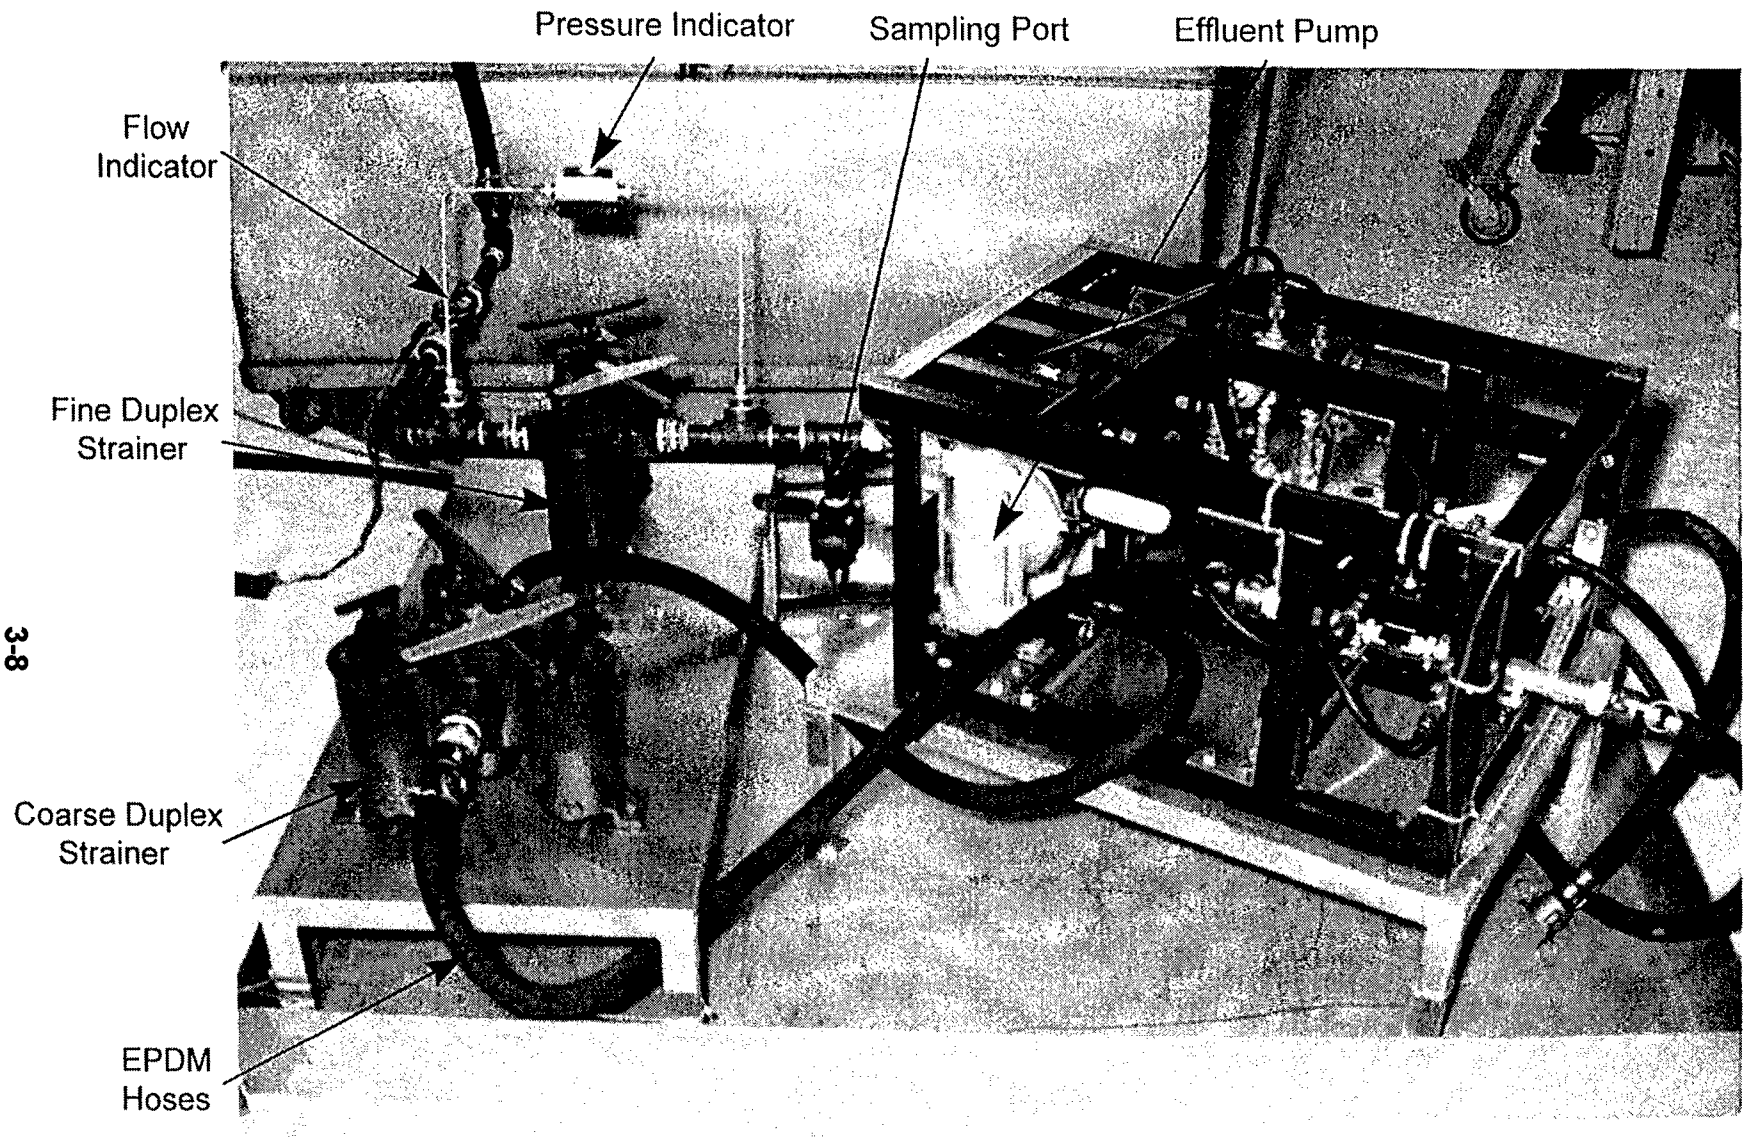
Figure 3-5. Pump Skid and Duplex Strainers

The effluent pump was an ALL-FLO KN-10 air diaphragm pump constructed of Kynar with Teflon diaphragms that was capable of pumping water at a rate of up to 33 gpm using a maximum air pressure of 70 psi. During the TC cleanout, the effluent pump had failed. It was replaced by a Wilden M2 air diaphragm pump.

Cleanout effluents were strained with a coarse (1/4 inch perforation) duplex strainer ahead of the pump and a fine (80 mesh) duplex strainer after the pump (Figure 3-5). The strainers were Hayward Model 50 1-1/2 inch National Pipe Thread (NPT) duplex strainers constructed of cast iron with 316 stainless steel (SS) perforated or mesh baskets. The coarse strainer served to protect the air diaphragm pump, which could only handle solid particles less than 1/4 inch in diameter. The fine strainer served to keep smaller particles out of the holding tank and to assist in determining whether or not the effluent can be recycled.

If the effluent is recycled in the pilot plant, it is recommended that appropriate strainers be placed in line to protect the pumps and to keep the spray nozzle from clogging. Also, it has been observed that it is critical to spray closer to the plug and eductor tube walls to thoroughly clean the TC ends.

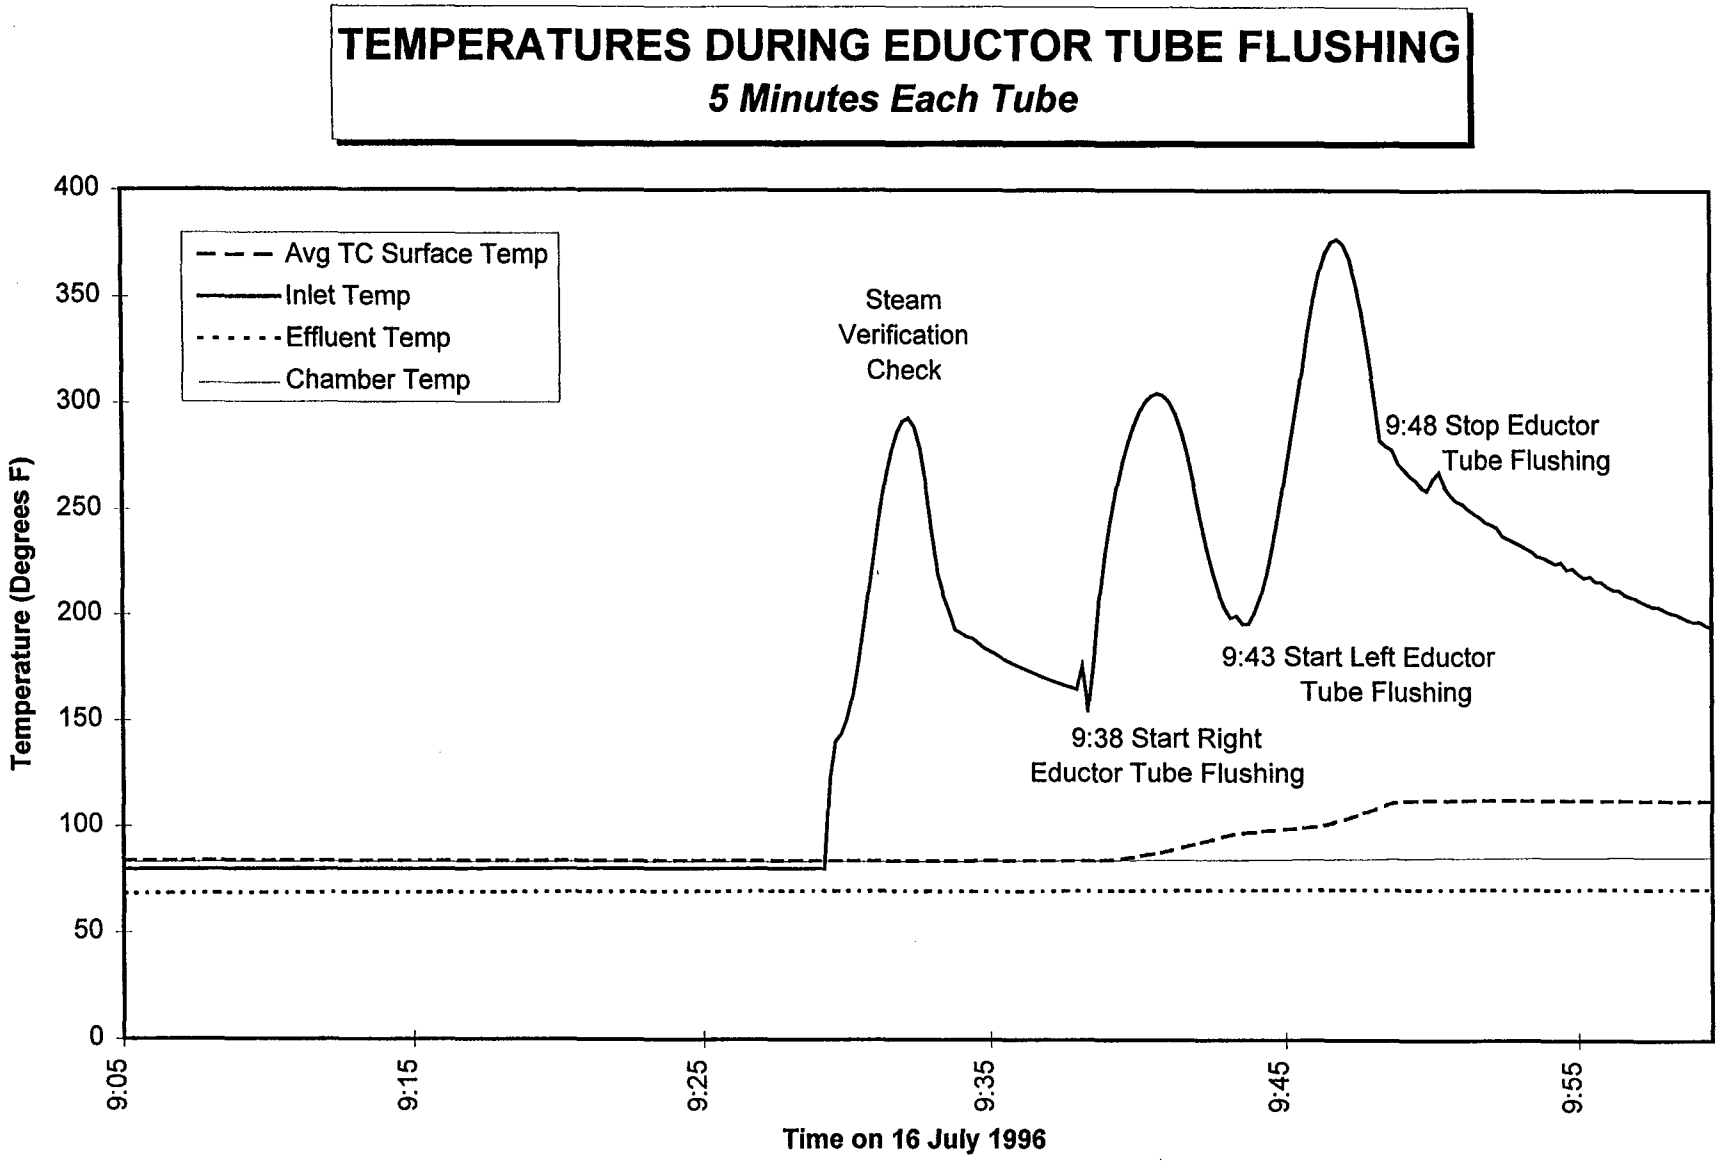
Figure 3-11. Temperatures during Steam Flushing of the Eductor Tubes

The two valves were removed and the "Y wand" hookup for the steam was installed. On 16 July 1996, the eductor tube flushing was initiated. The temperature profile during the steam flushing of the eductor tubes can be found in Figure 3-11. On this plot, the first temperature spike was the pre-flushing steam verification check, and the second and third temperature spikes were the flushing of each eductor tube.

At 09:43, the steam was switched to the left eductor tube for five minutes of steaming. Once again, the temperature increased (to approximately 375°F) until the blockage was cleared. The average skin temperature increased to approximately 115°F. A total of 10 gallons of condensate was added to the ton container during the flushing of the eductors. A summary of flushing the eductor tubes with steam can be found in Table 3-3.
