Research Product 2001-01

Bradley Fighting Vehicle: Heat in the Driver's Compartment

January 2001

Infantry Forces Research Unit

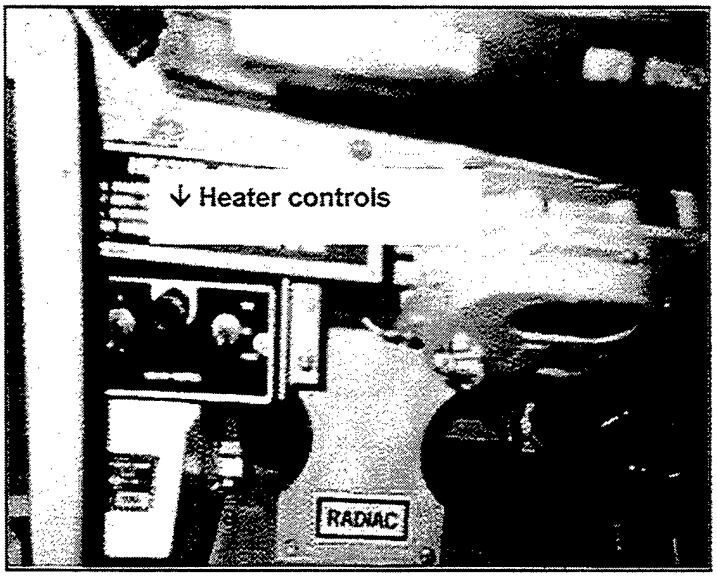
Figure 1. Left side – heater controls

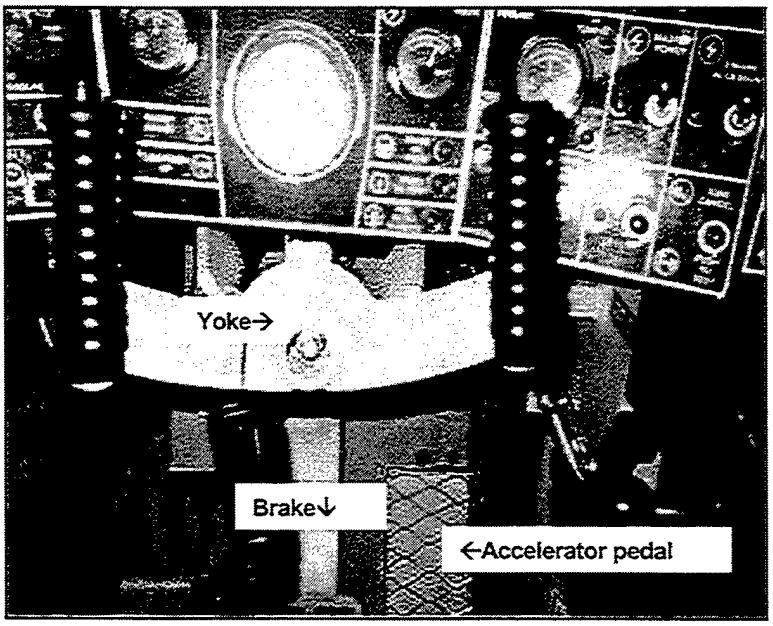
Figure 2. Center – steering yoke, foot pedals

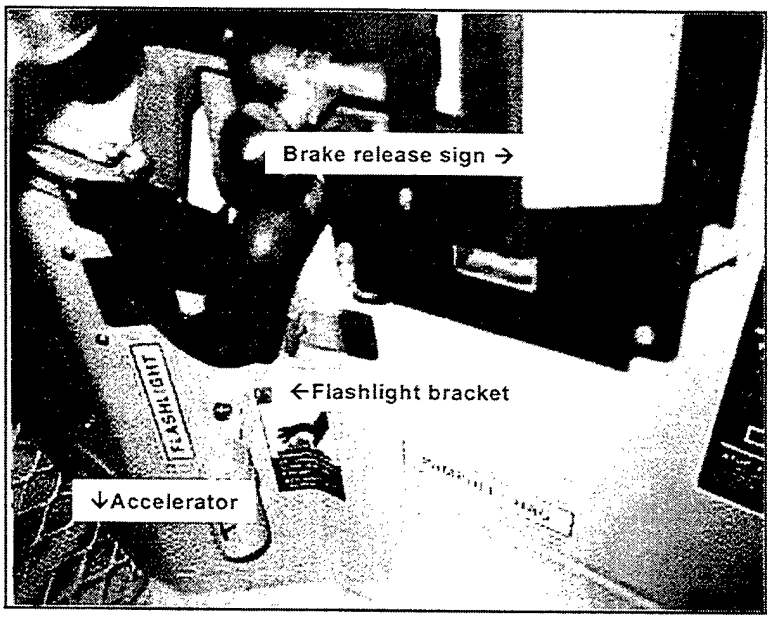
Figure 3. Right side (forward, low) – flashlight bracket

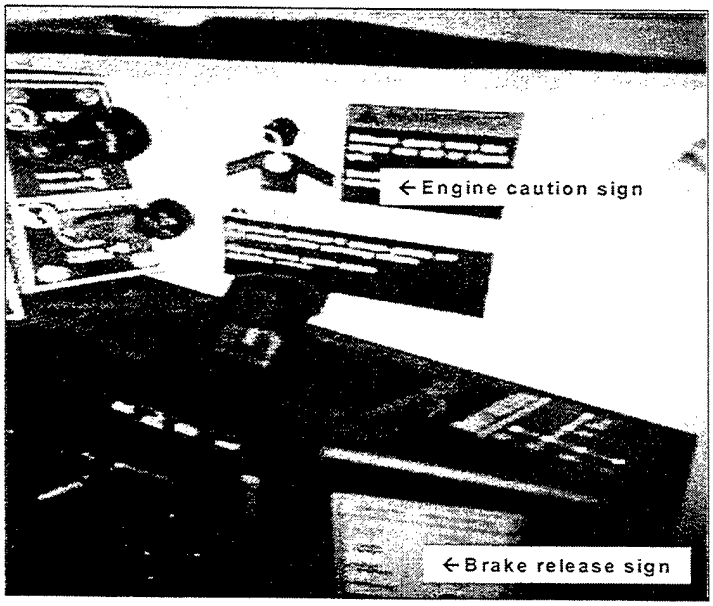
Figure 4. Right side (forward, high) – engine caution sign, brake release sign

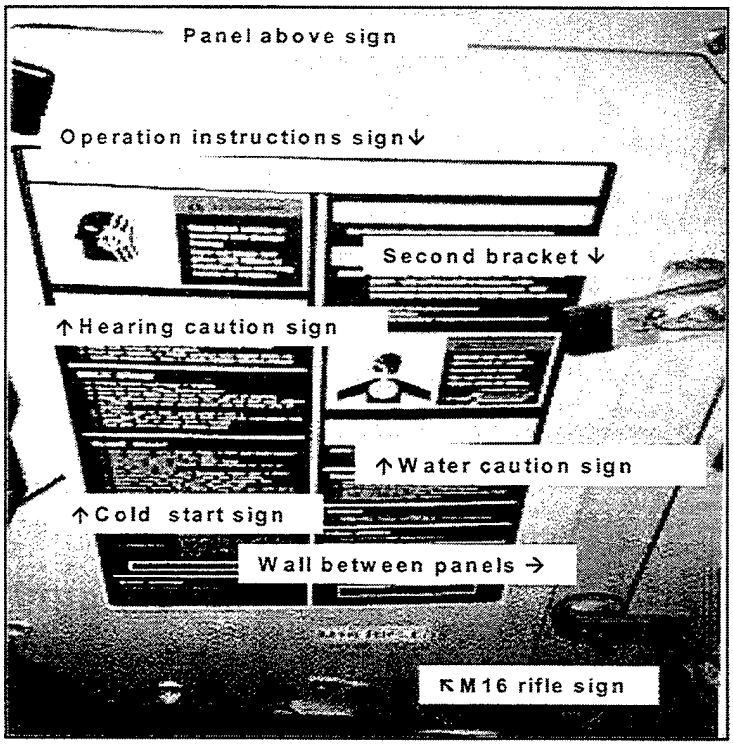
Figure 5. Right side (front) – forward engine access panel, with operation instruction sign

In other areas on the right side, however, the rise in temperature was very large, especially in areas adjacent to the engine access panels. Based on these initial and preliminary measurements, it was apparent that the M2A3's driver compartment was reaching a warm interior ambient temperature (100°F) and that some areas had surface temperatures in excess of 140°F. The next logical step was to compare these data to data collected from other vehicles.

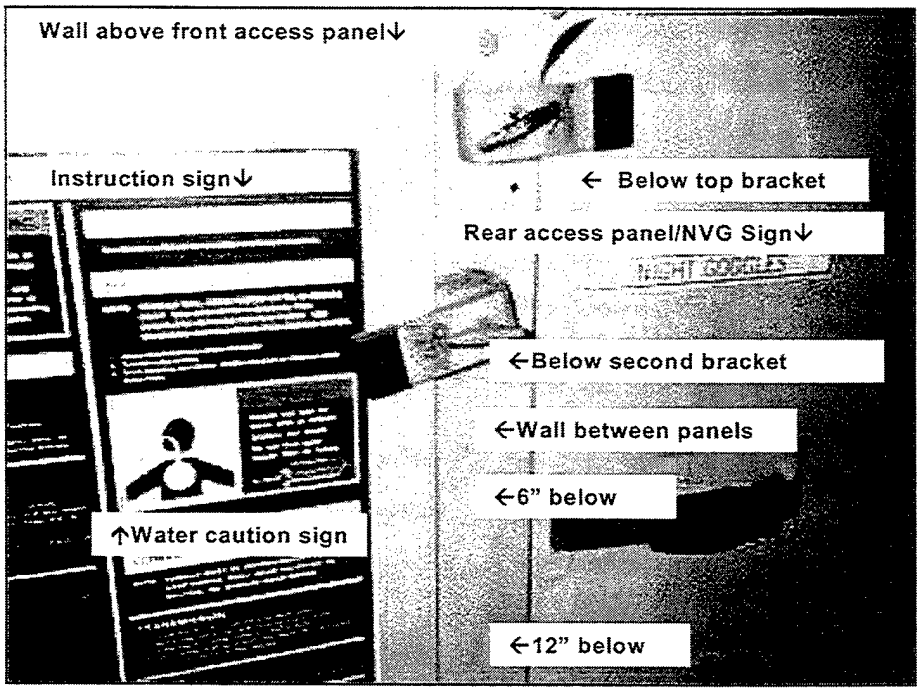
Figure 6. Right side (rear) – rear engine access panel, brackets, wall between access panels
