NRL/MR/6180--03-8668

Requirements for an Aircraft Carrier Flight Deck Fire Fighting Test Facility

February 20, 2003

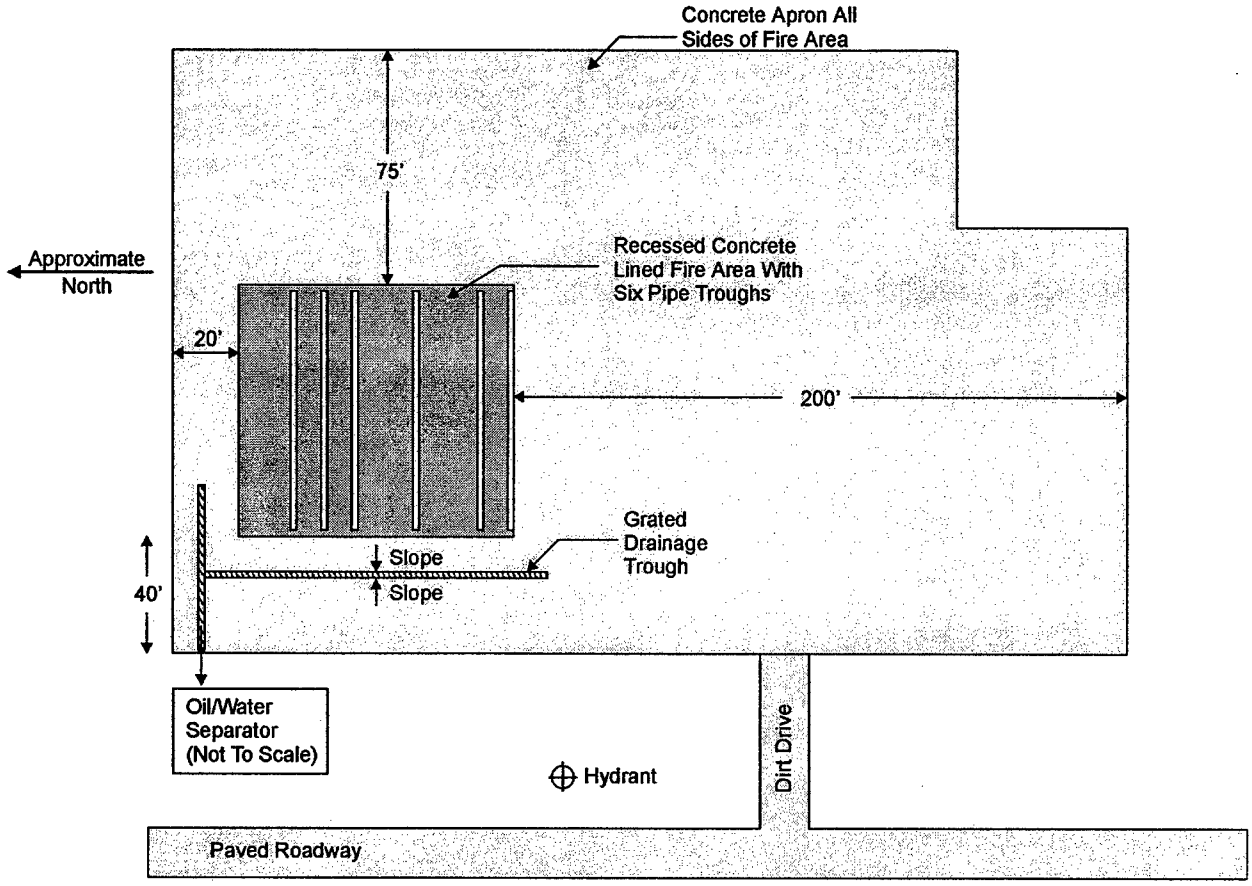
Figure 3 – Current China Lake "Mini Deck"

Figs 3 and 4 show the current configuration of the "mini-deck". The recessed fire area is approximately 90 feet by 82 feet. An extensive concrete apron surrounds the fire area. The apron slopes toward drainage troughs that carry liquid effluent to the oil/water separator. Pipe troughs, which could be used to carry feed pipes for flush deck nozzles, cross the fire area. On the west side of these pipe troughs there are drain lines that allow liquid from the deck to flow into the bottom of the drainage troughs. Fig 5 and 6 show the pipe troughs that cross the fire area. Each of these pipe troughs is covered with removable steel plates. Fig 7 shows the grated drainage trough that feeds the oil/water separator on the west side of the fire area. Fig 8 illustrates how the fire area is recessed from 1-2 inches within the surrounding apron.

- The oil/water separator appears to be functional.
- A piped water source is available at the site (the approximate location of the existing fire hydrant is shown in Fig 3). The available flow capacity and pressure at the hydrant is unknown.

- Confirm the long-term viability of the existing oil/water separator.
- Conduct a flow test of the hydrant to assure adequate flow and pressure.
- Provide a wind generator to simulate normal flight deck winds during launch and recovery.
- Determine the ability of the existing concrete in the fire test area to resist penetration by fuel and AFFF. Make repairs as necessary to assure an impermeable test surface.
- Provide adequate pumping capacity at the site, assuming simultaneous flow from flush deck nozzles, deck edge nozzles, and hoselines.
- Confirm functionality of existing water/AFFF tanks. Repair or replace as necessary.
- Install a flush deck and deck edge nozzle system (flush deck should include nozzles in both the fire area and a simulated "upwind zone").
- Install simulated carrier flight deck hose stations (reels and racks).

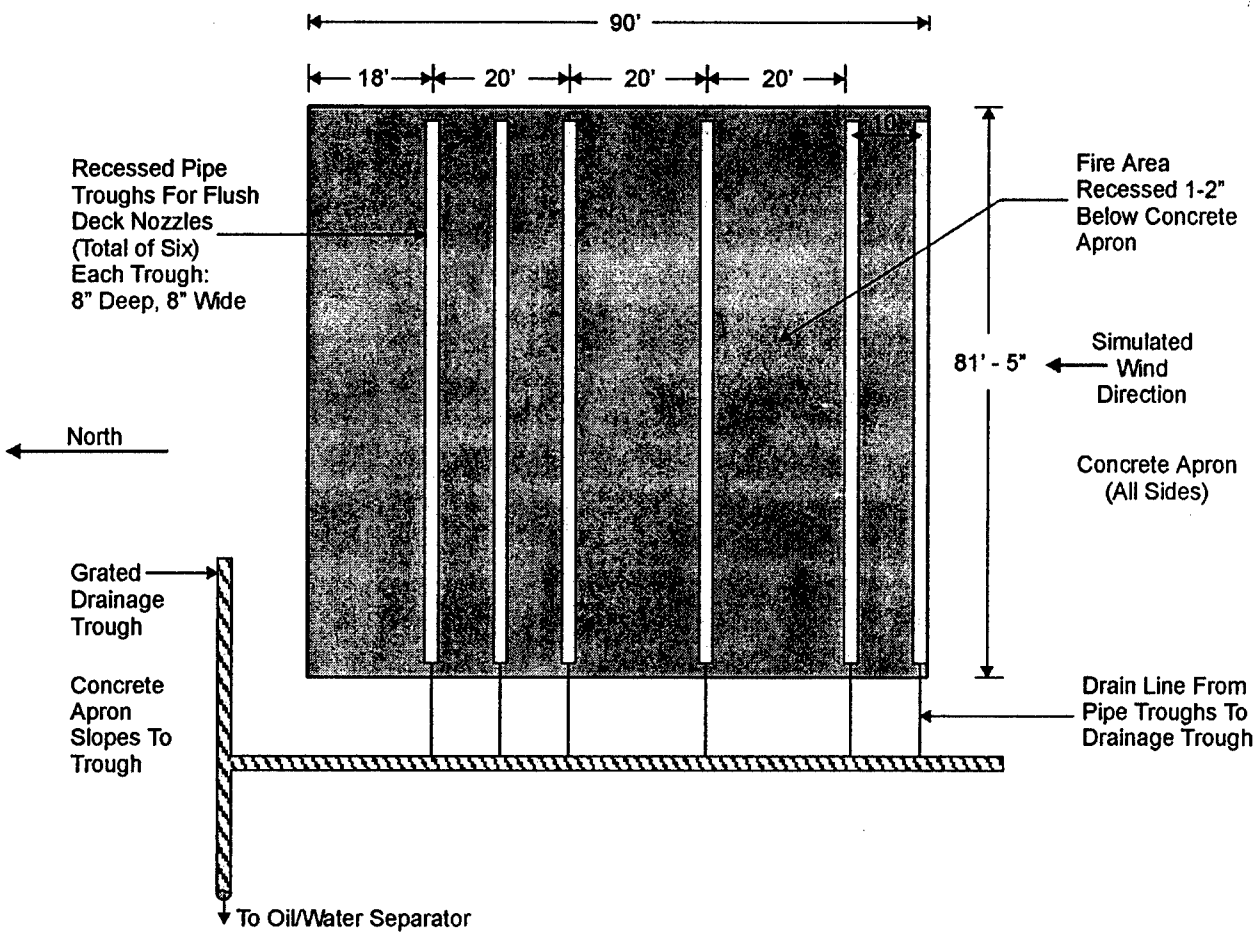
Figure 4 – Recessed fire area

- There is no wind generating capability.
- The entire fire area, and surrounding apron, is constructed of concrete, but the tightness of the concrete surfaces has not been confirmed. The ability of the concrete to prevent seepage of fuel and AFFF into the ground below is the biggest unknown relative to environmental suitability.

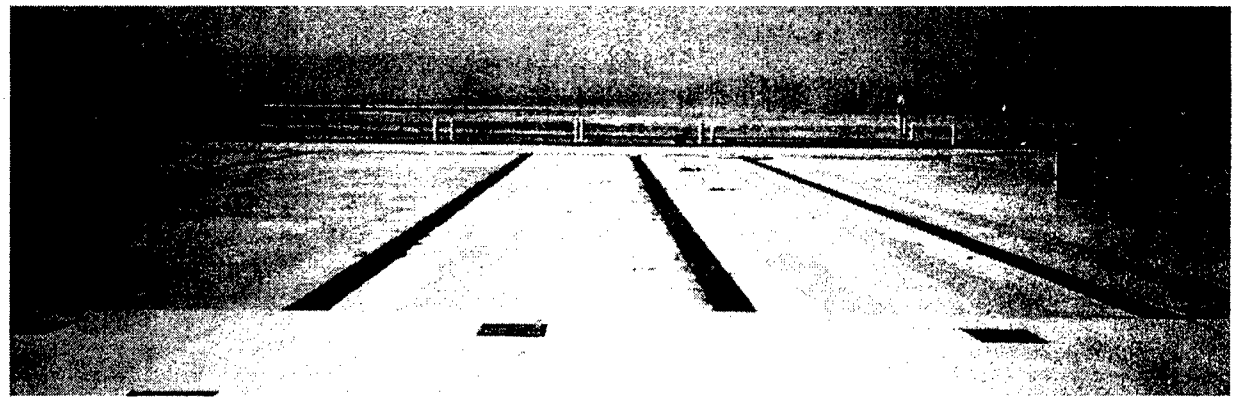
Figure 5 – Photo showing pipe troughs (looking from east side of deck)

- Pipe troughs, that originally carried the distribution piping that fed the flush deck nozzles, are empty. Additionally, there are no deck edge nozzles or hose reels, though

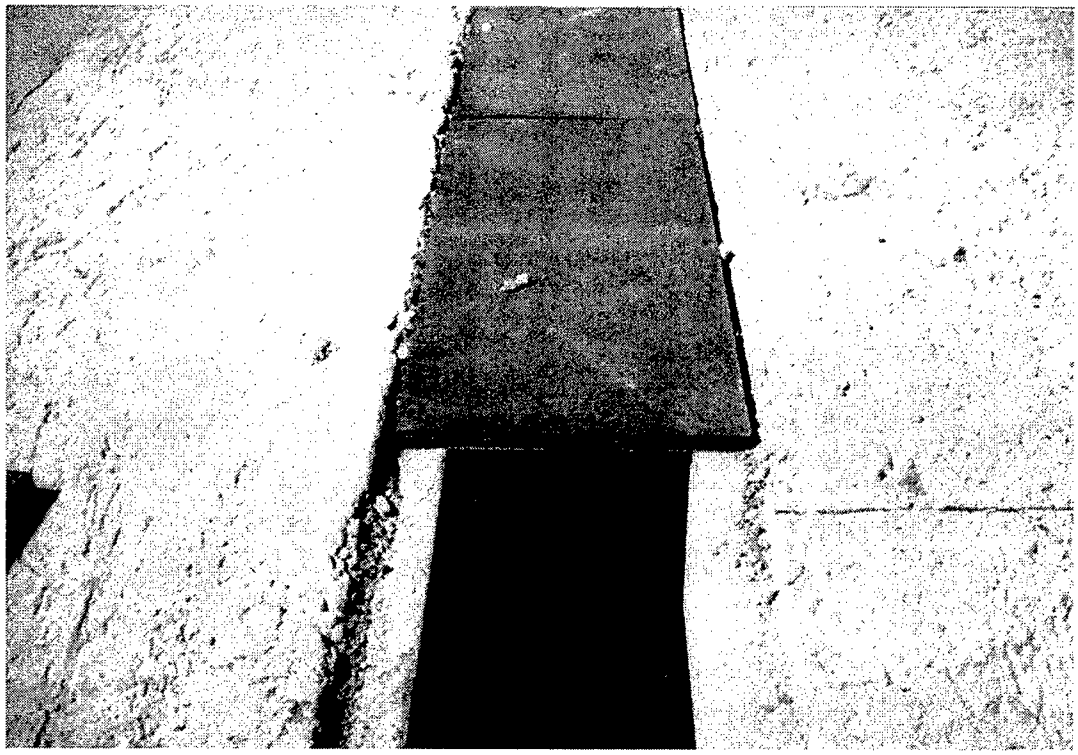
Figure 9 – Close up photo of pipe trough

these could be easily installed and fed by surface piping or supply hoses. Fig 9 is a close up view of an existing pipe trough (each trough is approximately 8 inches in width and 8 inches deep). Fig 10 is a sketch showing how flush deck and deck edge nozzles could be fed by surface supply mains running along the east and west sides respectively. These supply mains could be fed by either surface piping or fire hoses run from a stationary pump or pumper truck.
