Technical Report SL-97-9
September 1997

Durability of Posttensioned Concrete After 33 Years of Marine Exposure

by Morris Schupack, Schupack Suarez Engineers, Inc.
Edward F. O'Neil, WES

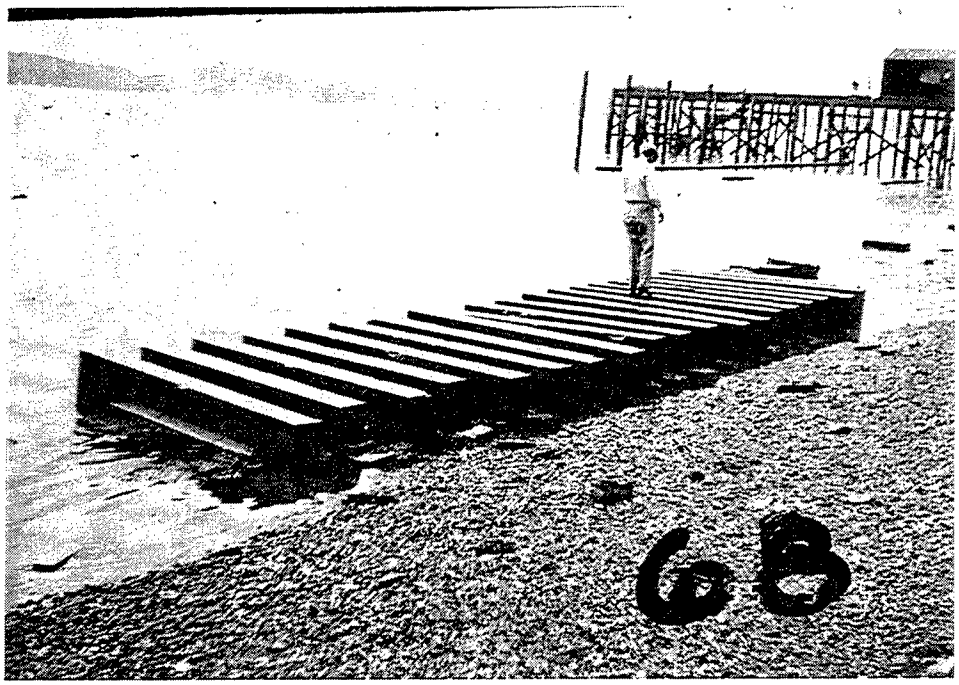
Fig. 1A

1968 - Twenty post tensioned beams partially submerged.

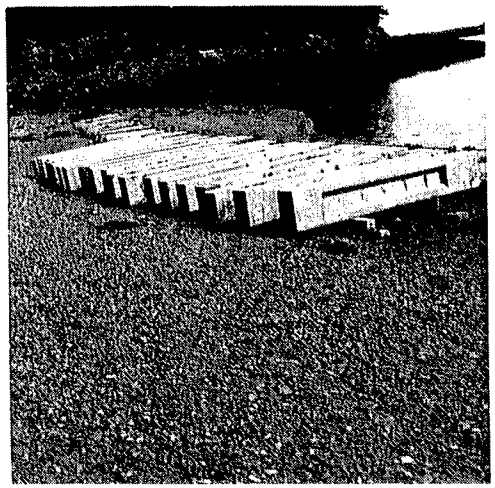
Fig. 2A

1962 - 20 Beams placed in 1961

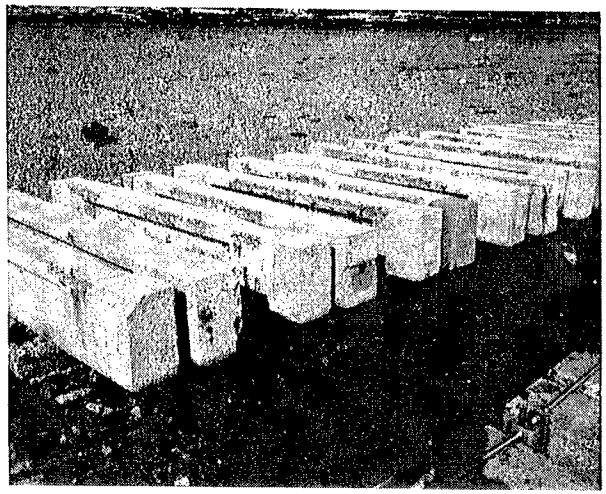
Fig. 2B

1972 - 20 beams

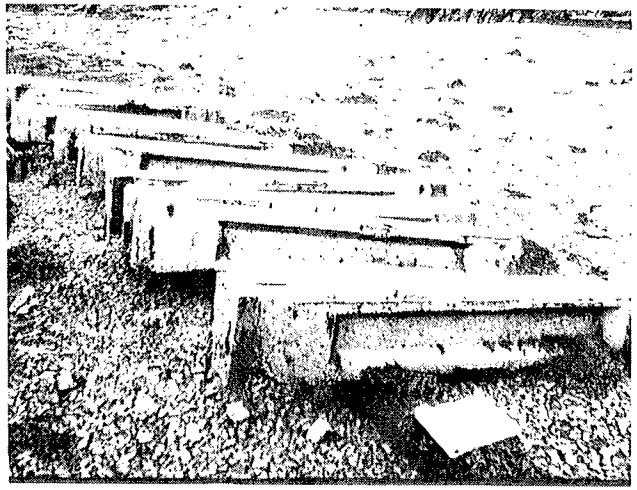
Fig. 2C

1982 - 12 beams remaining - 8 removed for autopsy at WES in 1973 and 1974

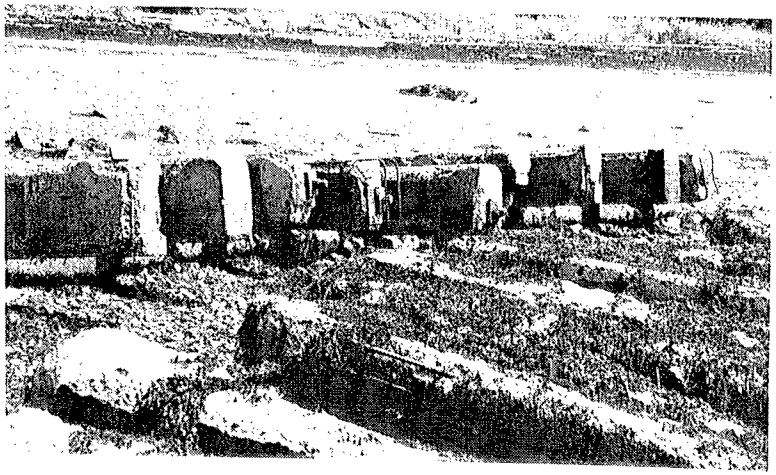
Fig. 2E

The post-tensioning beams in the severe Treat Island environment did not suffer overall structural failures. The degradation that occurred only nominally affected the load carrying capacity. Figure 2 shows the beams at low tide on their supports in 1962, 1972, 1982, 1990, and 1994. The eight beams autopsied in 1973 and the three in 1984 did not reveal any flexural cracking or a decrease in expected structural capacity when tested to failure. The remaining nine beams in 1994 did not show any indication of tendon failure or flexural cracking. No evidence of tendon failure occurred even though end-anchorage protection failures occurred as early as 1963. The 1973-74 autopsy of eight beams and the 1984 autopsy of three beams did not reveal any tendon failures.

1994 - 9 post-tensioned beams at Treat Island

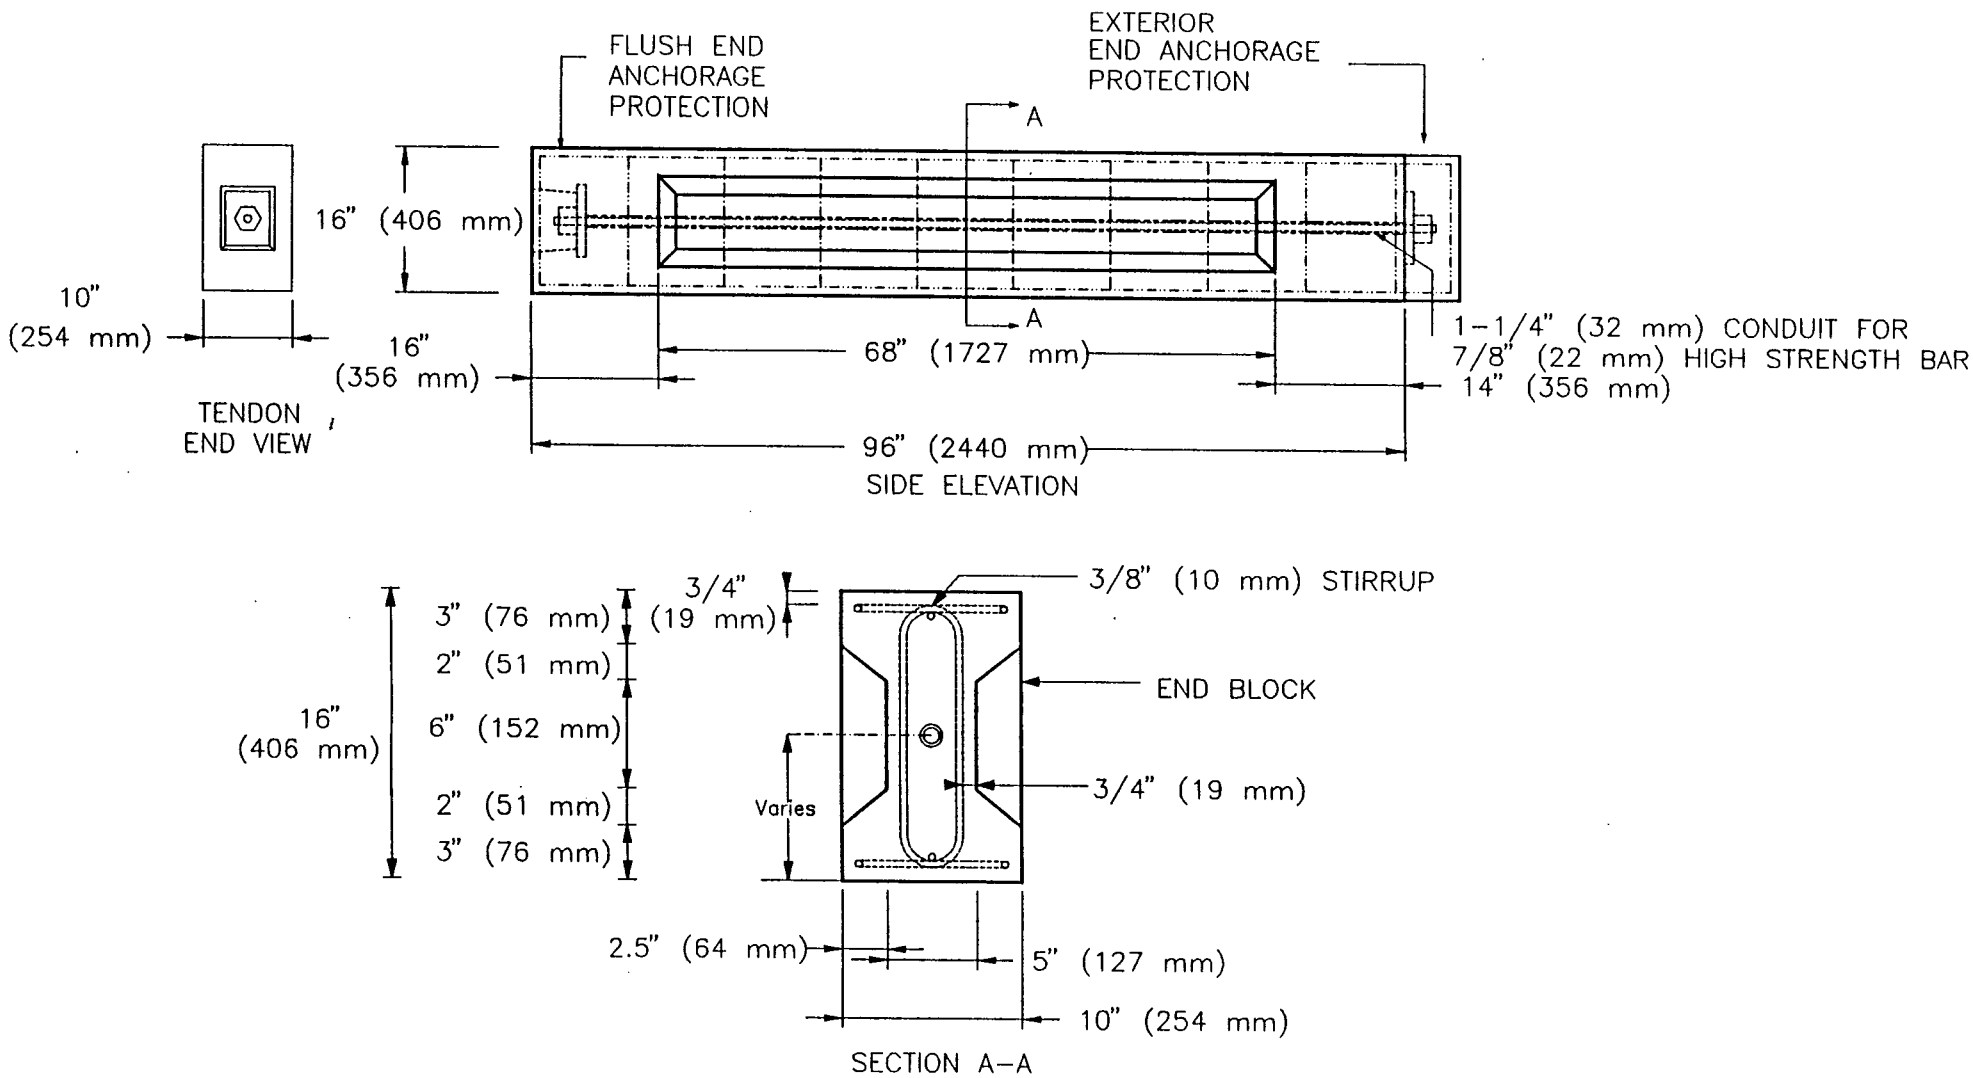
TEST BEAM DETAILS
FIG. 3

Because of the small size of the "I" beam section and to control cracking, reinforcing was placed with a concrete cover in the flanges and webs of 3/4 in. (19 mm). This became an interesting resource to determine the effectiveness of such small cover in this hostile environment.

All beams contained normal reinforcing steel which was provided with a nominal 3/4-in. (19-mm) concrete cover. The details of reinforcement are shown in Fig. 3 and Table 4 of Appendix A. Figure 9-2G shows a typical reinforcing cage removed from an autopsied beam.

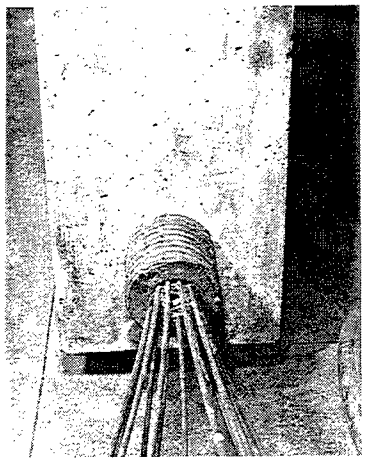
Fig. 4A

Exterior
No reinforcement
No surface prep.
(Freyssinet tendon
prior to cutting wire)

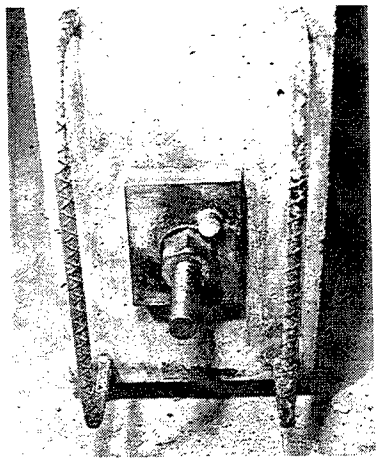
Fig. 4B

Exterior
With reinforcement
No surface prep.
(High strength bar)

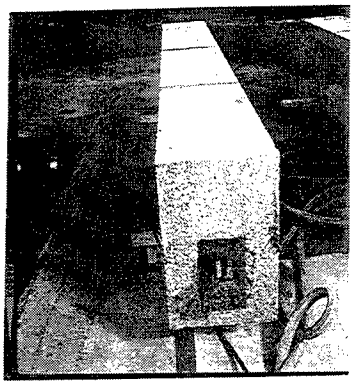
Fig. 4C

Exterior
No reinforcement
Bush hammered
(Prescon tendon)

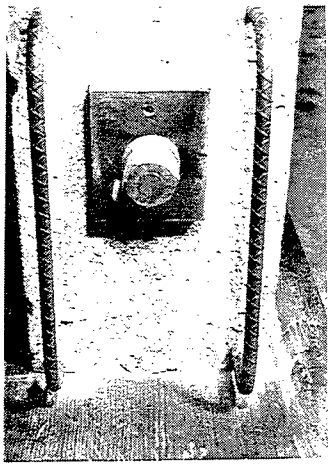
Fig. 4D

Exterior
With reinforcement
Sandblast prep.
(High strength bar)

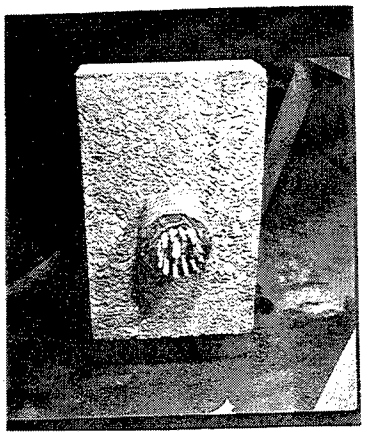
Fig. 4E

Exterior
No reinforcement
Bush hammered prep.
(Freyssinet tendon)

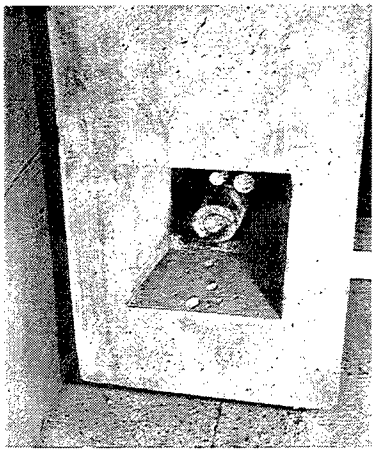
Fig. 4F

- Flush - anchorage recessed into a pocket within the end of the beam, which is filled with protective material after post-tensioning (Fig. 4F).

Flush
No surface prep.
(High strength bar)

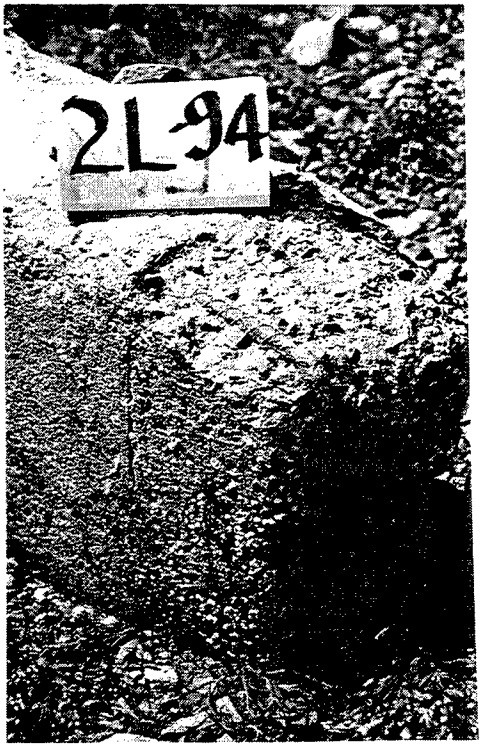
Fig. 5-3K

1. Surface preparation - bush hammer, 4 ends (Fig. 5-3K).

Beam 2 - Landward end - 1994

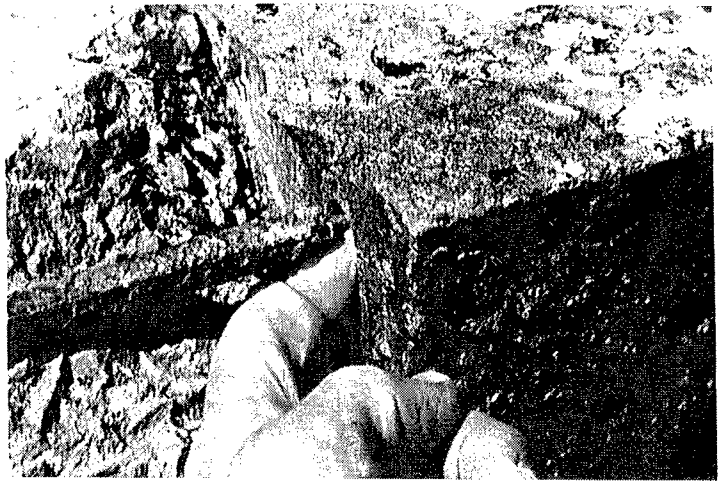
The only complete wasting of reinforcing steel that has occurred are those that were contiguous to and in epoxy-resin concrete. Figure 7G through 7L and 8B through 8G shows similar performance. The rebars penetrating the epoxy were destroyed to an unknown depth into the end cap and the bar adjacent to the epoxy-resin concrete interface also was completely corroded and had spalled the concrete off. The reason for this type of complete dissolution of the reinforcing steel is not fully understood. A possible explanation for this is the far superior electrical isolation of the epoxy concrete compared to the portland-cement concrete and the consequent large cathode-small anode corrosion cell. It is also possible that once the interface between the epoxy resin and the concrete suffered concrete deterioration, the reinforcing steel progressively corroded inward toward the body of the epoxy resin. A further study of some of the remaining beams may reveal the reasons for this more aggressive corrosion and the progression of the rebar corrosion into the epoxy-resin concrete.

Beam 12- Landward end - 1980
Rebar corrosion into epoxy end protection
Fig. 7-2G

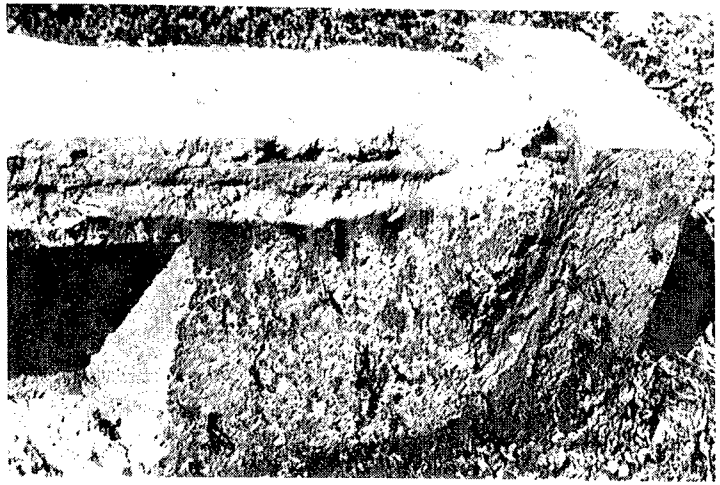
Beam 12 - Landward end - 1980
Edge spalling and rebar corrosion
Fig. 7-2H

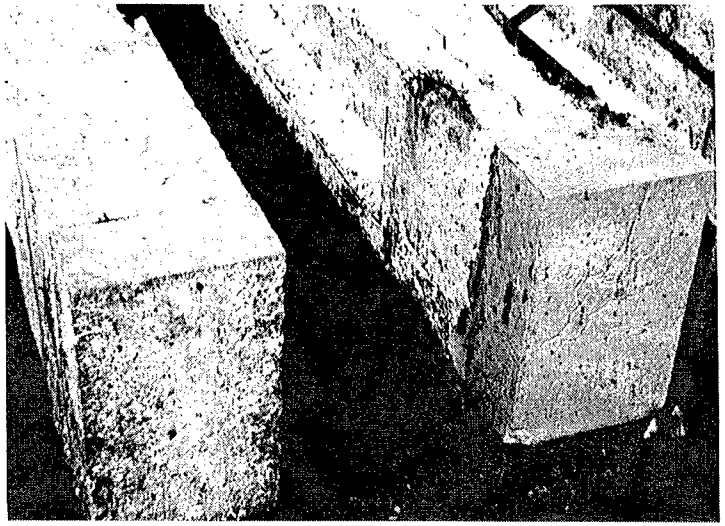
Beam 16 - Seaward end - 1972
Rebar corrosion
Fig. 8-1A

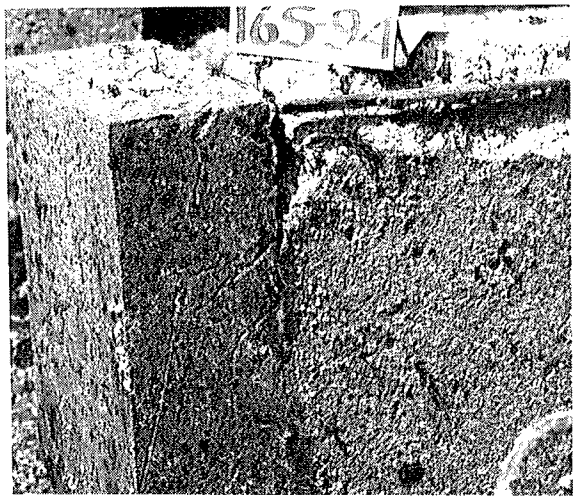
Beam 16 - Seaward end - 1994
Interface failure
Fig. 8-1D

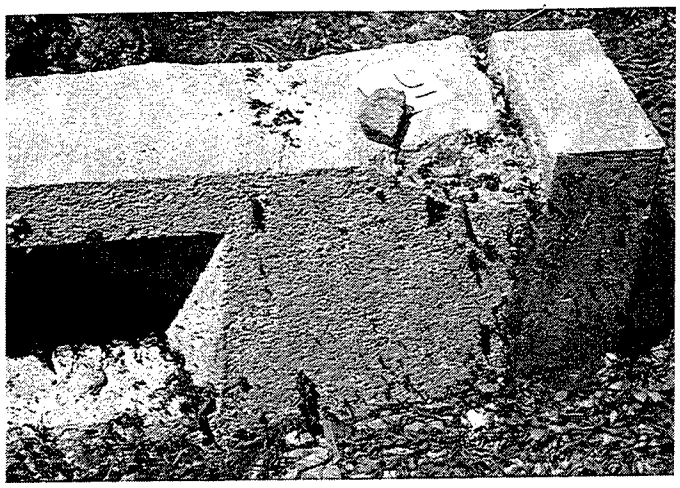
Fig. 8-2F

Although the epoxy-resin itself behaved very well for 33 years, the interaction between the epoxy-resin and the concrete manifested deterioration of the concrete interface and corrosion of the reinforcing steel that extended from the portland-cement concrete into the epoxy-resin concrete (Fig. 8-1, 8-2, and 8-3I). The concrete deterioration first appeared in 1972 in beam ends 16L and 20S. (Table 2-3). Prior to 1972 it appeared that the epoxy-resin concrete was a superior detail. The concrete deterioration was probably affected by the following conditions:

Beam 16 - Landward end - 1988

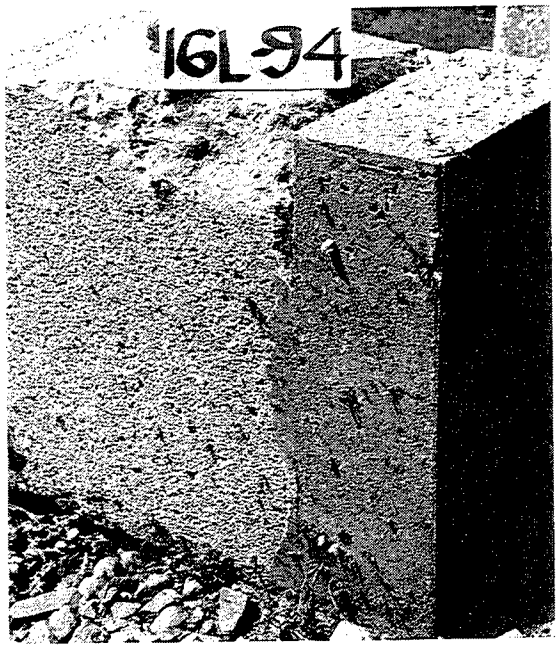
Fig. 8-2G

A. No reinforcement through cold joint (Fig. 8-2G).

Beam 16 - Landward end - 1994

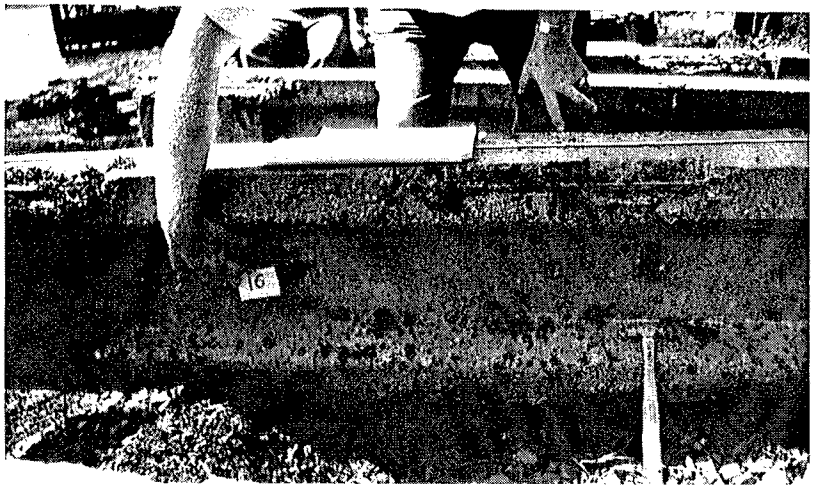
Beam 16 - 1984
First indication of stirrup corrosion
Fig. 8-3I

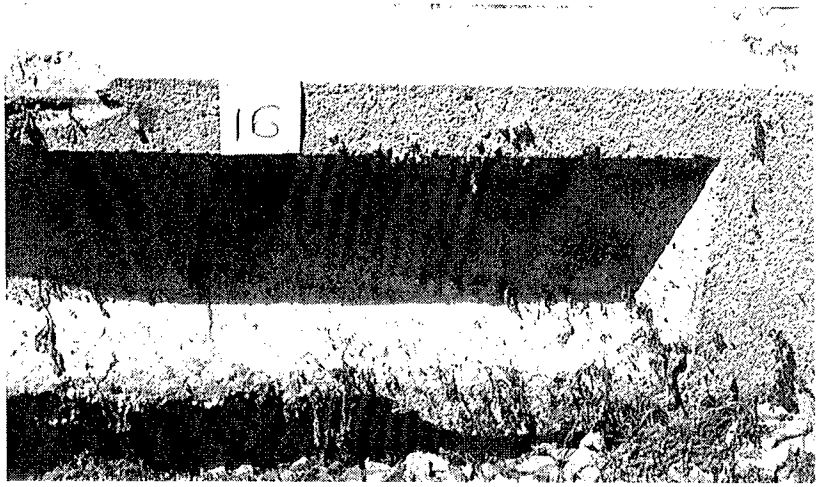
Beam 16 - 1988
Stirrup corrosion has not progressed
Fig. 8-3J

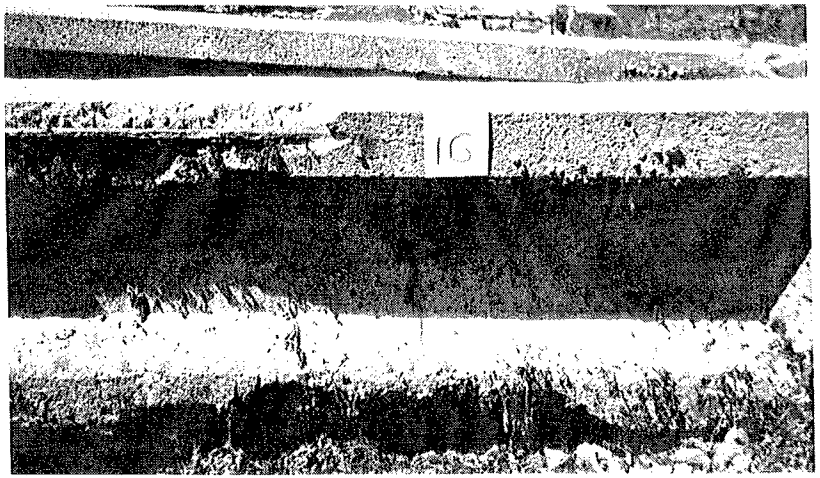
Beam 16 - 1990
Stirrup corrosion
Fig. 8-3K

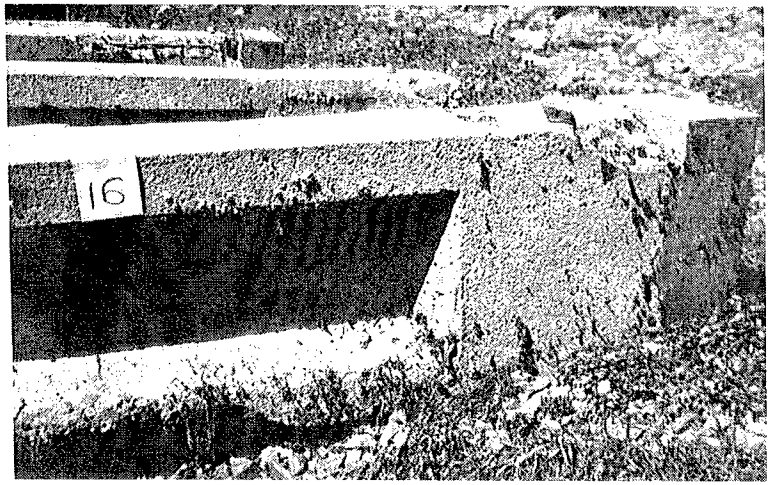
Beam 16 - 1994
Stirrup corrosion
Fig. 8-3L

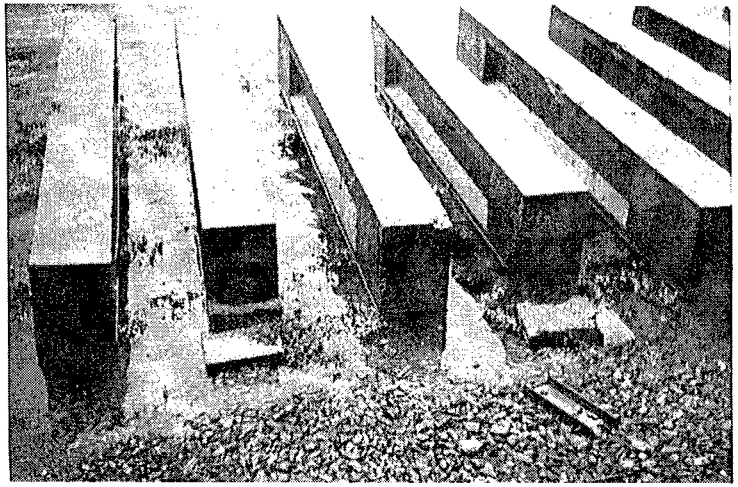
Beam 17 - Landward end - 1972
End protection failed
Fig. 9-1A

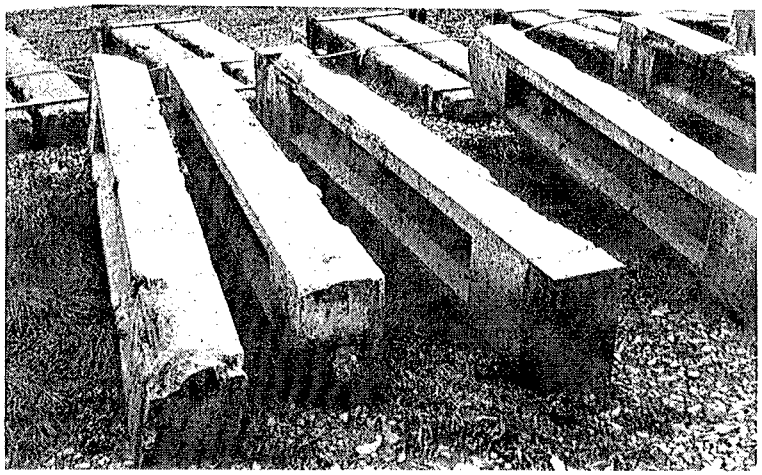
Beam 17 - Landward end - 1976
Edge spall
Fig. 9-1B

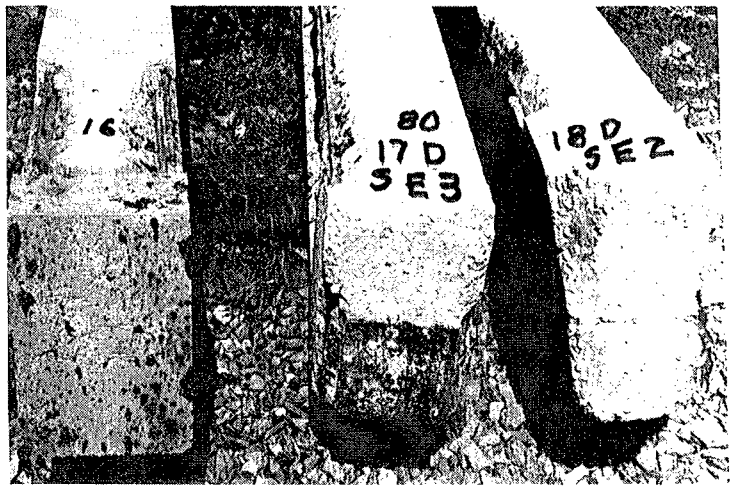
Beam 17 - Seaward end - 1980
Failed 1963
Fig. 9-1C

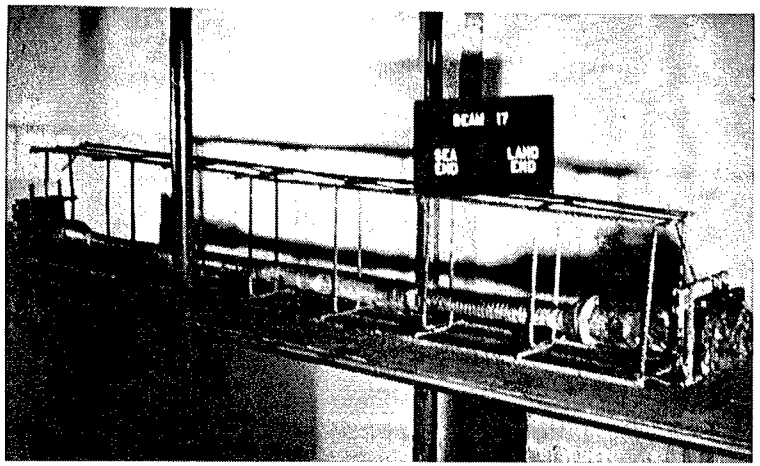
Fig. 9-2G

Beam 17 - Reinforcement cage - 1984

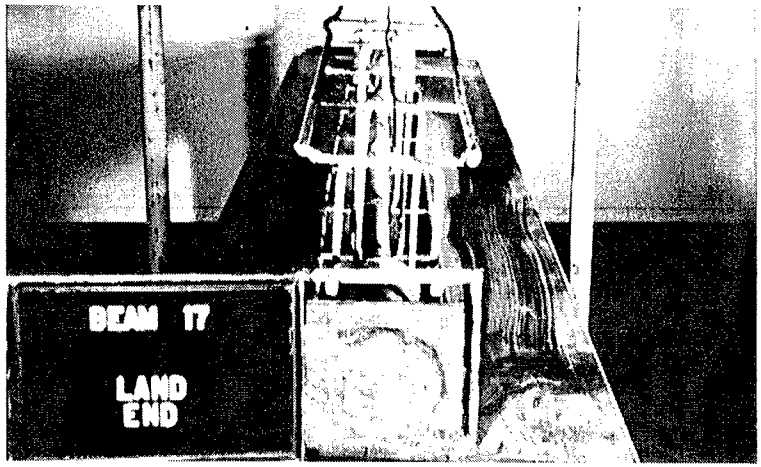
Fig. 9-2H

Beam 17 - Landward end reinforcement, anchorage - 1984

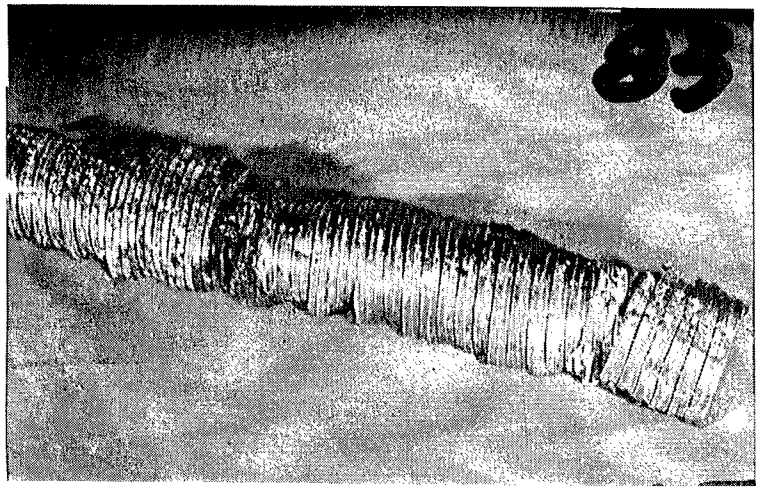
Beam 17 - Outside - 1984
Post-tensioning conduit corrosion
Fig. 9-3I

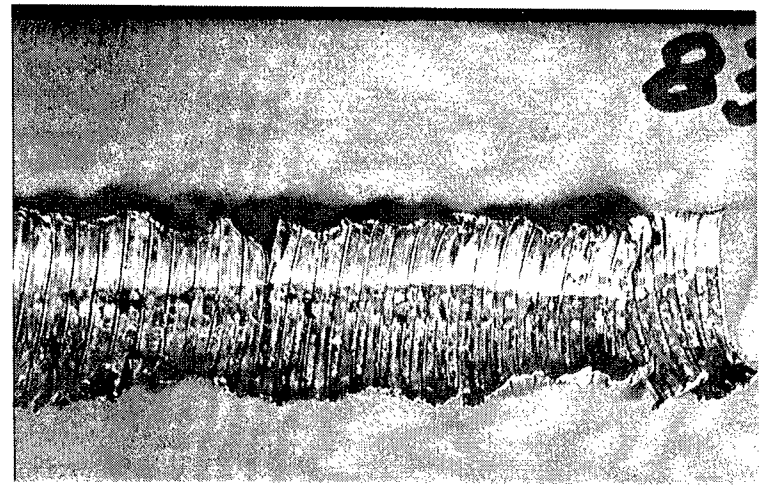
Beam 17 - Inside - 1984
Post-tensioning conduit corrosion
Fig. 9-3J

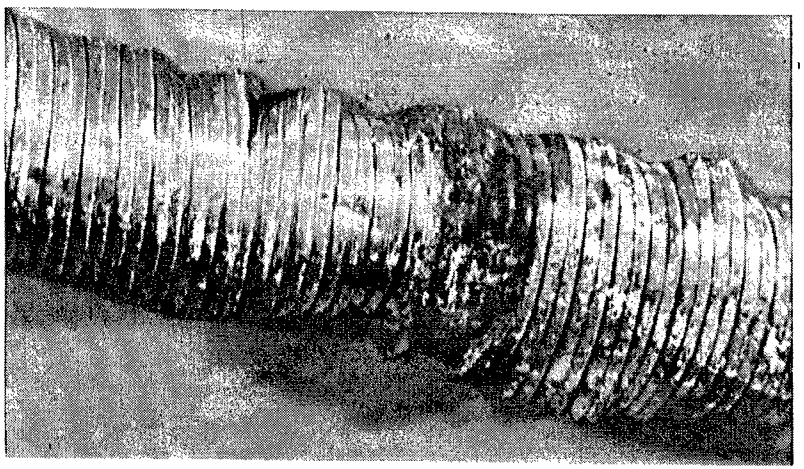
Fig. 9-3K

Beam 17 - Post-tensioning conduit corrosion - 1984

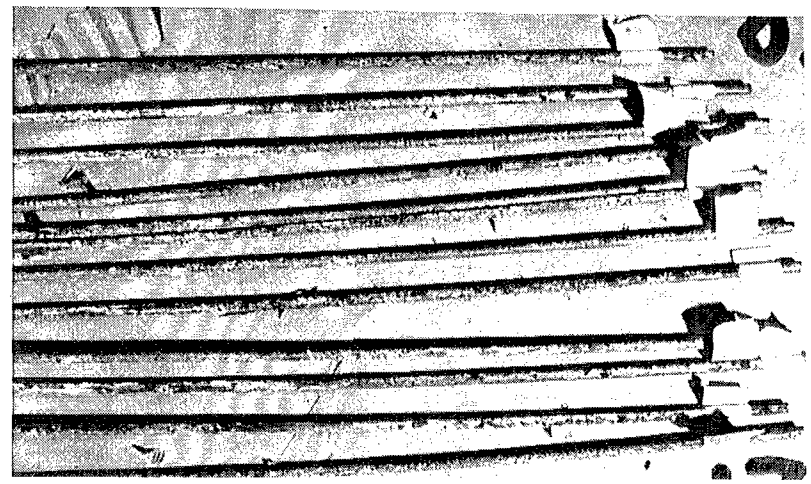
Fig. 9-3L

Of the eleven beams autopsied in 1973, 1974, and 1983, no significant corrosion of the prestressing steel between the anchors was found except for the unbonded wire tendon which showed a small decrease in ultimate strength as well as its ductility. The WES Autopsy Reports[2,4] describe in detail the condition of the tendons. They utilized relative terms to describe the intensity of the corrosion observed. The terms heavy, moderate, and

Beam 17 - Prestressing wire corrosion - 1984

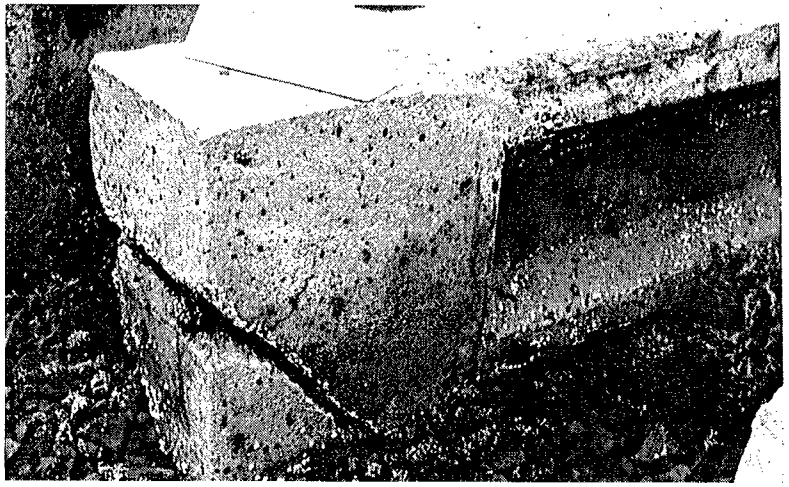
a) One failed in 1972, autopsied in 1983 (Fig. 10-1A).

Beam 4 - Seaward end - 1982
Failed flush epoxy anchorage protection
Fig. 10-1A

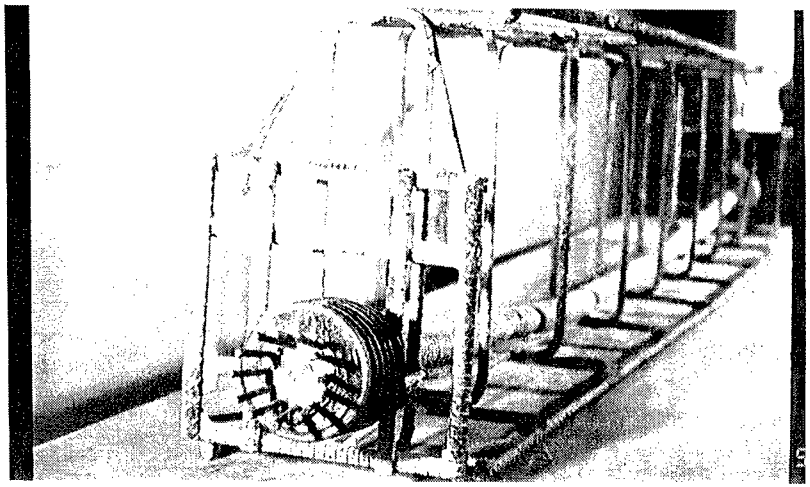
Beam 4, land end, had an epoxy-resin concrete exterior protection. It was in good condition in 1983 when it was autopsied. Figure 10-1B shows the Freyssinet anchorage after removal of the epoxy-resin concrete.

Beam 10 - Autopsy - 1983
Anchor and reinforcement cage
Fig. 10-1B

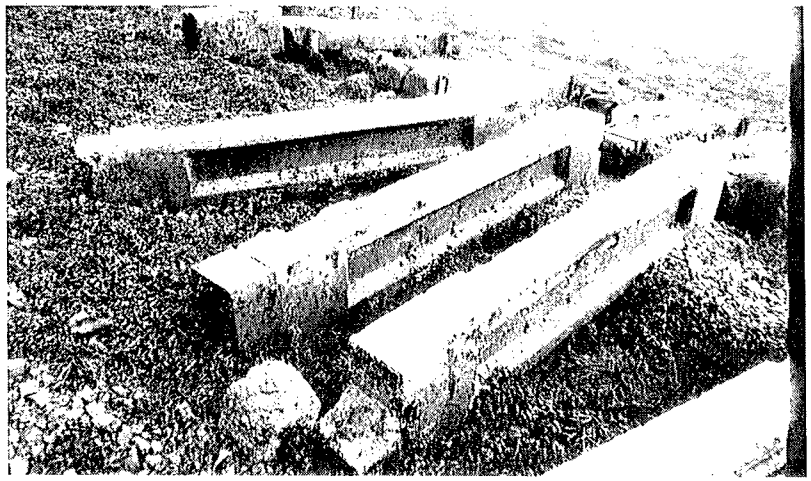
Fig. 10-1D

Beam 4 - Landward end - 1982

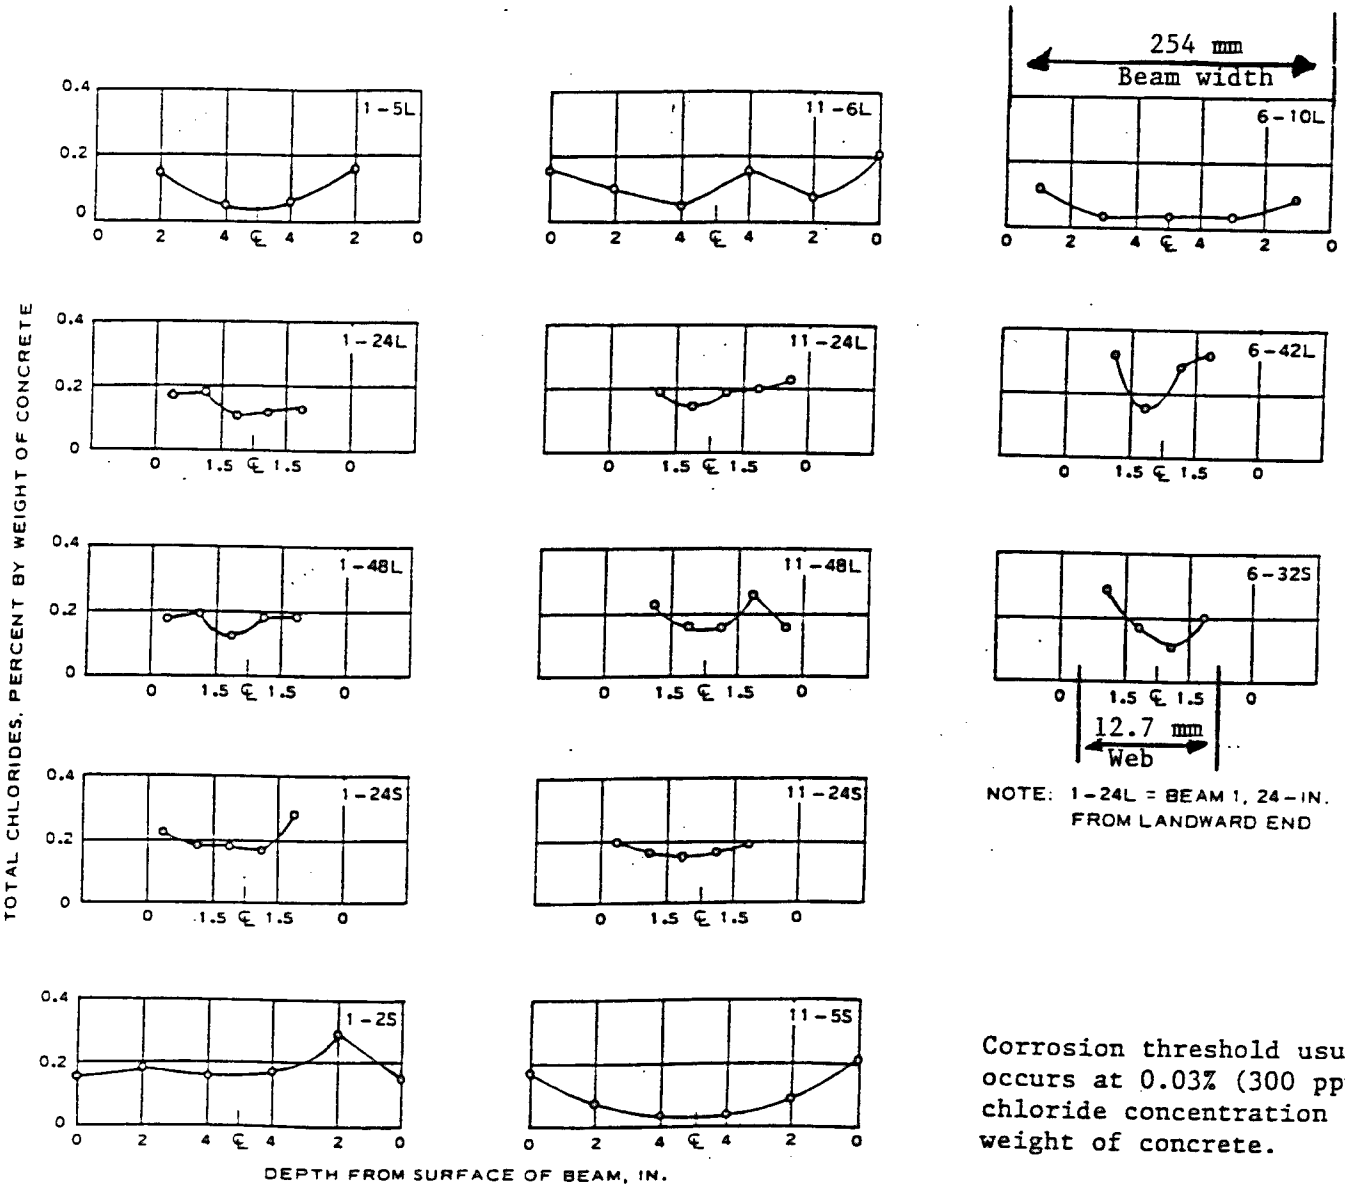
Fig. 11 - Total Chloride Content vs Depth from Vertical Beam Surface

In the 1973-74 autopsies as reported in the WES Report[2], the chloride gradient through the webs indicated sufficient chlorides to expect that all reinforcement would have been seriously corroded. Figure 11, was extracted from the WES Report and modified to show the chloride threshold at which there is a 90% chance that corrosion will occur. It is surprising that with this amount of chloride contamination found after twelve years, that the remaining nine 33 year old beams show very limited evidence of web stirrup corrosion.

Corrosion threshold usually occurs at 0.03% (300 ppm) chloride concentration by weight of concrete.

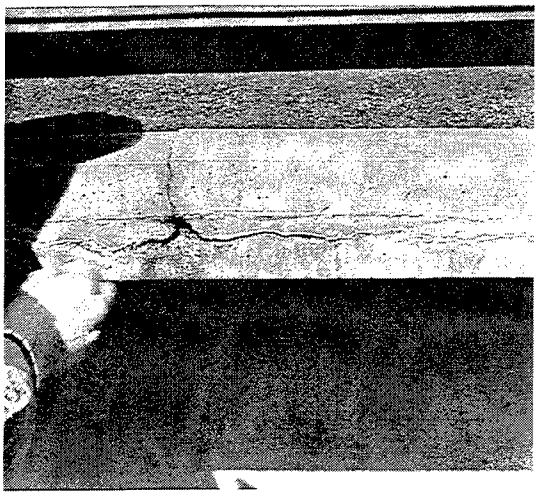
Fig. 12-B Concrete railroad platform with epoxy mortar curb showing concrete deterioration.

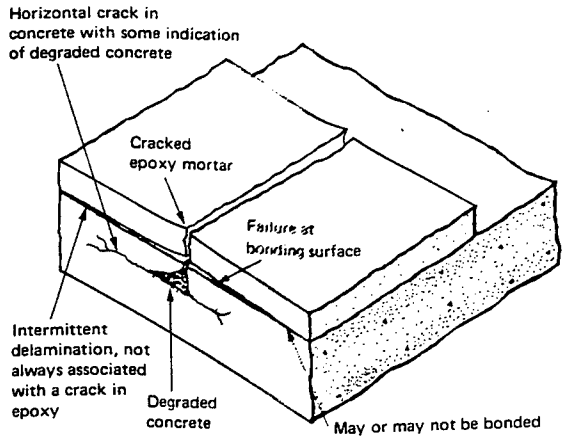
Fig. 12-A

Condition of the same concrete and epoxy mortar after several years **(Ref. 10)**

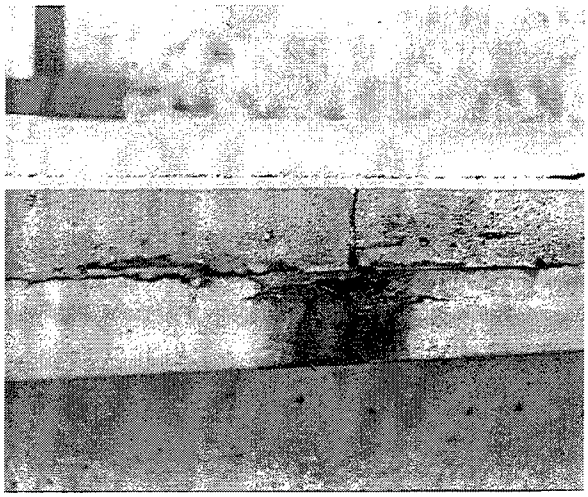
Fig. 12-C Concrete railroad platform with epoxy mortar curb showing concrete deterioration.
