Australian Government
Department of Defence
Defence Science and
Technology Organisation

Assessment of filament-wound glass-reinforced plastic (GRP) pipe technology for RAN surface ship application

DSTO-GD-0375

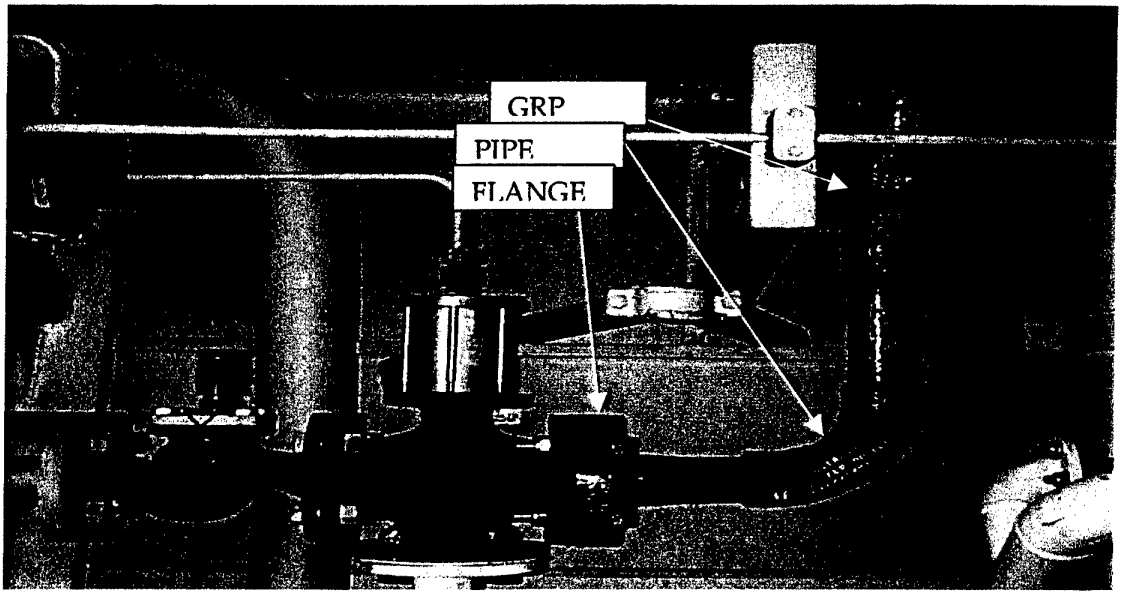
All existing pipe brackets and mountings were used with the exception of one bracket on the vertical leg after the 3-way valve [Figure 2]. This bracket was not used due to the radius limitations on the GRP pipe. The task of installation was completed with minimal difficulty using no special tooling other than the trade specific tools.

Figure 2: GRP piping for Oily Bilge piping system in HMAS Anzac

The spools selected were part of the Bilge De-Oiler overboard discharge line. The selected spools, 90 elbows and tees of DN 40 were replaced by 40 NB, 5.5 mm thick Bondstrand Series 7000M® anti-static conductive GRE (E stands for epoxy) pipes, see Figure 2. Pipe connections to bend and tees were carried out using the Quick-Lock® adhesive joining technique [6]

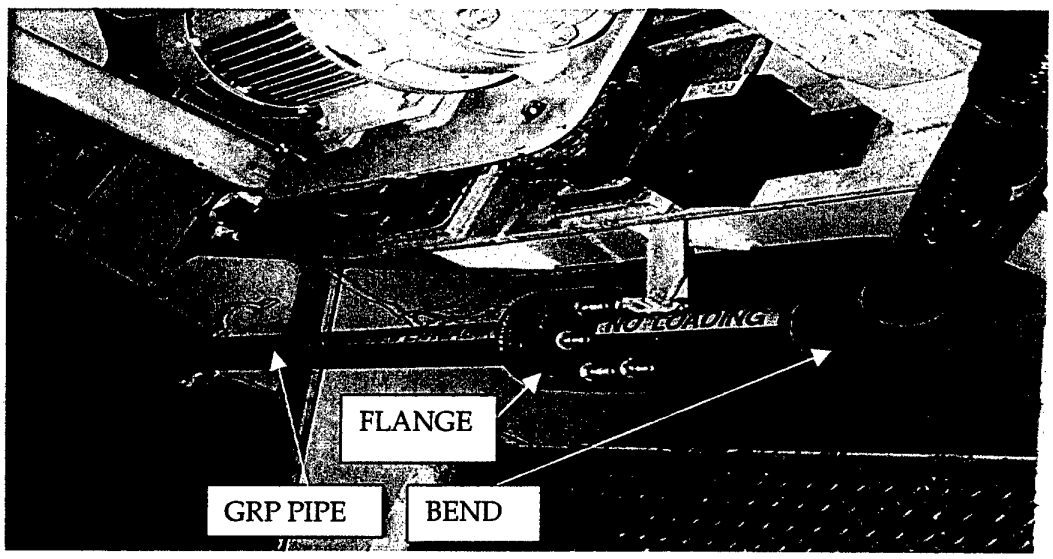
Figure 3: GRP piping for Provisional Seawater Cooling on HMAS Anzac.

All existing pipe supports and brackets were utilised however, longer bolts were required due to the larger outside diameter of the GRP pipes. Installed pipework was marked 'GRP Pipe Trial' and 'No Loading' due to its elevation and its proximity to a walkway.

The ship staff tagged the system, prior to the removal of the metallic pipework. The whole of the suction line, made up of two spools, 32 DN CuNi, from seawater strainer to the isolating valves just before the seawater cooling pumps was replaced with 40 NB Bondstrand Series 2000M® GRE pipes, see Figure 3. Deck plates were removed to gain access to the system. Metallic couplings comprising Pyplok Crimp with tail connections, were supplied to the subcontractor. The Pyplok Crimp part of the coupling connects to existing valves. The tail connection of the coupling was inserted into a 25 NB GRE pipe and joined adhesively using the same resin as that used to bond the GRE together. This method has proved very successful in the past. A piece of 50 mm wide skrim tape of woven fibreglass was wrapped around the base of the coupling and the top of the GRE pipe in a spiral, utilising a 50% overlap. The tape was impregnated with resin during the process. This gives added strength to the joint between the GRE and the tail connection of the coupling. The Quick Lock Adhesive joining technique was used for all other connections involving GRE pipe to GRE elbows, tees and reducers.

The greater part of this system was pre-fabricated at the subcontractor's workshop from measurements taken from the removed original pipework. The fabricated GRP pipework was site measured, cut and glued then removed to the workshop for heat curing of joints and pressure testing prior to final installation.
