# Operation UPSHOT-KNOTHOLE

EFFECTS OF AN ATOMIC EXPLOSION ON TWO TYPICAL  
TWO-STORY-AND-BASEMENT WOOD-FRAME HOUSES

FEDERAL CIVIL DEFENSE ADMINISTRATION  
WASHINGTON D.C.

Federal Civil Defense Administration  
Washington, D. C.  
September 1953

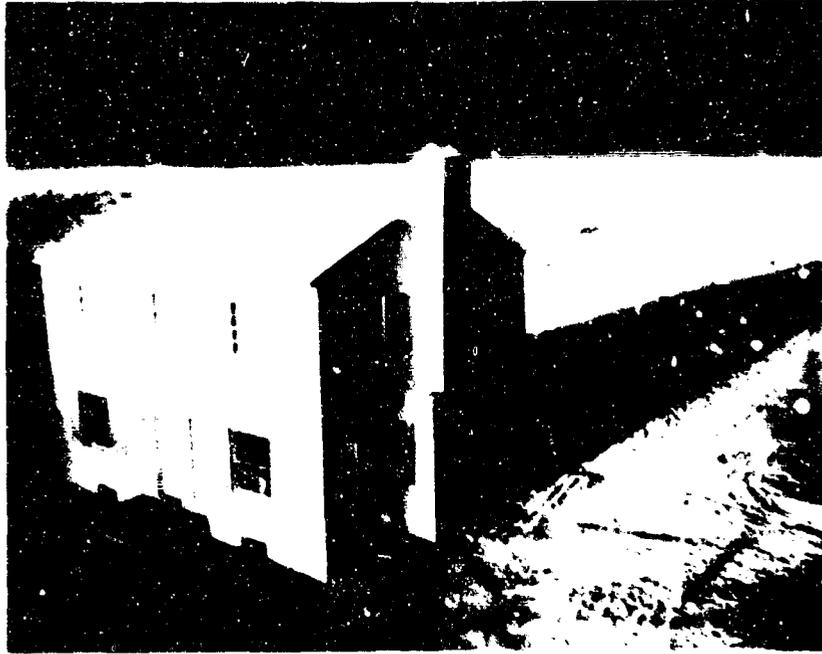
**Fig. 1.1**—House at 3500 ft, zero time, instant of detonation. The blinding light from the detonation throws the house, the desert, and the surrounding hills into sharp relief.

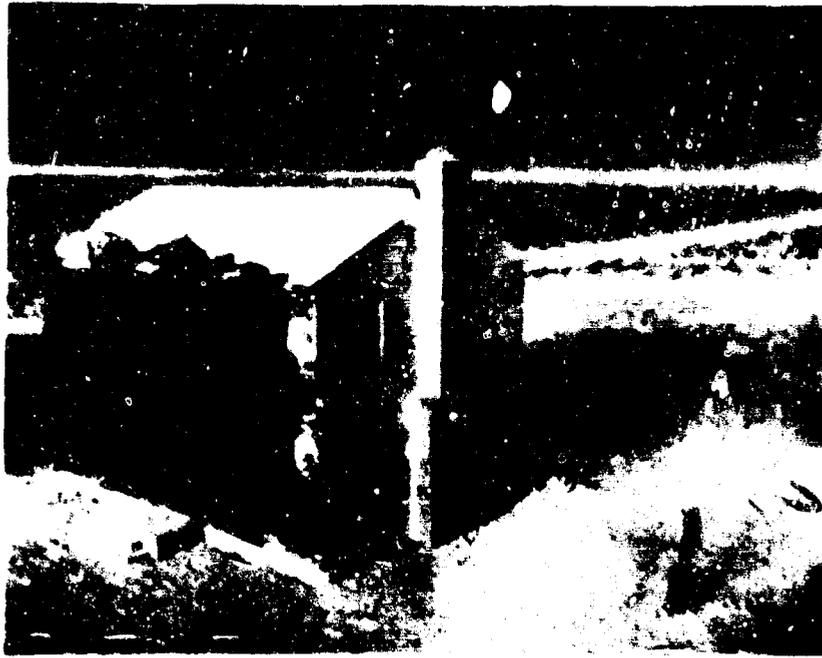
Fig. 1.3—House at 3500 ft,  $\frac{18}{24}$  sec after detonation. The front of the house is almost obscured by smoke.

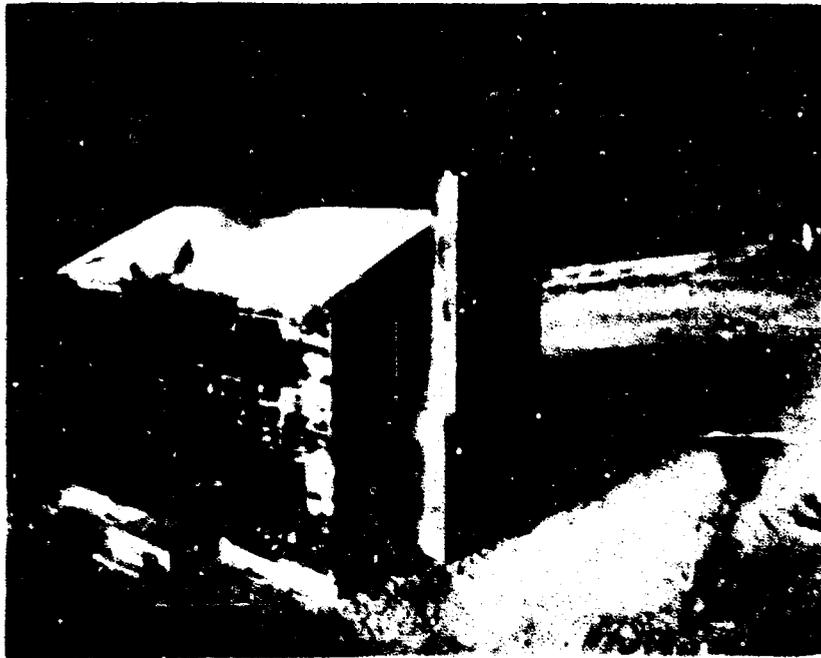
Fig. 1.4—House at 3500 ft,  $\frac{18}{24}$  sec after detonation. The smoke is virtually gone.

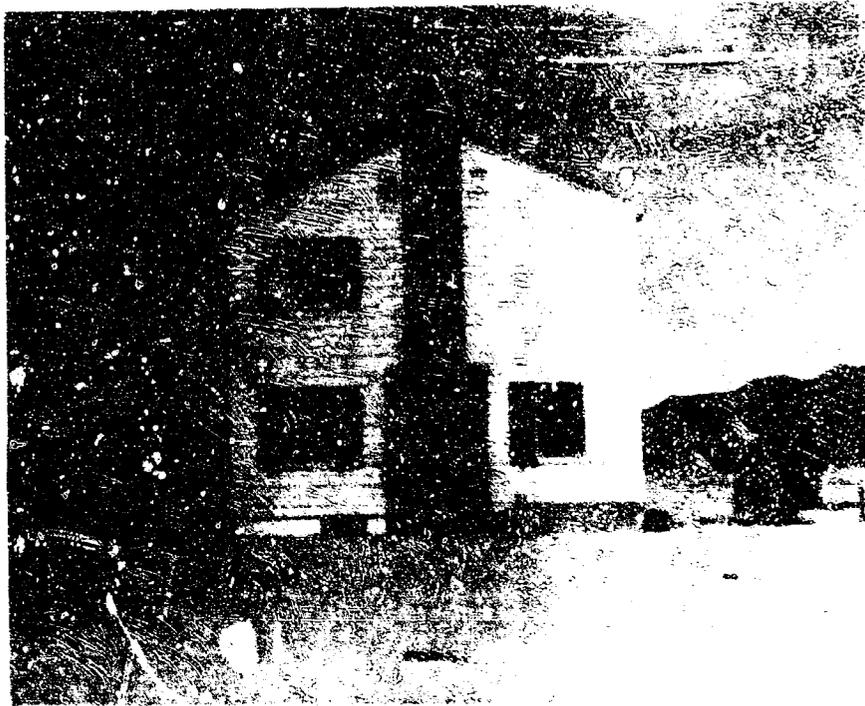
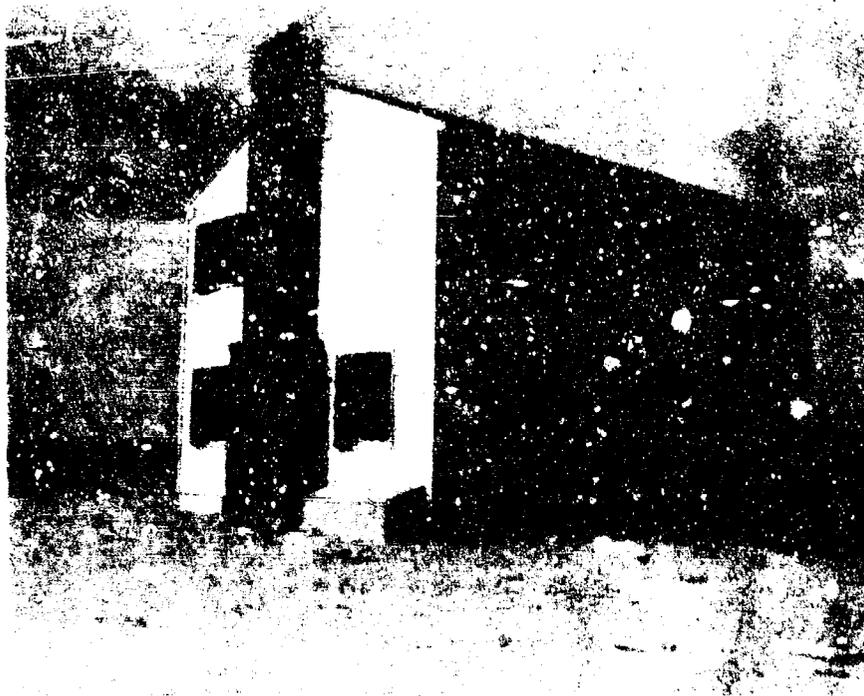
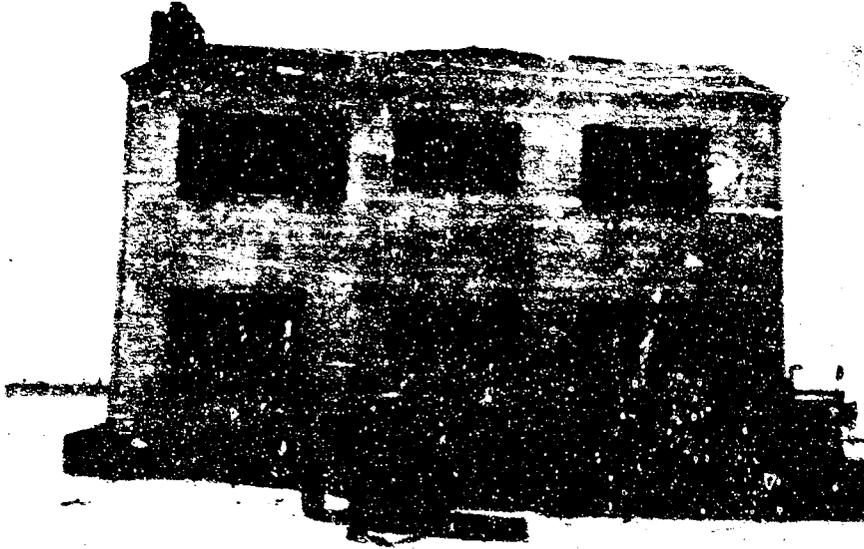
Figures 2.1 and 2.2 show the far-range house before and after the blast. Figures 2.3 to 2.6 show blast damage from the outside on sides and rear of the house. Doors, windows, and window frames in general either were blasted out of the walls or remained in place in badly damaged condition. The glass in the windows was shattered into small particles and scattered uniformly about the interior of the house. The exceptions to the general rule were four windows in the rear of the house, which had been sheltered by partitions from the blast that entered through the front and side openings, and the basement windows in the rear of the house, which were blown open inward.

Fig. 2.3—House at 7500 ft after the blast.

Fig. 2.4—House at 7500 ft after the blast.

Fig. 2.5—House at 7500 ft after the blast.

Fig. 2.6—House at 7500 ft after the blast.

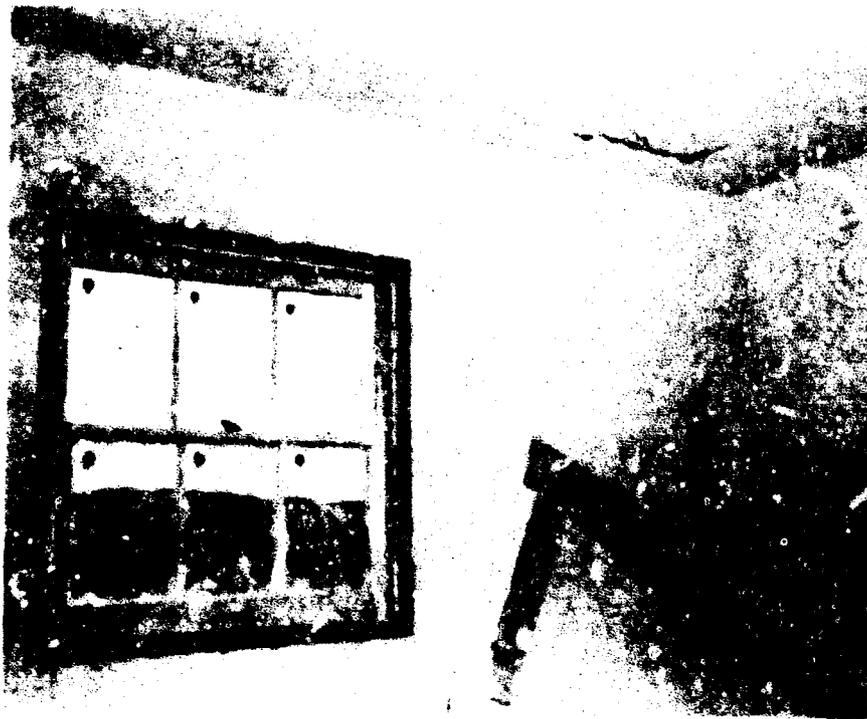
Fig. 2.25—Kitchen wall and ceiling after the blast.

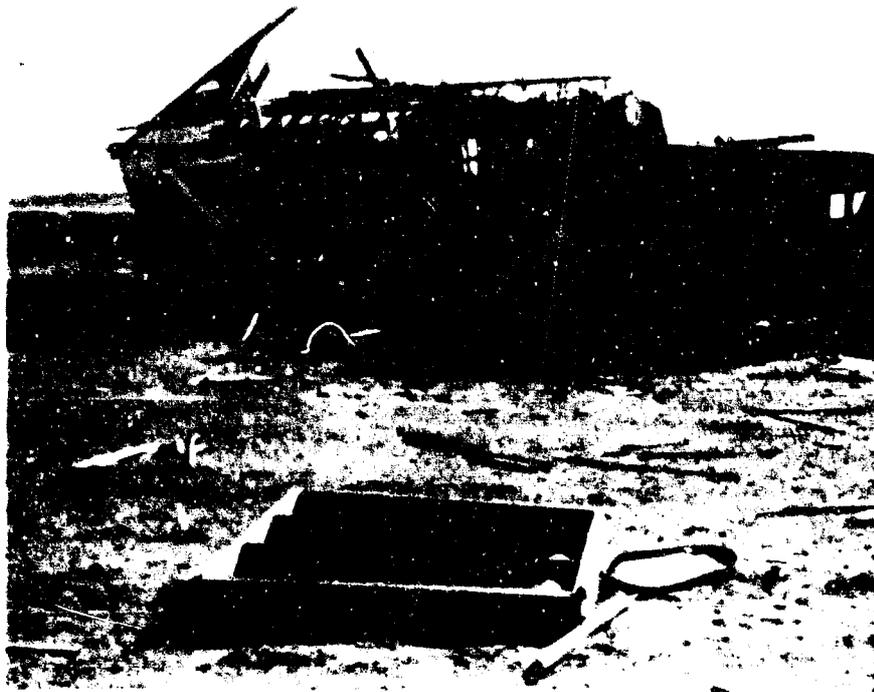
Figure 2.37 shows the front (facing the blast) of the near-range house before the explosion. Figure 2.38 shows a general view of the house after the blast, taken from about the same point. Moving around the house from the front counterclockwise, the damage is shown on the other three faces in Figs. 2.39 to 2.41. In the foreground of Fig. 2.41 the floor of the kitchen entrance is shown in an upside-down position. The house was demolished beyond repair.

Fig. 2.39—Side of the house at 3500 ft.

Fig. 2.40—Rear of the house at 3500 ft.

**Fig. 2.41—Kitchen side of the house at 3500 ft.**

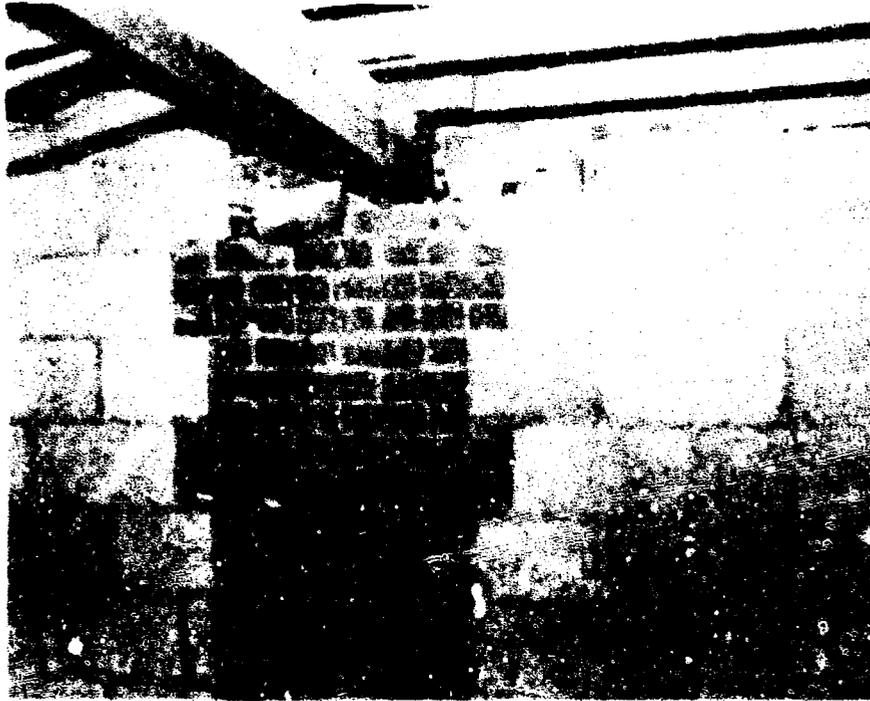
Fig. 2.47--Rear wall punctured by a wood girder.

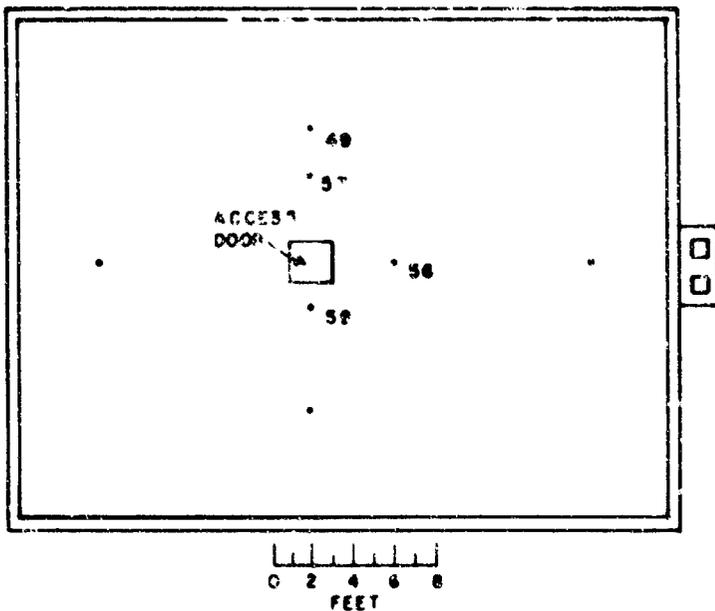
Fig. B.1—Location and total gamma readings of film badges.

GENERAL NOTE  
ALL NUMBERS INDICATE TOTAL  
GAMMA RADIATION DOSES IN  
ROENTGENS
